Inspection Report of 3 Houses – Ribamar

Case 1573/24

Date of Inspection:  
December 11, 2025

Technical Responsible Tiago  
Borges (Eng.)

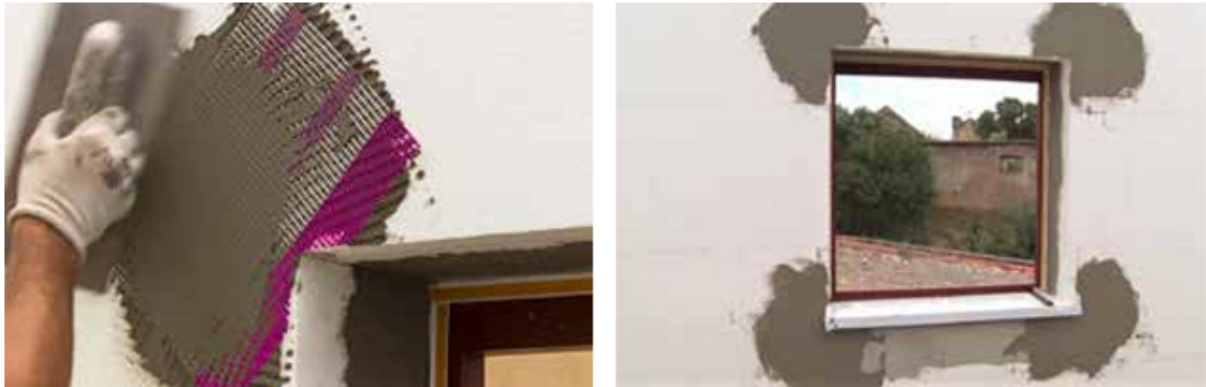
Still on the façade cladding, it is possible to observe that the lower corners of some glazed openings already have some cracking, revealing possible infiltrations on the part of the window and its threshold, as well as deficient application in this area of fiberglass, which obeys a different application from the rest, precisely to avoid this type of cracks, as shown below.

The thresholds of the glazed openings also seem to have insufficient delivery, which can contribute to infiltrations and consequently this type of cracking.

At the corners of doors and windows it is necessary to insert diagonal reinforcement nets to be applied to the bracket before applying the reinforced bar and to be fixed so that the edges of the strips are directly at the corner with an inclination of about 45 °. Network strips typically have a size of approximately 200 x 300 mm. Precast nets can be used.

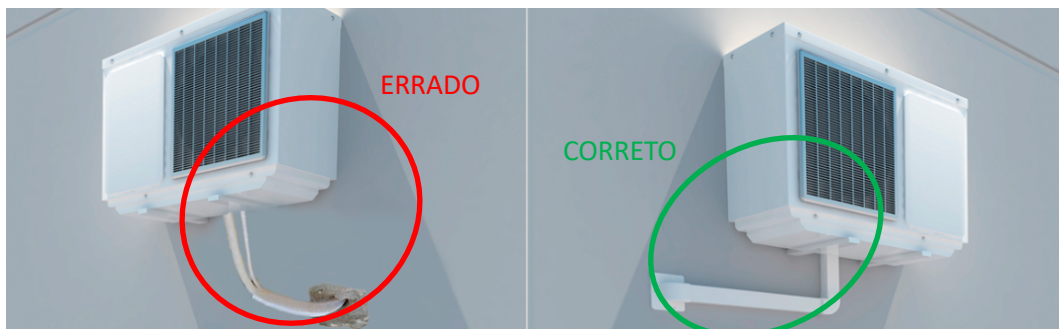
Regarding the outdoor units of air conditioners, the lack of protection of their cables through a technical rail stands out, to ensure more effective tightness and a more adequate finish, the same happens with the wiring of solar panels.

These pipes must be protected with a technical rail with the crossings fully covered with polyurethane foam as shown in the following image.

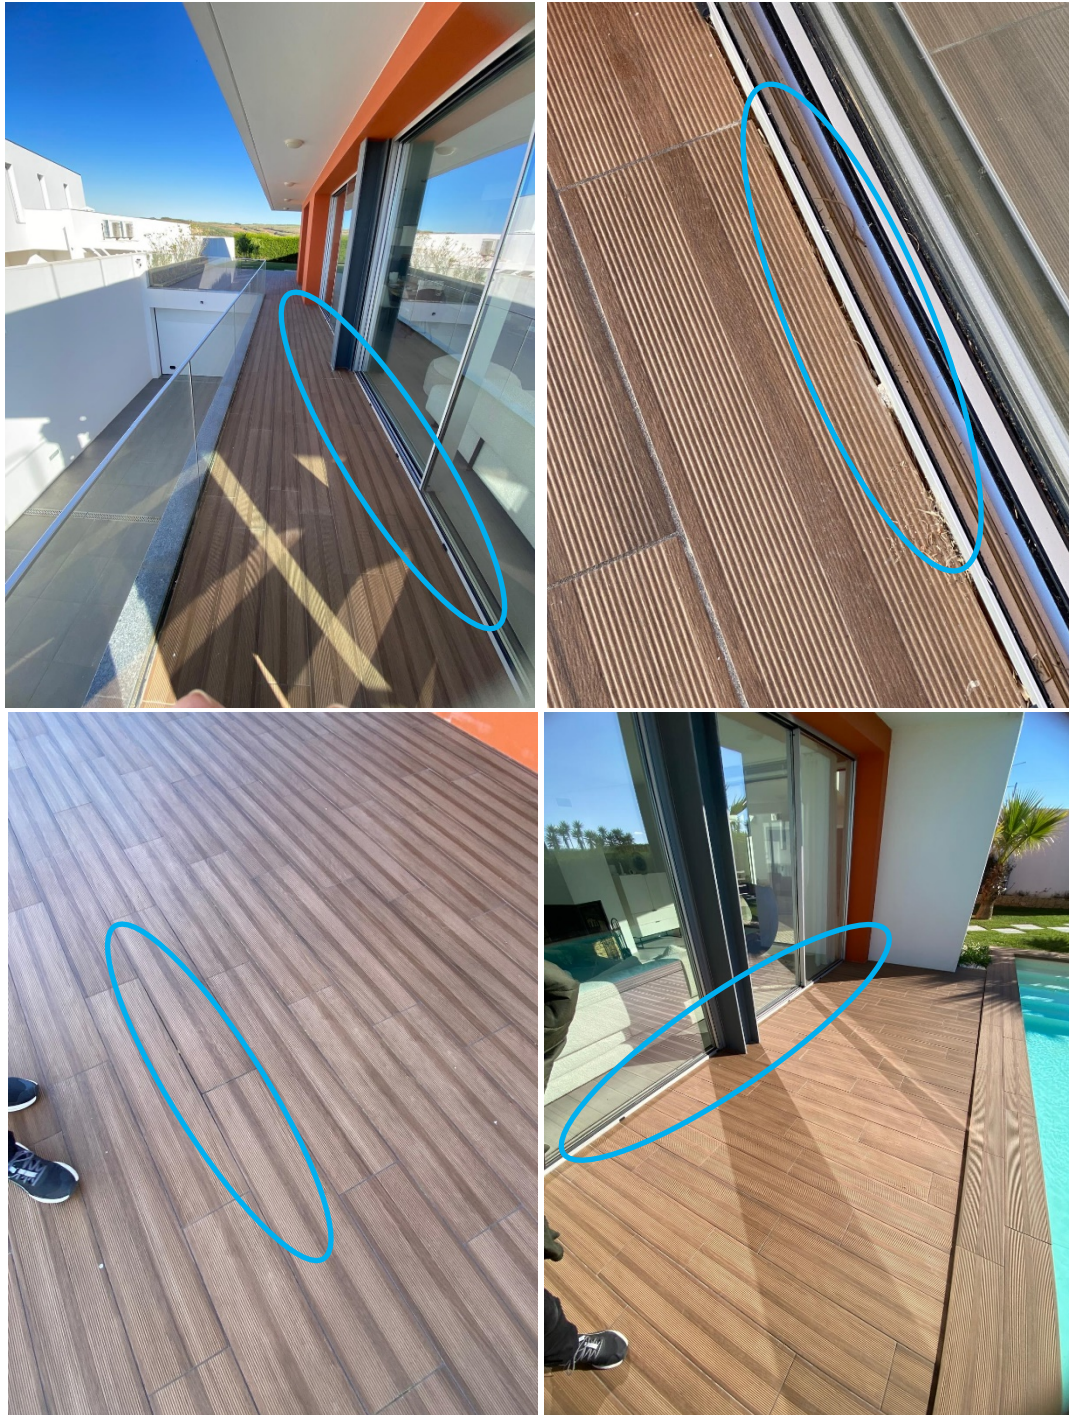
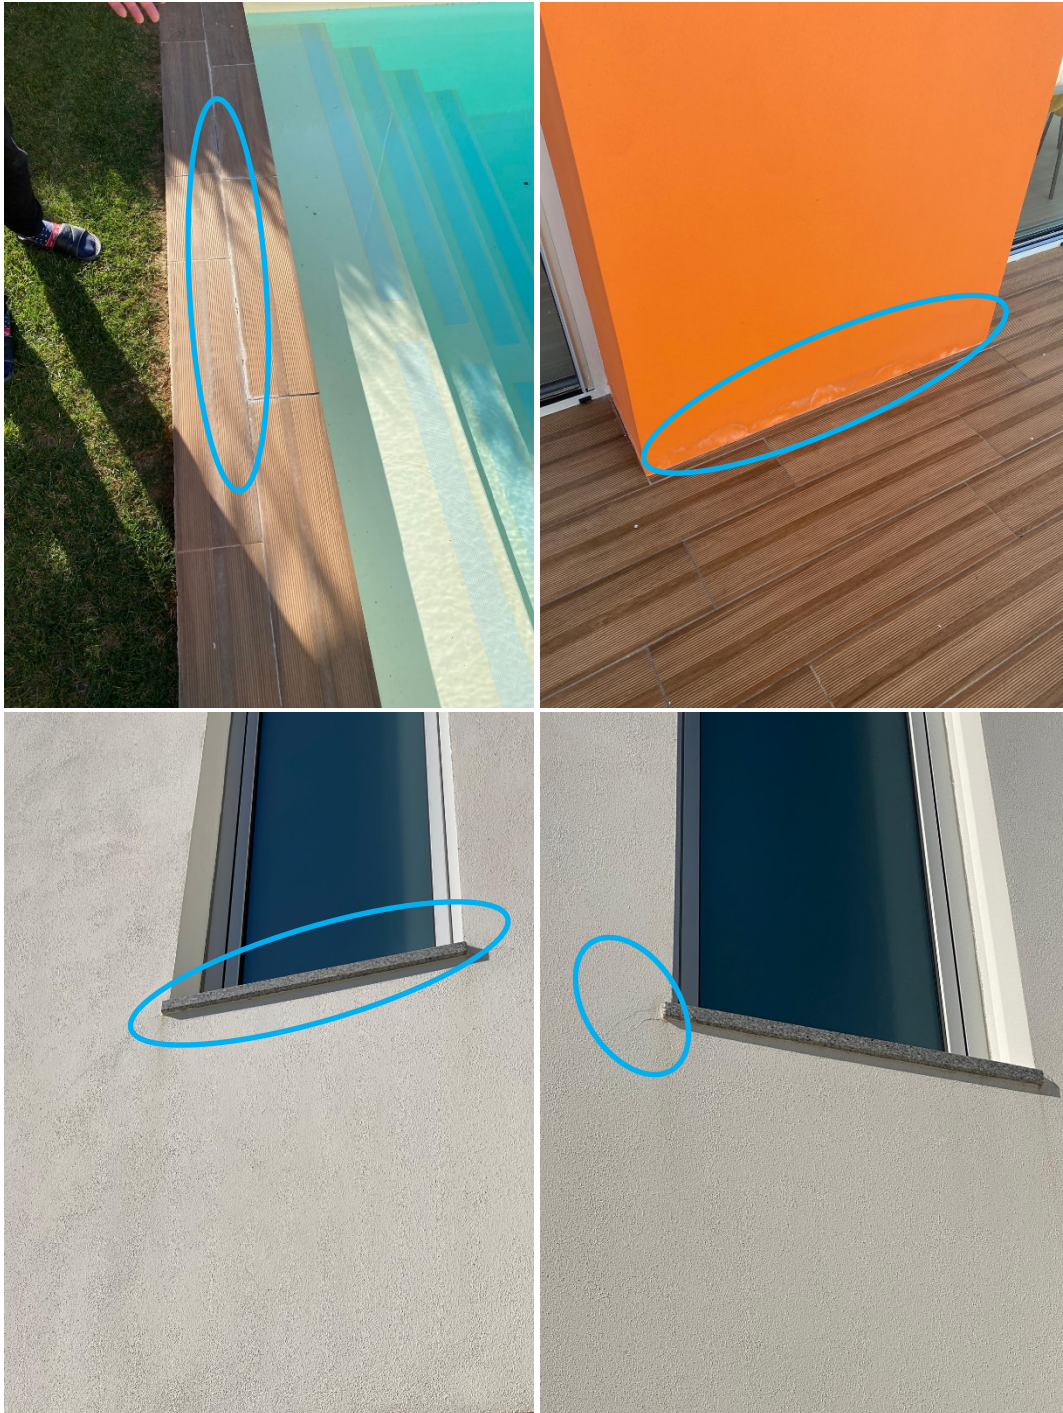
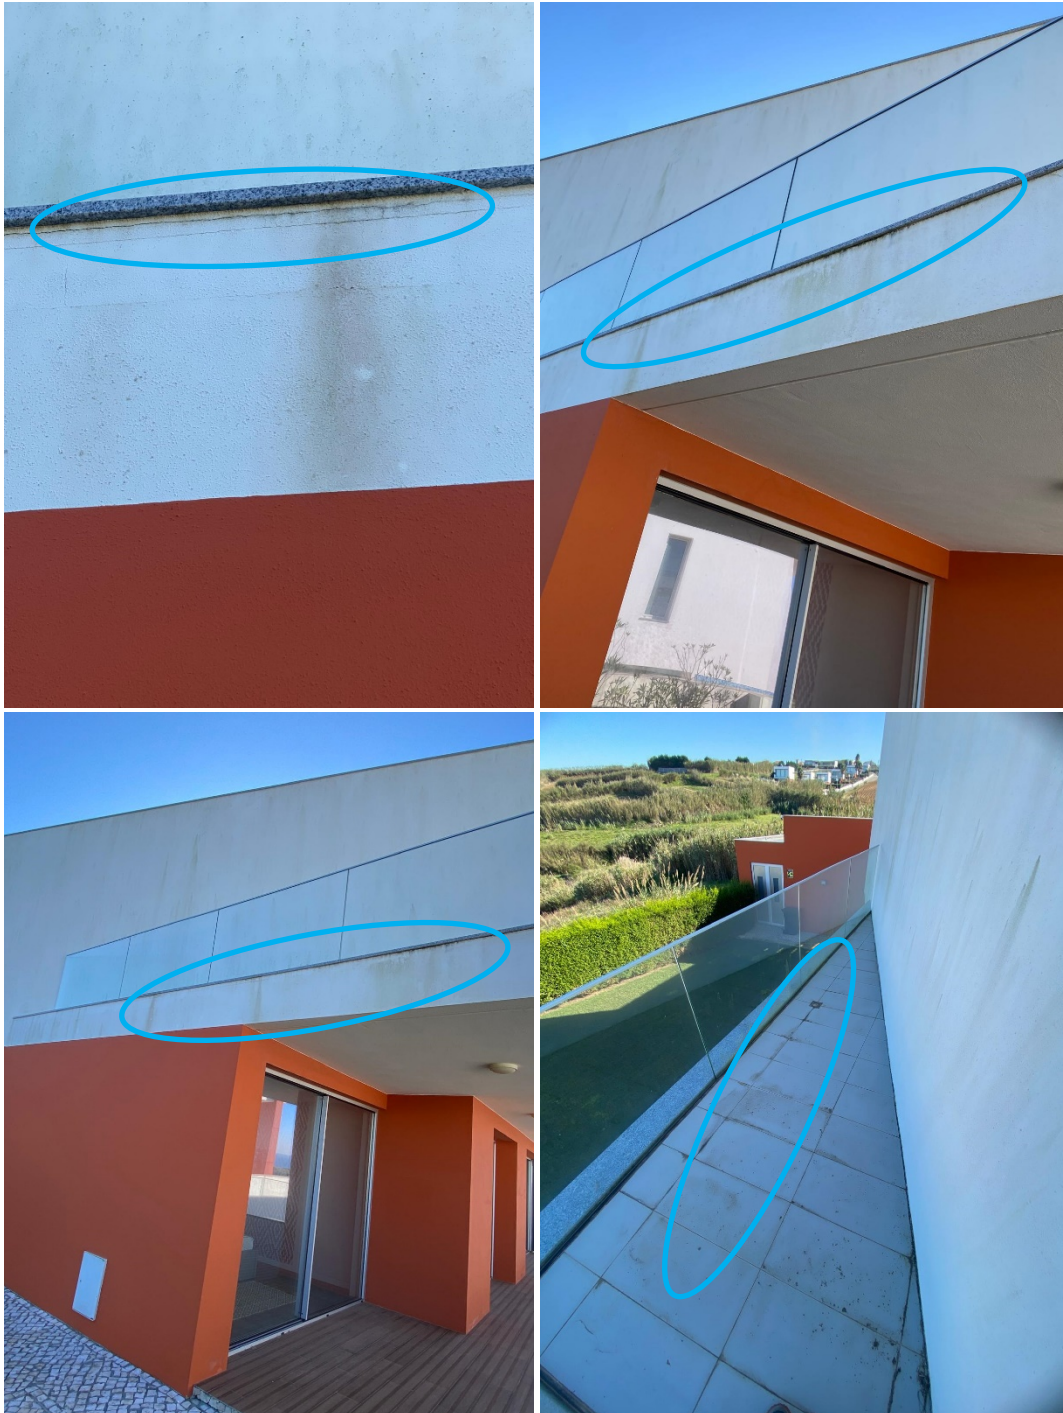
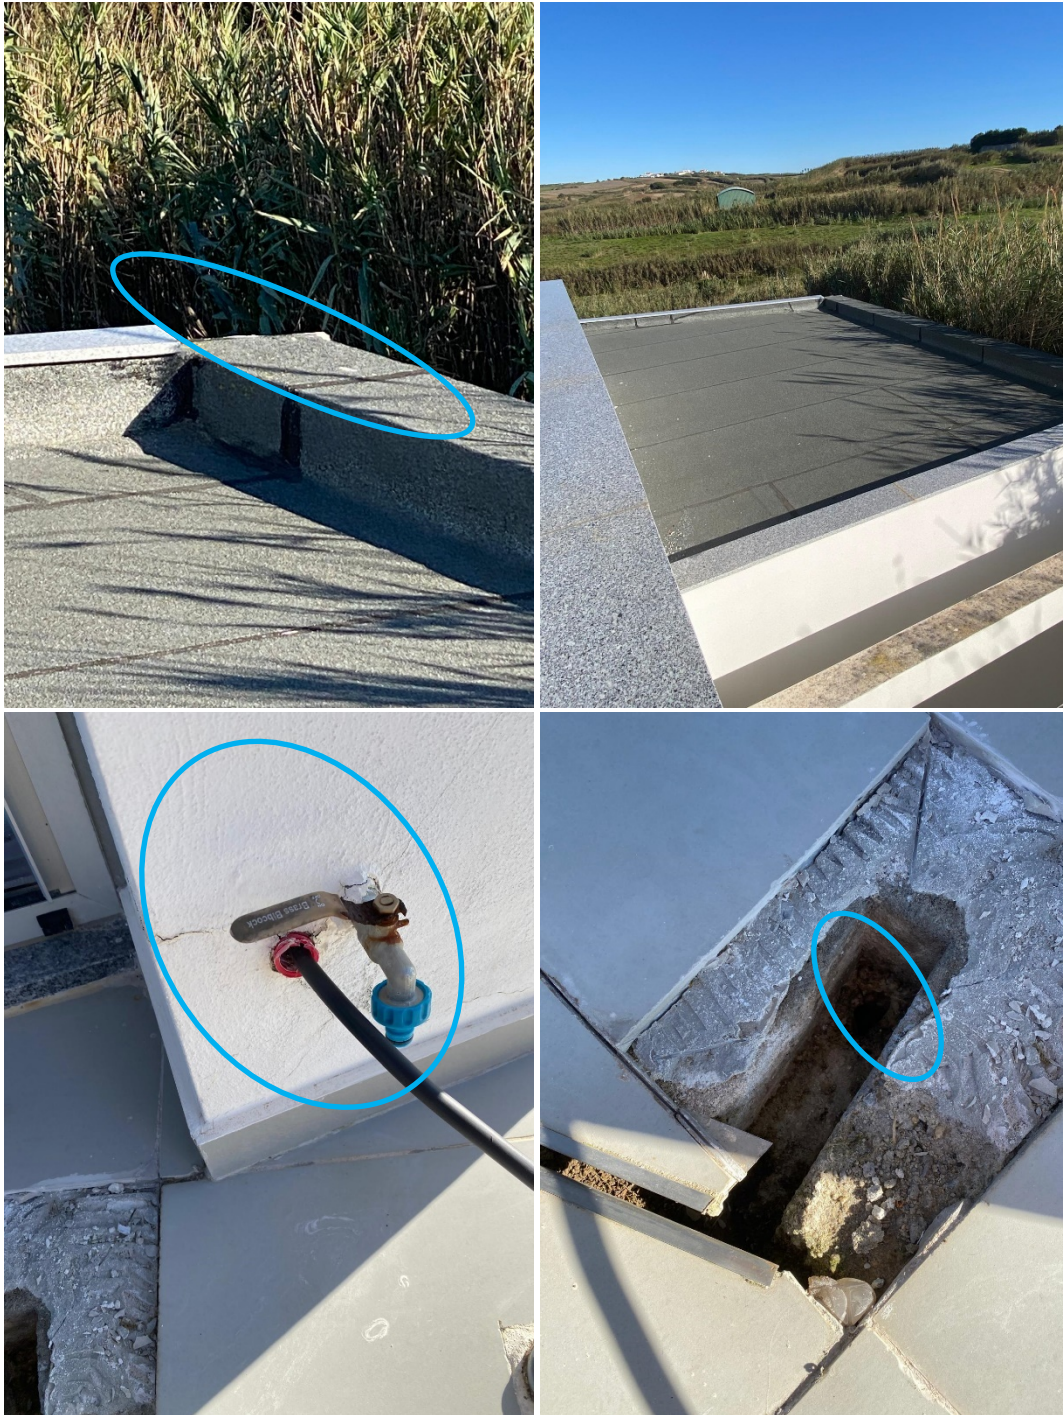
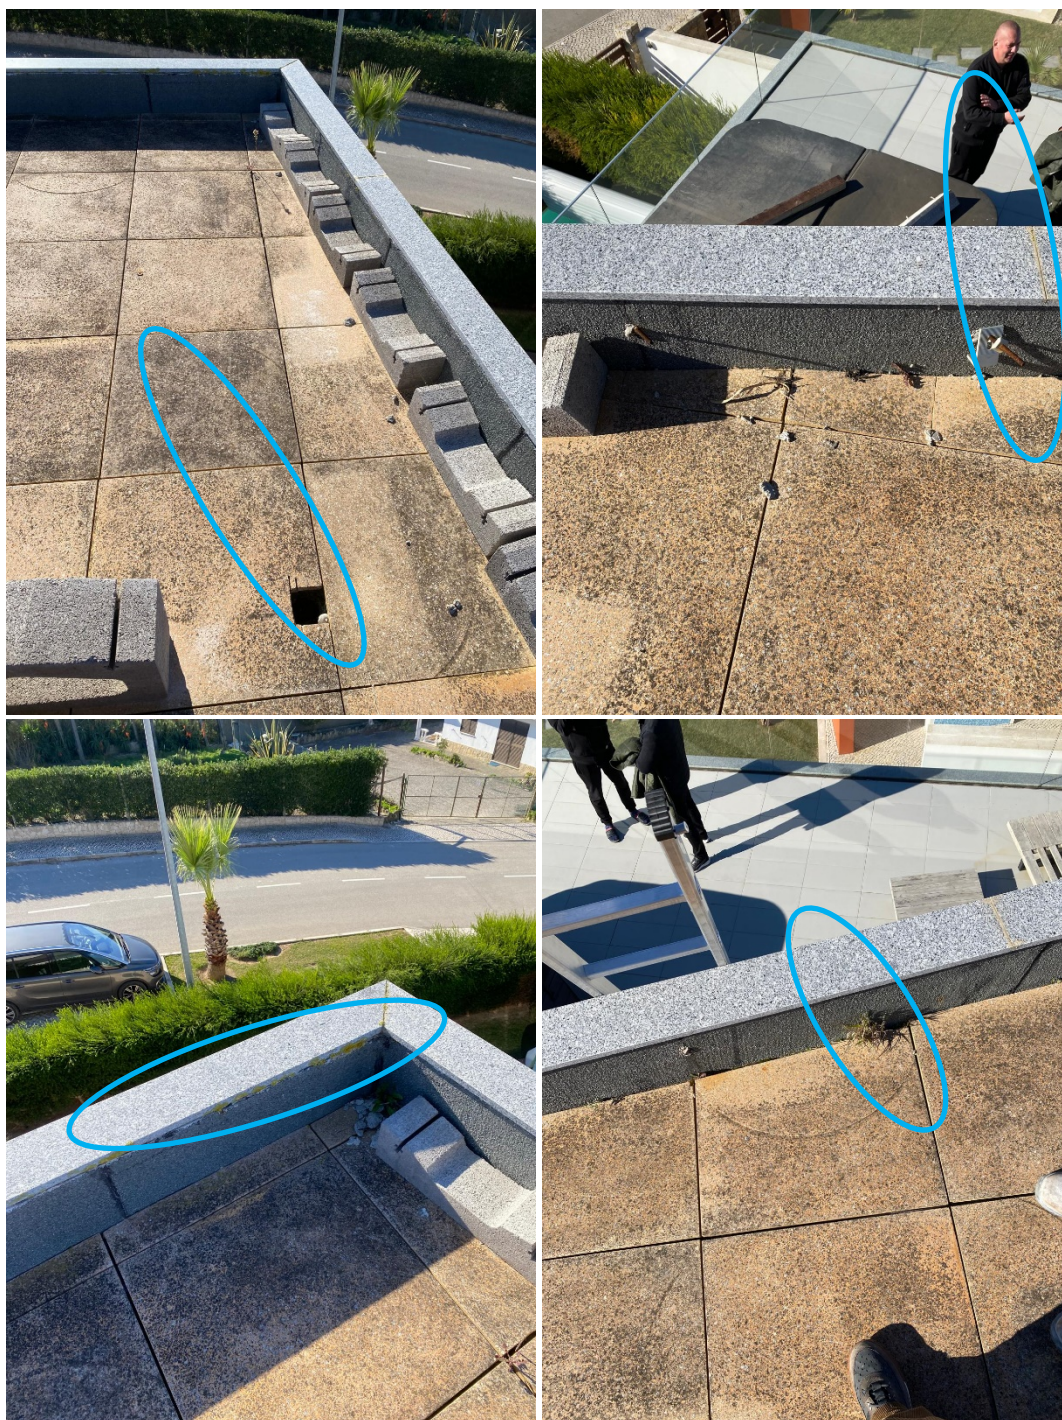
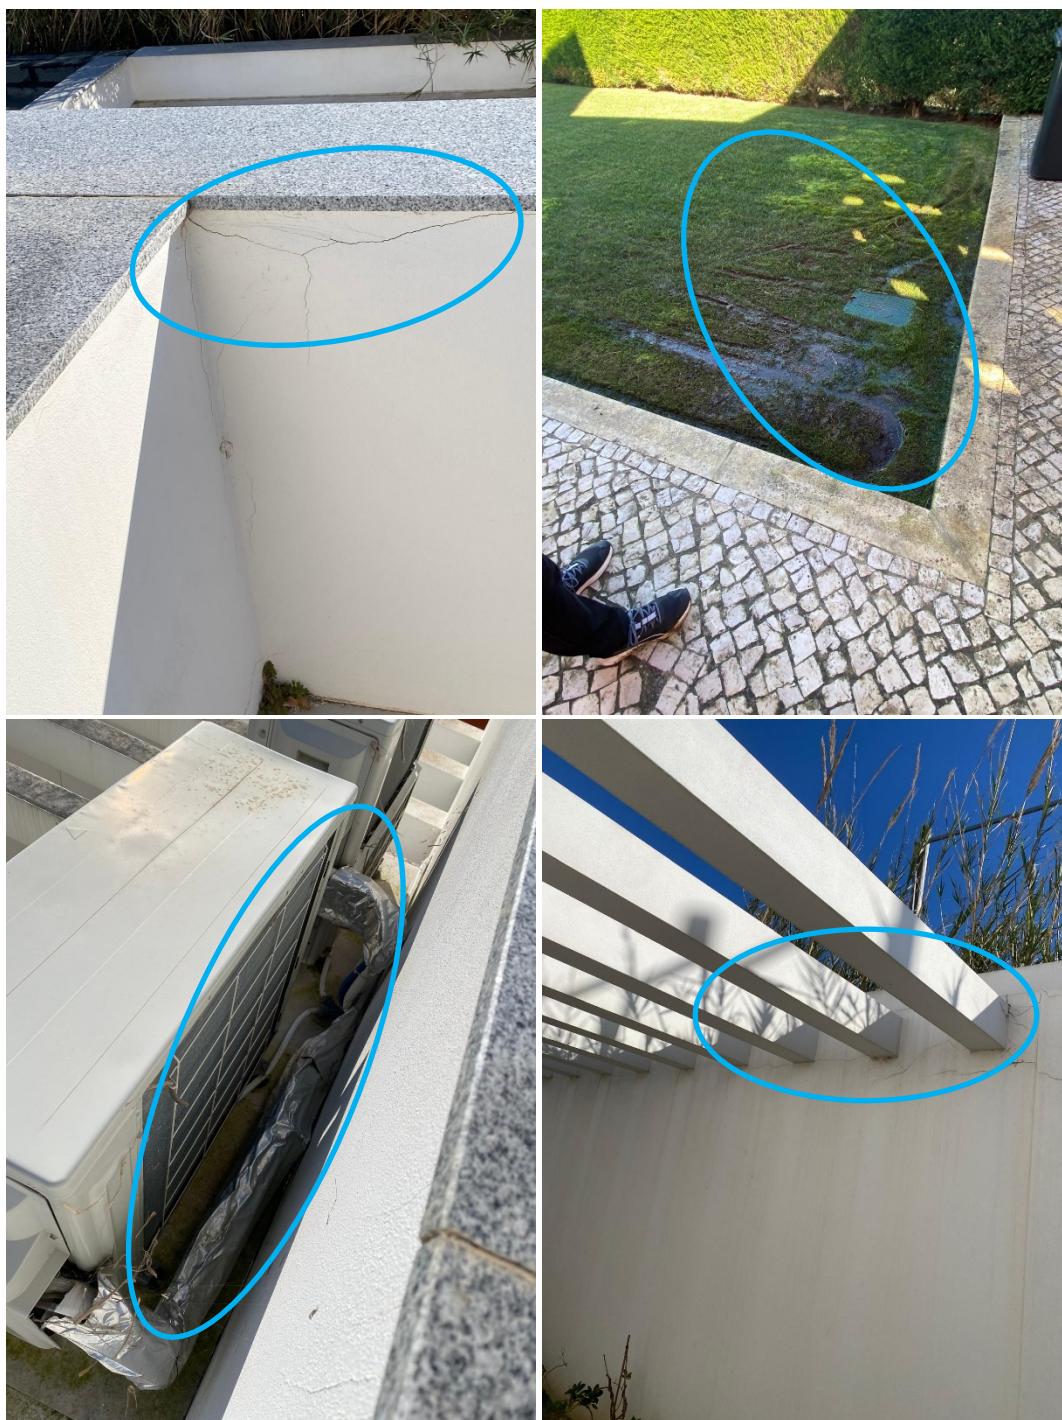
Fotos 3 a 30 – Anomalias indicadas nas fotos

Regarding the terraces of the house, it is once again noted the poor quality in the application of ceramics, especially with regard to the joints, with a deficient and poorly executed filling, very poor and deficient finishes.

The drainages in these areas also seem to be very deficient, with few rainwater collection points, in places that do not promote free and efficient drainage, such as behind chimneys, as well as unusual drainage solutions, not very effective and without taking into account future cleaning and maintenance actions, namely a tear/opening solution in the middle of the area to be drained, in turn the rainwater was sent to a very small orifice. All terraces have deficient drainage, with accumulation of water and proliferation of parasitic vegetation.

All the capping of the walls of the terraces and roof were executed in stonework, and these stone pieces do not have any drip pan, promoting drainage along the walls where they are applied. In addition to the above, the stonework solution is not the most effective because there is the possibility of infiltrations in the joints of the pieces, it is already possible to observe the presence of organic matter in these joints indicating the presence of water. Once again, aiming at a higher quality, sheet metal capping should have been chosen, as they are more effective in promoting the watertightness of the walls and the overall building. It is also noteworthy the absence of any capping in one of the walls of the roof of the annexes, and this roof even has watertightness problems, which is already manifested through dampness in ceilings and walls inside the annexes.

Another factor revealing the lack of perimeter drainage of this house is the accumulation of water in the gardens pooling large areas.

Some exterior walls also already have some cracking, namely next to some external beams that form a kind of pergola, as well as under some stone capping. These cracks are not worrisome, given their size, although they need to be repaired.

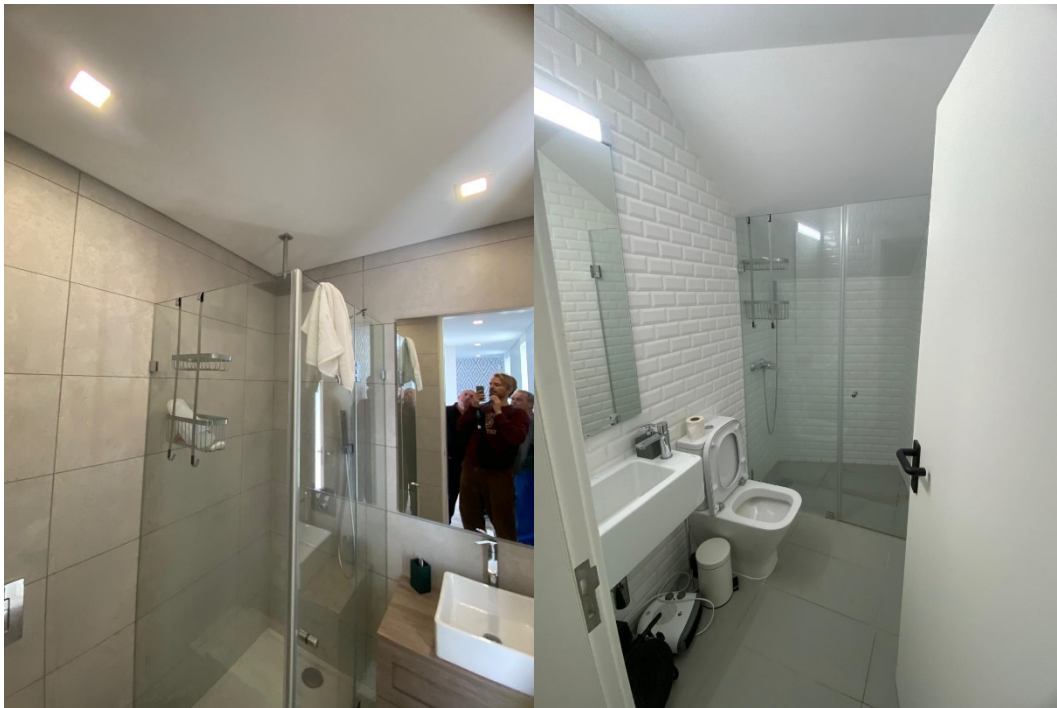
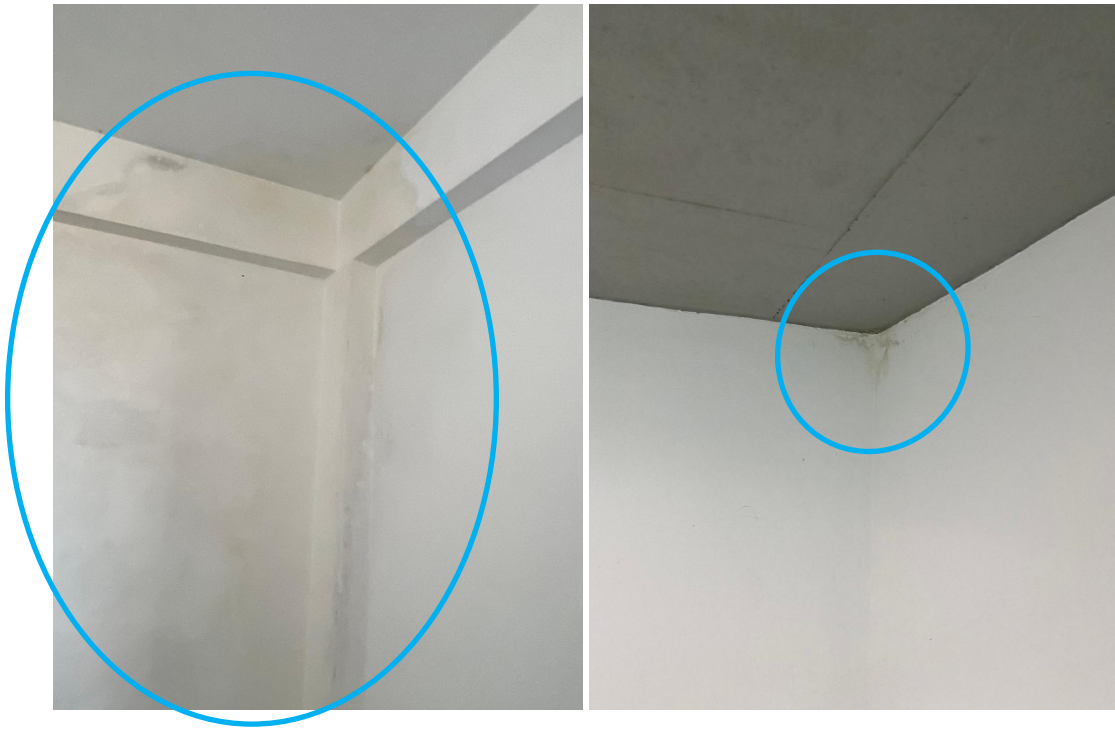
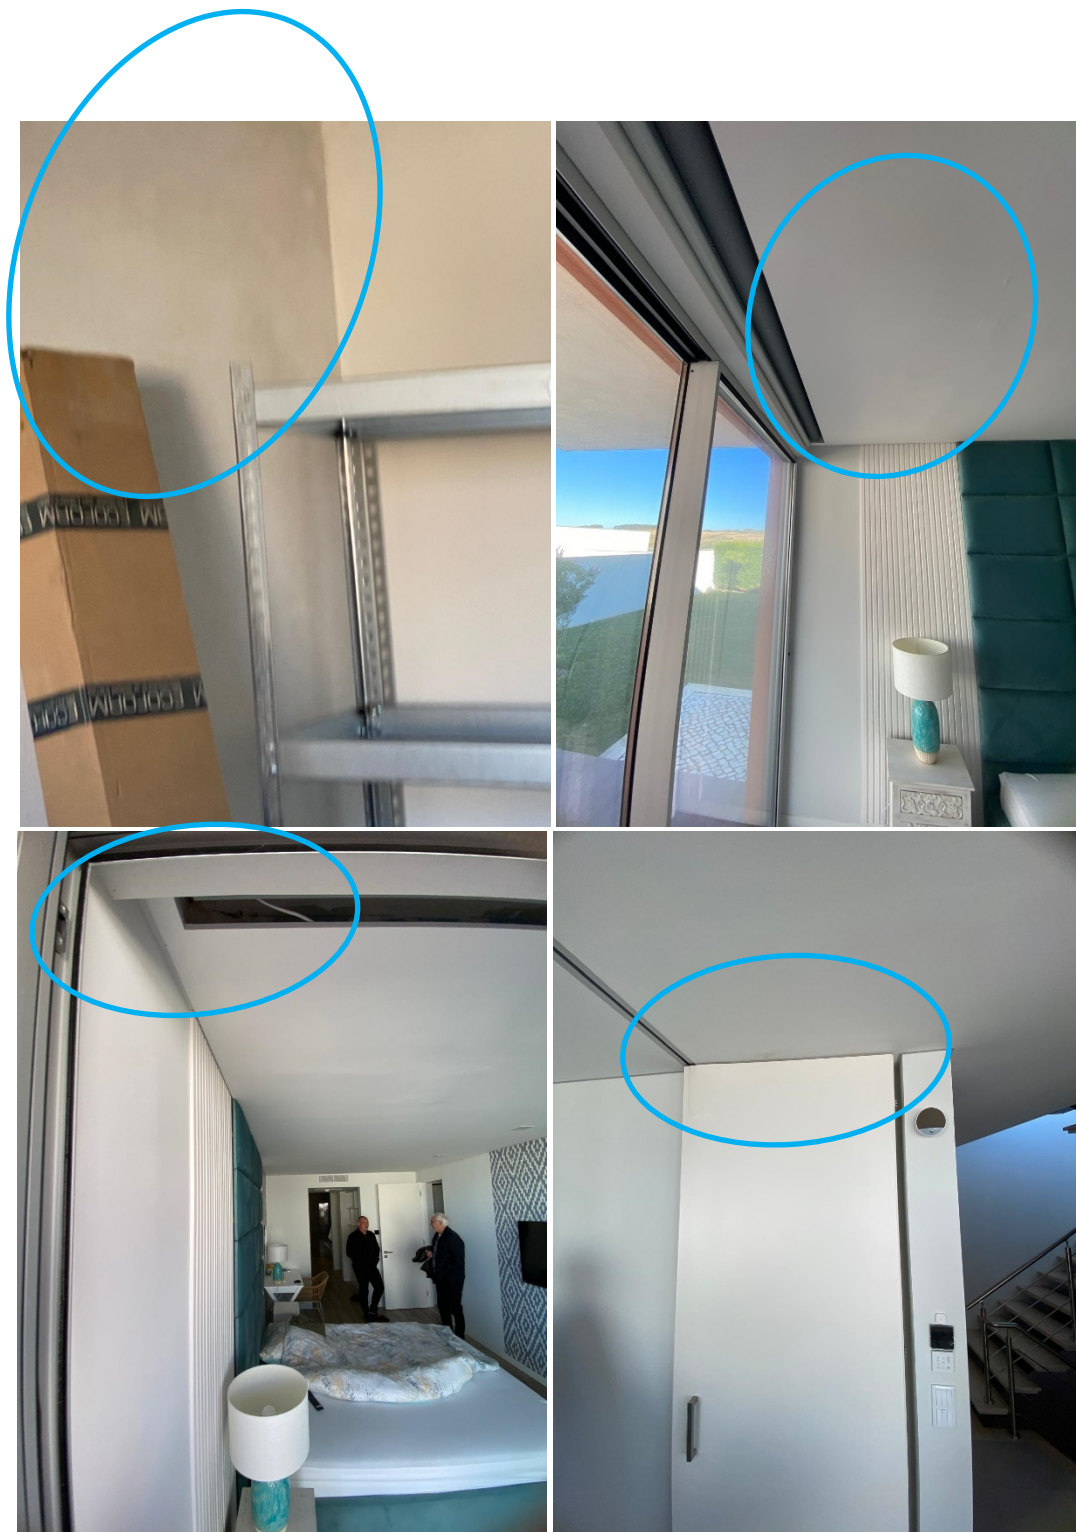
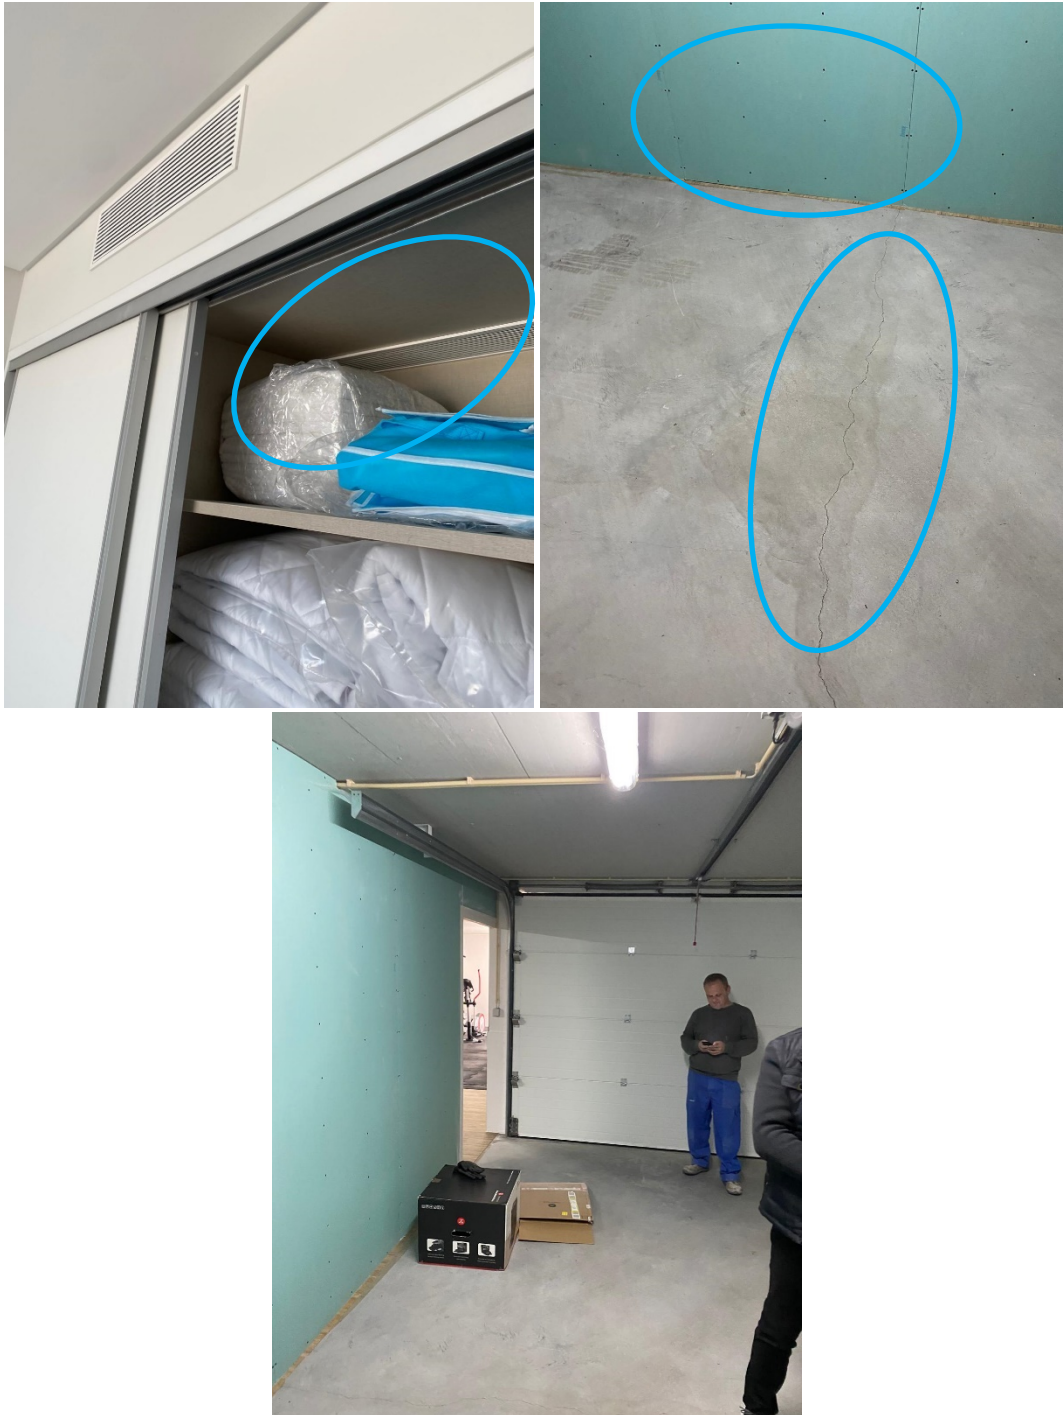
Photos 31 and 41 – Anomalies indicated in the photos

It should be noted that the ventilation of the ground floor toilet was carried out through a simple opening in the wall, without any piping and finished only with an open grille, which is not the right solution for this case, since there is no blockage to the entry of light and air currents from the outside. This type of ventilation serves to expel saturated air from the inside out, while preventing and/or mitigating the entry of air from the outside, as well as the entry of insects and light, which in this case is not the case, not being consistent with the quality that the house proposes. The remaining toilets

The annexes, as already mentioned, have humidity on the walls and ceilings resulting from the lack of watertightness of their roof.

It was decided to pass rainwater pipes, coming from the roof and upper terraces, through the inside of the false ceilings, an uncommon solution that is not the most suitable in terms of maintenance, as this type of pipes is exposed to external elements, having a greater probability of obstructions and clogs through debris, dust, leaves, etc., so it is desirable that its tracing is always carried out from the outside, avoiding infiltrations and flooding inside the house, which in this case has already happened, and it was necessary to open the false ceiling and/or repair it in several compartments, a bedroom and in the living room.

There are no technical trapdoors in the false ceiling for visiting and maintaining the A\C pipes, forcing them to be destroyed whenever any intervention of this type is necessary, as has already happened.

In the basement, the presence of moisture by capillary in the walls is notorious, as well as cracks in the reinforced concrete floor, in order to hide the moisture on the walls, they were covered with sheets of insulating and waterproof material, however this procedure **only masks the problem without solving it, demonstrating once again insufficient perimeter drainage of the house.**

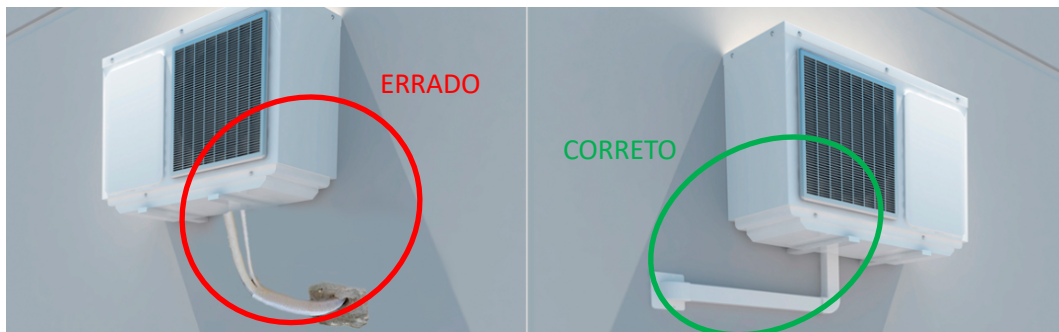
Regarding the outdoor units of air conditioners, the lack of protection of their cables through a technical rail stands out, to ensure more effective tightness and a more adequate finish, the same happens with the wiring of solar panels.
