Inspection Report of 3 Houses – Ribamar

Case 1573/24

Date of Inspection:  
December 11, 2025

Technical Responsible Tiago  
Borges (Eng.)

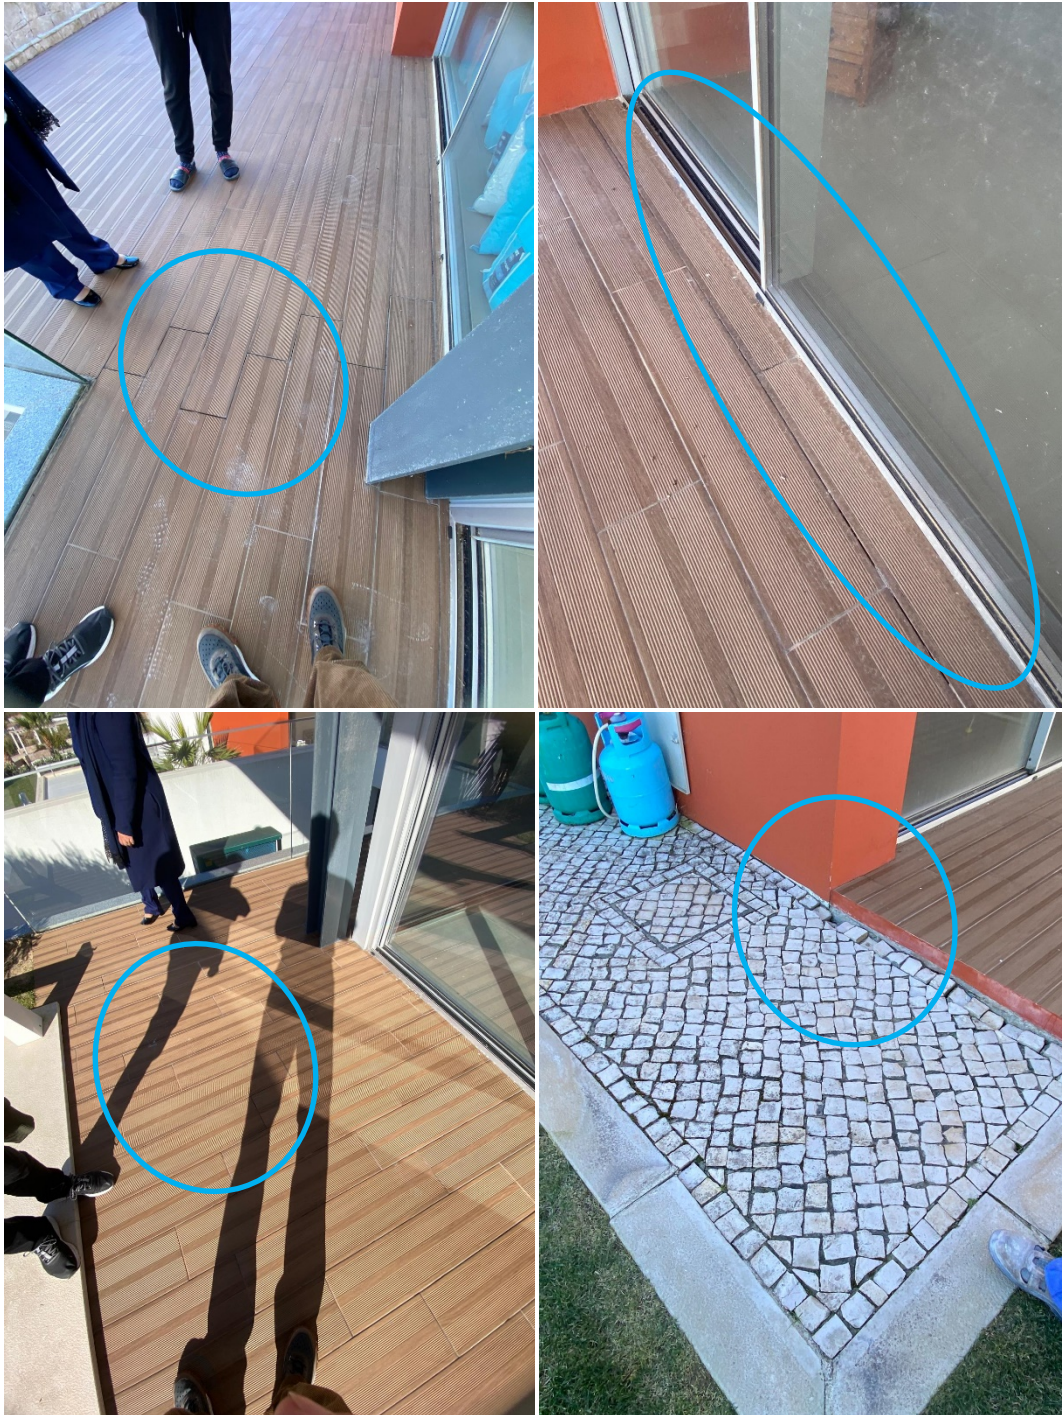
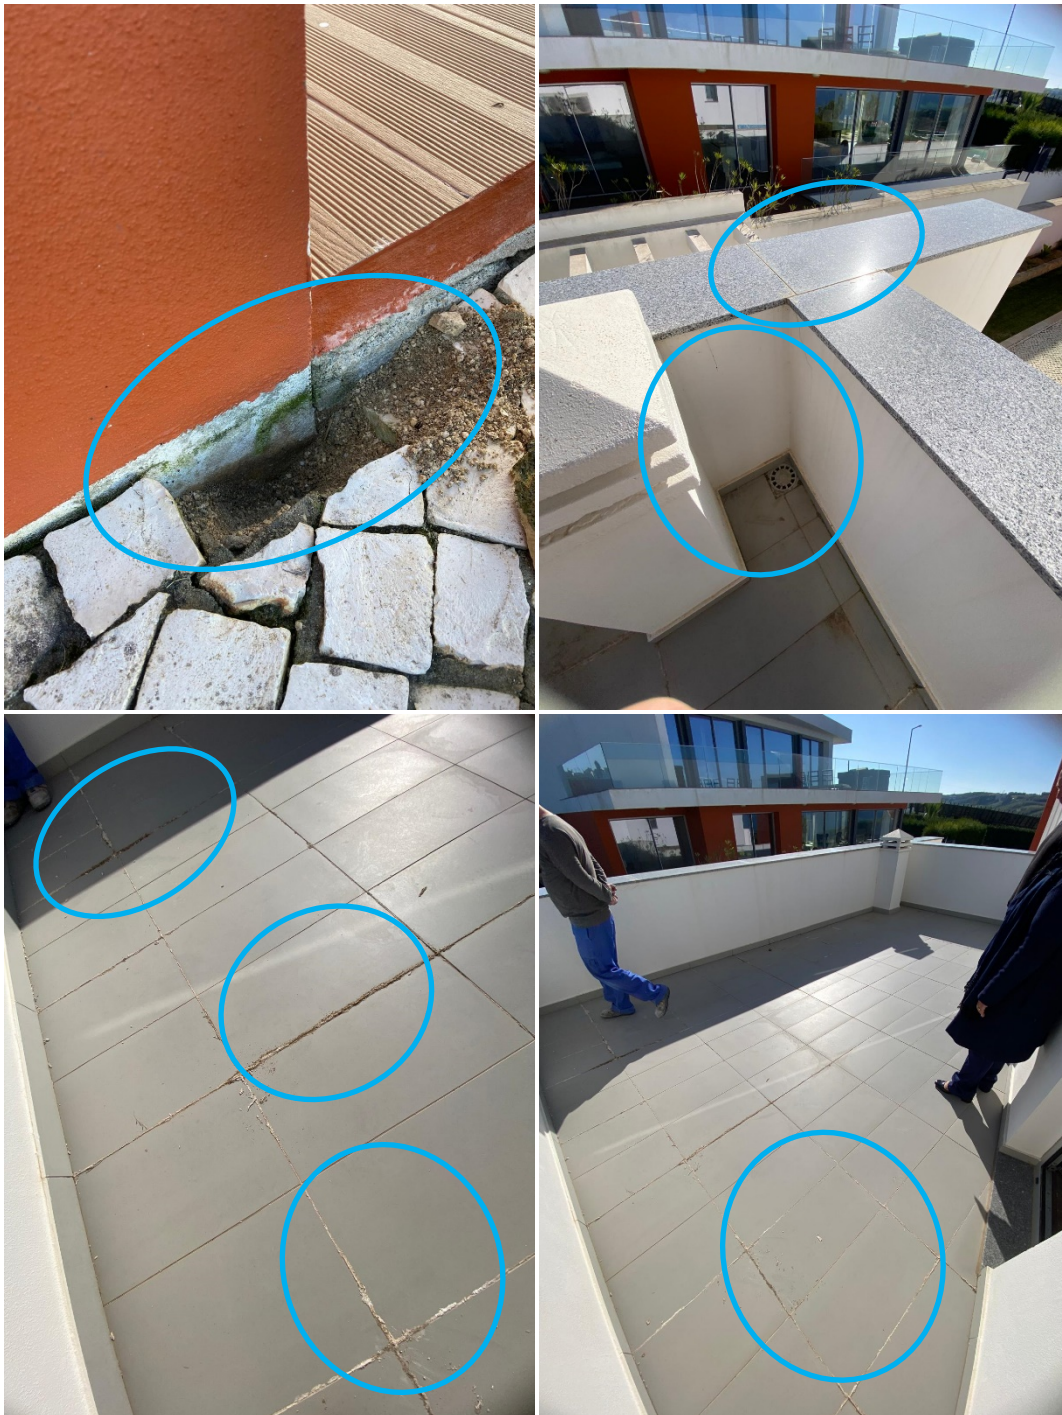
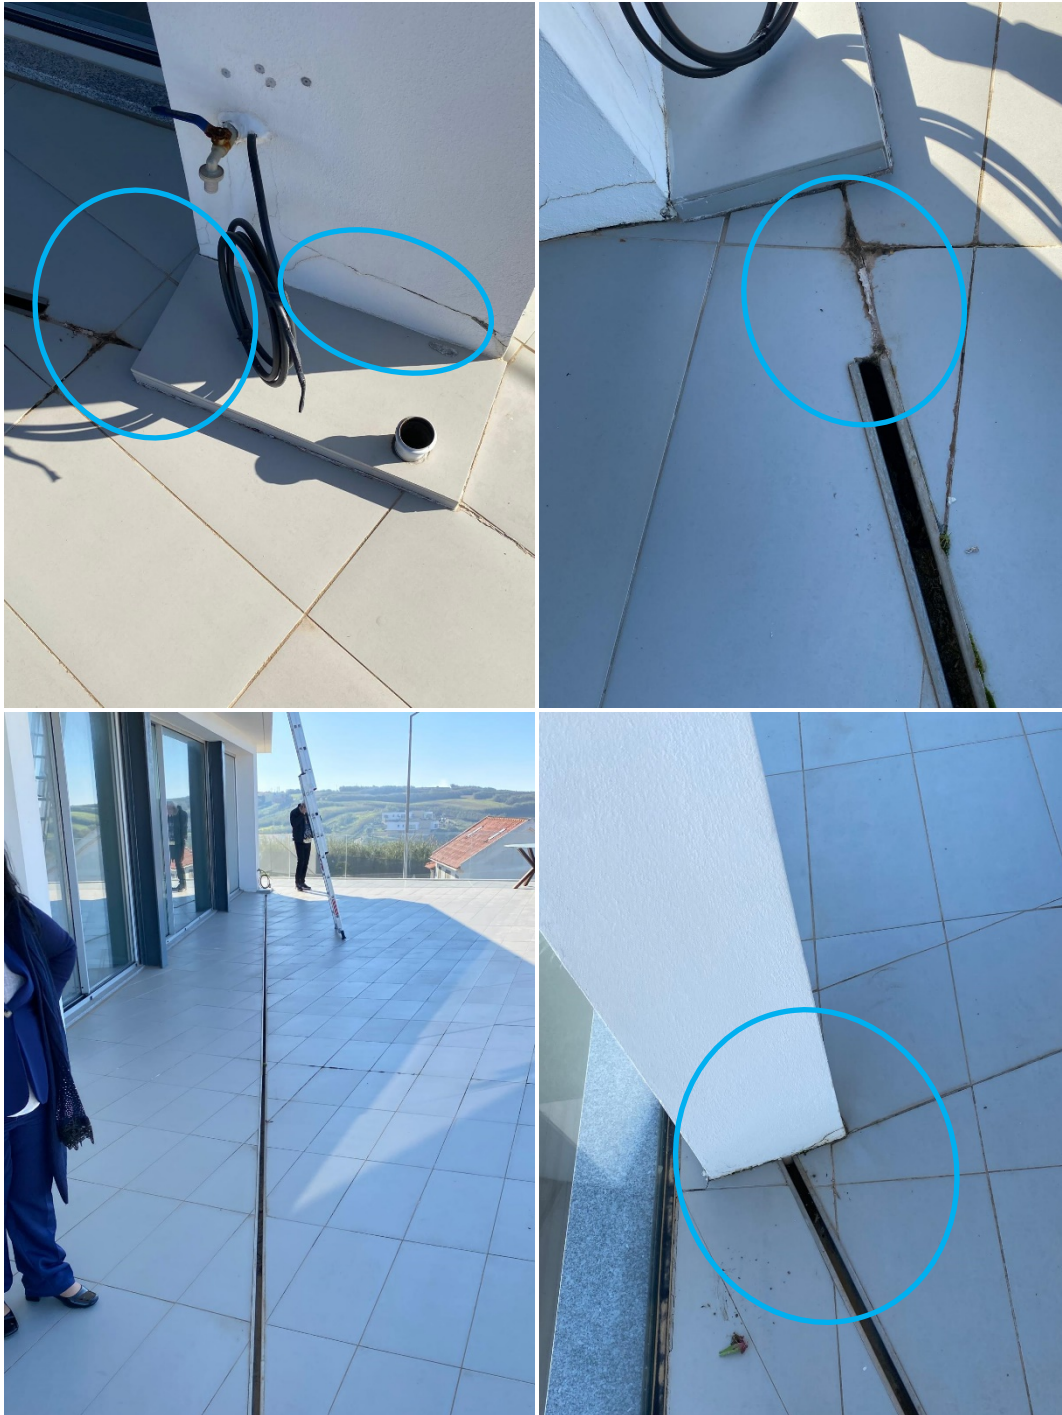
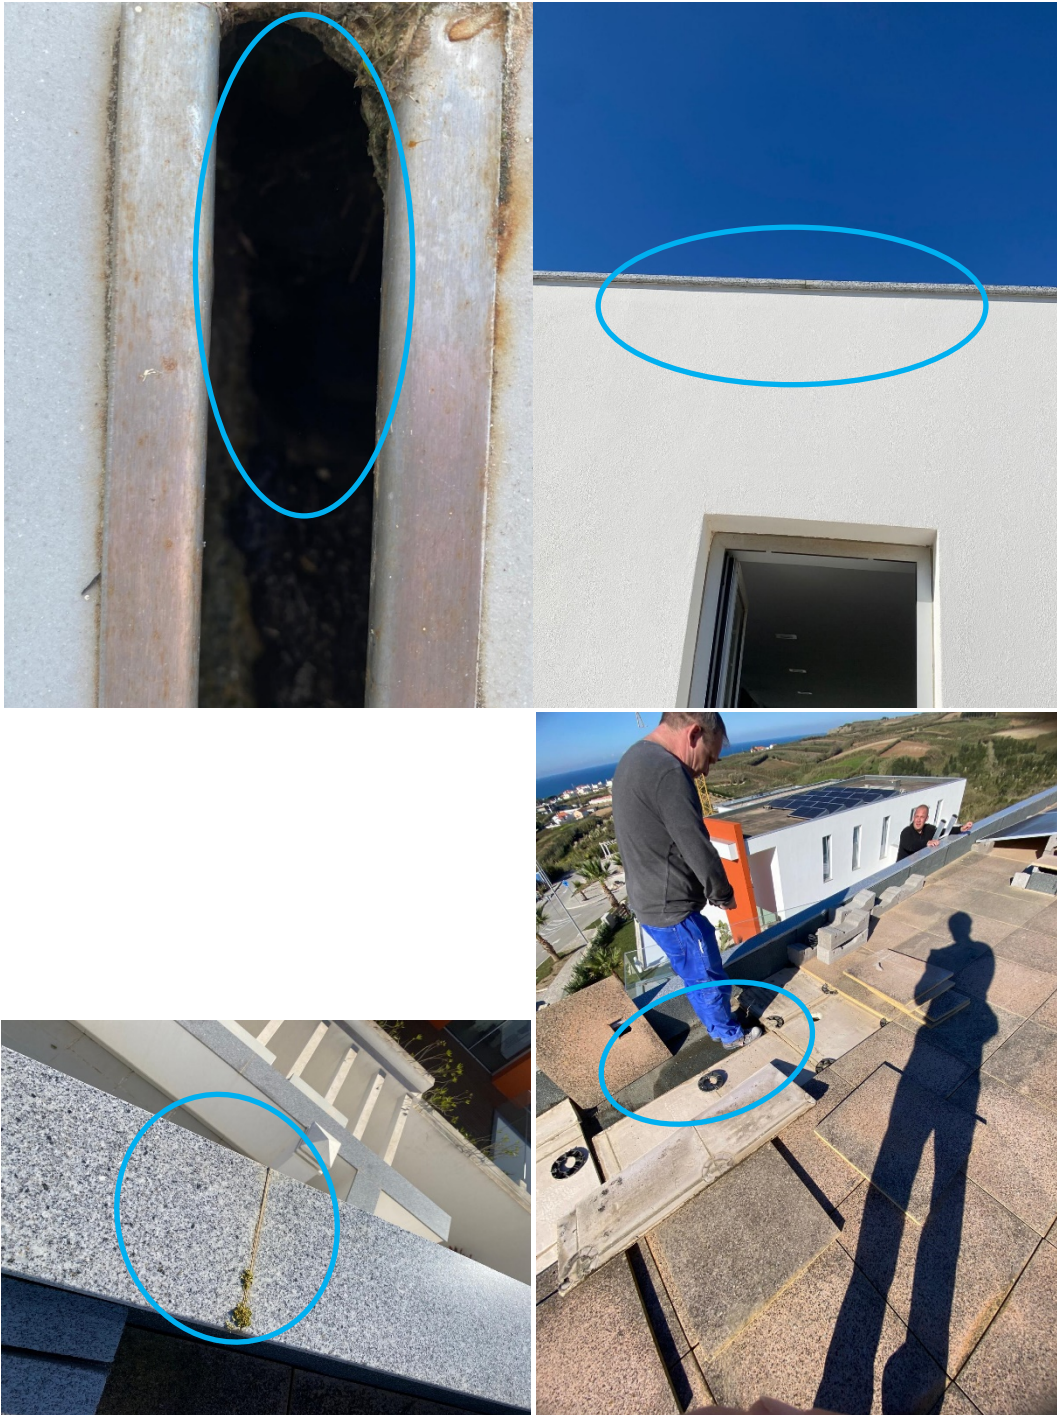
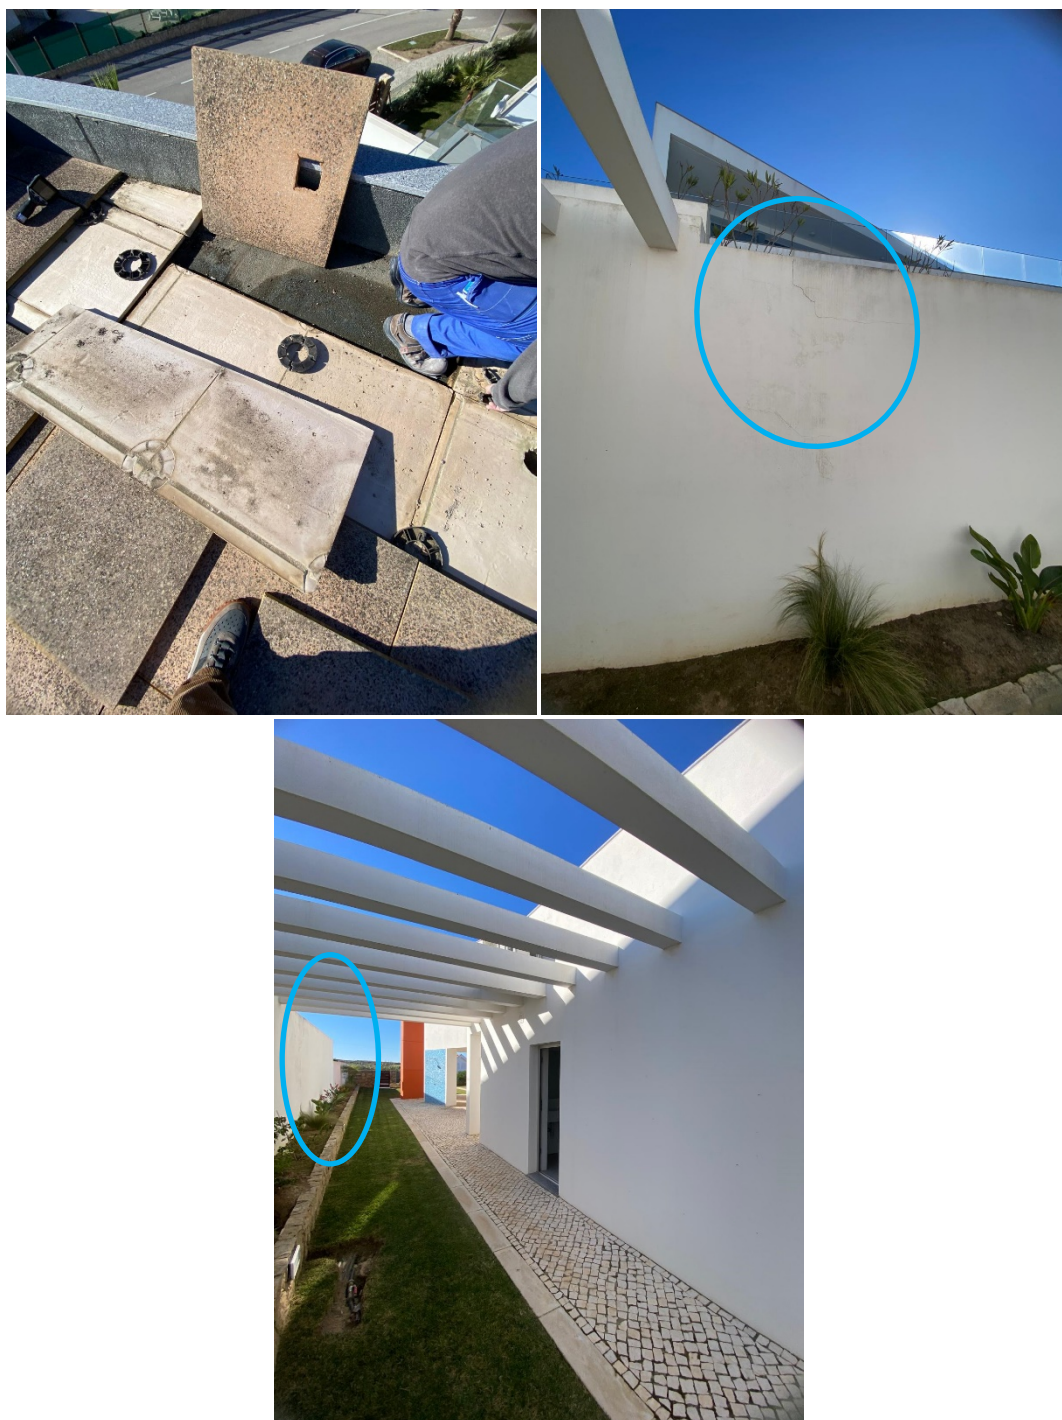
Fotos 43 a 69 – Anomalias indicadas nas fotos

In the areas of Portuguese pavement it is possible to observe settlements of the same, revealing that the base ground was poorly compacted and has high levels of water, once again associated with insufficient or non-existent perimeter drainage of the soils.

Regarding the terraces of the house, it is once again noted the poor quality in the application of ceramics, especially with regard to the joints, with a deficient and poorly executed filling, very poor and deficient finishes.

The drainages in these areas also seem to be very deficient, with few rainwater collection points, in places that do not promote free and efficient drainage, such as behind chimneys, as well as unusual

drainage solutions, not very effective and without taking into account future cleaning and maintenance actions, namely a tear/opening solution in the middle of the area to be drained, in turn the rainwater was sent to a very small orifice.

All the capping of the walls of the terraces and roof were executed in stonework, and these stone pieces do not have any drip pan, promoting drainage along the walls where they are applied. In addition to the above, the stonework solution is not the most effective because there is the possibility of infiltrations in the joints of the pieces, it is already possible to observe the presence of organic matter in these joints indicating the presence of water. Once again, aiming at a higher quality, sheet metal capping should have been chosen, as they are more effective in promoting the watertightness of the walls and the overall building.

Some exterior walls also already have some cracking, namely next to some external beams that form a kind of pergola. These cracks are not worrisome, given their size, although they need to be repaired.

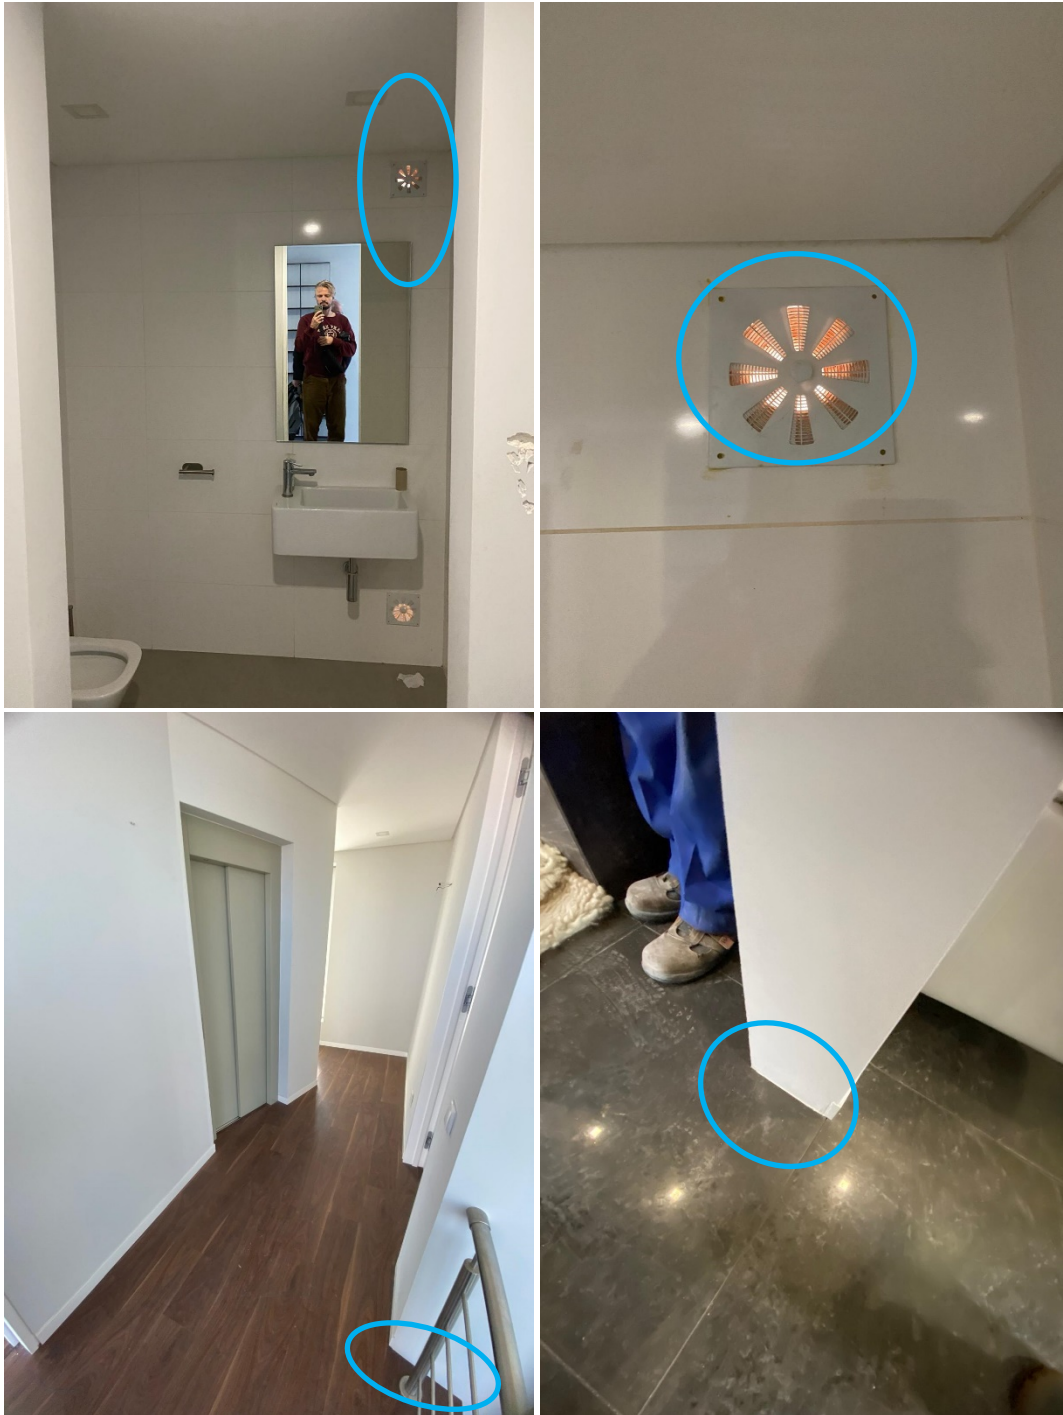
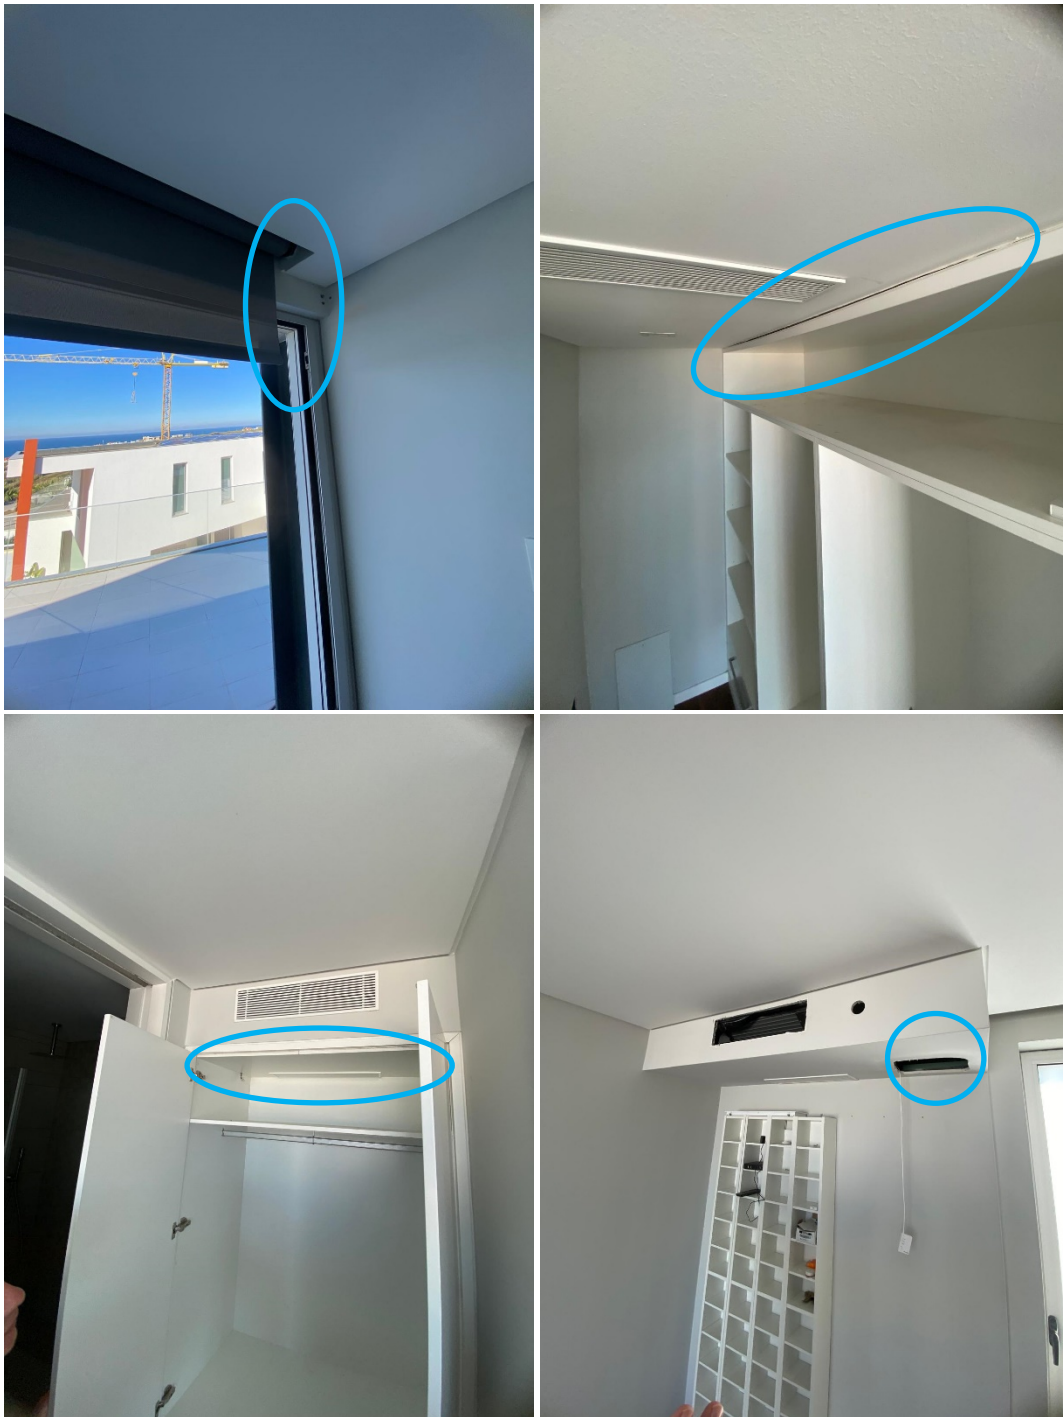
Fotos 70 a 85 – Anomalias indicadas nas fotos

It should be noted that the ventilation of the ground floor toilet was carried out through a simple opening in the wall, without any piping and finished only with an open grille, which is not the right solution for this case, since there is no blockage to the entry of light and air currents from the outside. This type of ventilation serves to expel saturated air from the inside out, while preventing and/or mitigating the entry of air from the outside, as well as the entry of insects and light, which in this case is not the case, not being consistent with the quality that the house proposes.

In terms of interior coverings, several defects and construction anomalies stand out, namely in the skirting boards that do not seem to have a coherent continuity, being present in certain walls and then in the adjoining walls do not exist, in ceramic coverings with different shades of colour, seeming that not all pieces have the same RAL and in the lower finish of the areas covered with stone. In the latter, instead of first applying the ceramic tile to the floor and then the stone coating to the wall, so that the border area between the two materials is perfectly disguised, the opposite was done, finishing the perimeter zone between the two materials with layers of mortar, a crude, unaesthetic and poor quality solution.

It was decided to pass rainwater pipes, coming from the roof and upper terraces, through the inside of the false ceilings, an uncommon solution that is not the most suitable in terms of maintenance, as this type of pipes is exposed to external elements, having a greater probability of obstructions and clogs through debris, dust, leaves, etc., so it is desirable that its tracing is always carried out from the outside, avoiding infiltrations and flooding inside the house, which in this case has already happened, and it was necessary to open the false ceiling.

In the kitchen, something completely unusual was found, the visible piping of the hood that enters inside the false ceiling does not continue to the outside, that is, all the vapors, fats, gases and smells resulting from the process of cooking food and absorbed by the hood, are expelled into the air space between the false ceiling and the slab of the house, instead of being sent abroad as it is supposed to, making the use of the hood completely irrelevant and reductive and disseminating cheiros coming

from the kitchen through the remaining compartments. In addition to being irregular, this aspect alone reveals a completely absurd and bad faith attitude on the part of the builder.

The built-in cabinets have poorly executed finishes near the ceilings and in some cases the air extraction and ventilation grilles of the compartments are inside them, so that, in order for there to be effective ventilation of the spaces, the users of the property are forced to open the doors of these cabinets.

There are no technical trapdoors in the false ceiling for visiting and maintaining the A\C pipes, forcing them to be destroyed whenever any intervention of this type is necessary, as has already happened.
