The Report

February 2025

This report systematises and organises the numerous construction and workmanship errors occurring in the private residential house located in Lote 2 - Casais Porto Dinheiro.

The discrepancies were identified based on the construction project of the residential building 12146/2017, hereinafter referred to as The Project.

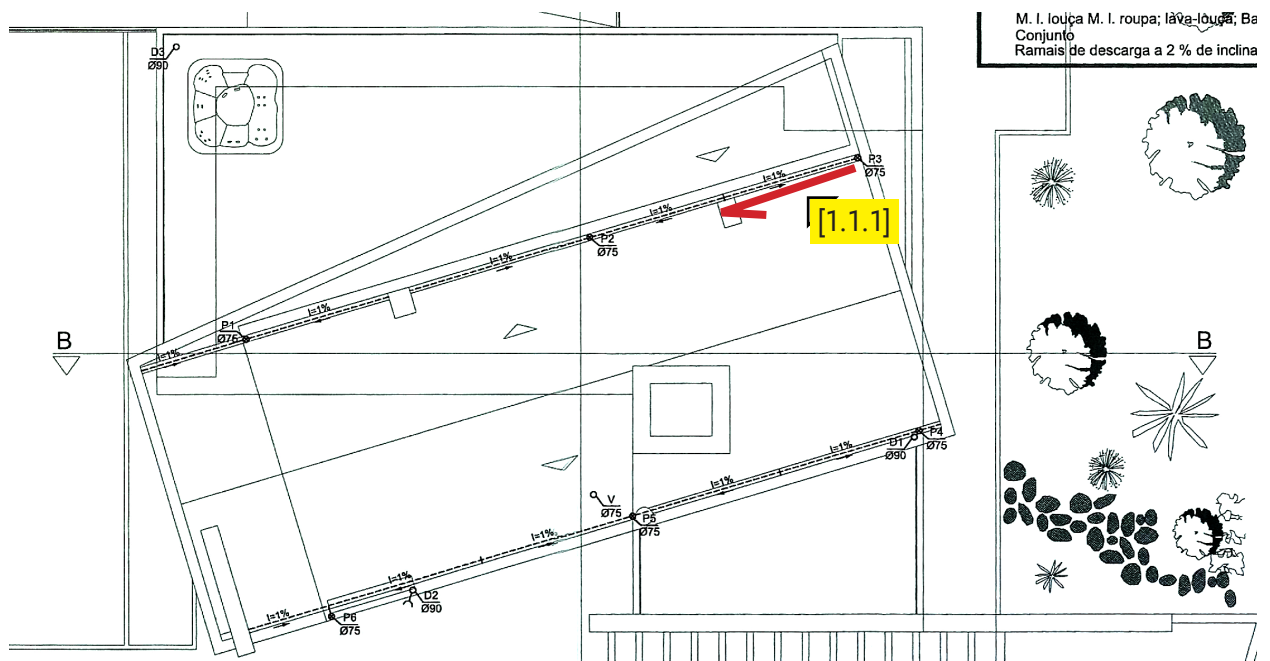
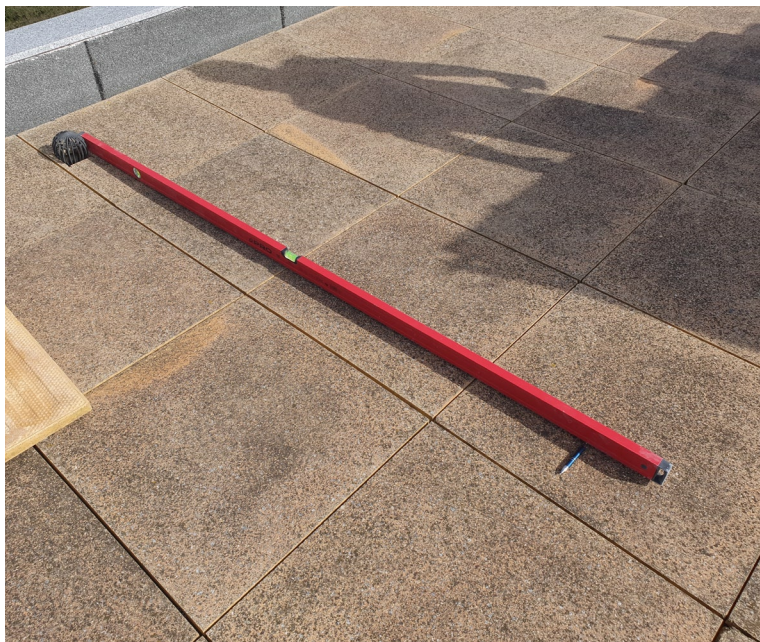
1.1. Roof profile

1.1.1. Roof profiling discrepancies were detected in relation to The Project. In some cases, the roof slope is the opposite of the design. Instead of a slope of about 1% towards the drain holes, a counterslope of about 0.5% was detected, which causes water to flow away from the drain hole.

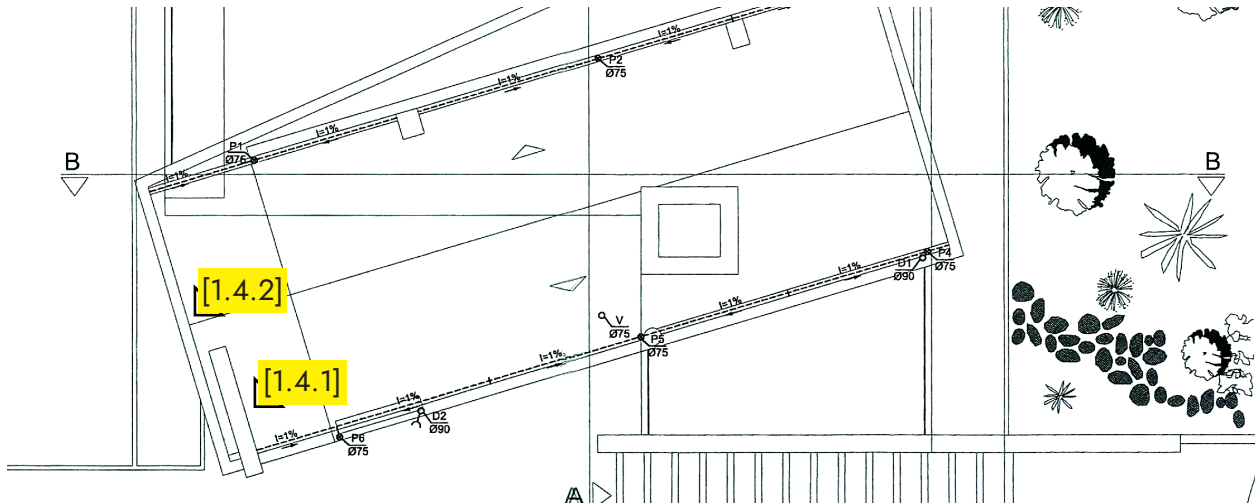
1.4. Cracks and other defects

1.4.1. The orange attic wall is all ckracked on top, with vegetation and water penetration inside. Lack of wall copings.

1.4.2. The other roof attic walls have copings made of stone, with many defects also lack of the grout on connections, improper connection with orange plastered wall and even a wooden dowel left behind.

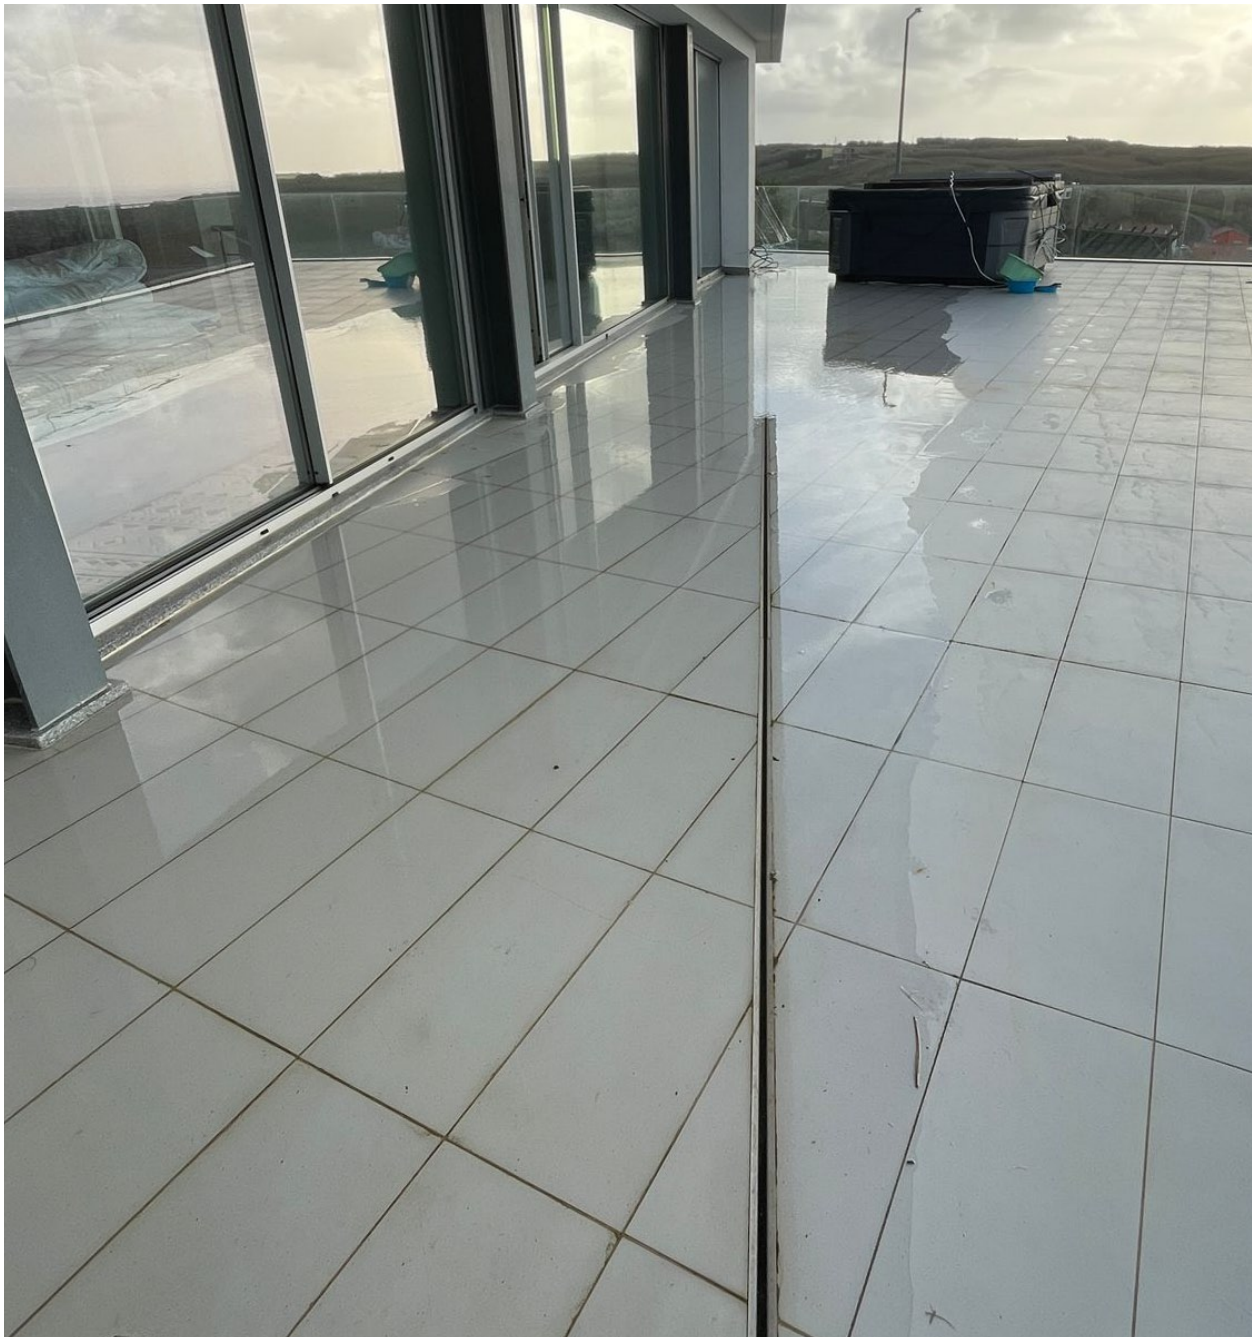
On the day of the inspection, a significant amount of water was found ponding on the terrace and numerous floods in the rooms below, as discussed later in the report.

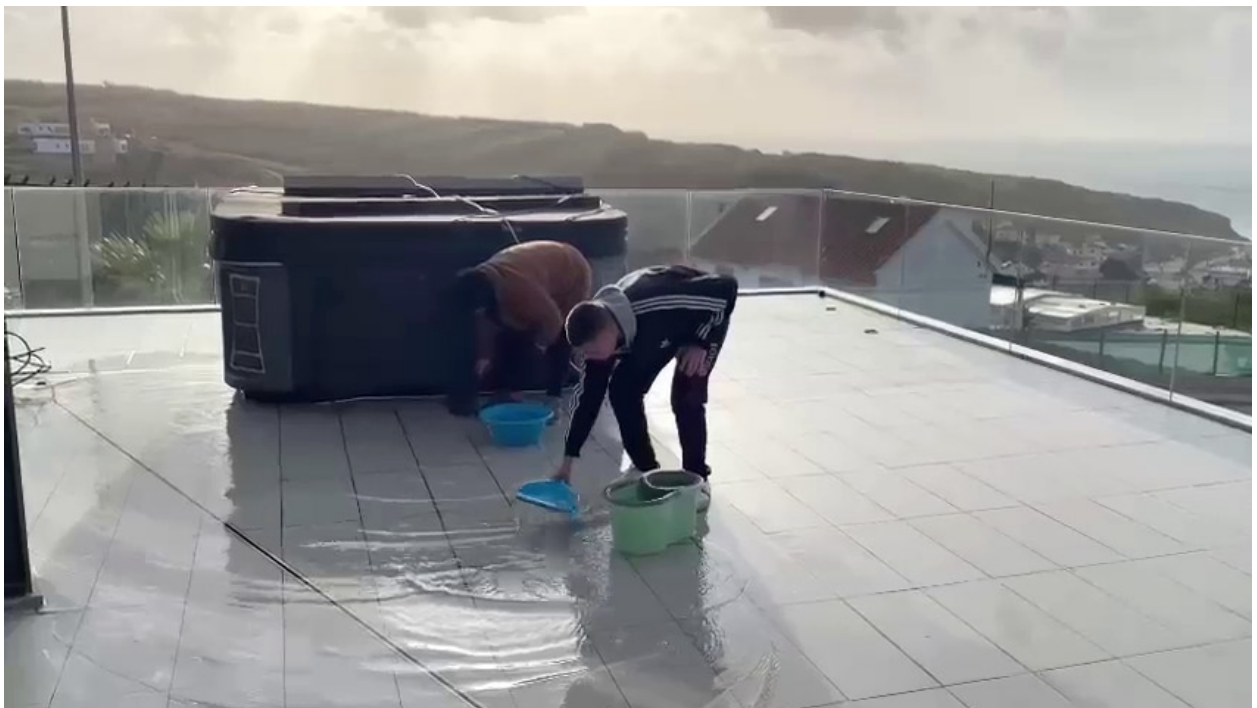
Despite exposing the drain hole and many attempt to unclog it, the water stored on the terrace could not be drained.

It was necessary to mechanically remove the water from the terrace.

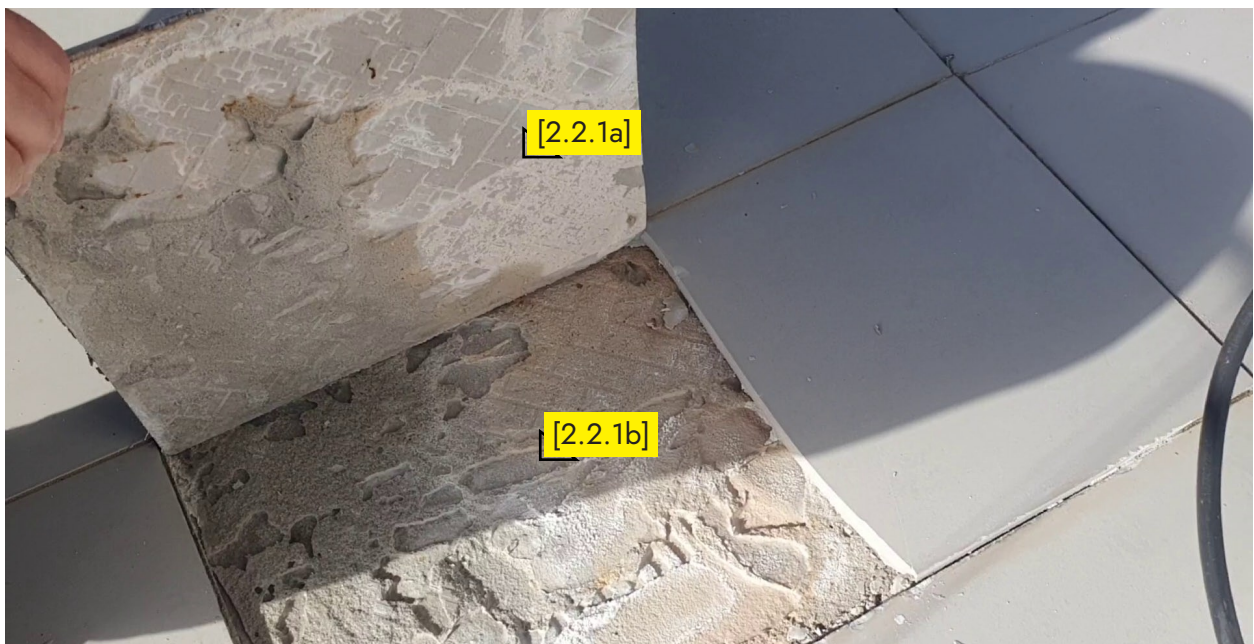
The adhesive mortar is not bonded to the tile over a significant area [2.2.1a]. Insufficient adhesive and voids between the adhesive layer and the tile are revealed [2.2.1b].

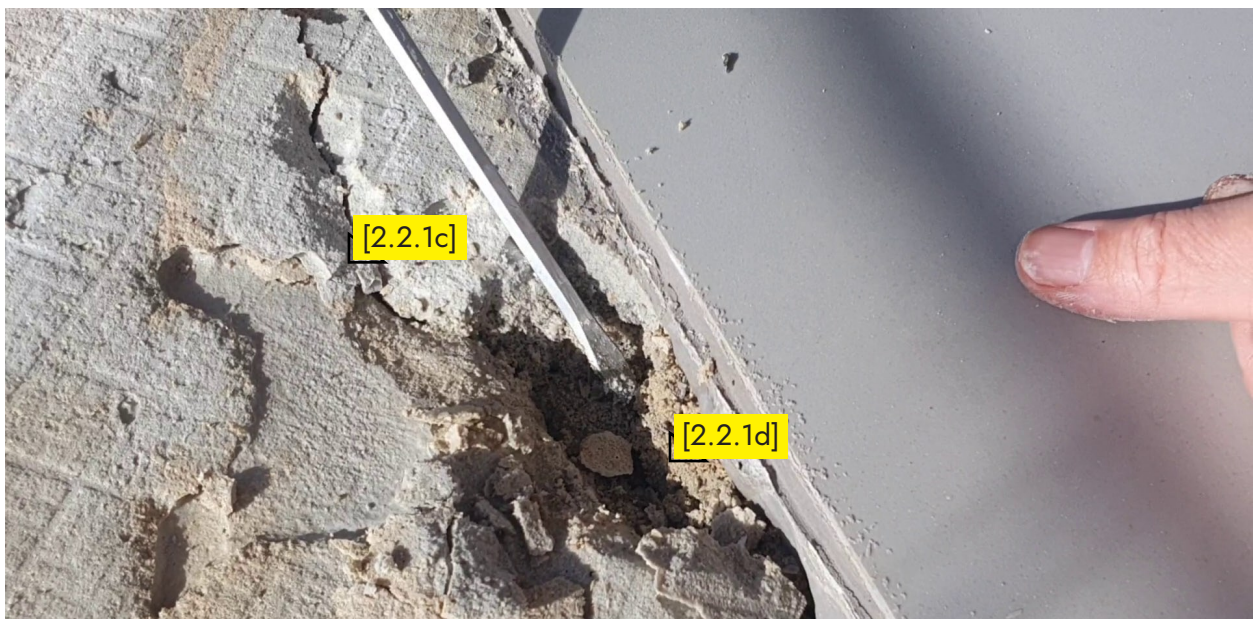
The adhesive layer under the tile was patchy and very cracked [2.2.1c]. The tile adhesive was very brittle and came off easily when undermined with a screwdriver [2.2.1d].

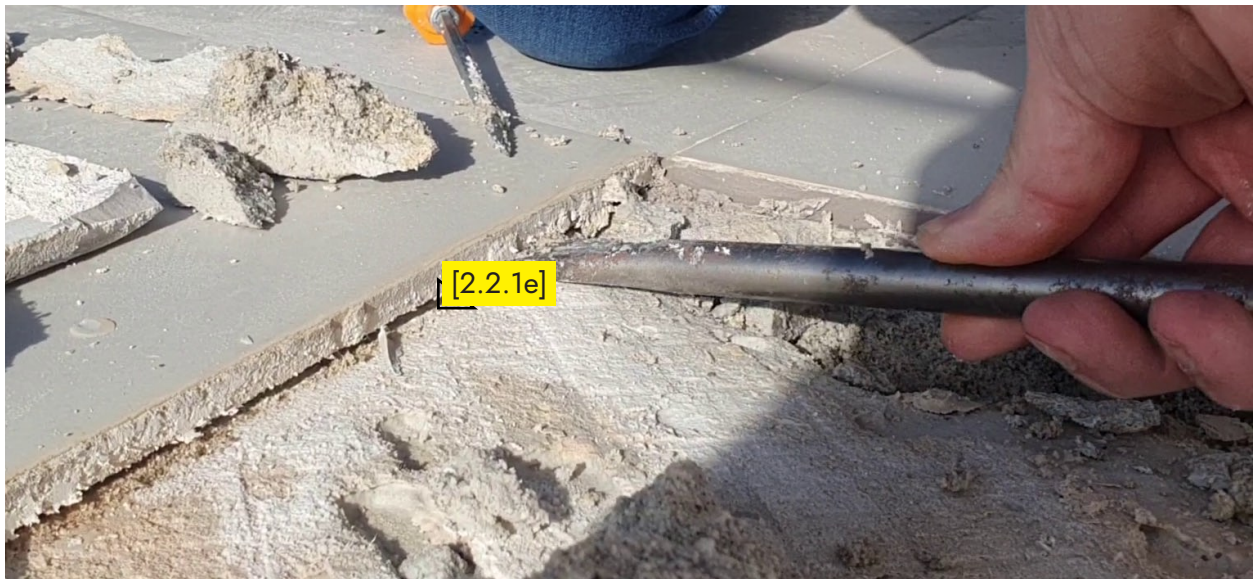
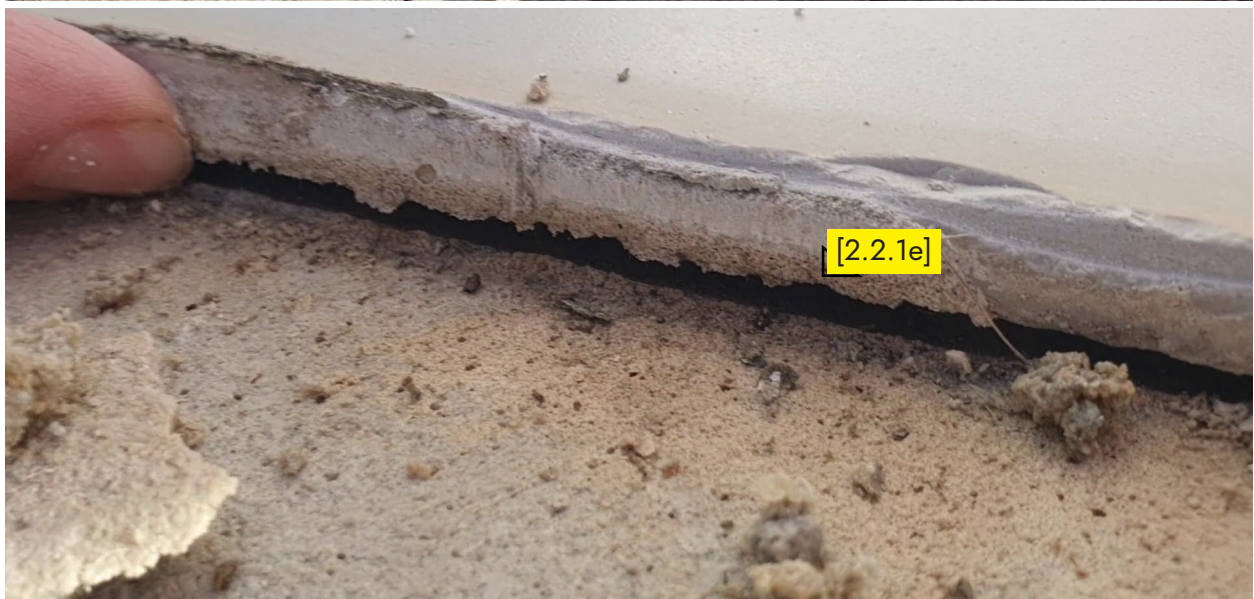
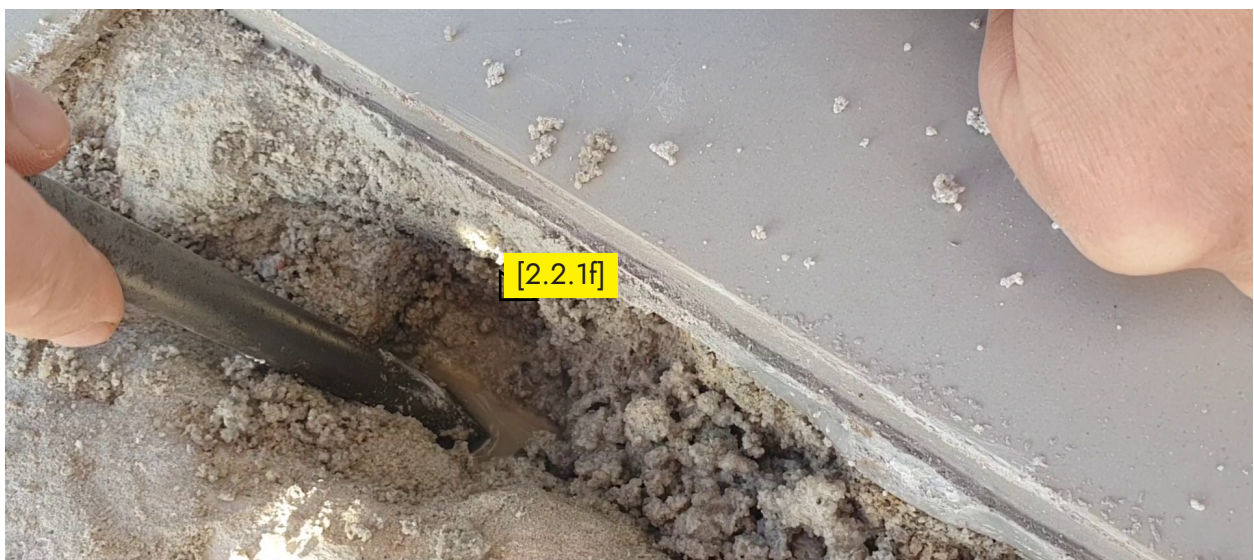
The adjacent tiles were also poorly attached to the substrate and could easily be undermined and torn off [2.2.1e].

Once the adhesive was easily removed, the xps foam layer was exposed and water appeared in the hole [2.2.1f].

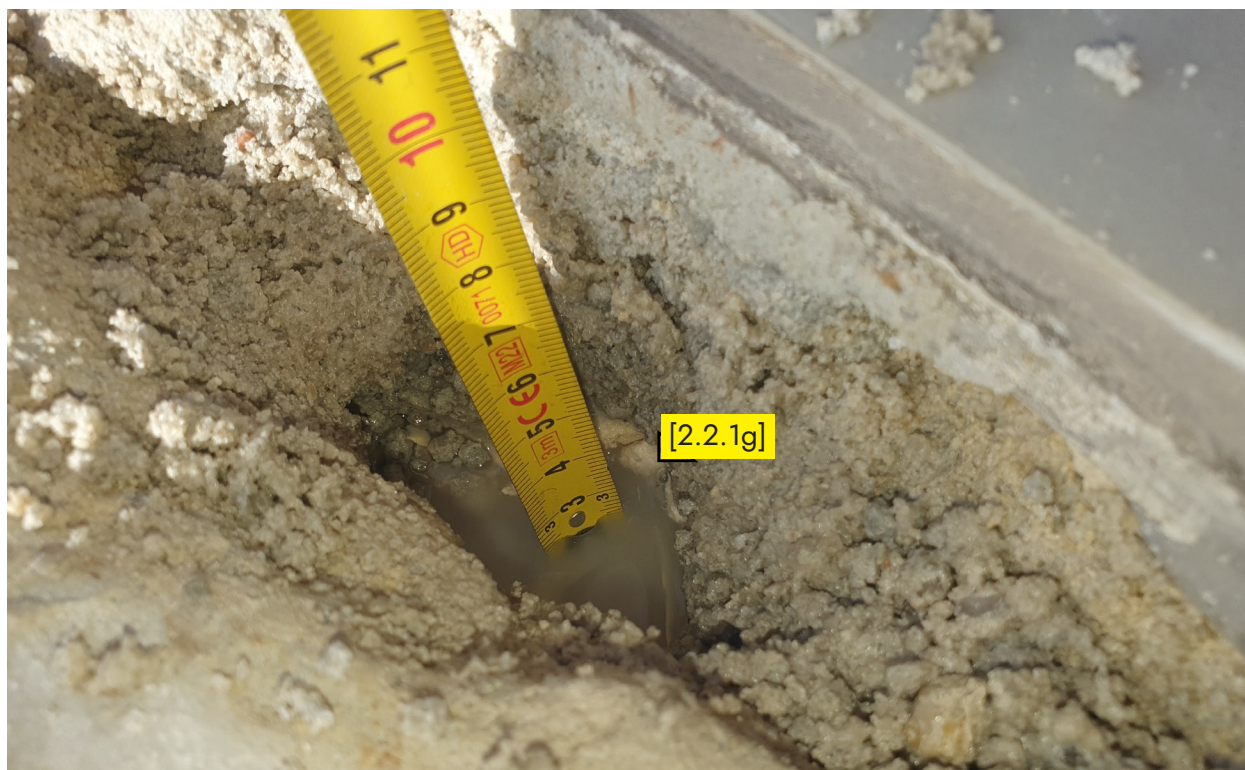
No waterproofing was found to protect the screed from water penetration.
A water layer of approximately 30 mm was found in the xps insulation, directly on the floor slab [2.2.1g].

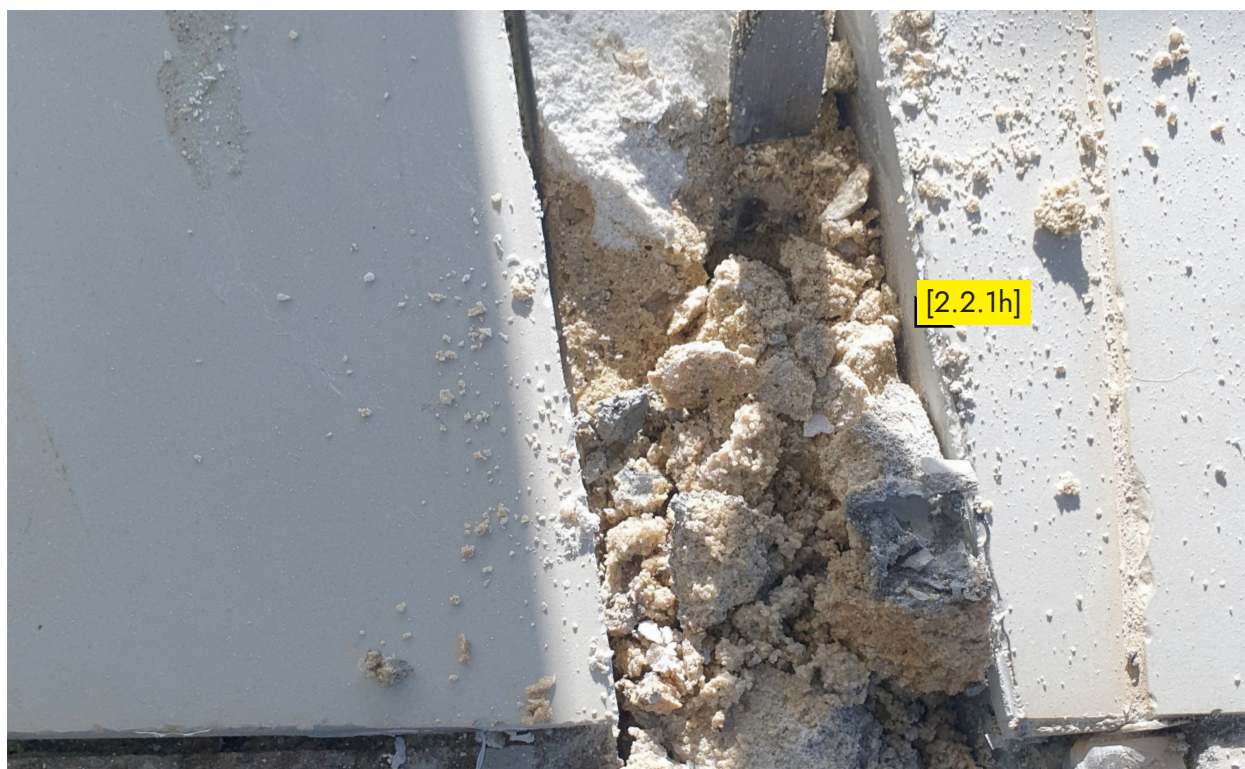
The adhesive layer was exposed elsewhere on the terrace and the situation was very similar: the mortar was very crumbly, non-cohesive and crumbled very easily in the hands. In colour and texture it resembled wet sand [2.2.1h].

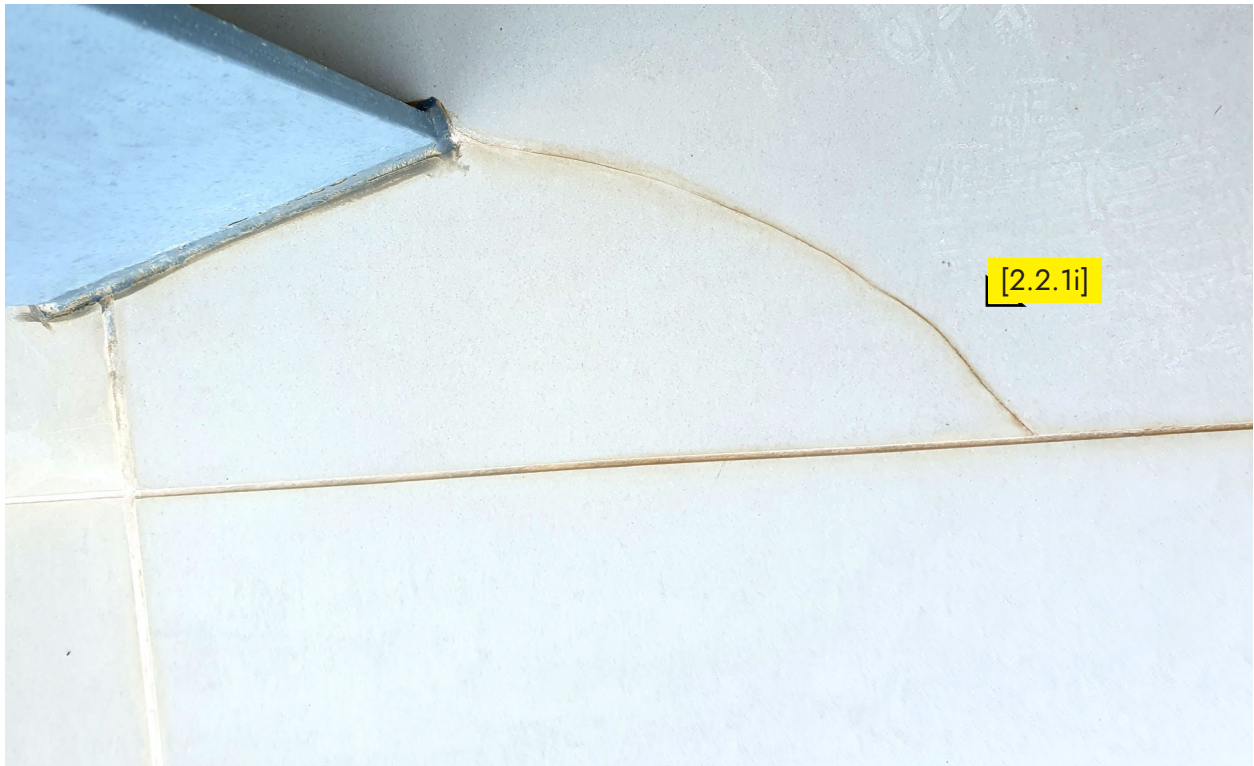
Stress cracks were found in the tiles around the steel pillars of the buildings' superstructure [2.2.1i].

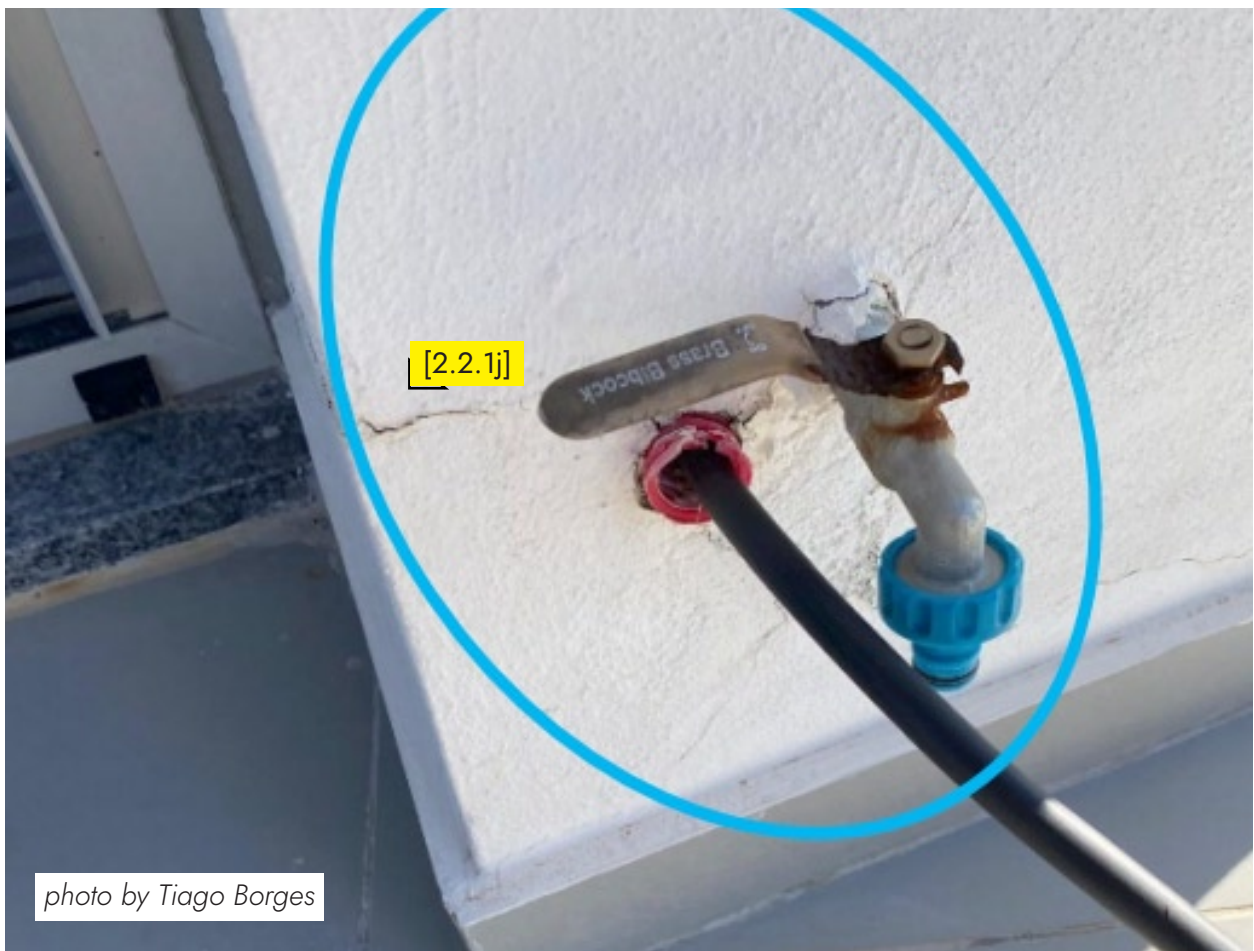
Stress cracks in the area of the connection between the terrace and the wall [2.2.1j].

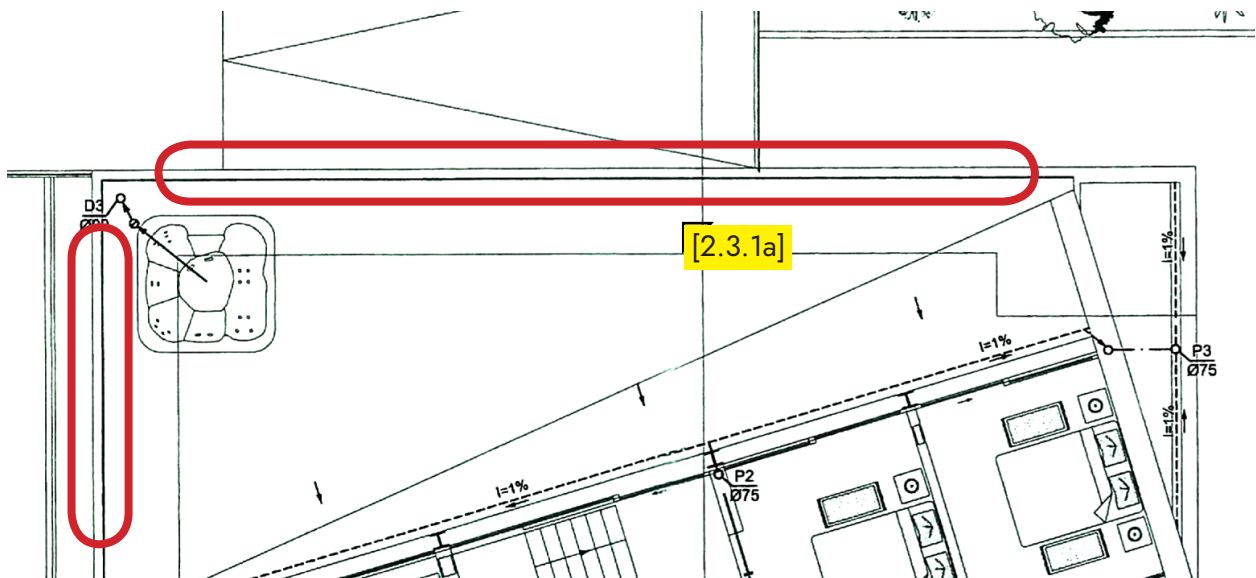
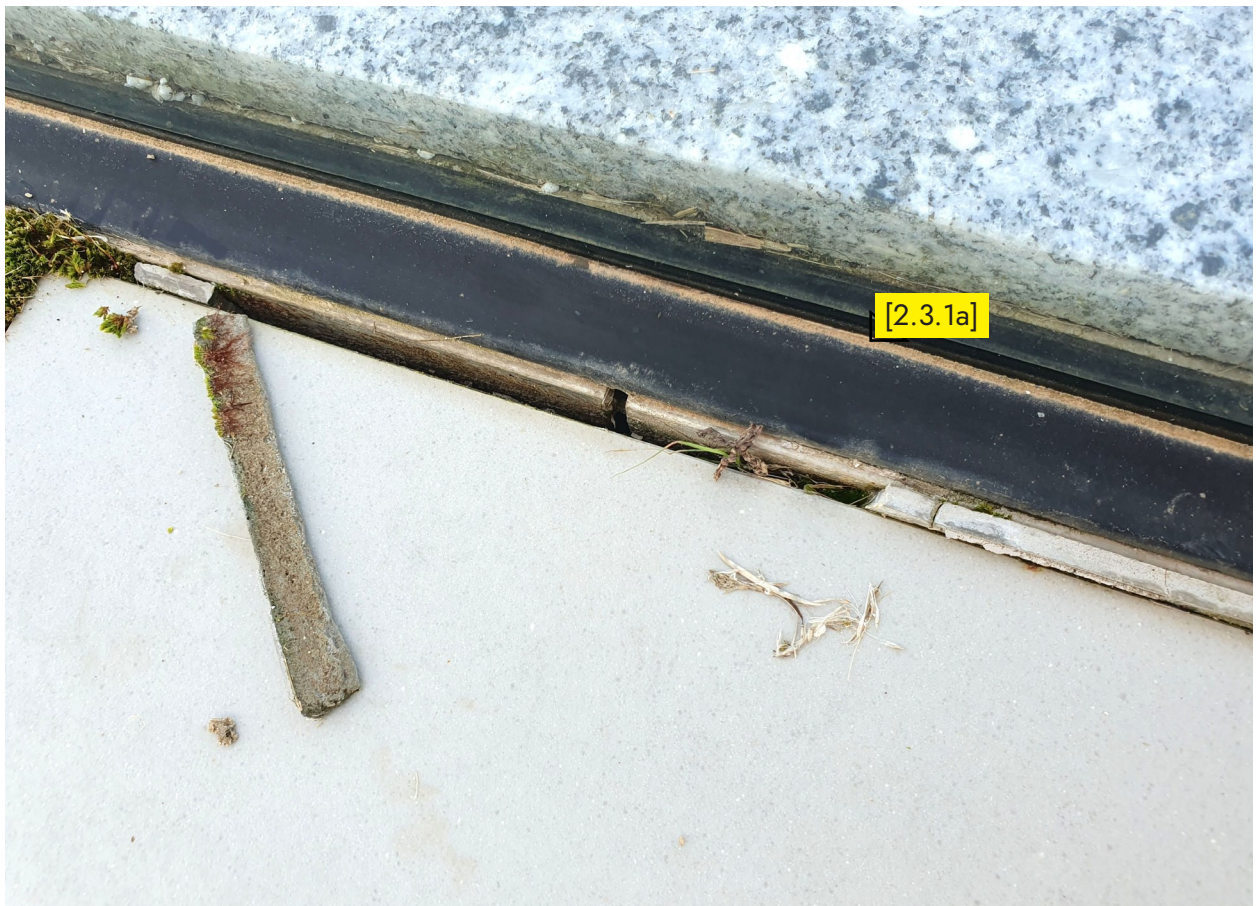
2.3.1. Numerous cavities and discolouration in the tile grouts were found on the overall terrace surface. There are many visible instances of grout erosion [2.3.1b].

The connection between the terrace surface and the balustrade is cracked or absent in many places. This creates the possibility of water penetrating into the balustrade attachment points and further erosion. Numerous vegetation can be seen nestled in the cracks [2.3.1a].

The connection between the balustrade and the terrace should be both watertight flexible.

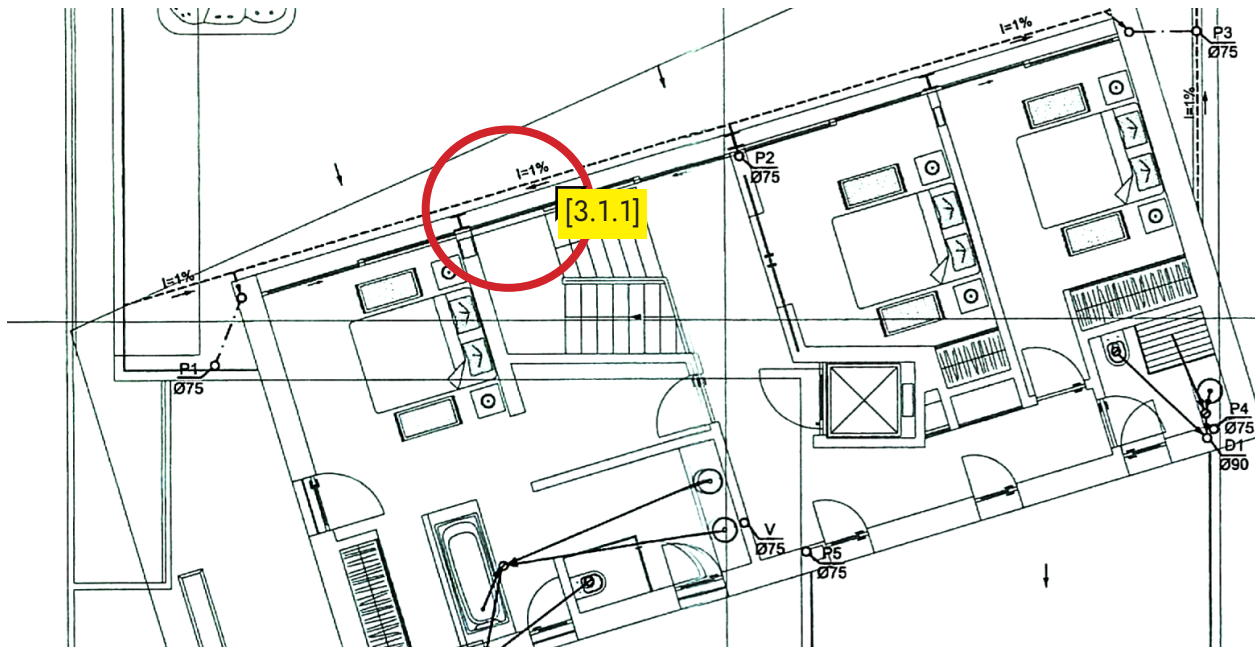
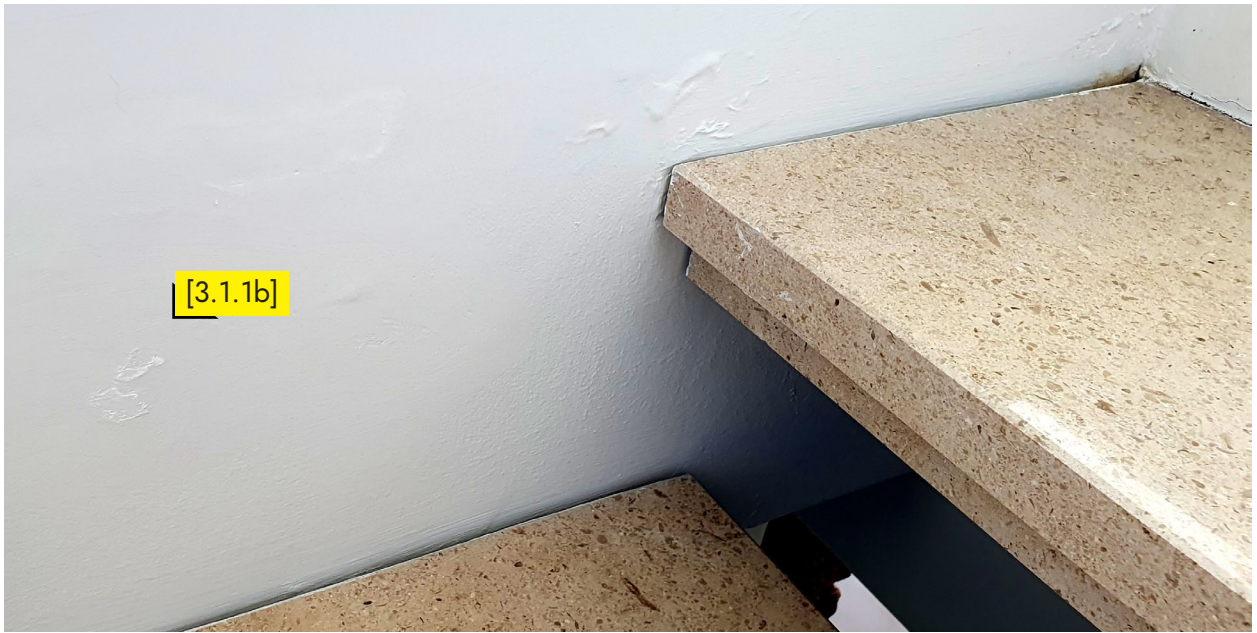
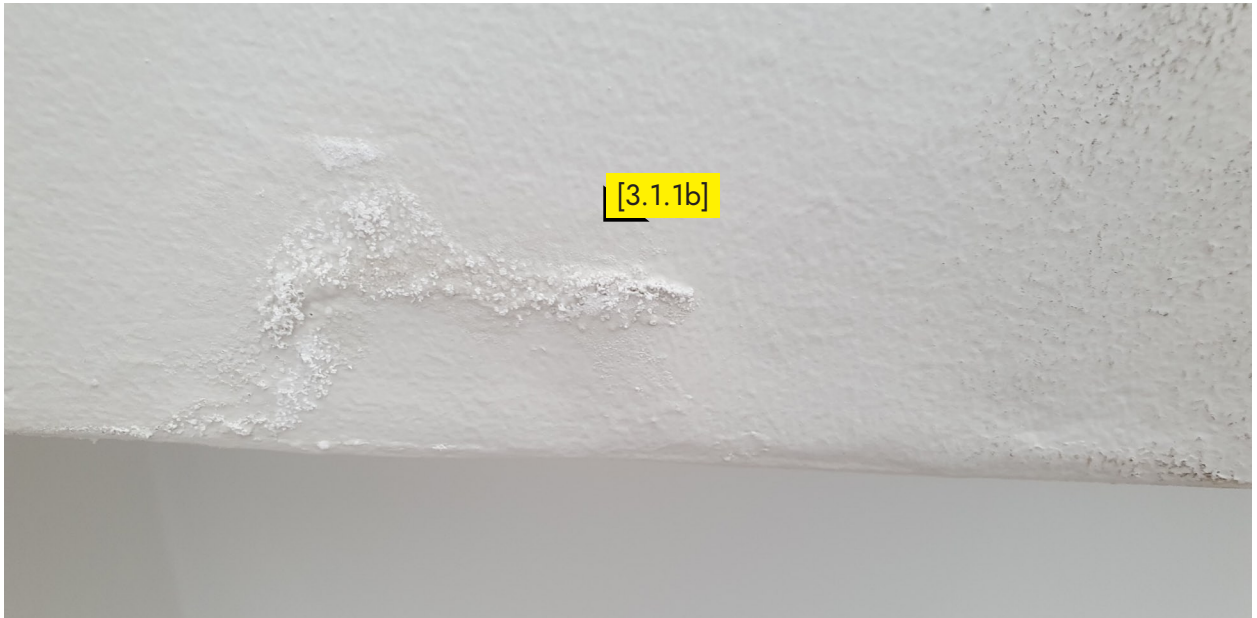
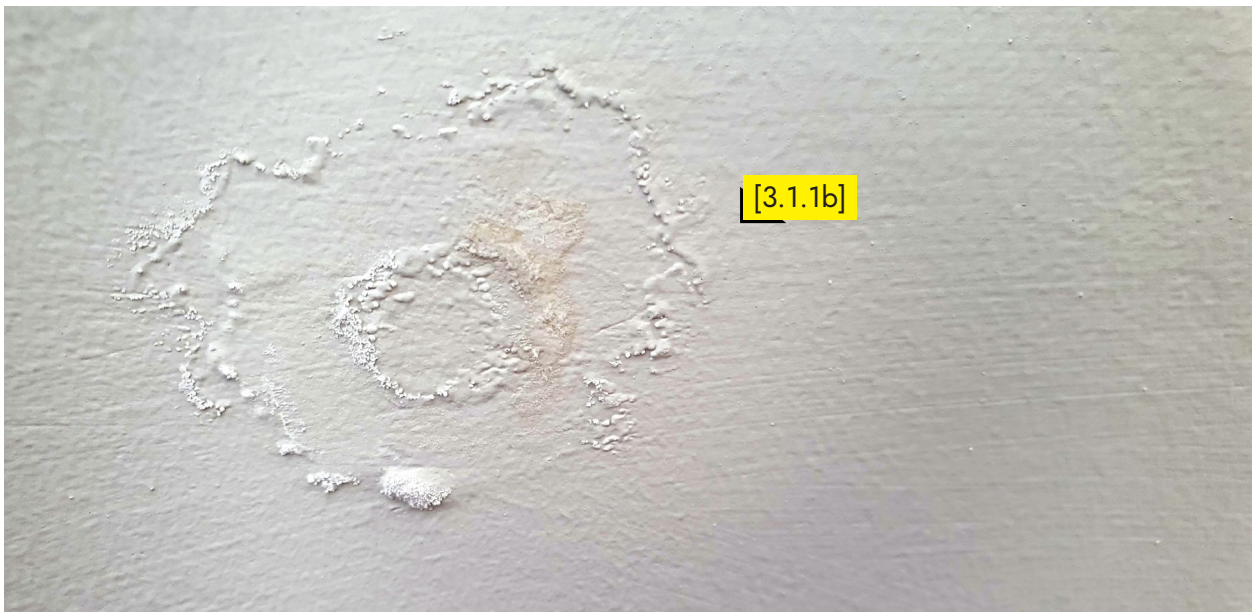
3.1. Flooding in the stairwell

Using a thermal imaging camera, dampness was detected in the west wall of the stairwell [3.1.1a]. Discolouration, cracks, paint chipping and plaster degradation can be seen in the area where the terrace floor slab meets the wall [3.1.1b].

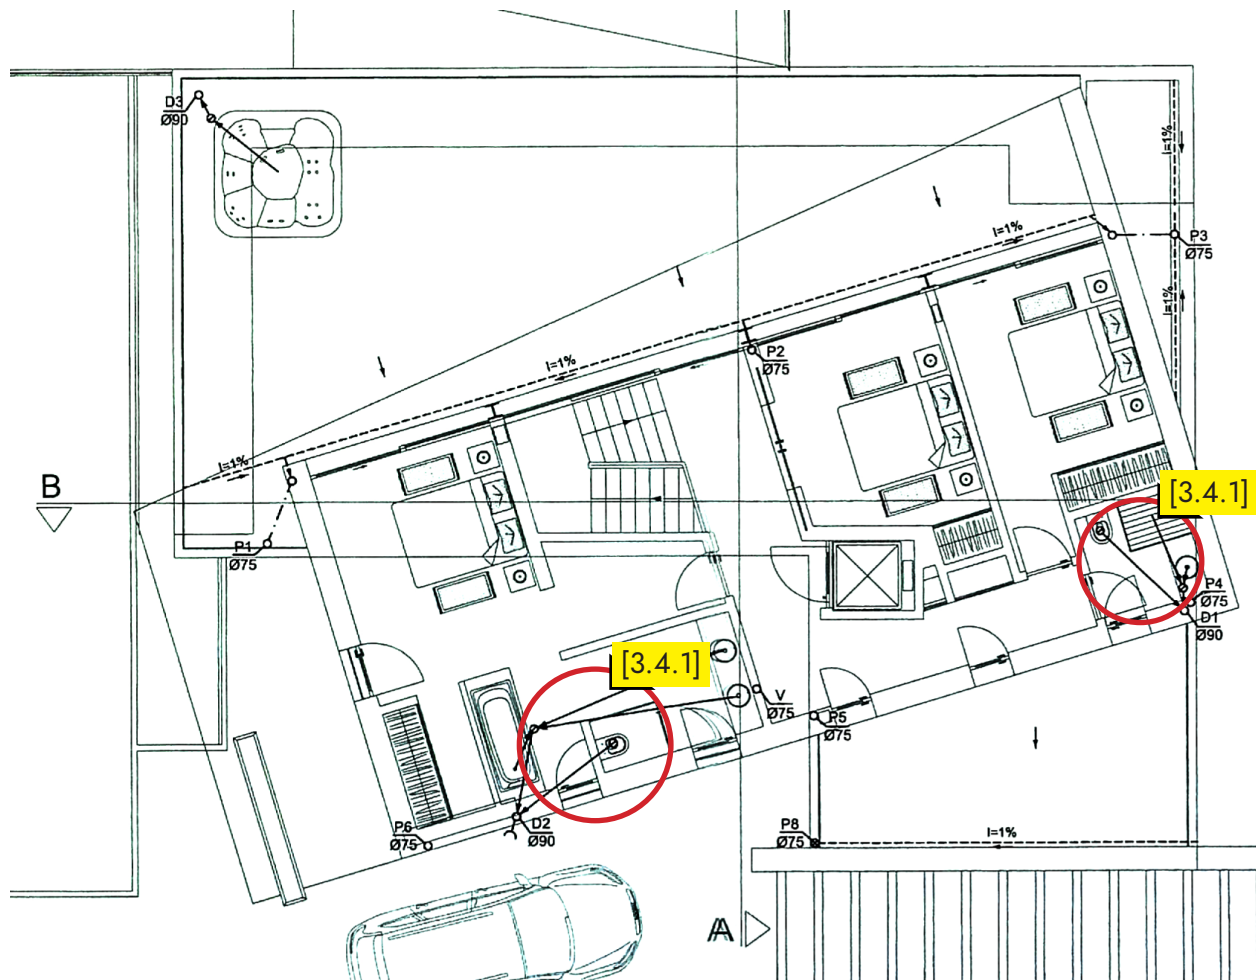
In the upstairs bathrooms [3.4.1], hot water does not appear until about 4 minutes after turning on the tap. This causes a wait and wastes a considerable amount of water, which uselessly flows down the drain during this time.

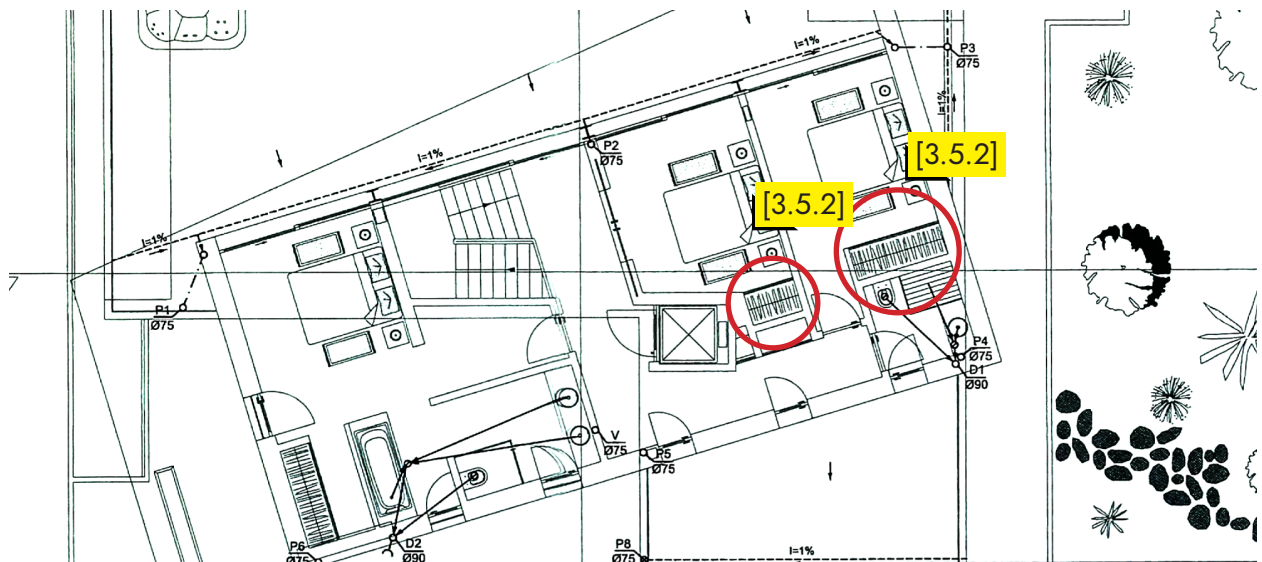
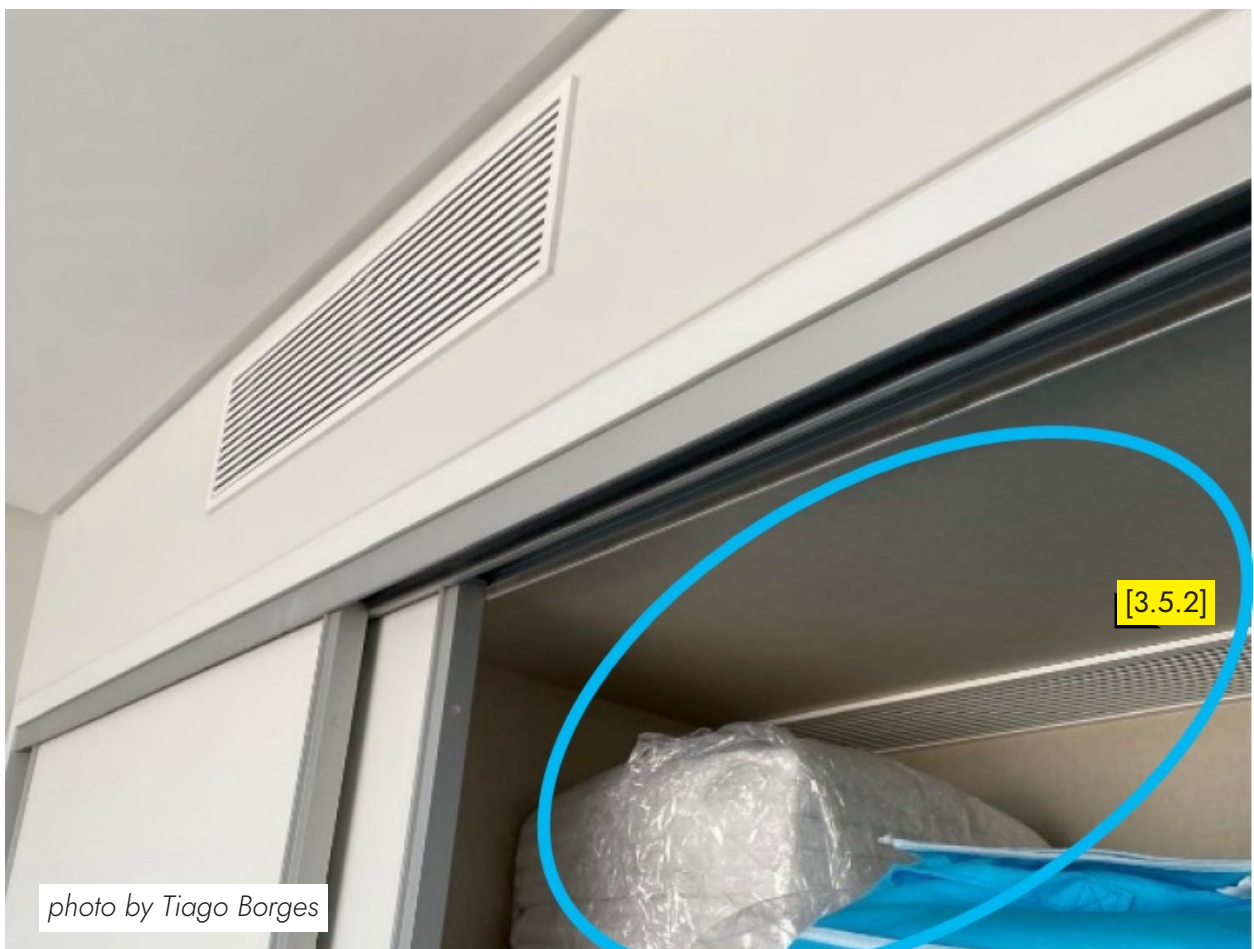
3.5. Air conditioning defects

3.4.1. On the first floor, three air-conditioning systems were installed built-in in the walls, the false ceiling and in the wardrobes. None of them has an inspection opening to access the junction box. In the event of a malfunction or the need to make adjustments, it will be necessary to drill a hole in the wall or dismantle the wardrobe.

3.4.2. In the two bedrooms on the north side of the house, the air conditioners have air intakes hidden in lockable wardrobes. For this reason, it is impossible to use them properly. For the air conditioner to work effectively, the wardrobe doors must be open.

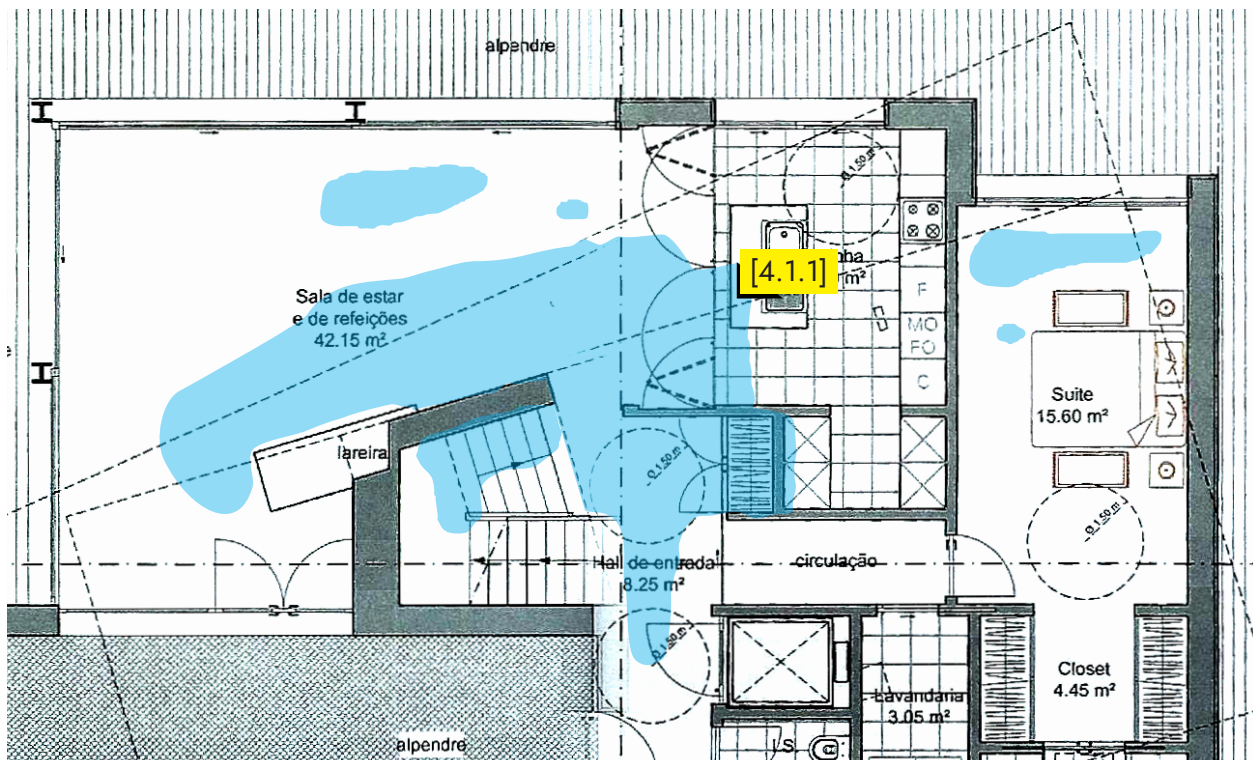
The following are the extent of the flooding that occurred in January and February 2025. The presence of water in the building's structure and equipment was determined by direct visual inspection, images from the endoscopic camera and images obtained from a thermal imaging camera. The projection below shows the areas affected by flooding including floors, walls, ceilings, furniture, wardrobe and light fixtures.
