The Report

February 2025

This report systematises and organises the numerous construction and workmanship errors occurring in the private residential house located in Lote 2 - Casais Porto Dinheiro.

The discrepancies were identified based on the construction project of the residential building 12146/2017, hereinafter referred to as The Project.

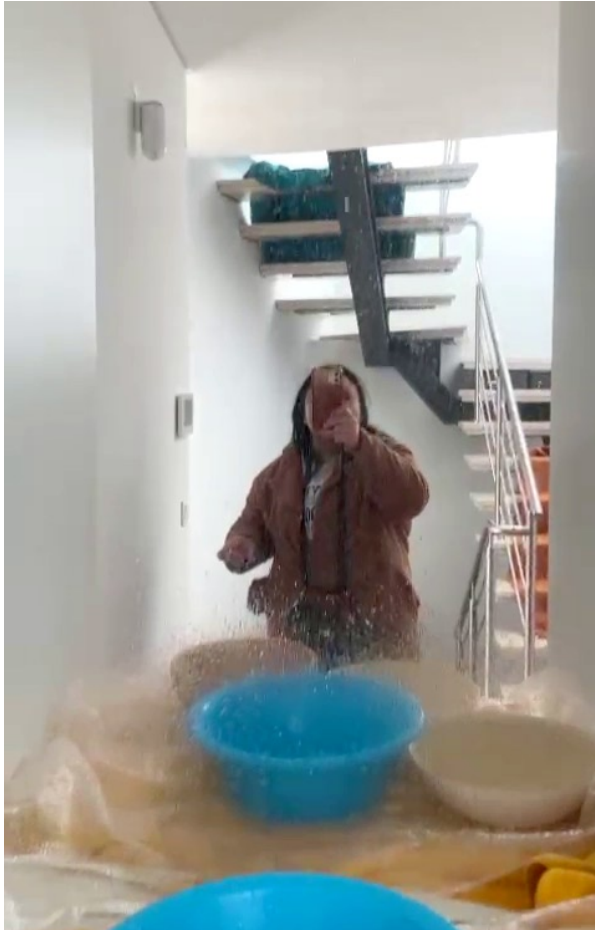
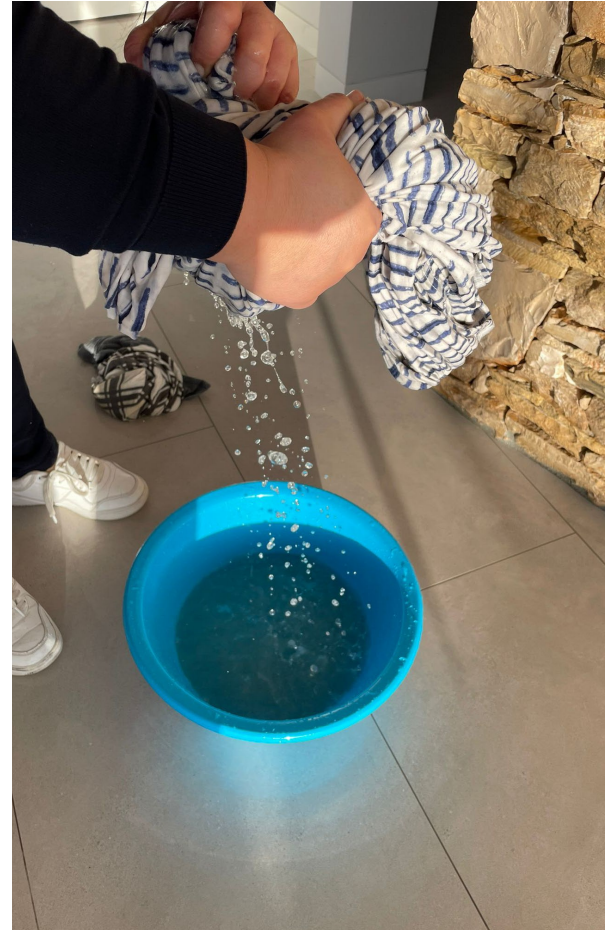
Rainwater flooding on January 2025

A consequence of the leaking terrace is the repeated flooding of the kitchen and living room with rainwater. On a number of occasions, water was observed dripping down the stone wall in the middle of the living room, water dripping from lamps suspended above the table, water dripping from light fittings on the ceiling [4.1.2a].

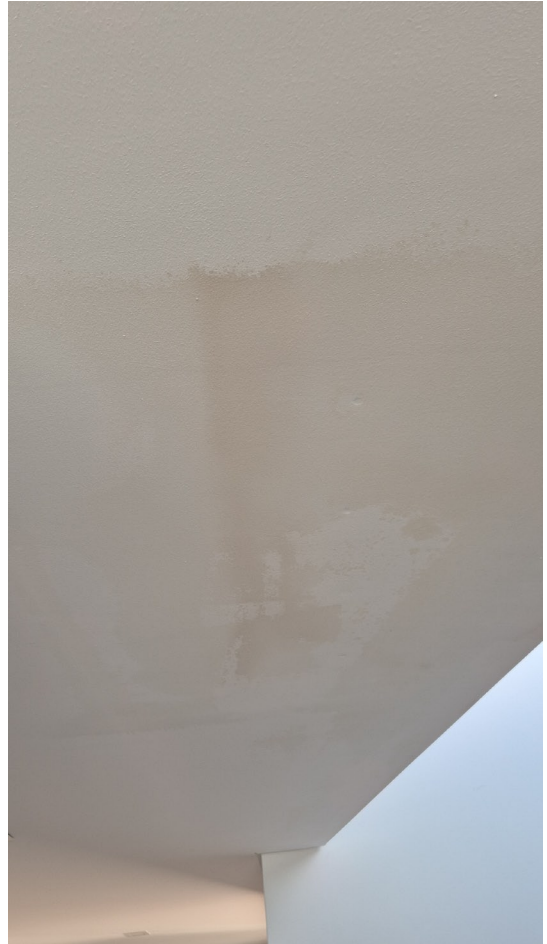
Stains on the corridor ceiling.

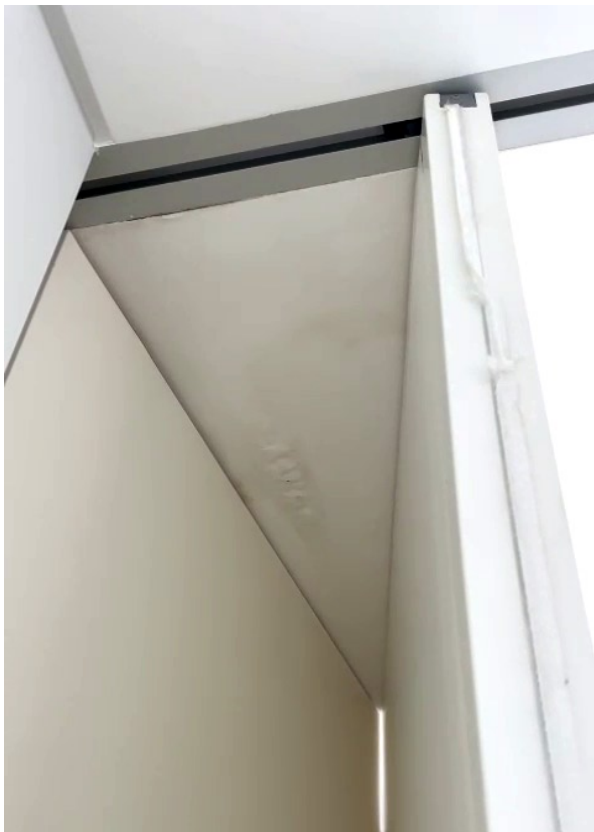
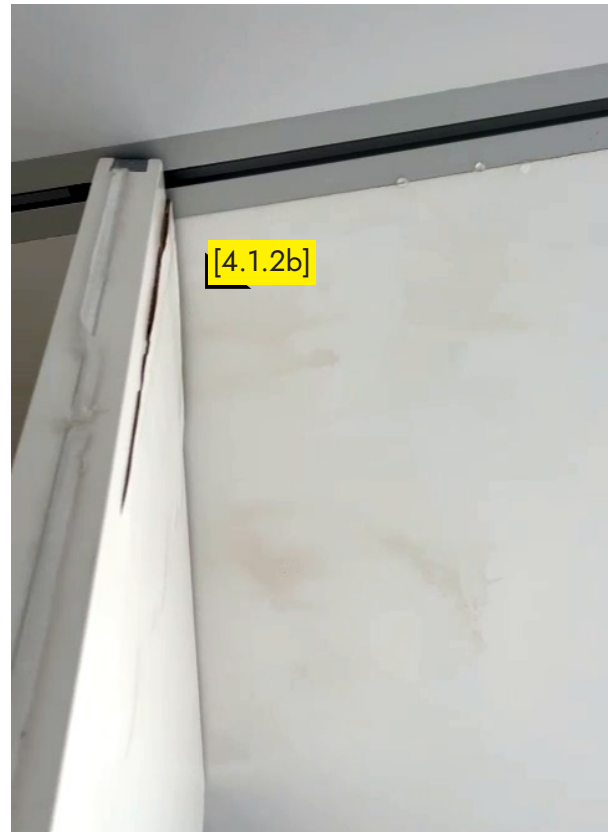
Bulged sliding doors in the kitchen.

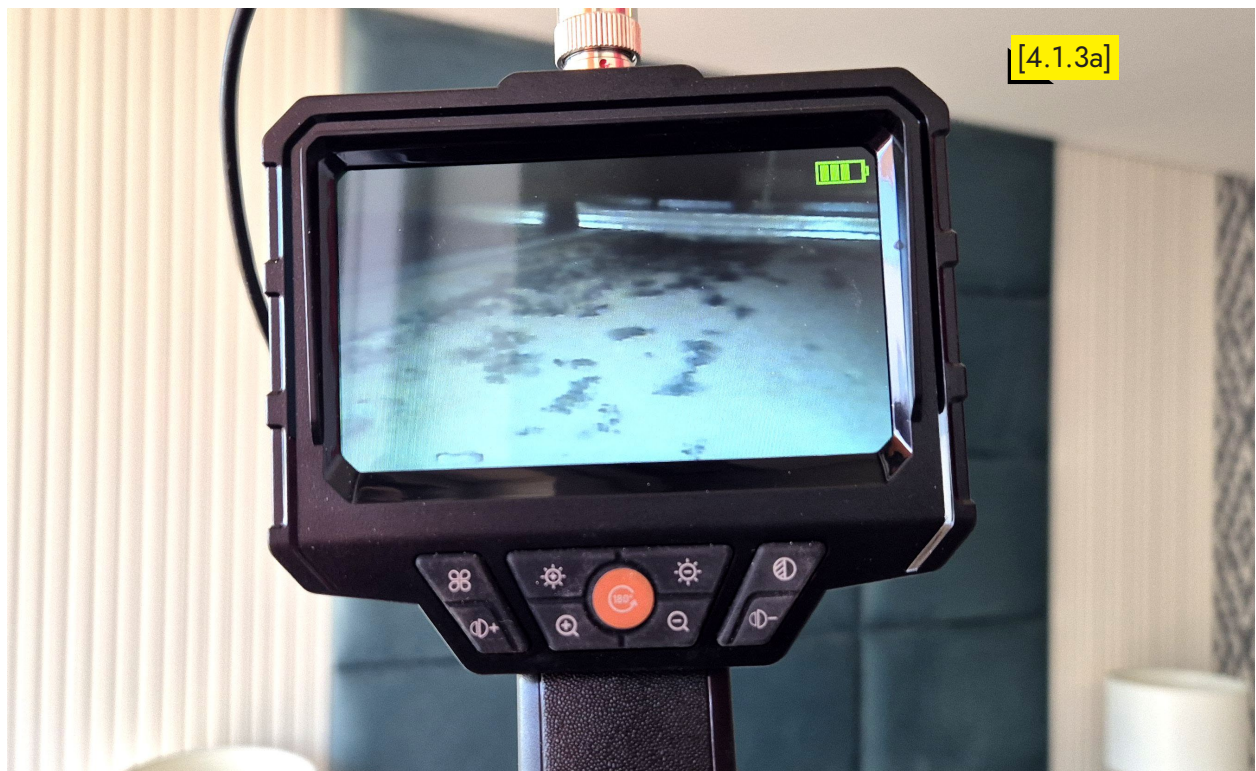
Moisture was found in the suspended ceiling of the bedroom during the inspection. Numerous mould colonies were detected on the ceiling and in the recess for the roller blinds [4.1.3a].

Endoscopic image of the suspended ceiling surface. Mould colonies are visible.

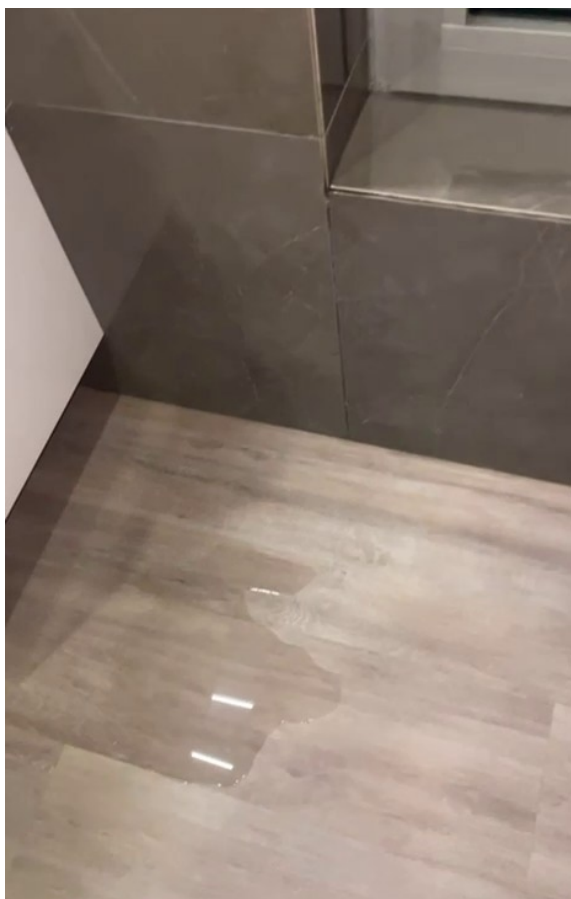
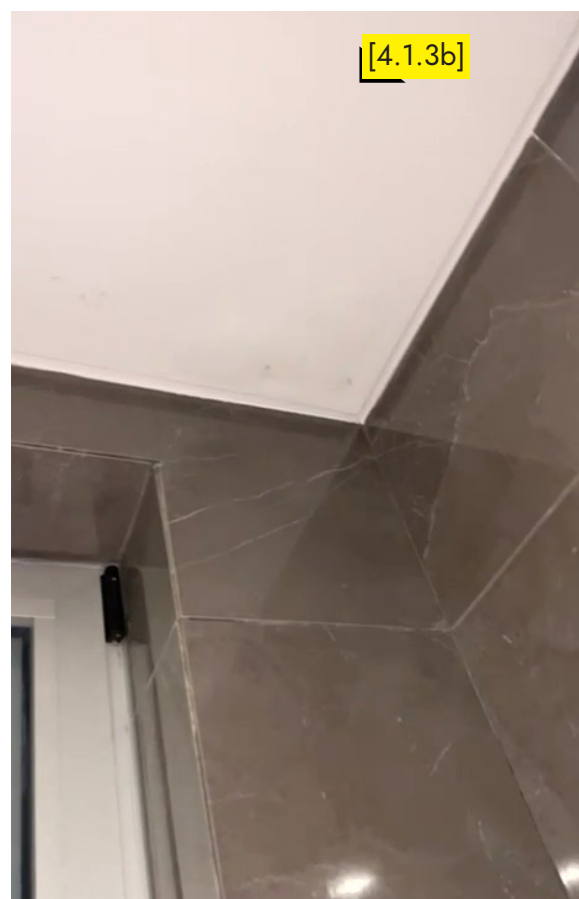
In the bathroom adjacent to this bedroom, there were repeated leaks on the ceiling and water collecting on the floor during rains. [4.1.2b].

Leaks in the nearby bathroom

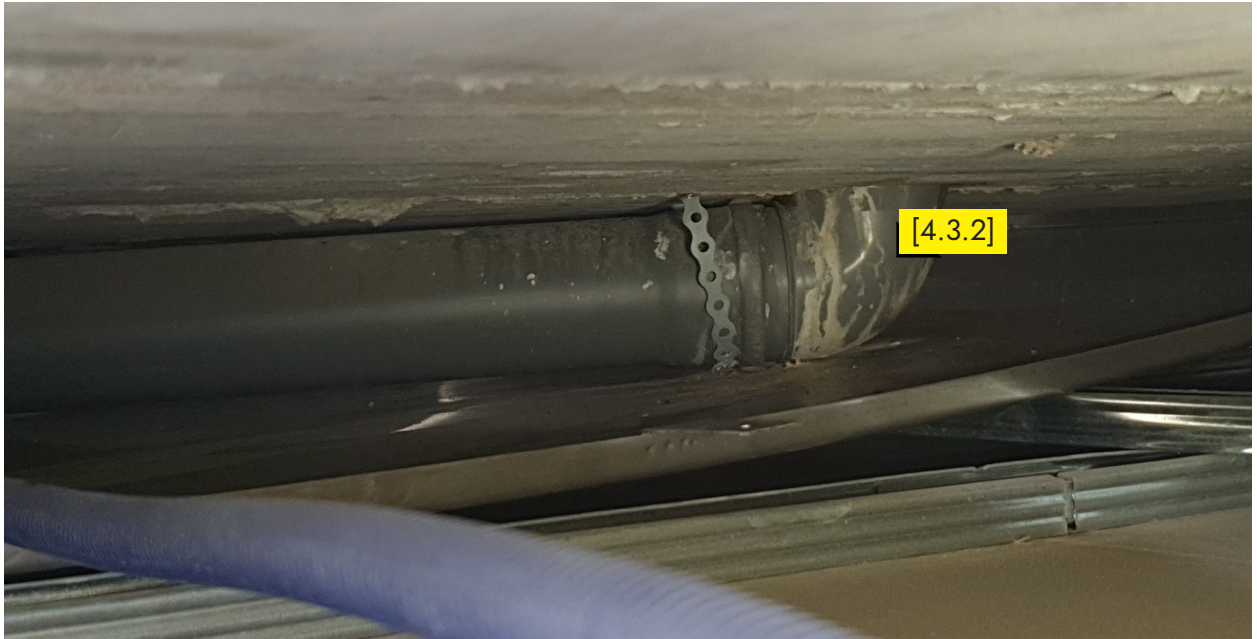
Space between slab and suspended ceiling surface. Stains streaks are visible.

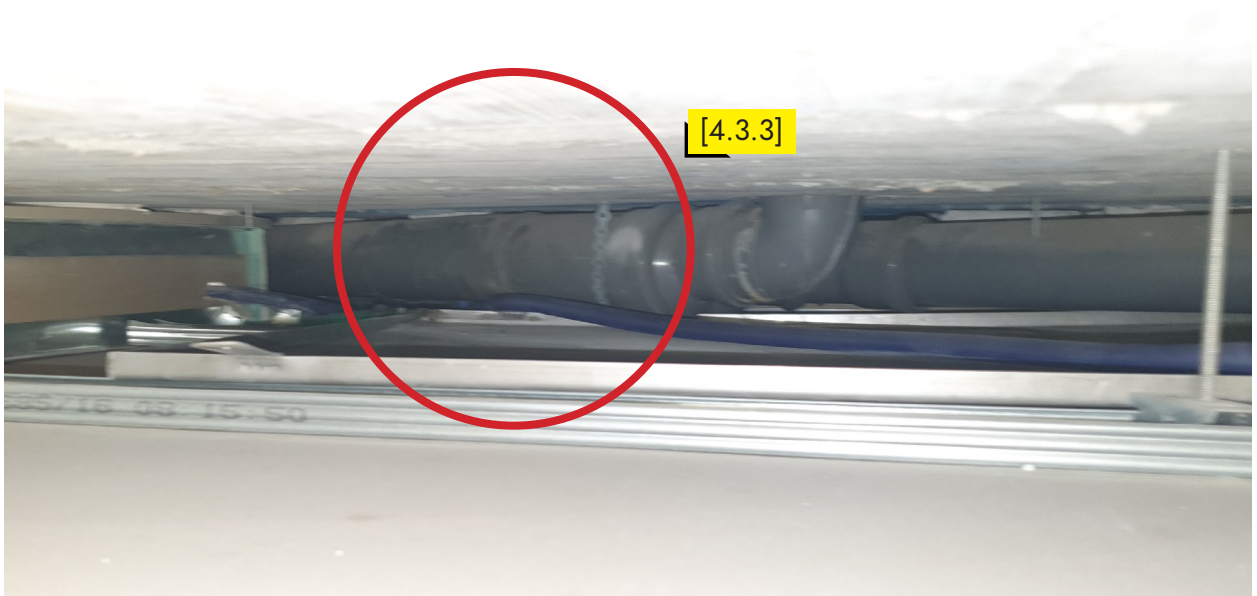
4.3.3. The drain pipe is bent upwards (counter-sloping), which is not acceptable. This causes dirt to settle in this area and stagnant water in the pipe. The drainage pipes used here are designed to work with a slope.

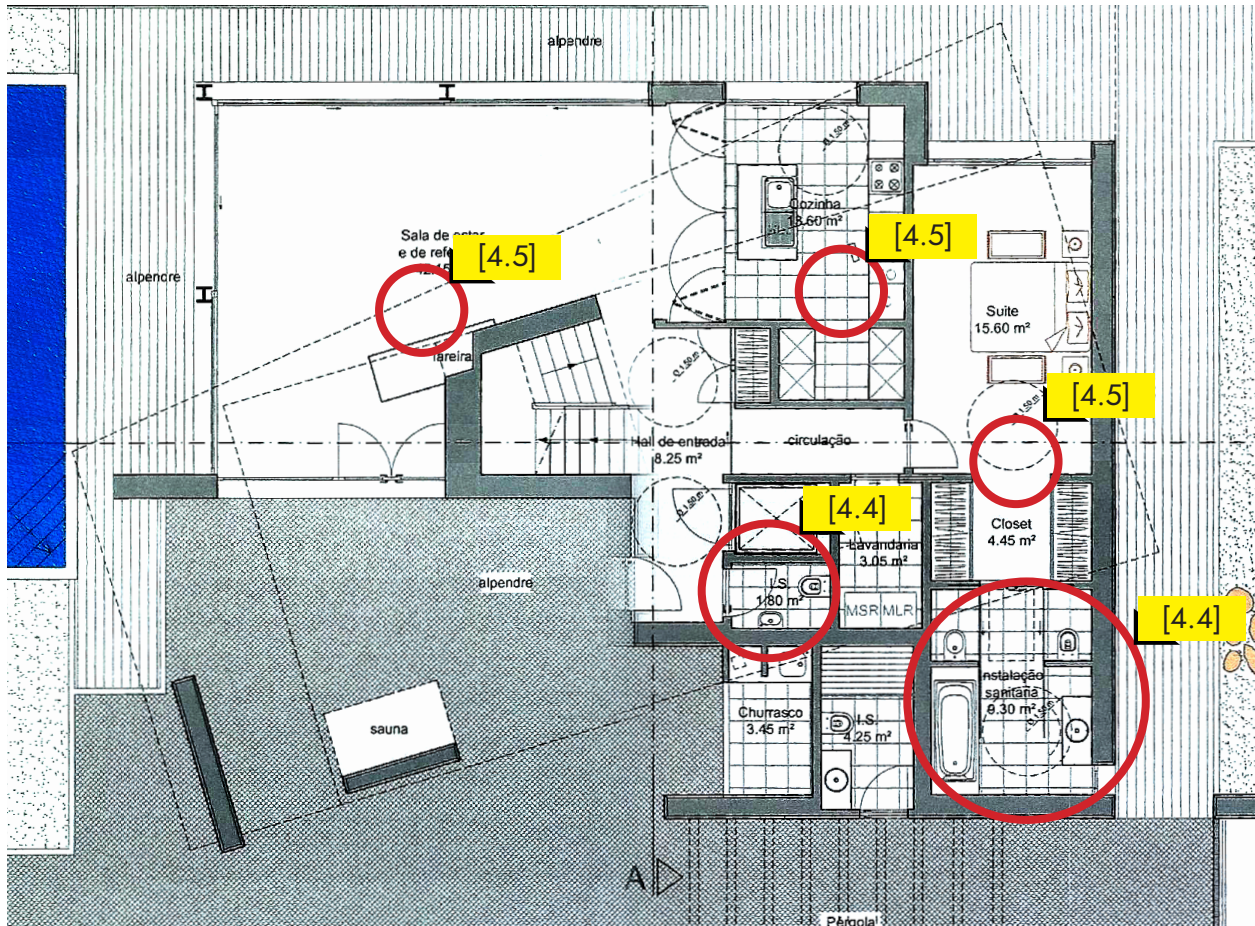
4.4. No ventilation in bathrooms

Neither of the two bathrooms on the ground floor has ventilation ducts.

The opinion that this is not required when windows are open is not true, as this would mean that during cold or rainy weather, residents would be forced face the weather elements to provide ventilation.

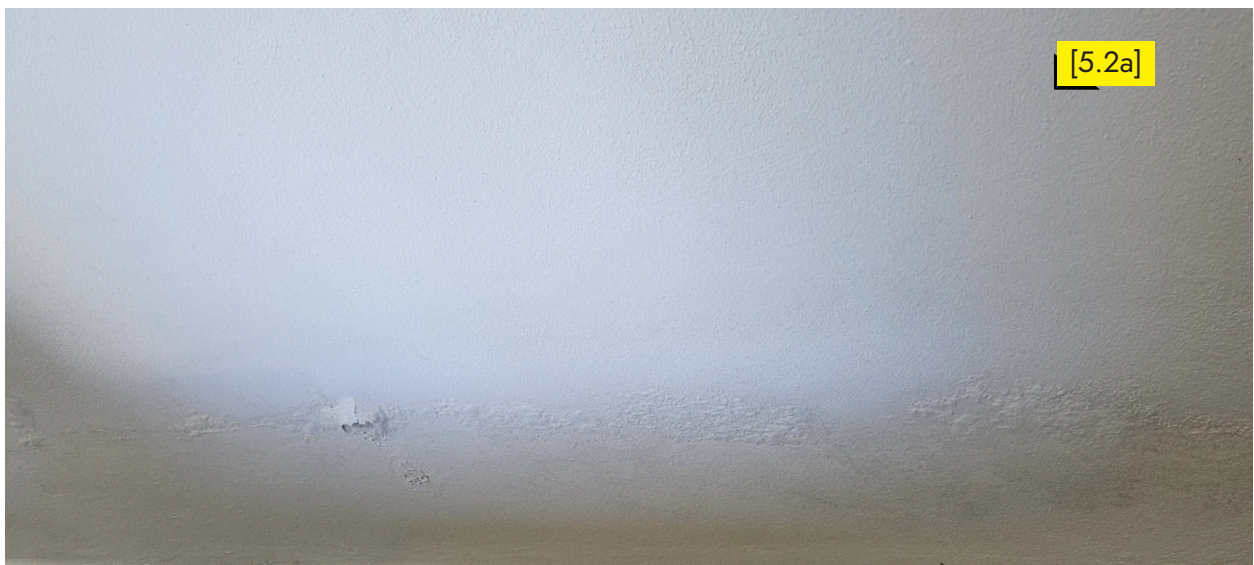
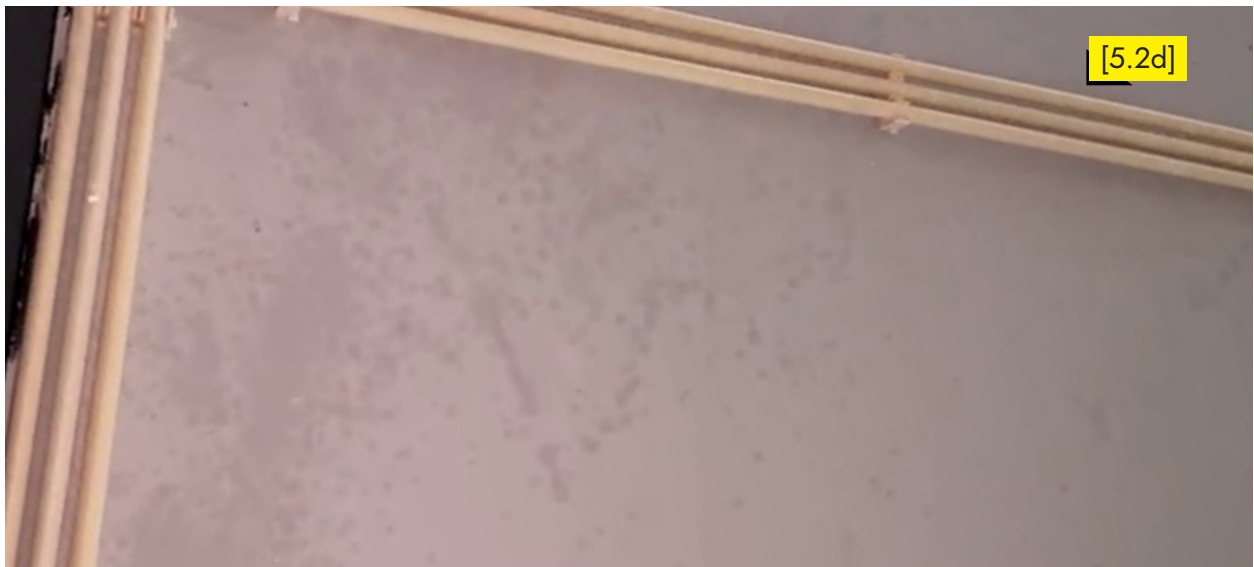
5.2. Moisture in walls and floors

The main problem in the basement is dampness. There are stains on the floor, damp patches on the walls – mainly in the corners. Poor horizontal damp protection of the floor and walls thus capillary seepage through the walls are responsible for this dampness.

To hide the dampness on the walls, they were covered with polystyrene boards and painted [5.2c]. This solution does not solve the problem. It only traps moisture in the wall, which promotes further wall degradation and the growth of fungi and mould, the spores of which are harmful to health!

All of the above despite the high-capacity industrial dehumidifier installed by the owner and running daily.

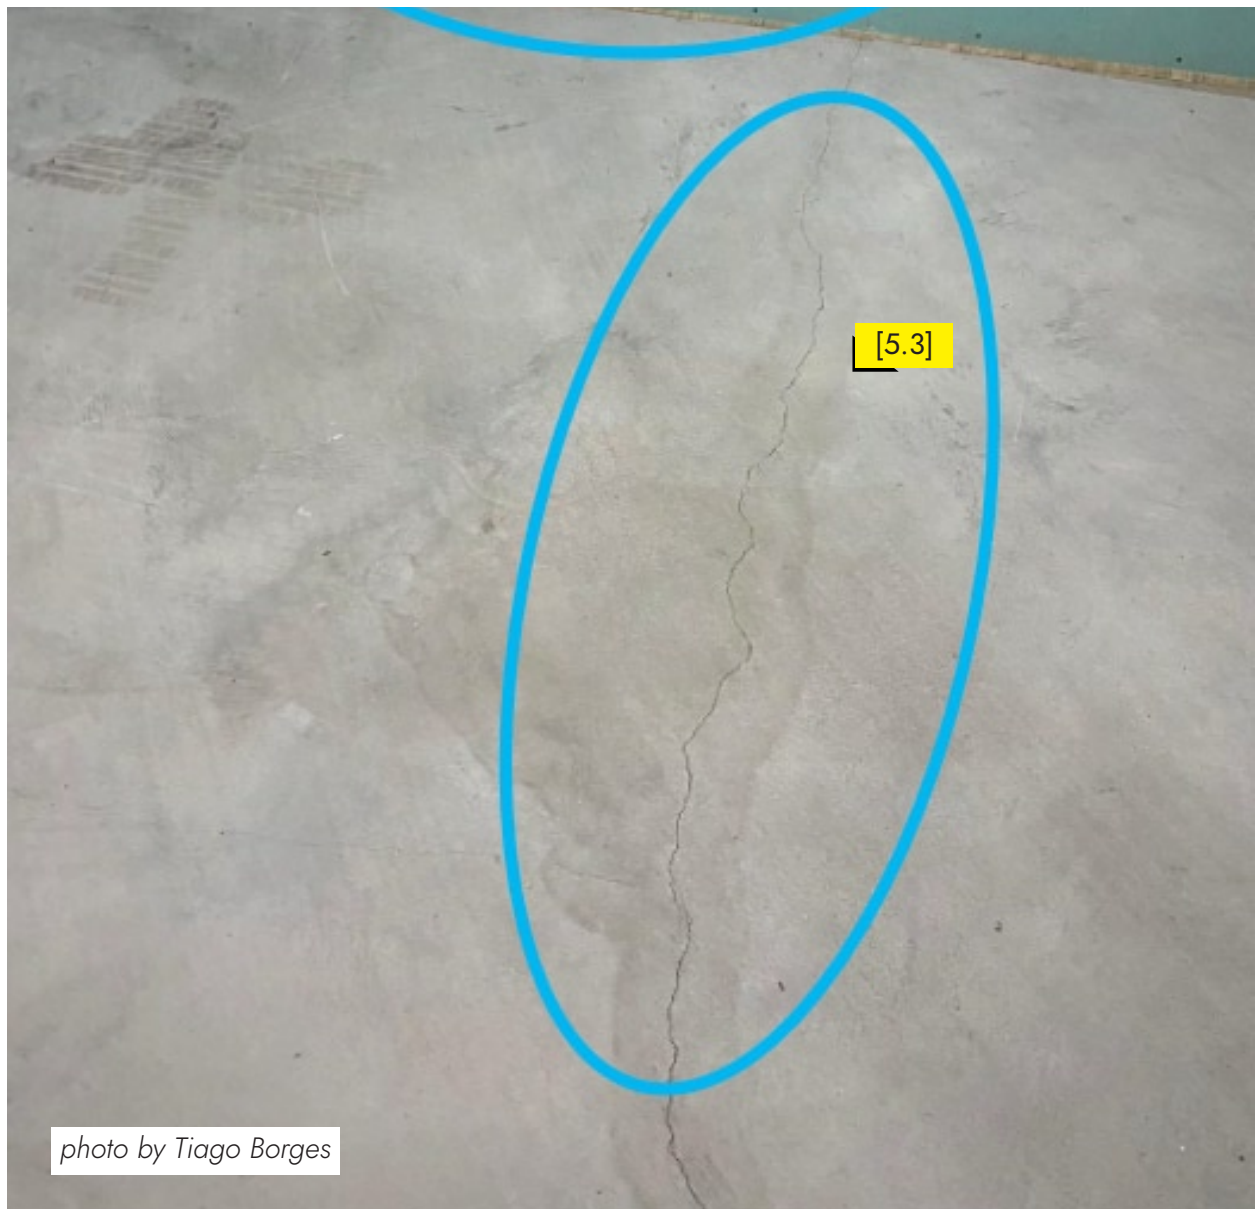
5.3. Cracked floor

The concrete screed is cracked in many places. Moisture stains can be seen in the cracks.

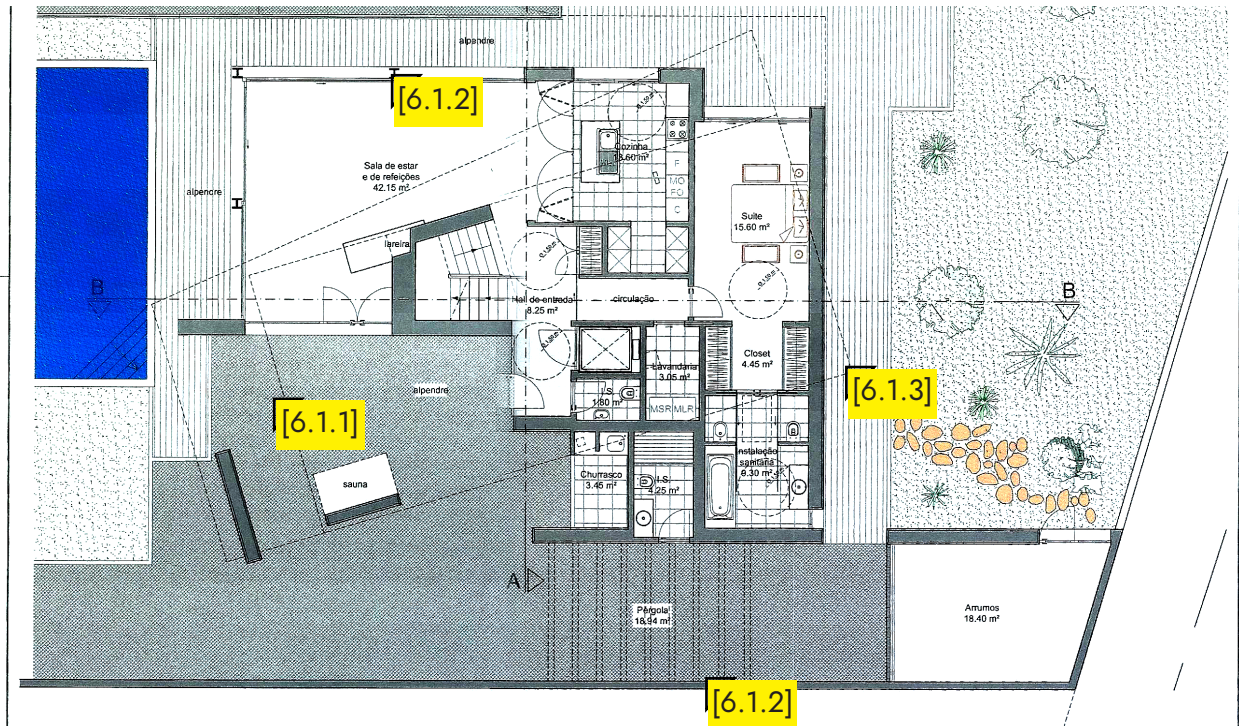
External walls have defects in design and workmanship, resulting in cracking and damp patches. Walls and fences have no copings. Plasters and paints appear to be of poor quality.

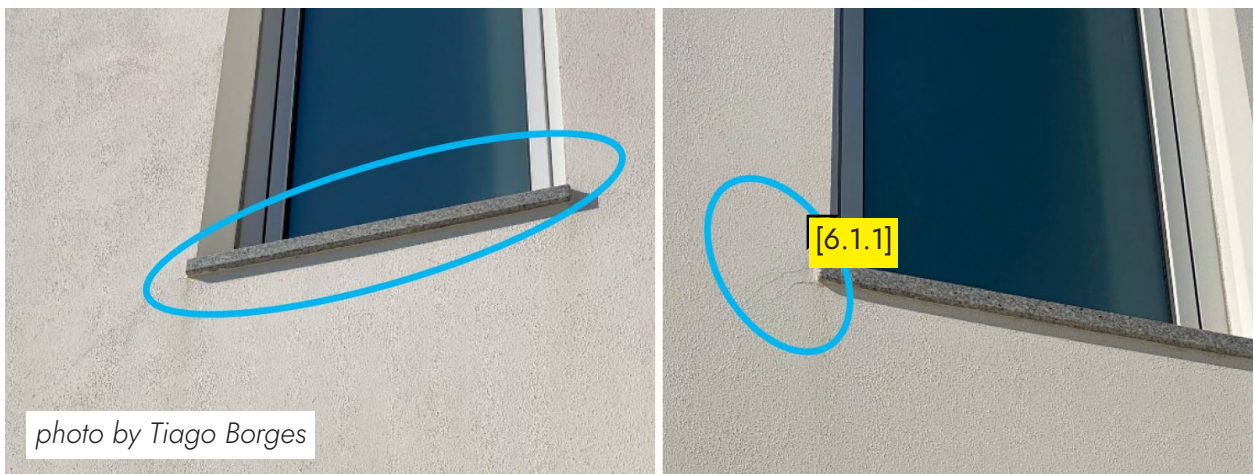
6.1.1. Cracks in the façade around the window openings.

The main cause of their formation is the lack of diagonal reinforcement in the plaster layer.

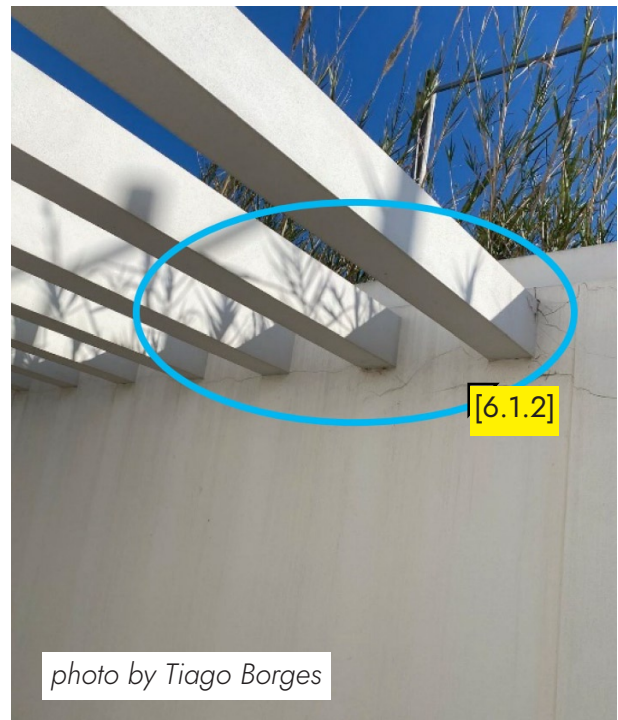
6.1.2. Cracks below top of walls and masonry.

The stone copings and window sills do not have throating (drip channels), thus the water flows along the walls and soak it. There are a lot of evidence of water penetrating house walls and fence walls.

Caused by water penetration due to missing or poorly executed copings, wall settlement and stresses arising at the boundary between different materials.

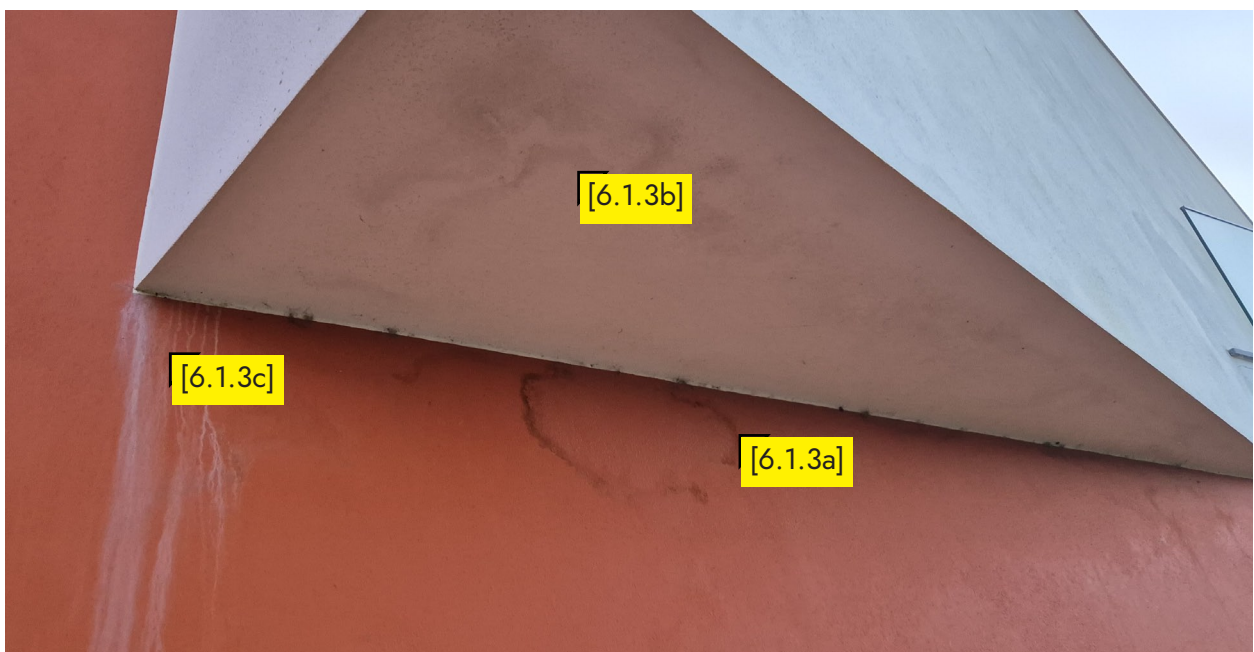
6.1.3. Discolouration and staining on the facade.

6.1.3a This is a possible exudation of water accumulated on the ceiling from a leaking terrace.

6.1.3b Stains from rainwater running off the walls. The water from the rain streaming down onto the horizontal surface instead of dripping off the edge of the wall.

6.1.3c Staining from rainwater washing out plaster/paint. Possible site of leaking water accumulated on the ceiling from leaking terrace covering.

The greenery and fungus in the north is either faulty plaster or a lack of a fungicide and algacide, the use of which is currently standard in the building industry.

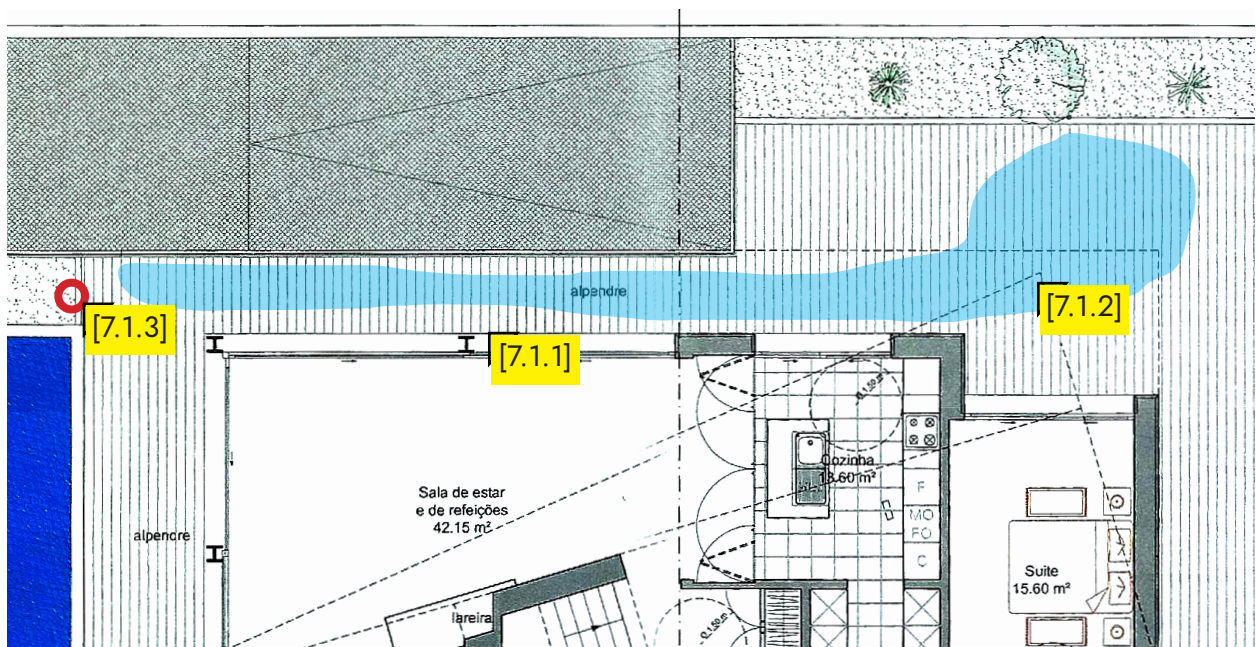
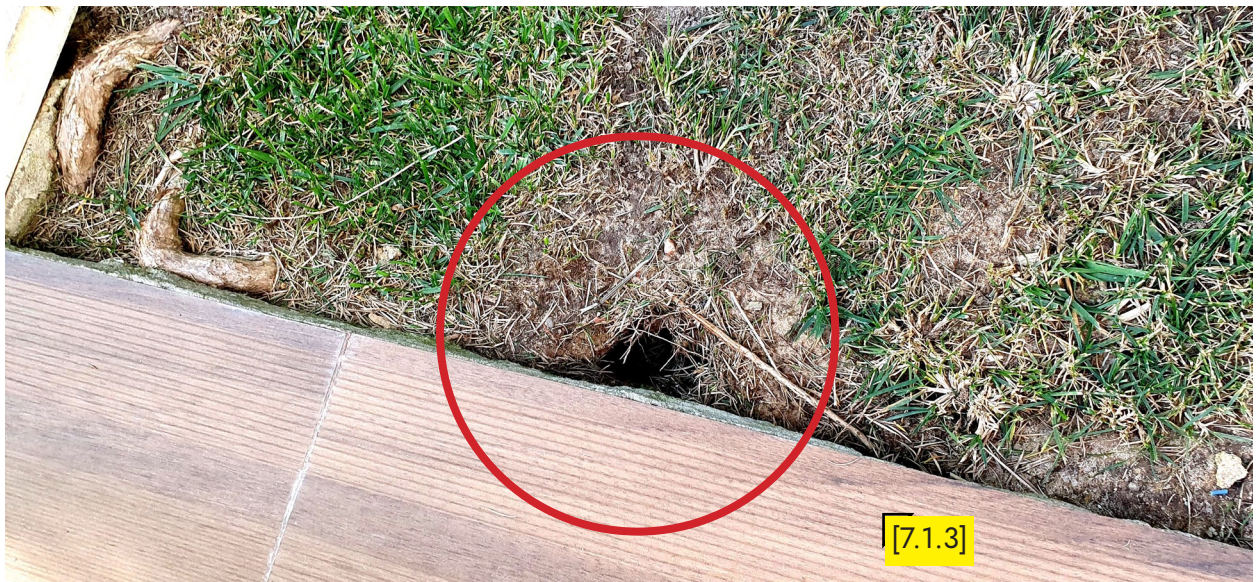
Patio surface on wrong profile – it forms a trough, there is no slope [7.1.1]. As a result, rainwater floods the patio in large puddles [7.1.2]. Excess water running off the patio is not drained anywhere. Therefore, the water has washed out a hole in the lawn [7.1.3], through which it runs off, washing up on the edges of the patio and the pool and on into the area of the underground pool pumping station room.

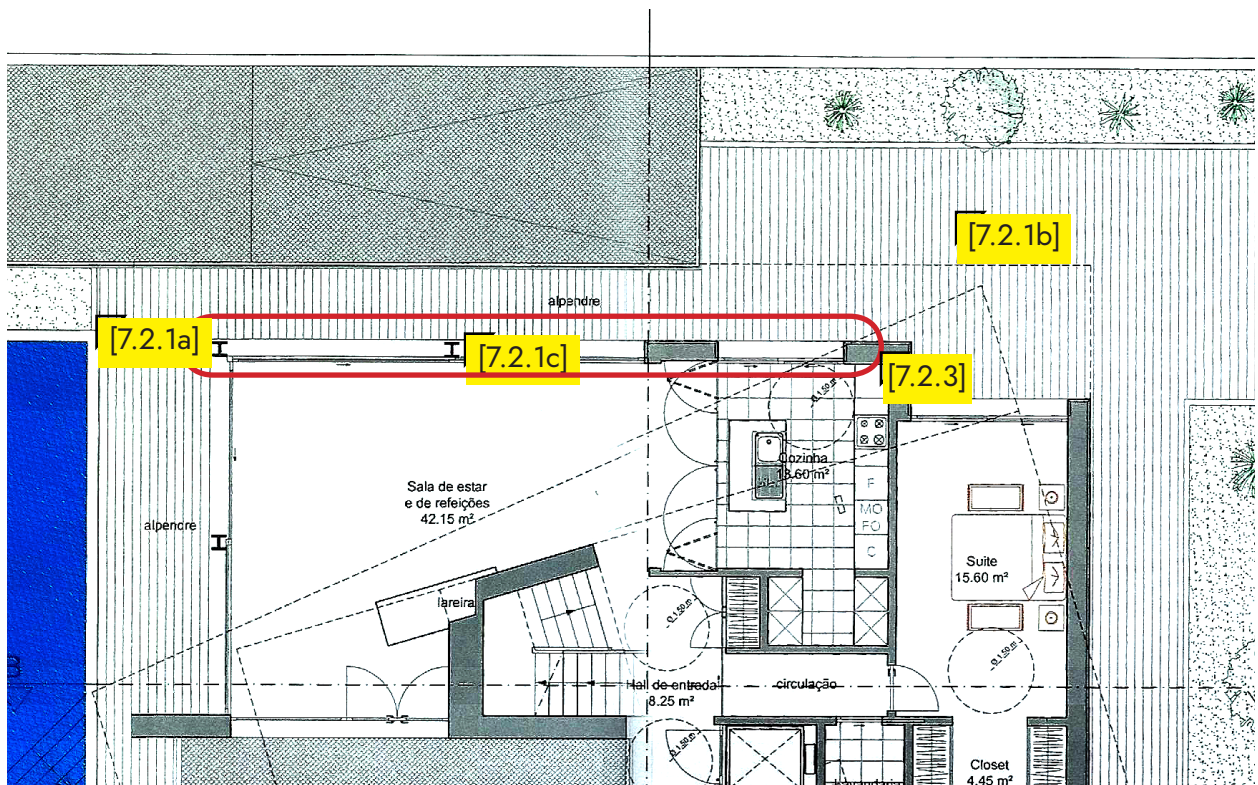
Grout is chipping all over the patio and water is seeping into the adhesive layer. Some tiles are falling off. [7.2.1a] Tile cracks are visible on the structural pillars [7.2.1b]. There are also visible signs of corrosion around the pillars [7.2.1b]. Water stains are visible on the walls of the building [7.2.2].

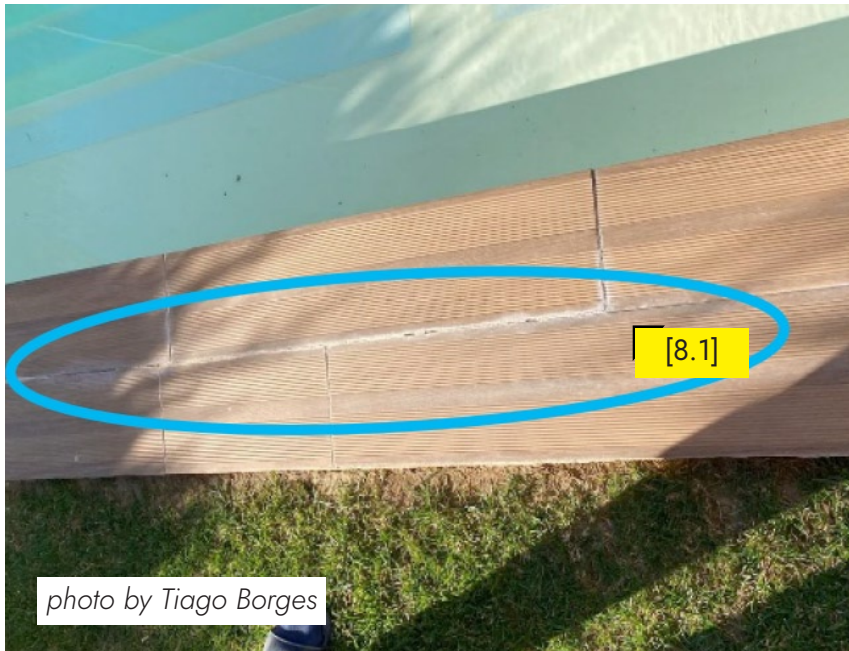
The edge of the pool is tiled in the same way as the patio. The same mistakes as on the patio are repeated - the tiles are coming off, the joints are chipped.

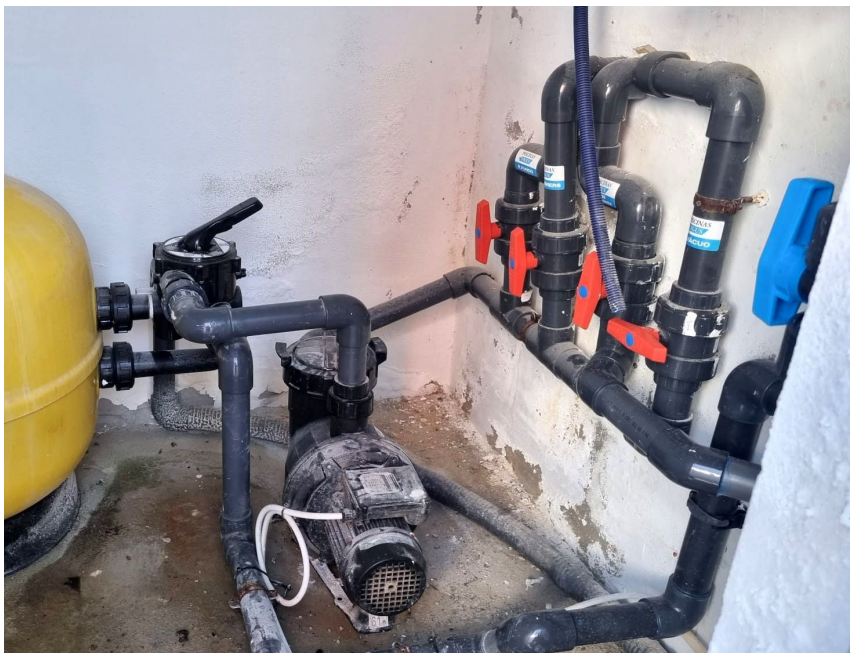
8.2. The pumping compartment

In the pool pumping compartment, the walls are damp and cracks are showing on the walls and ceiling. Plaster and paint are falling off the walls.

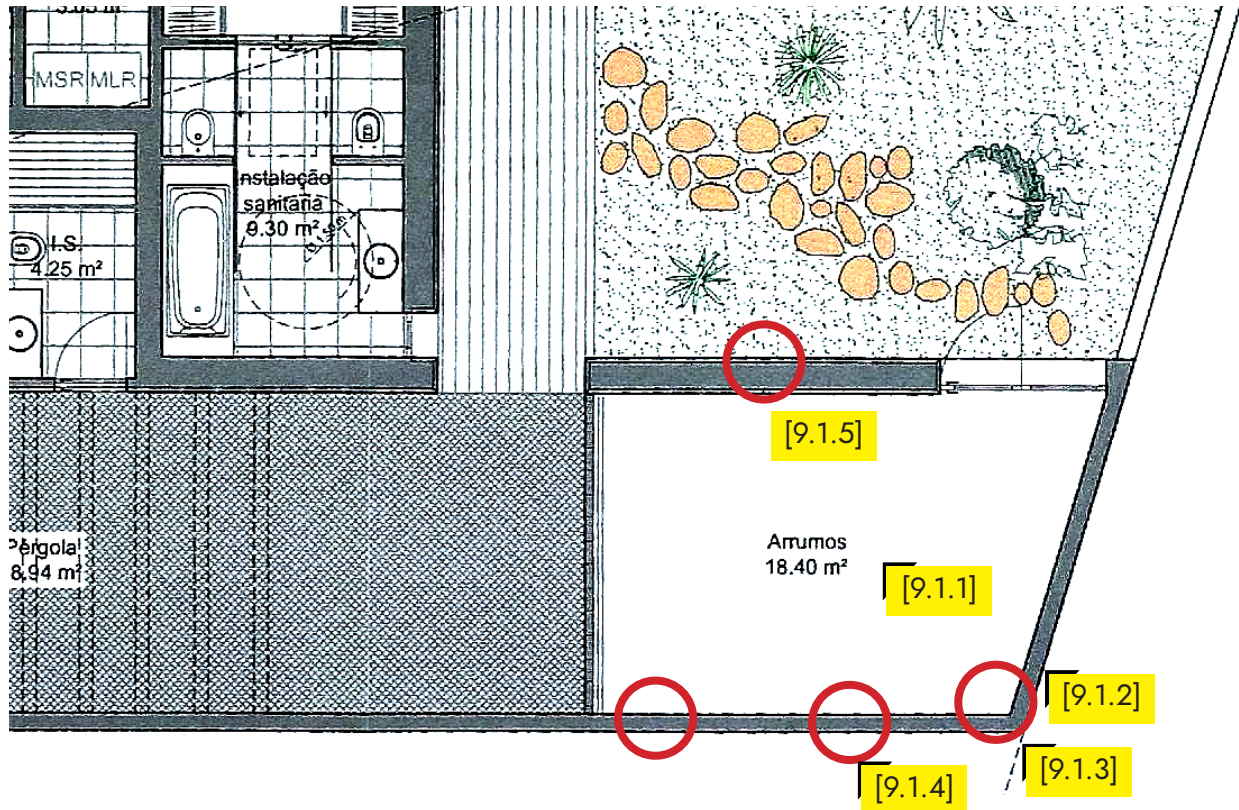
A small house is built next to the house. It is connected to the main house by a concrete pergola. A number of anomalies were discovered in this building, such as rainwater leaks from the roof, dampness in the walls, cracks in the attic copings and roofing errors.

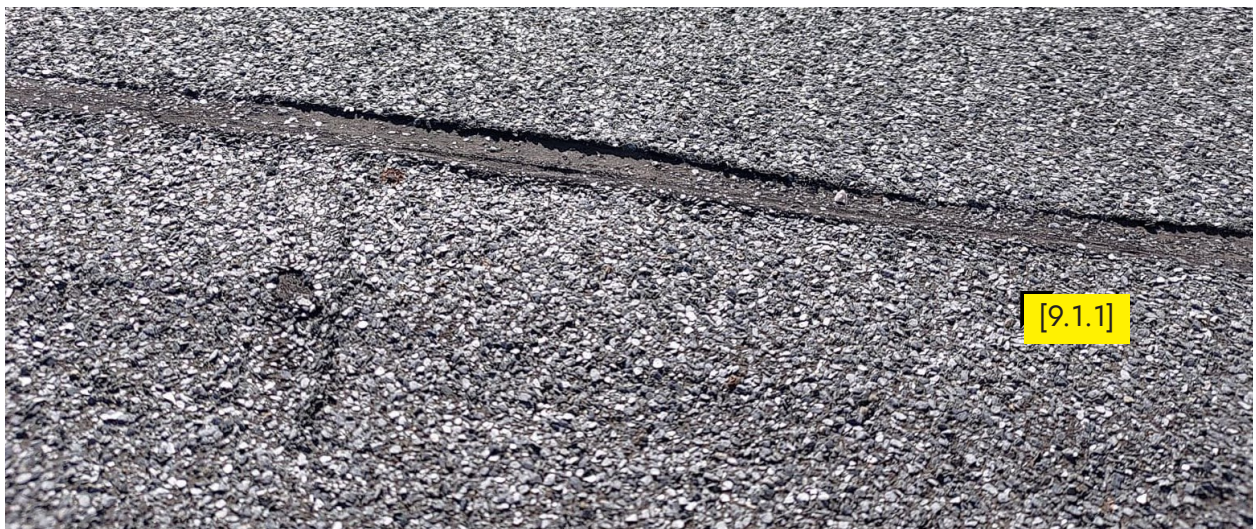
9.1.1. Improperly welded roofing felt. The visible strip without mineral sprinkling is the overlap for welding and should be welded across the width.

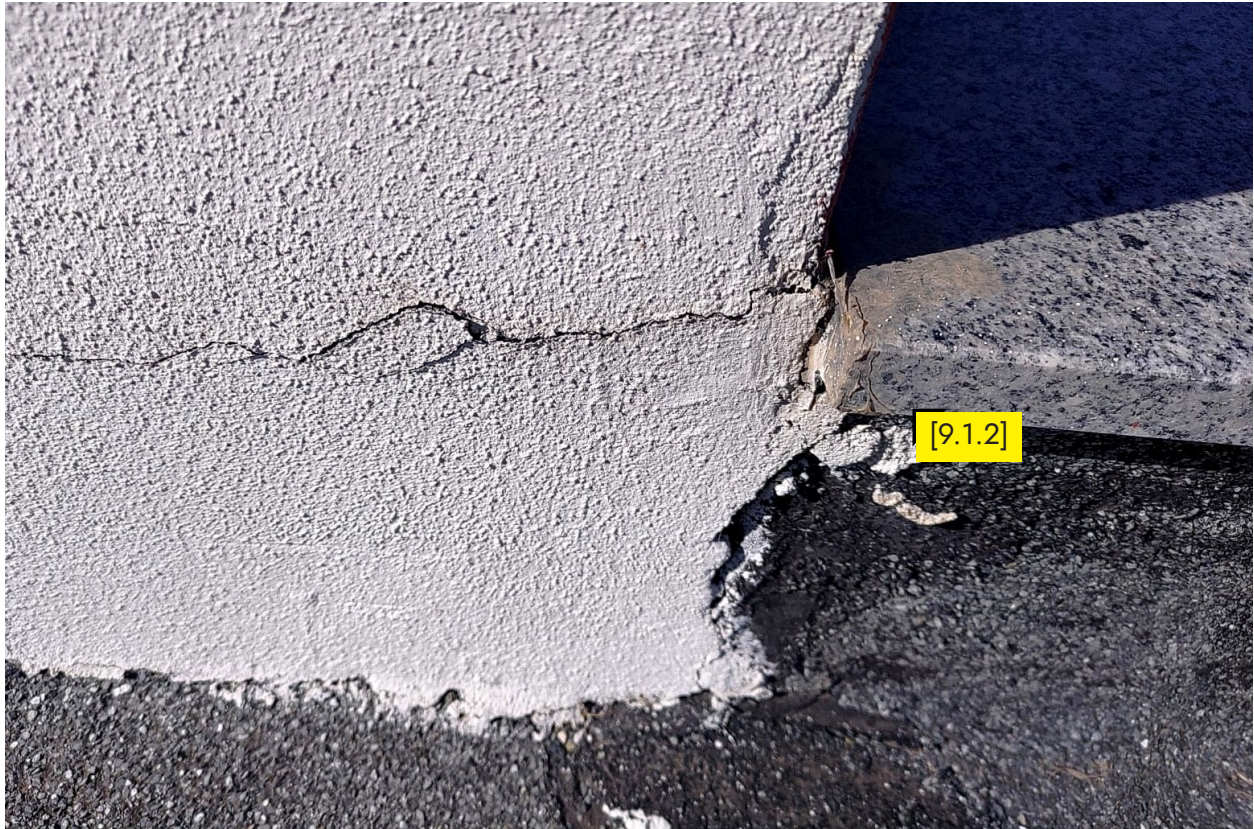
9.1.2. Cracks at the connection of the attic to the walls of the pergola and the house.

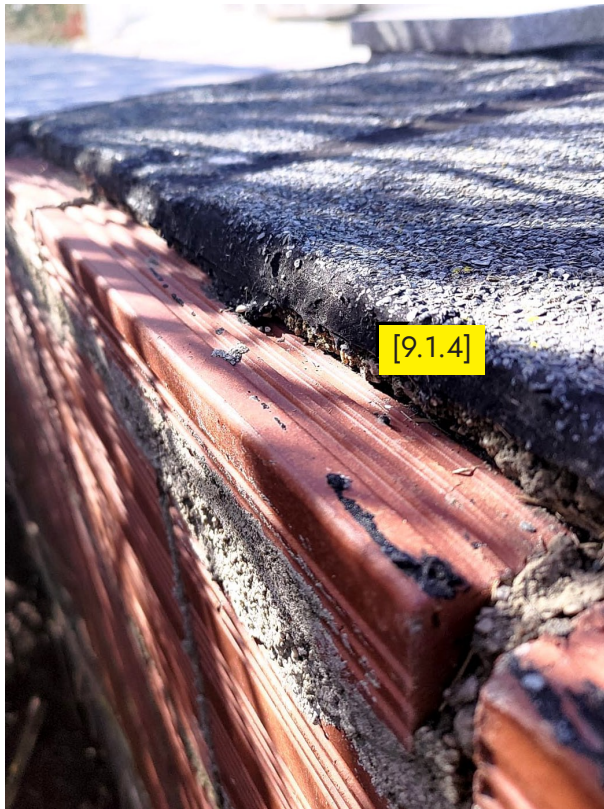
9.1.3. Lack of capping on the wall on the east side, roofing felt not properly welded.

9.1.4. Lack of proper capping on the wall on the east side, unprotected areas where water penetrates the wall.

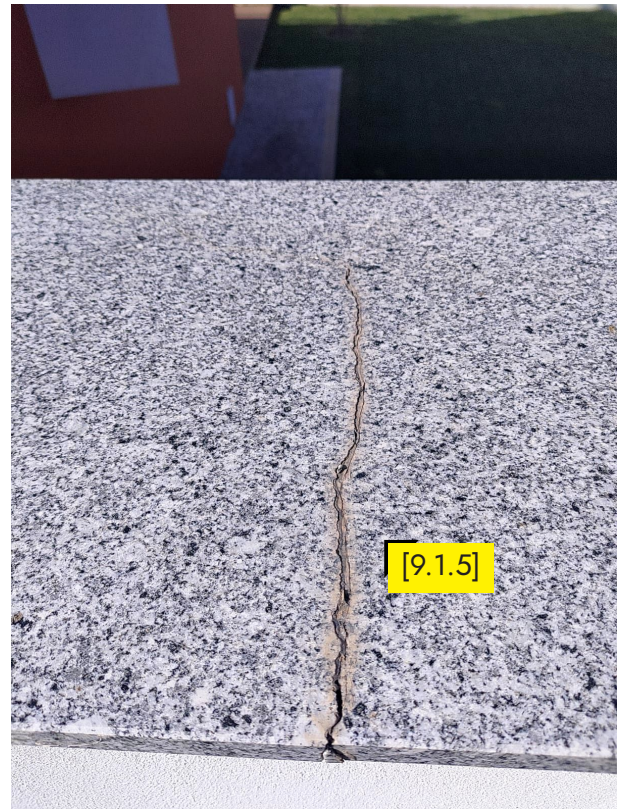
9.1.5. Cracks on the stonework on the attic wall.

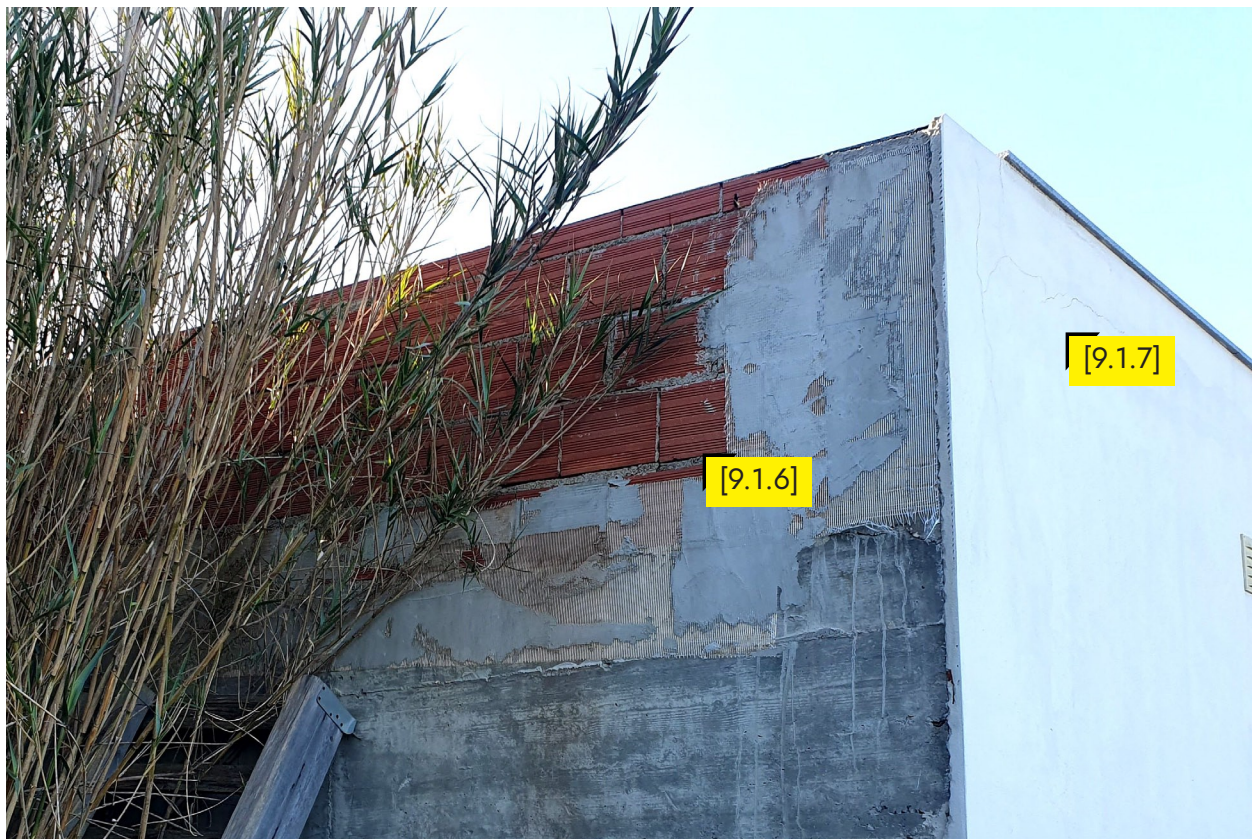
9.1.6. Complete lack of plaster and waterproofing on the east wall.

9.1.7. Cracks in the north-east corner.
