The Report

February 2025

This report systematises and organises the numerous construction and workmanship errors occurring in the private residential house located in Lote 2 - Casais Porto Dinheiro.

The discrepancies were identified based on the construction project of the residential building 12146/2017, hereinafter referred to as The Project.

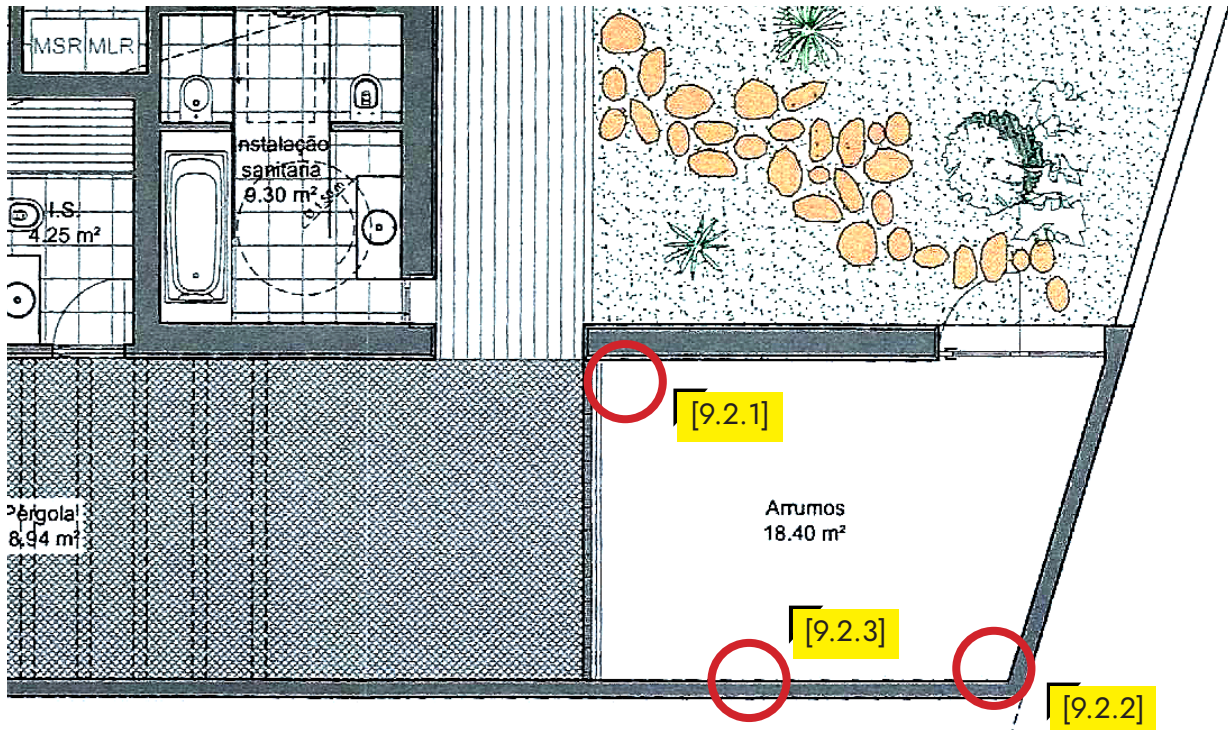
The humidity is high throughout the room and there is a distinct smell of mould. Furniture and furnishings left here are covered in mould and mildew. The covers of the garden furniture have an unpleasant musty smell.

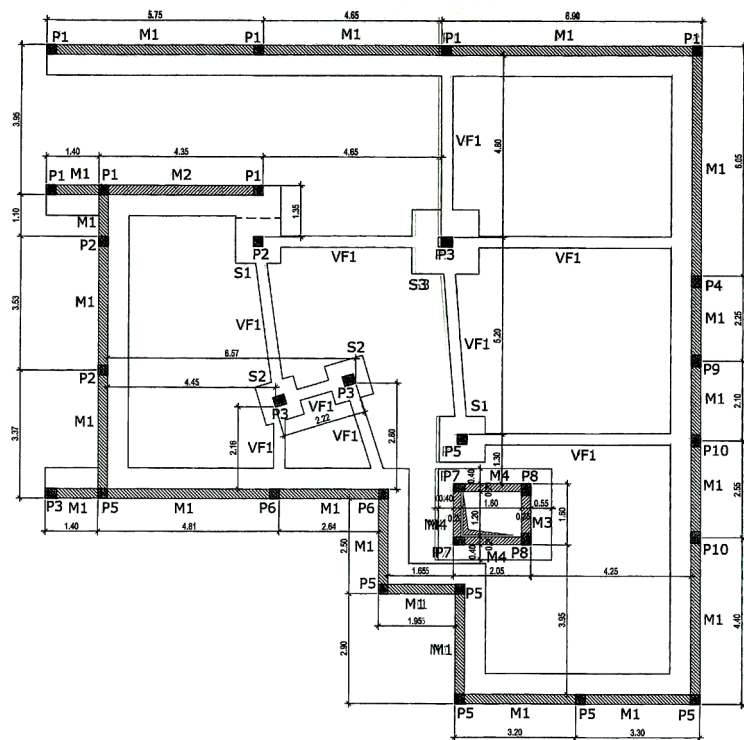
It is likely that the perimeter drainage around the house was not built as envisaged in The Project. The large amount of dampness in the basement walls and floor seems to confirm this. No drainage outlets were found during the inspection - neither in the manholes nor outside within the stone slope on the northern boundary of the plot.
