The Report

This report systematises and organises the numerous construction and workmanship errors occurring in the private residential house located in Lote 2 - Casais Porto Dinheiro.

The photographic material used in this report comes from the inspection on February 4–7, September 4-8, 2025 as well as other material produced between 2023 and 2025, and documents the various deficiencies and problems occurring during this period.

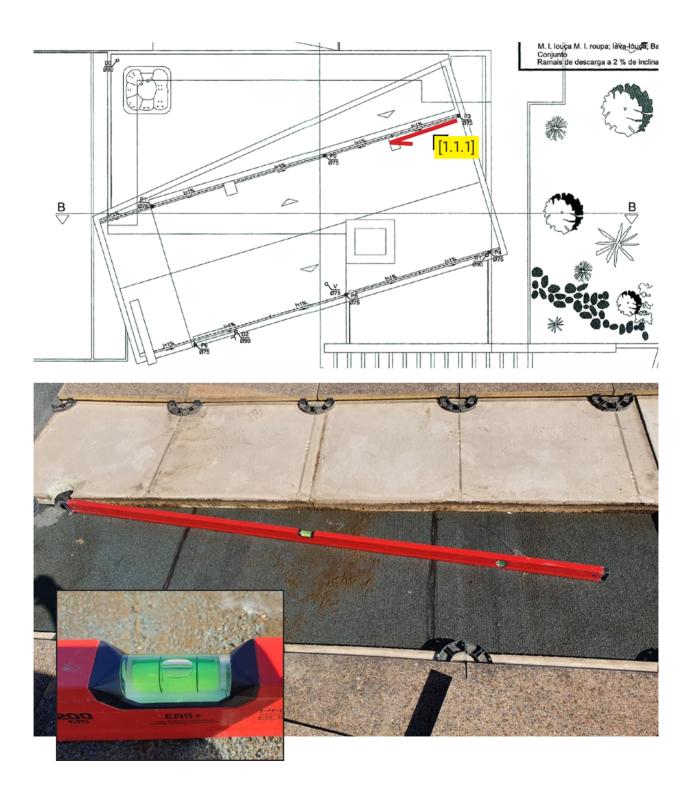
1.1.1. Roof profiling discrepancies were detected in relation to The Project. In some cases, the roof slope is the opposite of the design. Instead of a slope of about 1% towards the drain holes, a counterslope of about 0.5% was detected, which causes water to flow away from the drain hole.

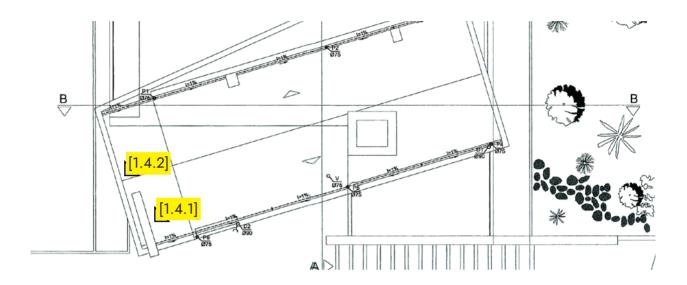
- **1.4.1.** The orange attic wall is all ckracked on top, with vegetation and water penetration inside. Lack of wall copings.
- **1.4.2.** The other roof attic walls have copings made of stone, with many defects also lack of the grout on connections, improper connection with orange plastered wall and even a wooden dowel left behind.

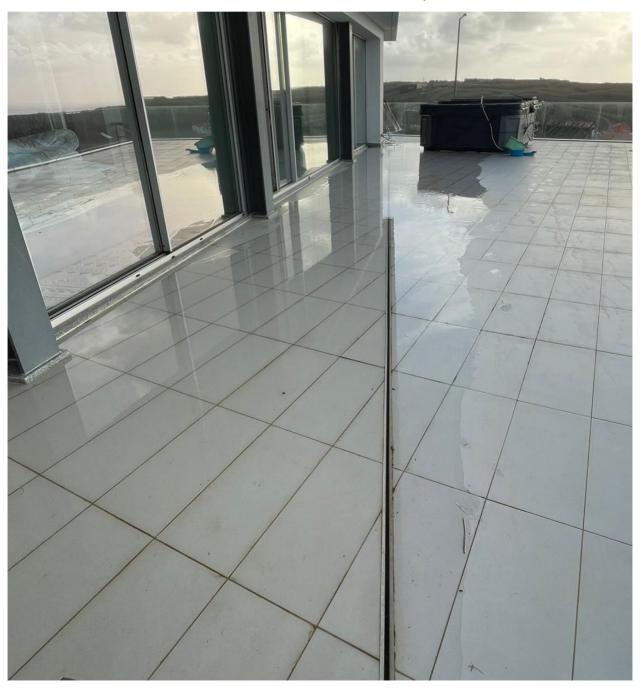
On the day of the inspection, a significant amount of water was found ponding on the terrace and numerous floods in the rooms below, as discussed later in the report.

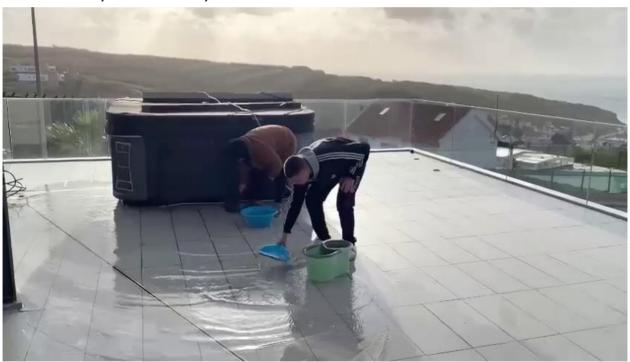
Despite exposing the drain hole and many attempt to unclog it, the water stored on the terrace could not be drained.

It was necessary to mechanically remove the water from the terrace.

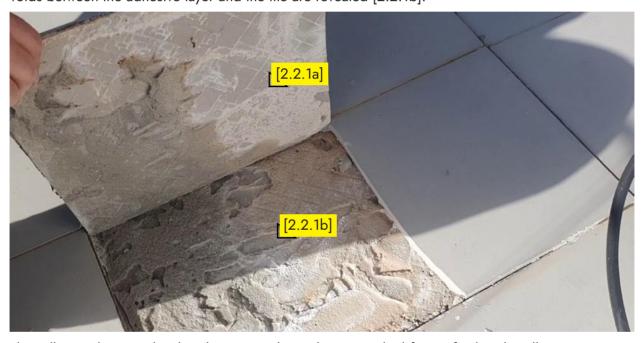
The tile was very poorly bonded to the screed and was easily removed when levered. The adhesive mortar is not bonded to the tile over a significant area [2.2.1a]. Insufficient adhesive and voids between the adhesive layer and the tile are revealed [2.2.1b].

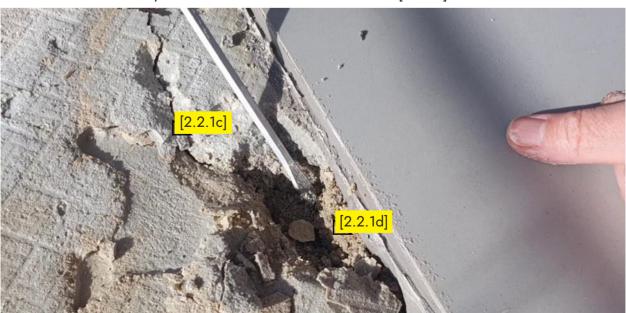
The adhesive layer under the tile was patchy and very cracked [2.2.1c]. The tile adhesive was very brittle and came off easily when undermined with a screwdriver [2.2.1d].

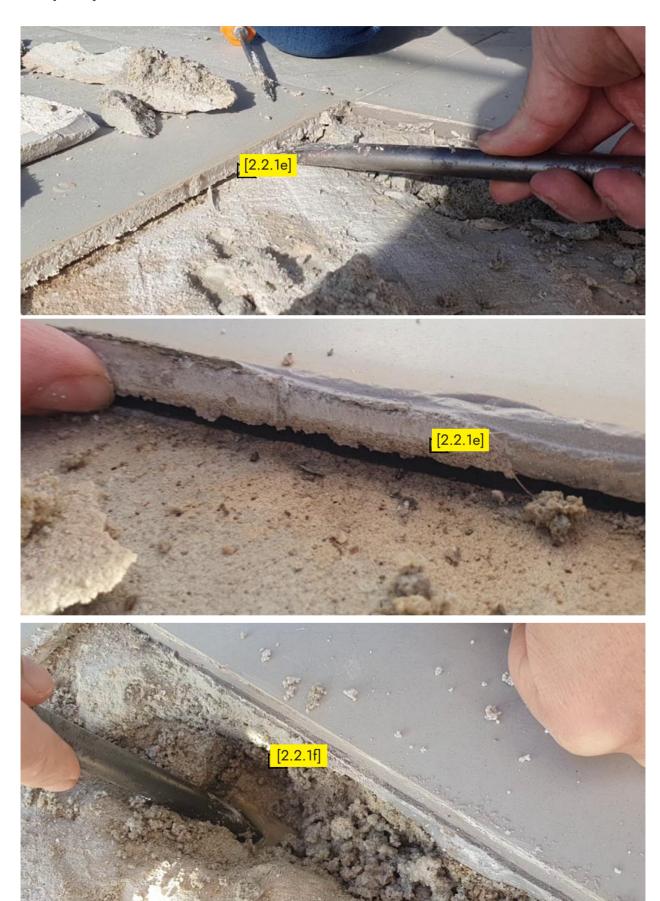
The adjacent tiles were also poorly attached to the substrate and could easily be undermined and torn off [2.2.1e].

Once the adhesive was easily removed, the xps foam layer was exposed and water appeared in the hole [2.2.1f].

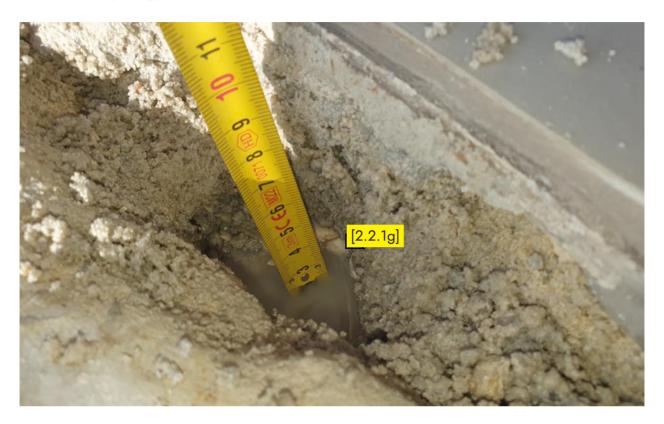
No waterproofing was found to protect the screed from water penetration.

A water layer of approximately 30 mm was found in the xps insulation, directly on the floor slab [2.2.1g].

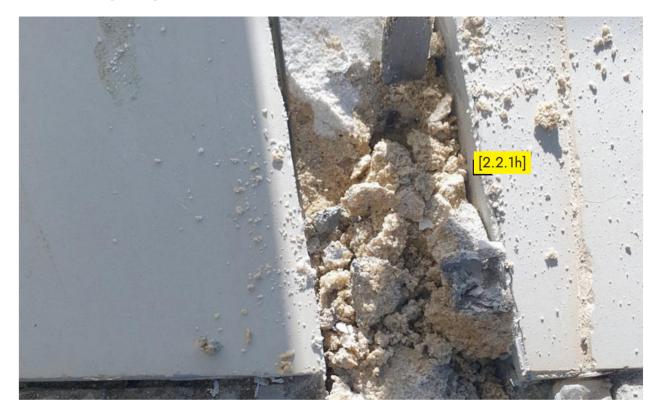
The adhesive layer was exposed elsewhere on the terrace and the situation was very similar: the mortar was very crumbly, non-cohesive and crumbled very easily in the hands. In colour and texture it resembled wet sand [2.2.1h].

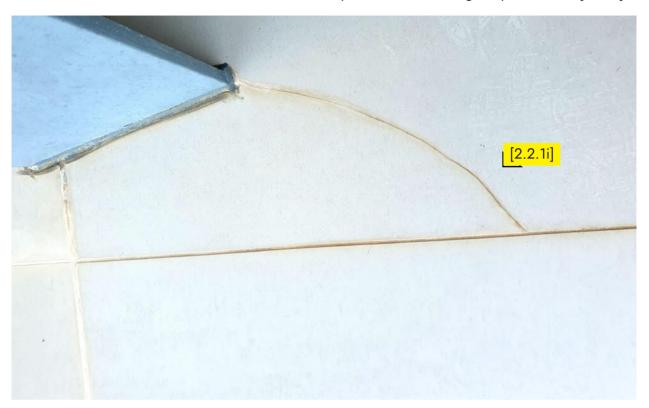
Stress cracks were found in the tiles around the steel pillars of the buildings' superstructure [2.2.1i].

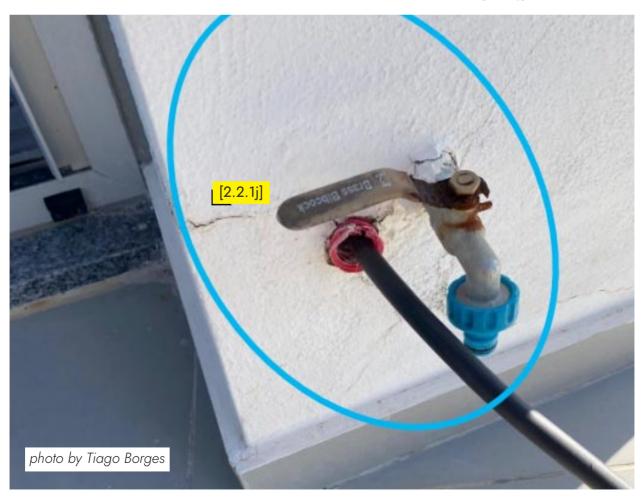
Stress cracks in the area of the connection between the terrace and the wall [2.2.1j].

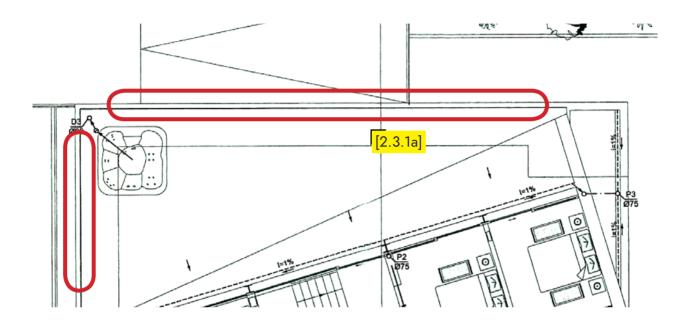
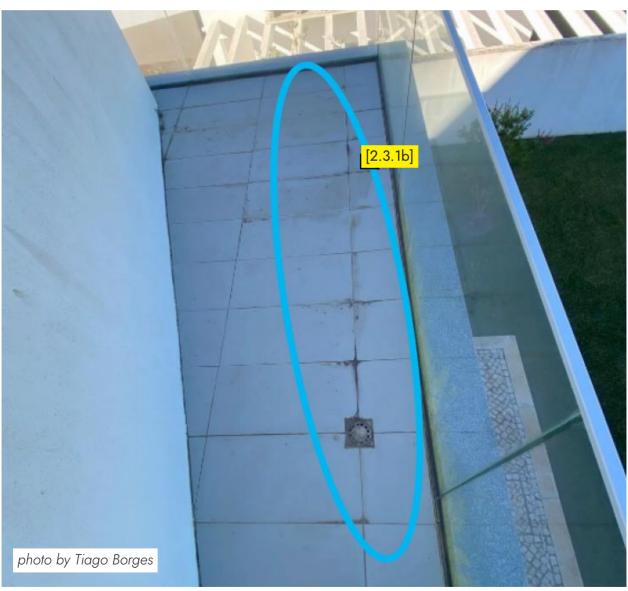
2.3.1. Numerous cavities and discolouration in the tile grouts were found on the overall terrace surface. There are many visible instances of grout erosion [2.3.1b].

The connection between the terrace surface and the balustrade is cracked or absent in many places. This creates the possibility of water penetrating into the balustrade attachment points and further erosion. Numerous vegetation can be seen nestled in the cracks [2.3.1a].

The connection between the balustrade and the terrace should be both watertight flexible.

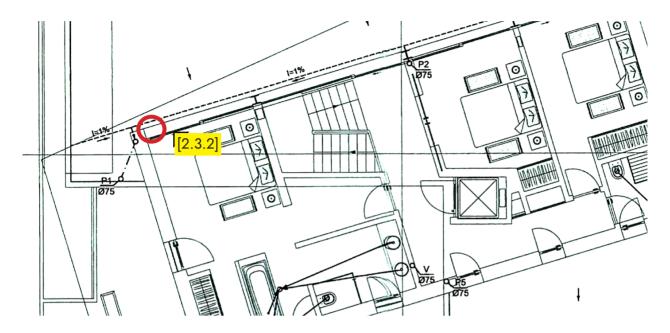
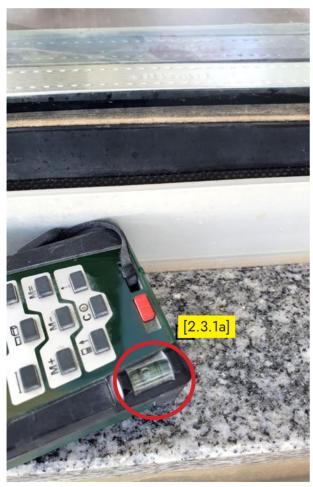
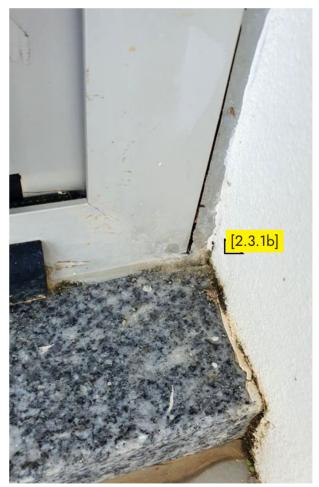
Terrace window parapets have the wrong slope (slope towards the window) [2.3.1a]. This causes water that runs down the panes to be directed to the window and flow into the masonry through gaps in the seal. Visible traces of fungus in the corners. [2.3.1b].

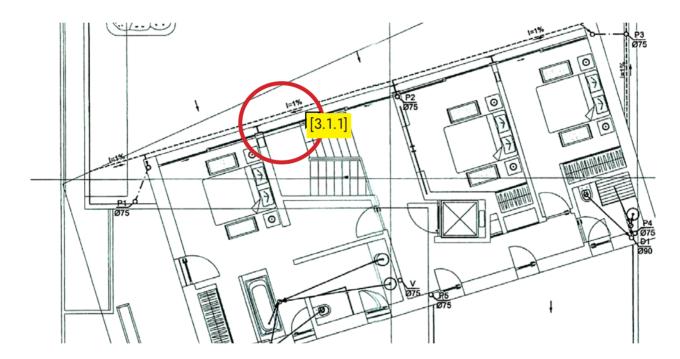
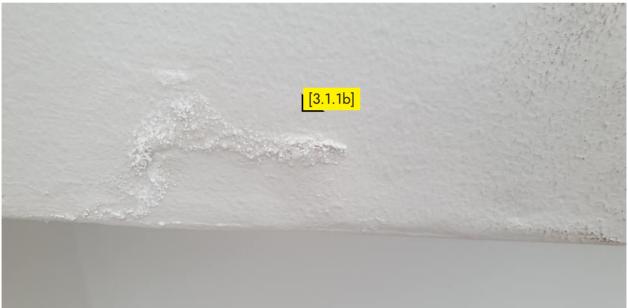
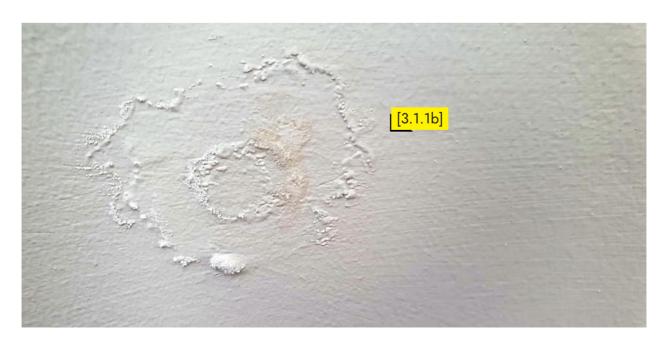
Using a thermal imaging camera, dampness was detected in the west wall of the stairwell [3.1.1a]. Discolouration, cracks, paint chipping and plaster degradation can be seen in the area where the terrace floor slab meets the wall [3.1.1b].

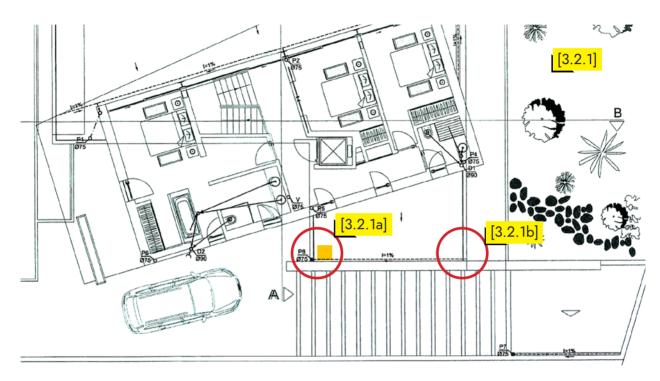
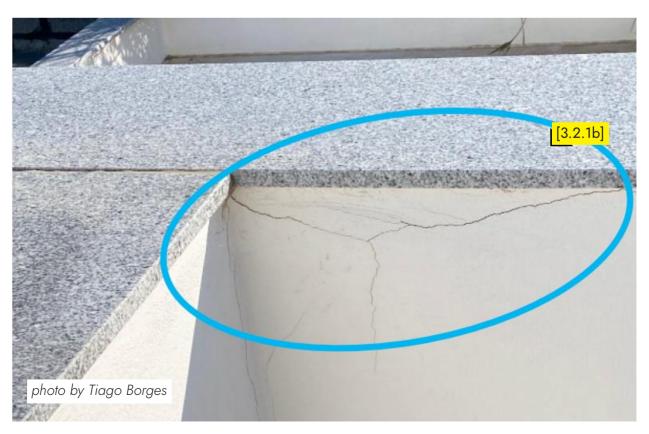
The diameter of the P8 drain pipe is 50 mm whereas by The Project it should be 75 mm. In addition, the P8 drain has been placed behind the chimney of the grill located on the patio below. This location of the drain results in the accumulation of debris and plant elements and makes cleaning the drain much more difficult. It should be mentioned that the grill chimney (highlighted in orange) is not present in The Project. [3.2.1a].

Cracks in the masonry fence of the balcony [3.1.1b].

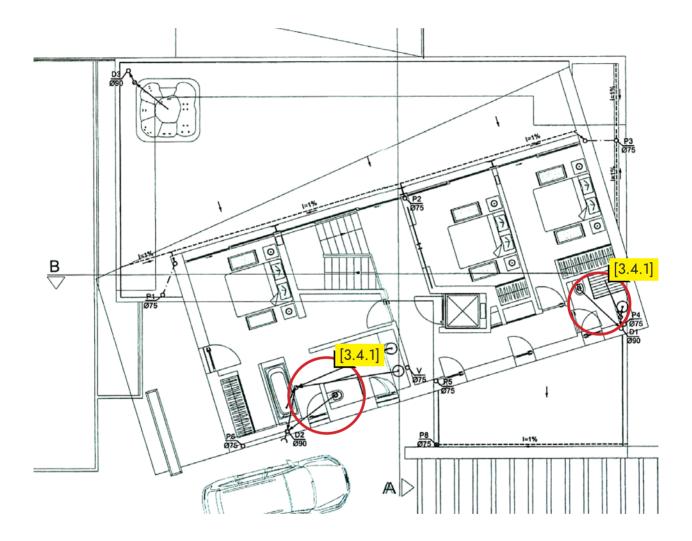
In the upstairs bathrooms [3.4.1], hot water does not appear until about 4 minutes after turning on the tap. This causes a wait and wastes a considerable amount of water, which uselessly flows down the drain during this time.

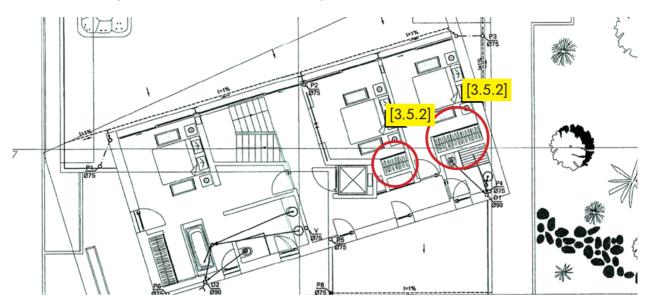
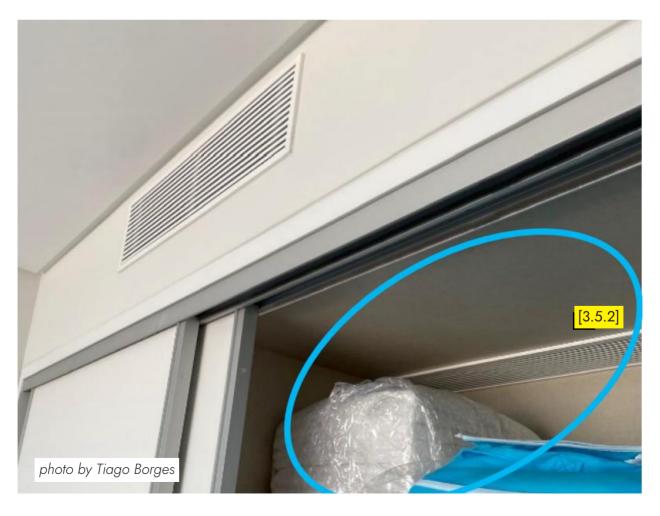
- **3.4.1.** On the first floor, three air-conditioning systems were installed built-in in the walls, the false ceiling and in the wardrobes. None of them has an inspection opening to access the junction box. In the event of a malfunction or the need to make adjustments, it will be necessary to drill a hole in the wall or dismantle the wardrobe.
- **3.4.2.** In the two bedrooms on the north side of the house, the air conditioners have air intakes hidden in lockable wardrobes. For this reason, it is impossible to use them properly. For the air conditioner to work effectively, the wardrobe doors must be open.

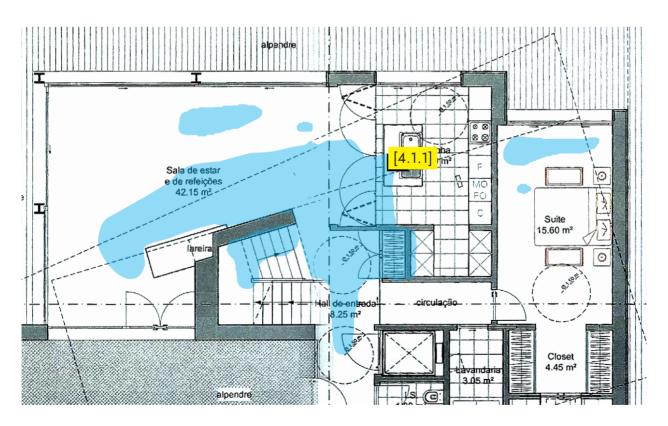
The presence of water in the building's structure and equipment was determined by direct visual inspection, images from the endoscopic camera and images obtained from a thermal imaging camera. The projection below shows the areas affected by flooding including floors, walls, ceilings, furniture, wardrobe and light fixtures.

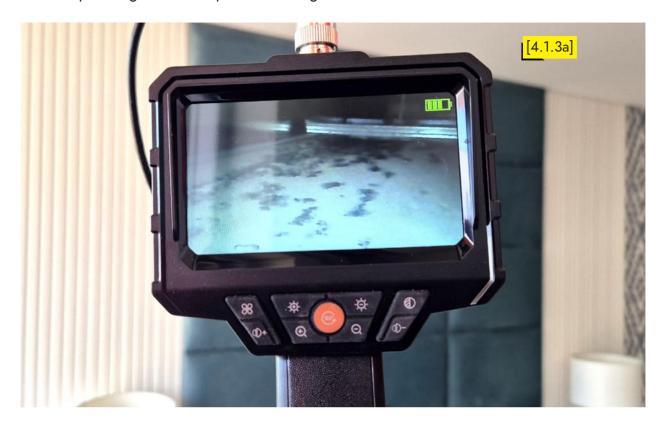
Moisture was found in the suspended ceiling of the bedroom during the inspection. Numerous mould colonies were detected on the ceiling and in the recess for the roller blinds [4.1.3a].

Endoscopic image of the suspended ceiling surface. Mould colonies are visible.

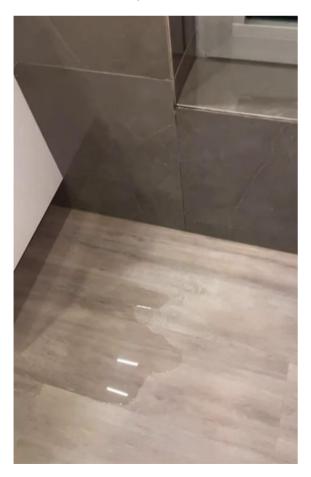
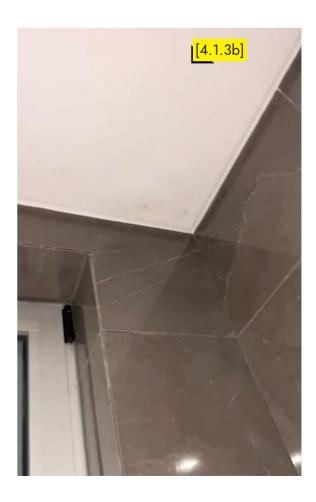
In the bathroom adjacent to this bedroom, there were repeated leaks on the ceiling and water collecting on the floor during rains. [4.1.2b].

Leaks in the nearby bathroom

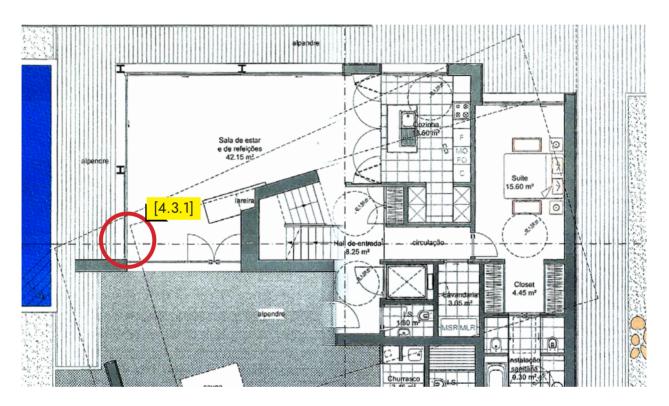
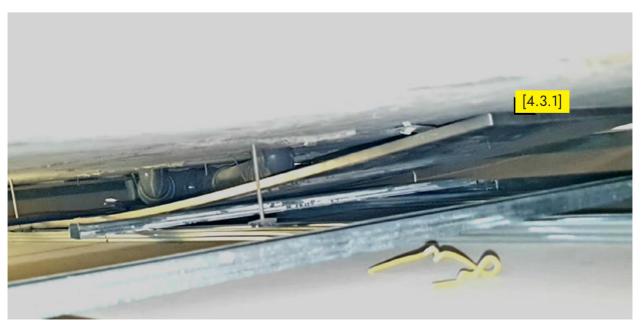
The tray is located underneath where the roof and terrace drainage pipes pass through the terrace ceiling. There are clear signs of staining on the pipes [4.3.2].

Presumably this is a device to catch leaks from the terrace that the contractor could not deal with. Instead of sealing the penetrations through the ceiling and fixing the problem, a leak masking device was installed.

This is an unprecedented, non-technological solution and should not be used in housing.

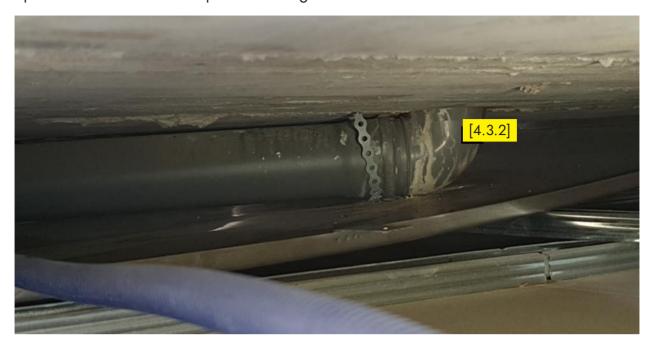
Space between slab and suspended ceiling surface. Stains streaks are visible.

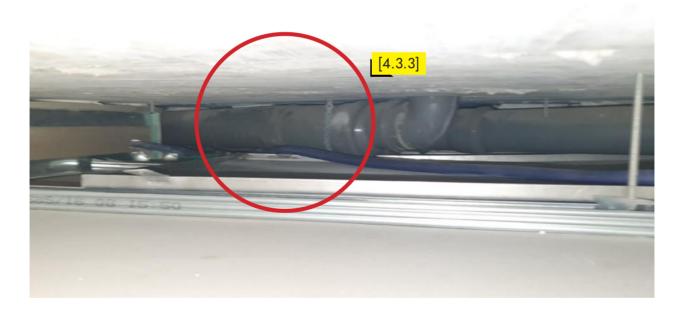
4.3.3. The drain pipe is bent upwards (counter-sloping), which is not acceptable. This causes dirt to settle in this area and stagnant water in the pipe. The drainage pipes used here are designed to work with a slope.

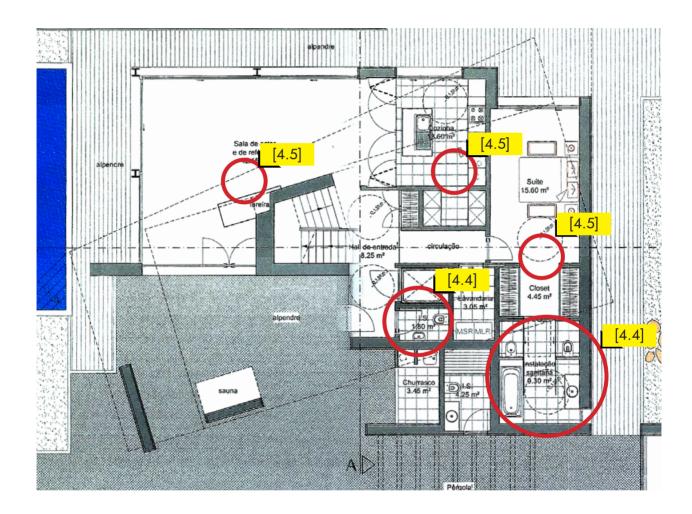
Neither of the two bathrooms on the ground floor has ventilation ducts.

The opinion that this is not required when windows are open is not true, as this would mean that during cold or rainy weather, residents would be forced face the weather elements to provide ventilation.

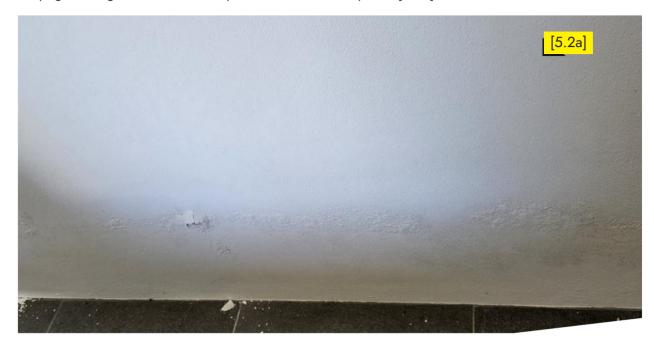
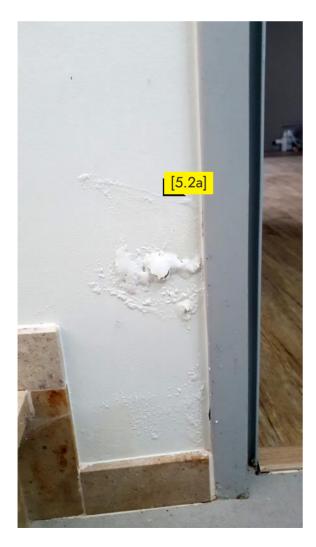
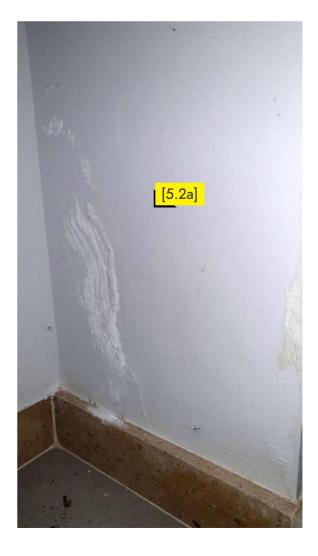
The main problem in the basement is dampness. There are stains on the floor, damp patches on the walls – mainly in the corners. Poor horizontal damp protection of the floor and walls thus capillary seepage through the walls are responsible for this dampness [2.5a].

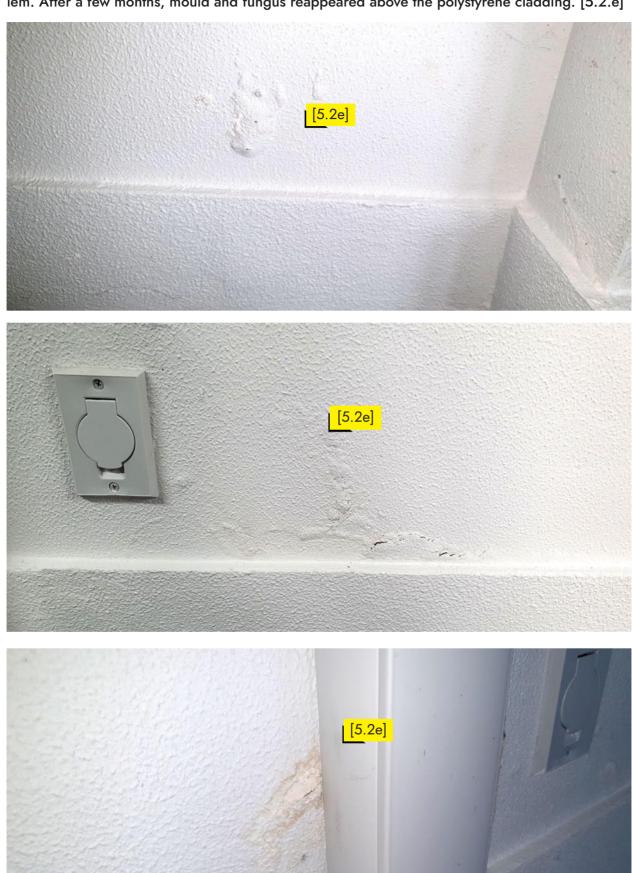
As could have been predicted, the measures described above did not solve the underlying problem. After a few months, mould and fungus reappeared above the polystyrene cladding. [5.2.e]

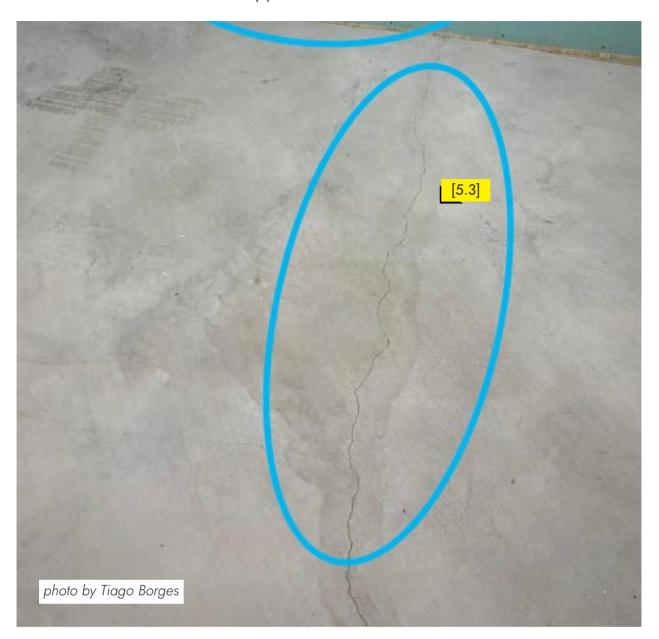
5.3. Cracked floorThe concrete screed is cracked in many places. Moisture stains can be seen in the cracks.

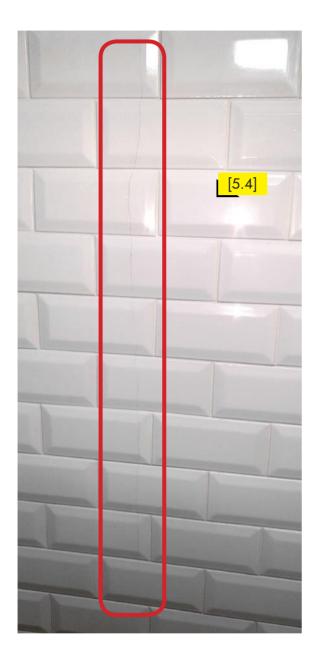
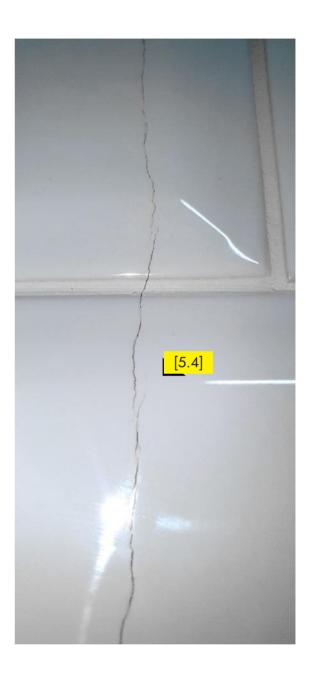
The tiles on the bathroom wall in the basement have cracked over a substantial length.

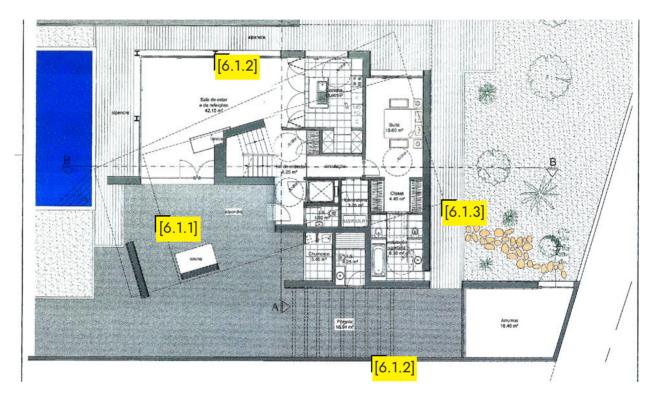
External walls have defects in design and workmanship, resulting in cracking and and damp patches. Walls and fences have no copings. Plasters and paints appear to be of poor quality.

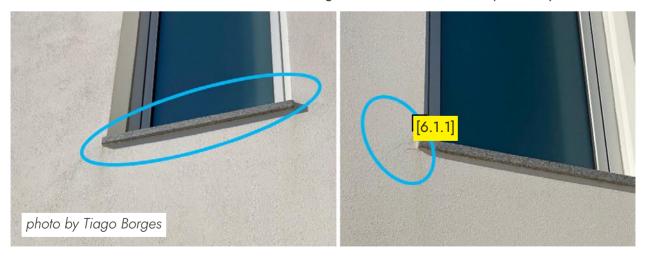
6.1.1. Cracks in the façade around the window openings. The main cause of their formation is the lack of diagonal reinforcement in the plaster layer.

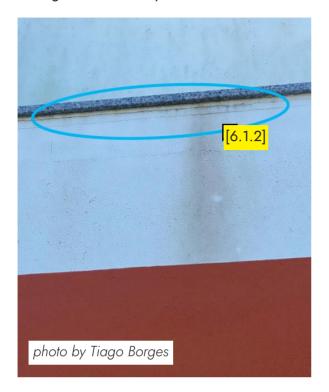
6.1.2. Cracks below top of walls and masonry.

Caused by water penetration due to missing or poorly executed copings, wall settlement and stresses arising at the boundary between different materials.

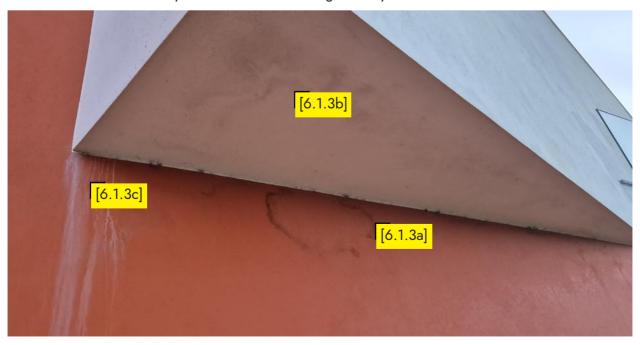
- **6.1.3.** Discolouration and staining on the facade.
- **6.1.3a** This is a possible exudation of water accumulated on the ceiling from a leaking terrace.
- **6.1.3b** Stains from rainwater running off the walls. The water from the rain streaming down onto the horizontal surface instead of dripping off the edge of the wall.
- **6.1.3c** Staining from rainwater washing out plaster/paint. Possible site of leaking water accumulated on the ceiling from leaking terrace covering.

The greenery and fungus in the north is either faulty plaster or a lack of a fungicide and algaecide, the use of which is currently standard in the building industry.

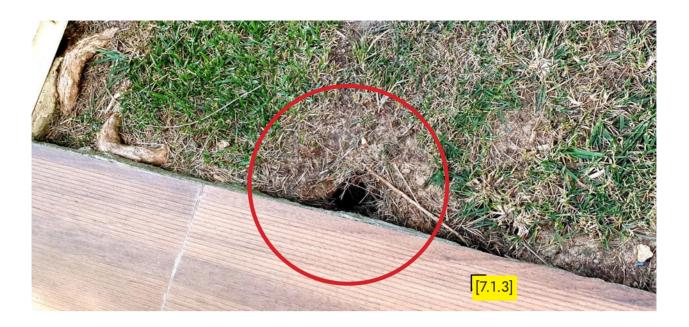
The patio drainage is inadequate. Tiling work has been carried out negligently, copings and window seals are missing.

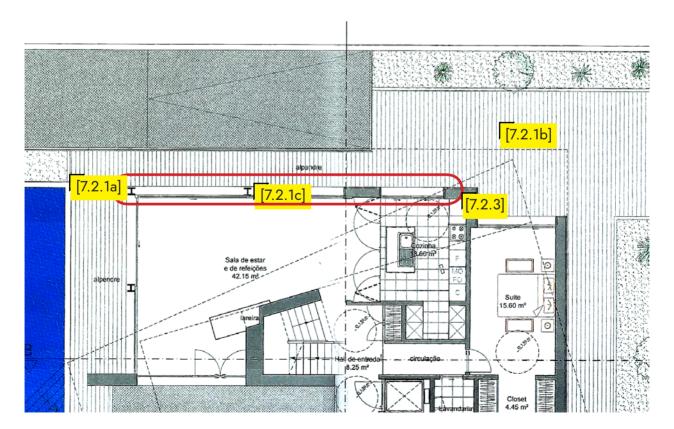
7.2.3 The sealing of the window openings is done extremely carelessly and in an extremely damaging way. Sealing is missing in all areas where the window drains are located! Thus, all the water that runs off the surface of the windows is introduced directly between the wall and the tiles!

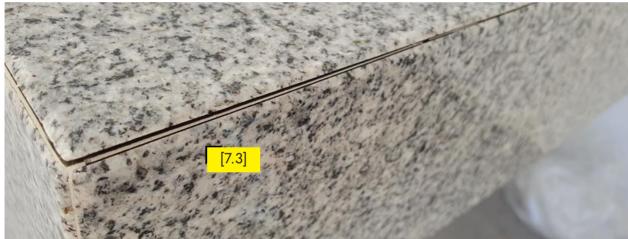
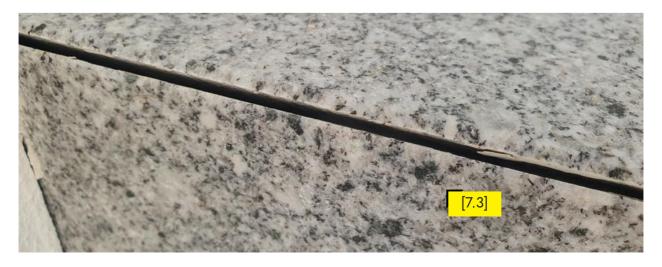
The kitchen worktop located on the patio is made of granite. Large cracks are visible at its joints. There is a concern that the front piece will fall off completely.

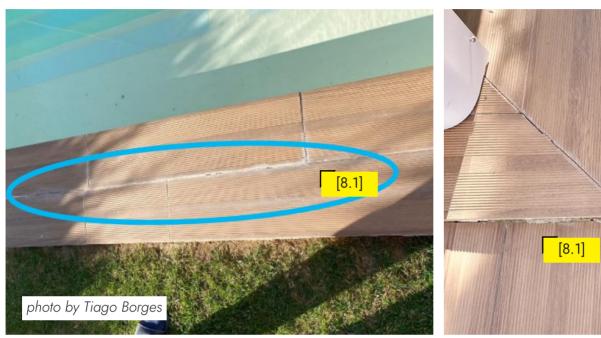
The edge of the pool is tiled in the same way as the patio. The same mistakes as on the patio are repeated - the tiles are coming off, the joints are chipped.

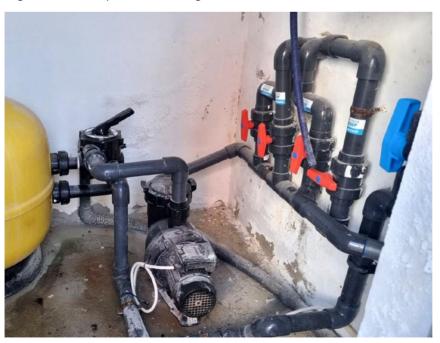
In the pool pumping compartment, the walls are damp and cracks are showing on the walls and ceiling. Plaster and paint are falling off the walls.

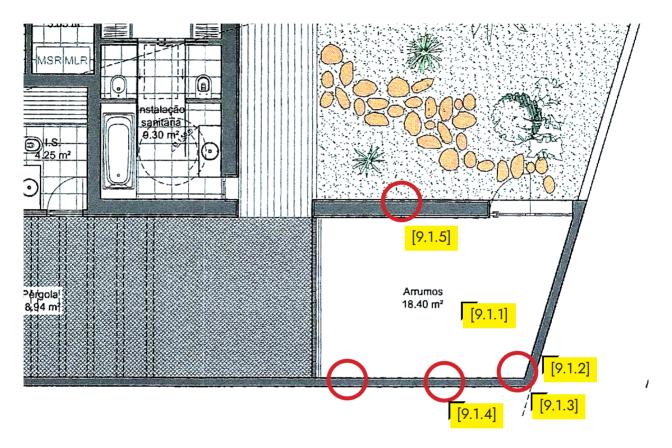
A small house is built next to the house. It is connected to the main house by a concrete pergola. A number of anomalies were discovered in this building, such as rainwater leaks from the roof, dampness in the walls, cracks in the attic copings and roofing errors.

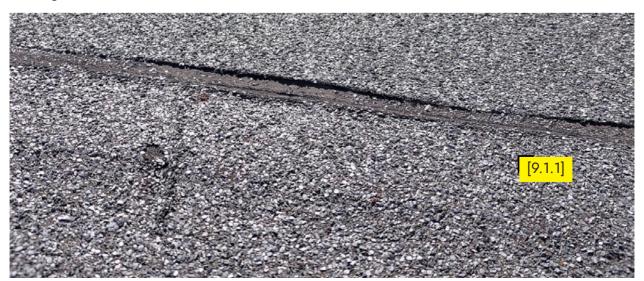
9.1.1. Improperly welded roofing felt. The visible strip without mineral sprinkling is the overlap for welding and should be welded across the width.

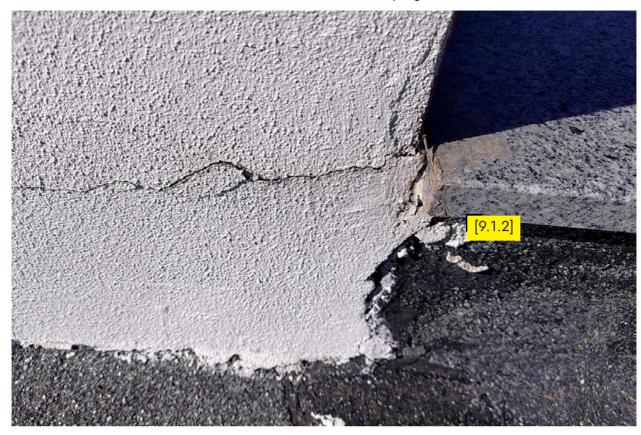
9.1.2. Cracks at the connection of the attic to the walls of the pergola and the house.

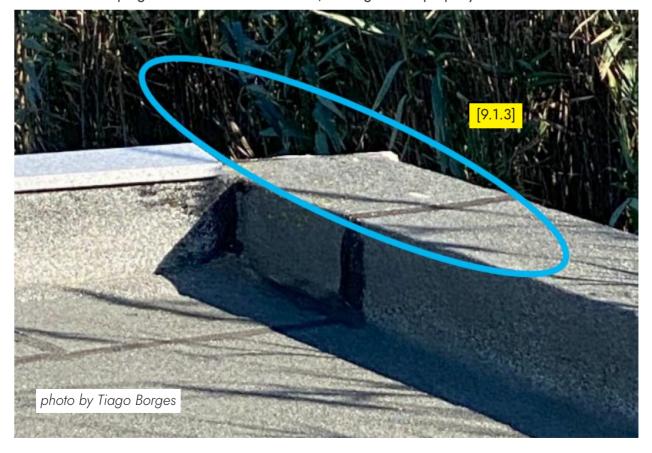
9.1.3. Lack of caping on the wall on the east side, roofing felt not properly welded.

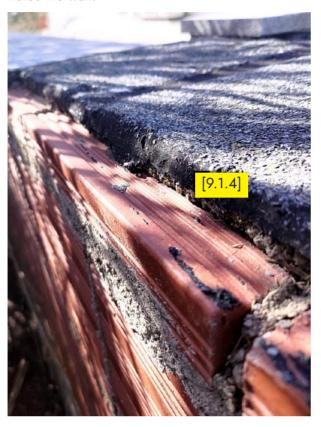
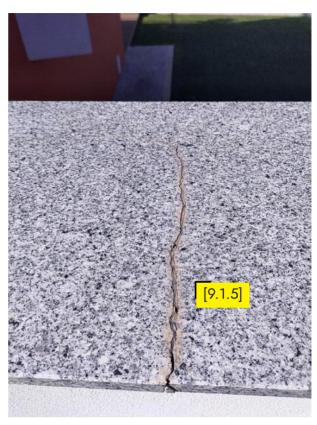
9.1.4. Lack of proper caping on the wall on the east side, unprotected areas where water penetrates the wall.

9.1.5. Cracks on the stonework on the attic wall.

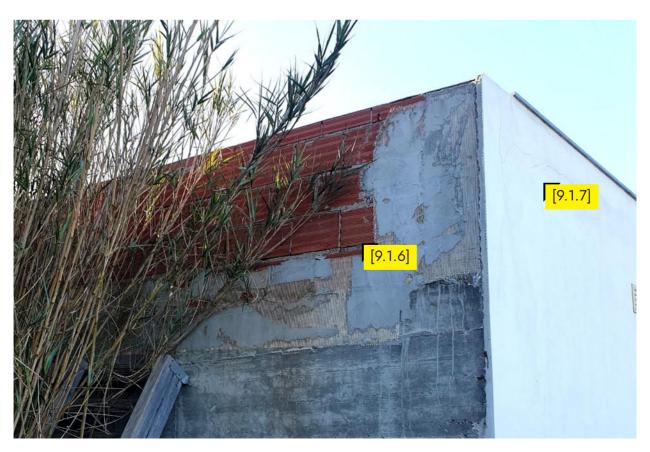
9.1.6. Complete lack of plaster and waterproofing on the east wall.

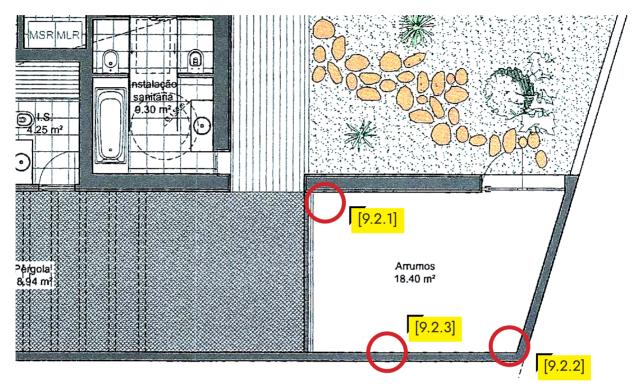
The humidity is high throughout the room and there is a distinct smell of mould. Furniture and furnishings left here are covered in mould and mildew. The covers of the garden furniture have an unpleasant musty smell.

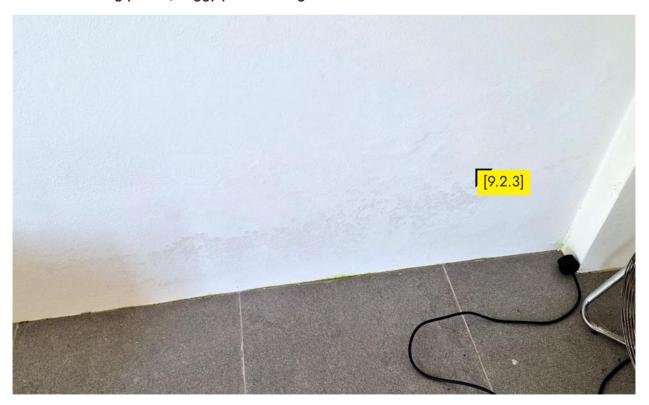
9.2.3. Crumbling plaster, soggy paint coming off.

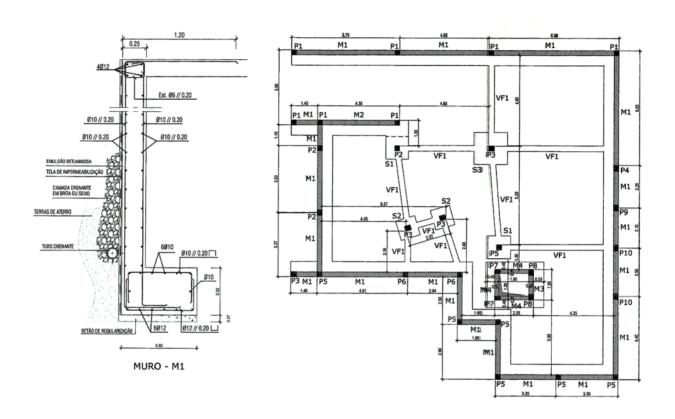
No drainage outlets were found during the inspection - neither in the manholes nor outside within the stone slope on the northern boundary of the plot.
