# The Report

House No 9

This report systematises and organises the numerous construction and workmanship errors occurring in the private residential house located in Lote 3 - Casais Porto Dinheiro.

The photographic material used in this report comes from the inspection on February 4–7, March 4-14, September 4-8 2025 as well as other material produced between 2023 and 2025, and documents the various deficiencies and problems occurring during this period.

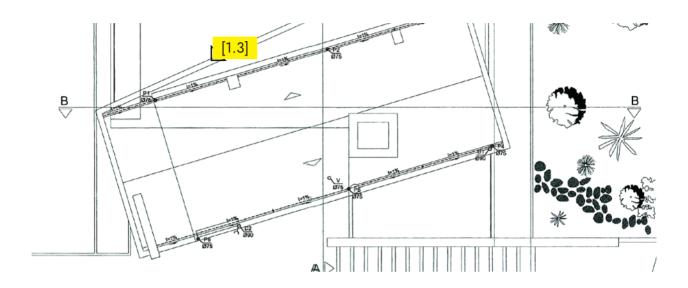
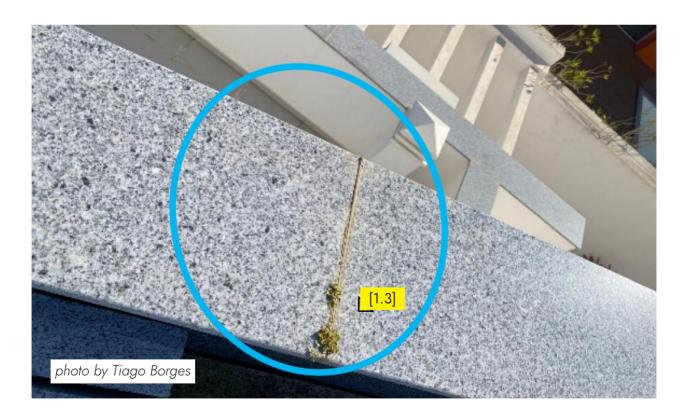
**1.3.** The roof attic walls have copings made of stone, with many defects also lack of the grout on connections. Cracks and leaks in the copings joints promote the nesting of vegetation, resulting in further degradation.

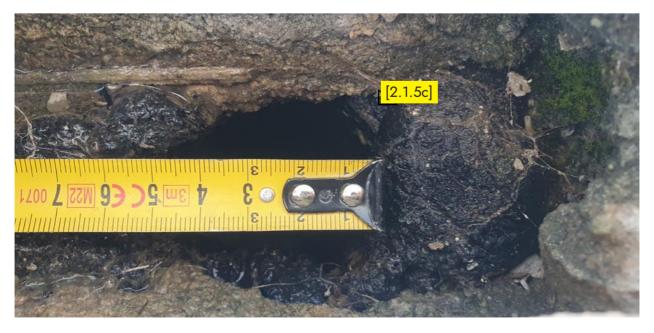
2.1.5. The drain on the south side was filled with pieces of tile and other construction waste. As these pieces were larger than the original size of the hole, it is not possible that they got in there after the construction was completed.

This kind of negligence could easily have led to the drain becoming clogged and consequently filling the terrace with water with all its consequences.

To prevent the drain from becoming completely blocked, the owner decided to take off part of the terrace covering [2.1.5a] and remove the debris that had accumulated there [2.1.5b]. Cross-section of the drain after unblocking [2.1.5c]

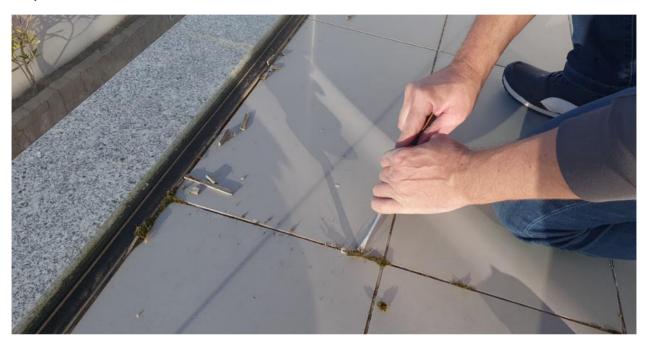
Total lack of expansion joints, which causes the joints between the tiles to crumble and the tiles to detach from the substrate.

A section of the terrace covering was dismantled to ascertain the quality of the work and the materials and technology used. The tiles came off easily, without cutting or hammering, just using simple tools such as a screwdriver.

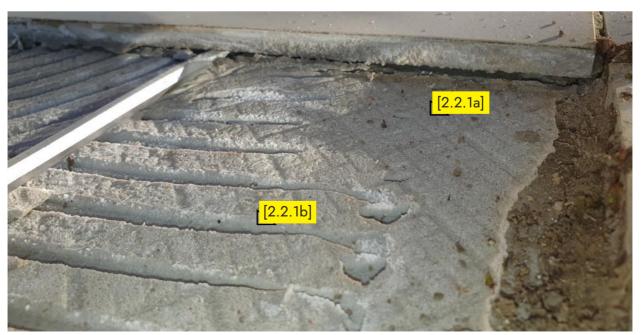
The tile was very poorly bonded to the screed and was easily removed when levered. The adhesive mortar is not bonded to the tile over a significant area [2.2.1a]. Insufficient adhesive and voids between the adhesive layer and the tile are revealed [2.2.1b].

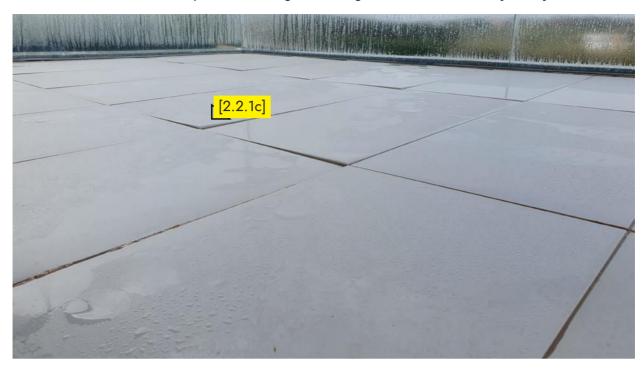
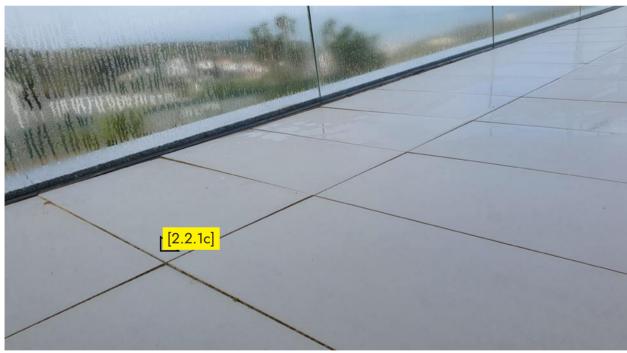
Numerous tiles are defectively laid, their edges standing out from the surface. [2.2.1c].

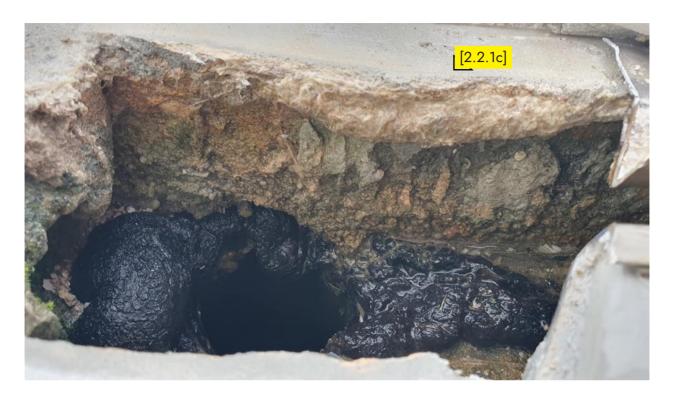
No waterproofing was found to protect the screed from water penetration [2.2.1c]. The only insulation against the water is the tar fabric on the concrete slab. This causes all the above layers to be penetrated by the rain water sipping thru the grout cracks.

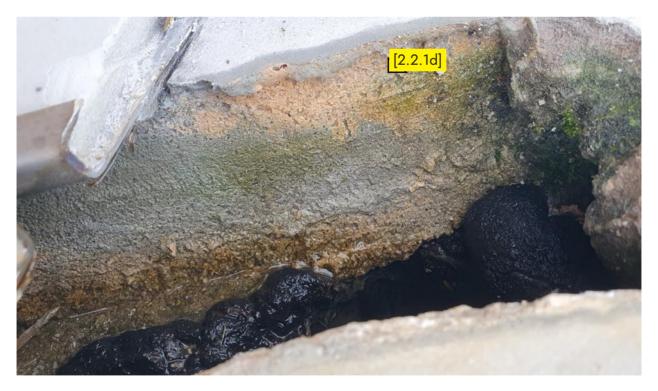
The concrete screed is yellow in places, very crumbly and resembles wet sand in texture. [2.2.1d].

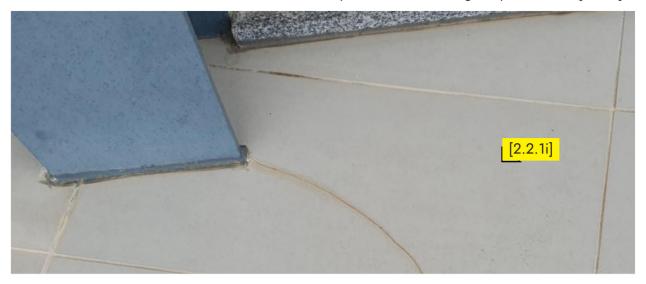
Stress cracks were found in the tiles around the steel pillars of the buildings' superstructure [2.2.1i].

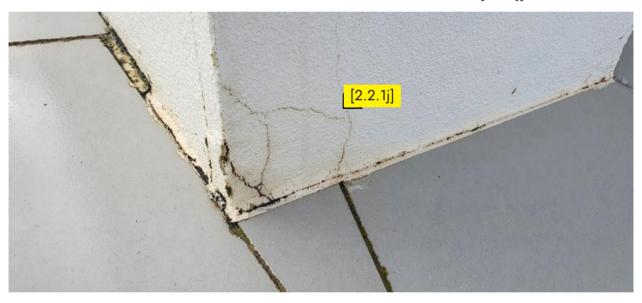
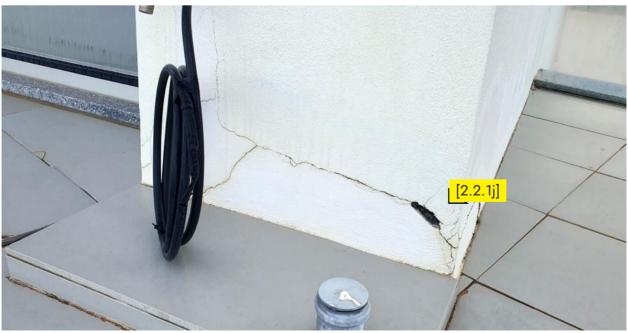
Stress cracks in the area of the connection between the terrace and the wall [2.2.1j].

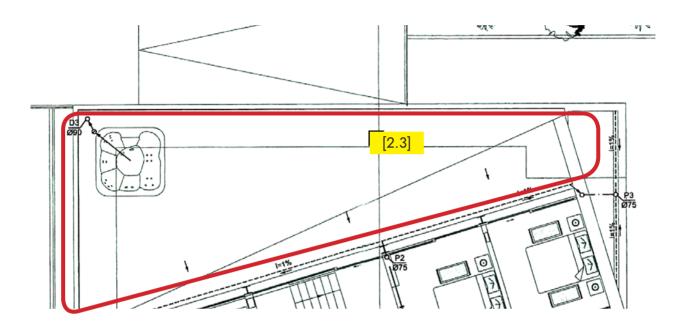
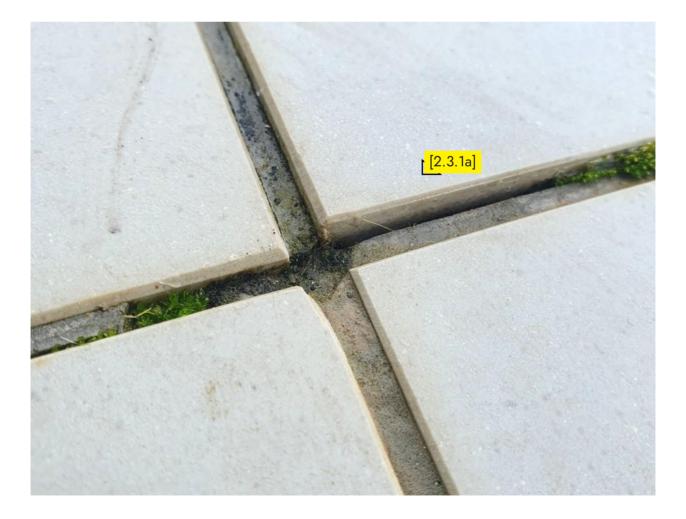
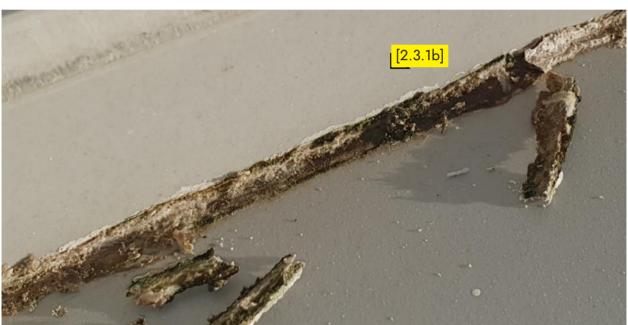
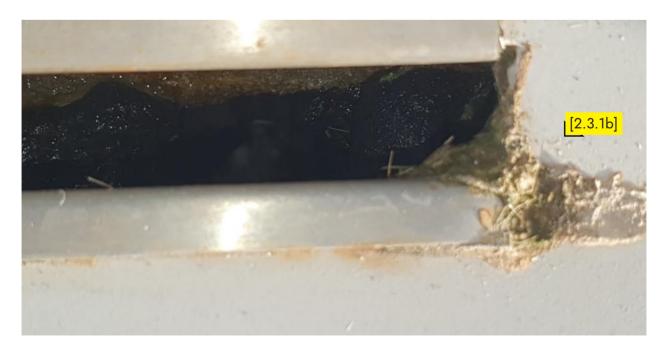
**2.3.1.** Numerous cavities and discolouration in the tile grouts were found on the overall terrace surface. There are many visible instances of grout erosion [2.3.1a].

The connection between the terrace surface and the balustrade is cracked or absent in many places. This creates the possibility of water penetrating into the balustrade attachment points and further erosion. The connection between the balustrade and the terrace should be both watertight flexible.

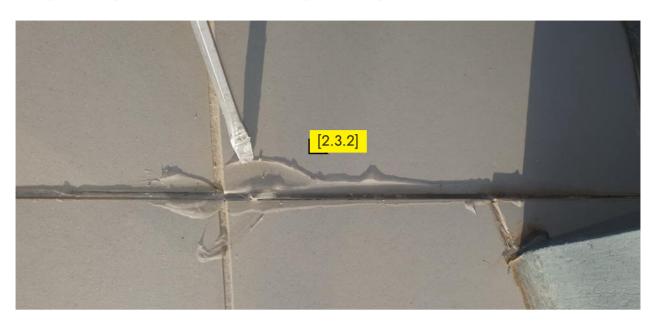
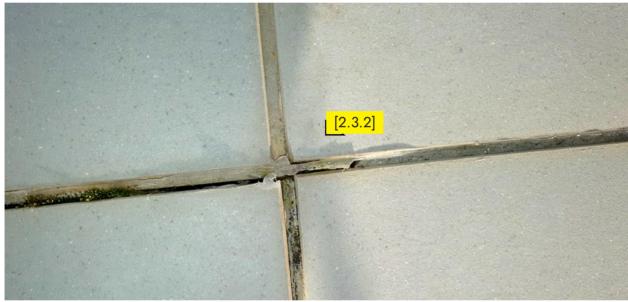
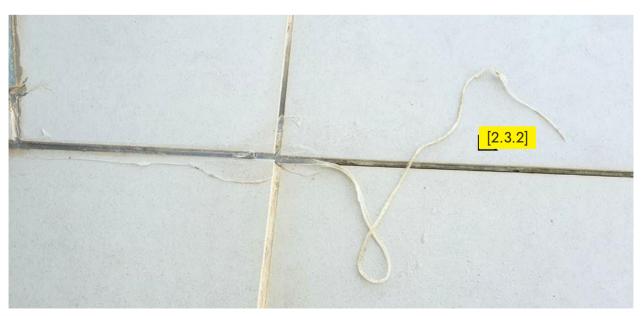
**2.3.2.** Some joints show signs of repair and sealing. These are ineffective treatments because the wrong technology and materials were used. Significant degradation of repaired joints can be seen.

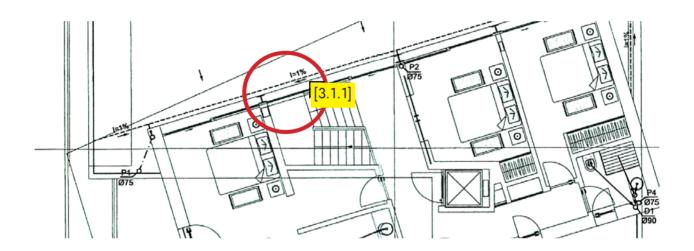
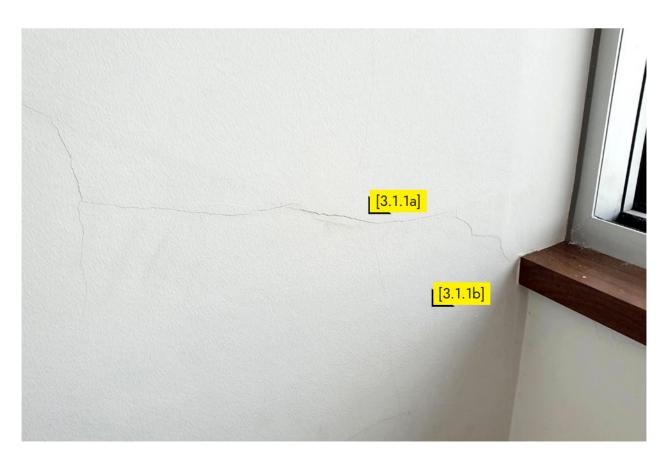
Numerous cracks running from the terrace lintel [3.1.1a].

From under the layer of paint, previous cracks in the same area can be seen. [3.1.1b].

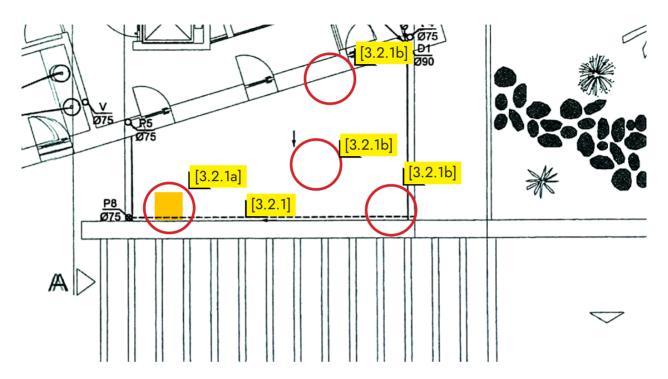
The diameter of the P8 drain pipe is 50 mm whereas by the building design it should be 75 mm. In addition, the P8 drain has been placed behind the chimney of the grill located on the patio below. This location of the drain results in the accumulation of debris and plant elements and makes cleaning the drain much more difficult. It should be mentioned that the grill chimney (highlighted in orange) is not present in the building design. [3.2.1a].

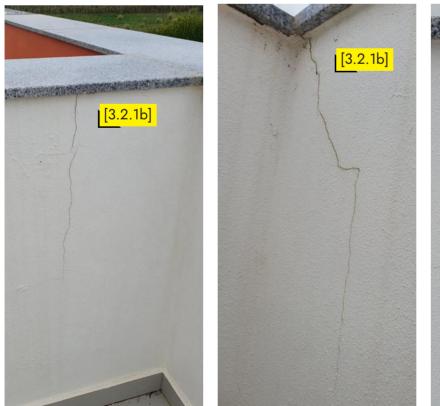
Cracks in the masonry fence of the balcony [3.1.1b].

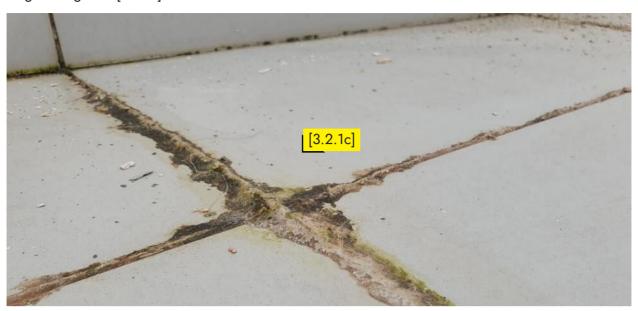
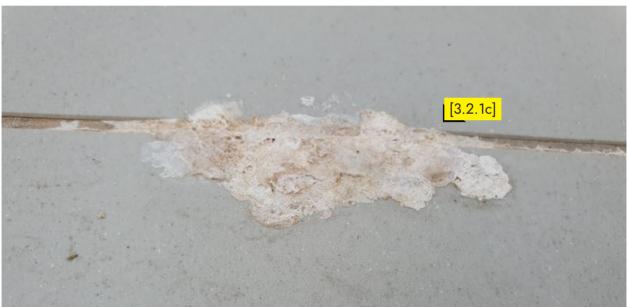
Degraded grouts [3.1.1c].

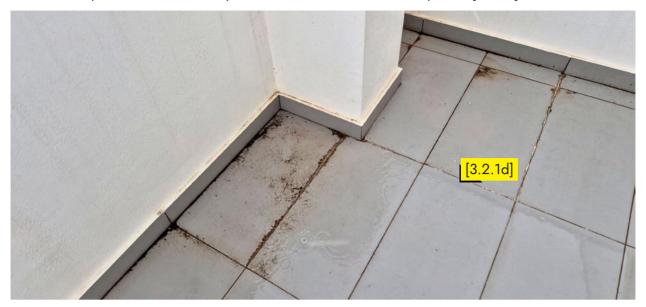
Rainwater deposited on the balcony as a result of incorrect surface profile [3.1.1d].

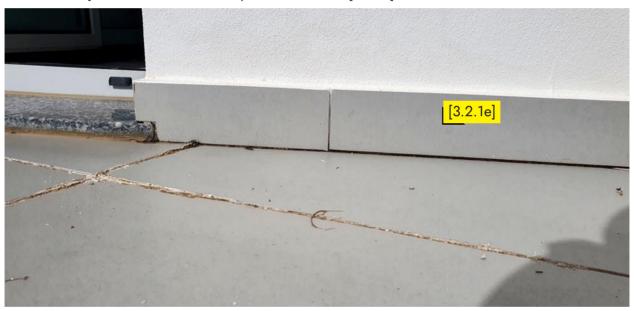
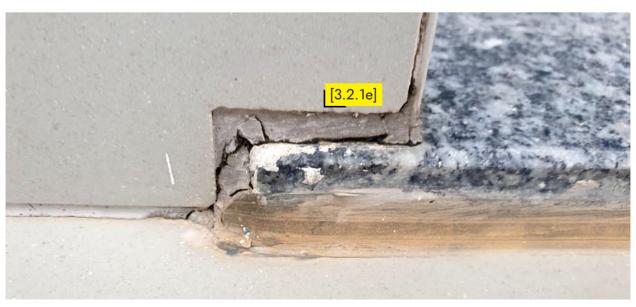
Cracks at the junction between balcony and house wall [3.1.1e].

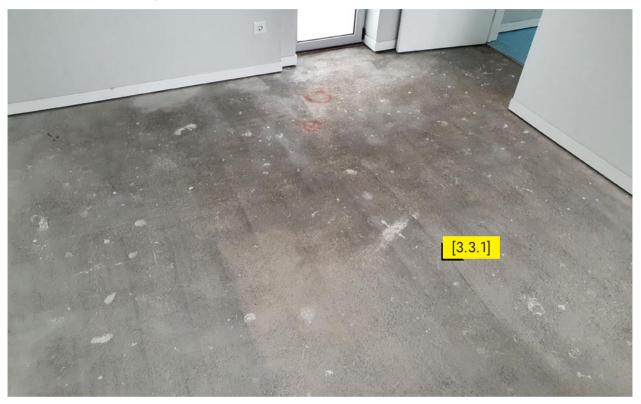
There is a distinct musty smell in the northen bedroom and the nearby corridor, despite the fact that the air conditioner has been running in the room in dehumidification mode every day for the past six months.

3.3.1. The floor boards had been removed. Clear traces of dampness covering almost half of the room were noted on the screed. The probable cause of the dampness is rainwater leaking from the balcony on the east side of the house. It can be assumed that there is also no waterproofing on the balcony and rainwater is seeping into the screed in the bedroom.

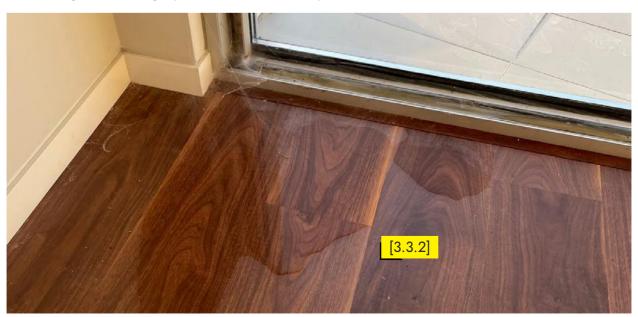
3.3.2. The bedroom on the south side has developed leaks around the patio window. The window frame was covered with green algae, there was water in the floor and in the window frame. The skirting board is slightly swollen from the dampness.

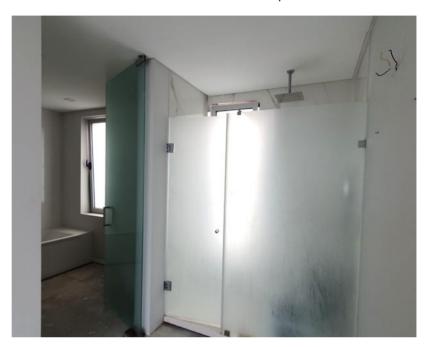
**3.4.1.** Neither of the two bathrooms on the first floor has ventilation ducts.

This is particularly important for the south-facing bathroom, which is one room with the bedroom. All odours and dampness will be allowed to enter the living areas and soak the the clothes in the open wardrobe located near by.

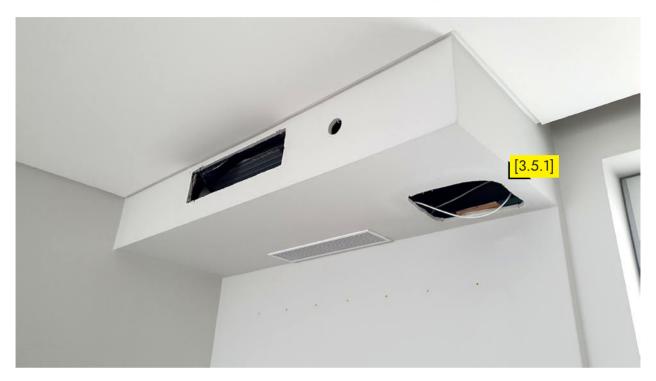
**3.5.1.** On the first floor, three air-conditioning systems were installed built-in in the walls, the false ceiling and in the wardrobes. None of them has an inspection opening to access the junction box. In the event of a malfunction or the need to make adjustments, it will be necessary to dismantle the wardrobe or to drill a hole in the wall. The owner was forced to do so in this case.

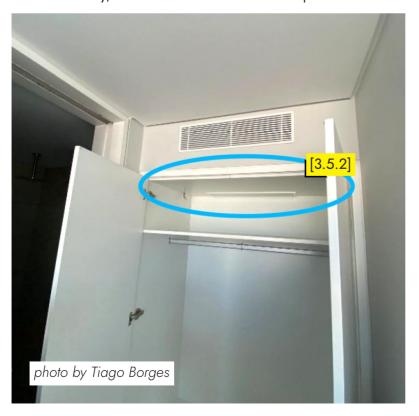
**3.5.2.** In the middle bedroom in the center of the house, the air conditioner have air intake hidden in lockable wardrobes. For this reason, it is impossible to use them properly. For the air conditioner to work effectively, the wardrobe doors must be open.

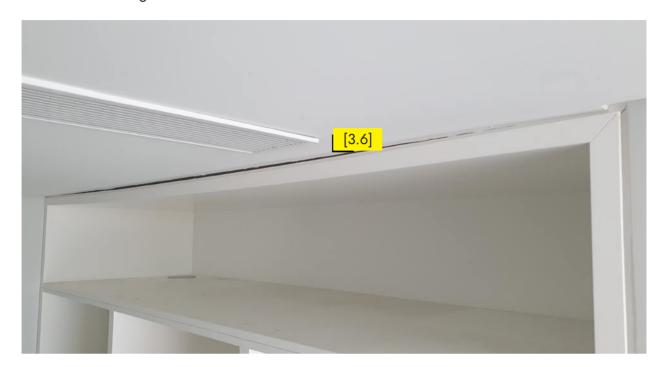
The wardrobe in the south bedroom is bulging and a large gap has been created between the wardrobe and the ceiling.

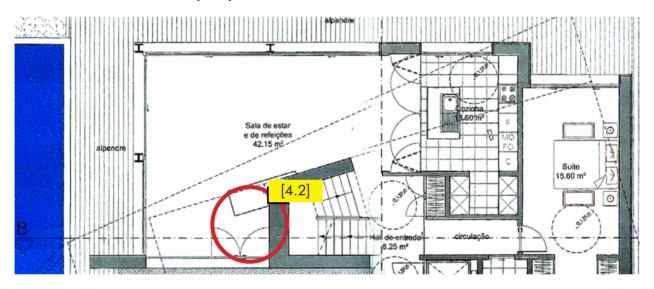
Using a fireplace in this building is a serious danger for the health and life of the people in the house!

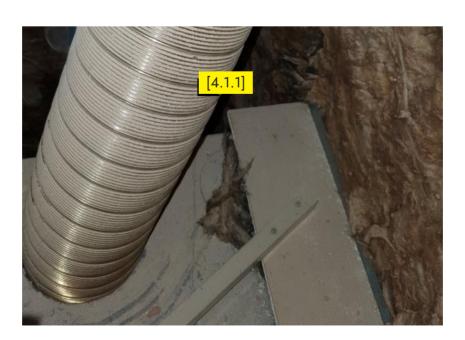
4.1.1. The fireplace was connected to the flue via a flexible flue pipe! This type of pipe is not approved for flue gas from solid fuel burners, where the flue gas temperature is not controlled and can reach up to 700 °C.

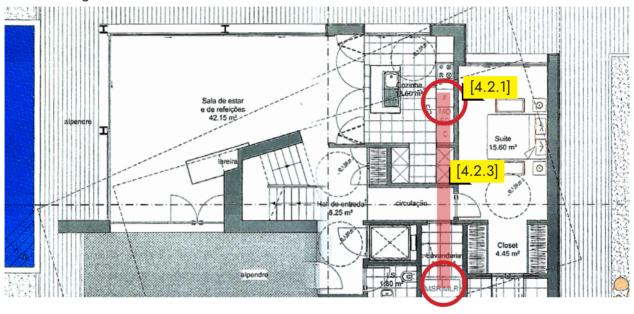
## 4.2.1. The cooker hood was not connected to the ventilation duct!

The pipe from the cooker hood was led into the space between the concrete slab and the false ceiling [4.2.2]. A few metres of ventilation pipe are missing between the cooker and the ventilation duct [4.2.3].

All cooking fumes, odours and moisture are introduced into the hollow space below the false ceiling and spread throughout the flat.

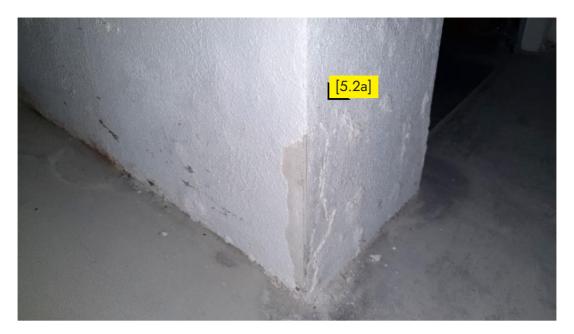
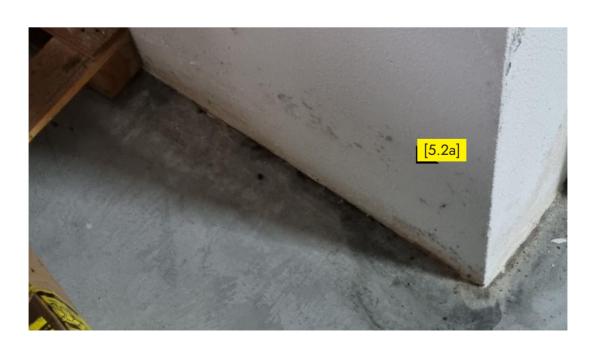
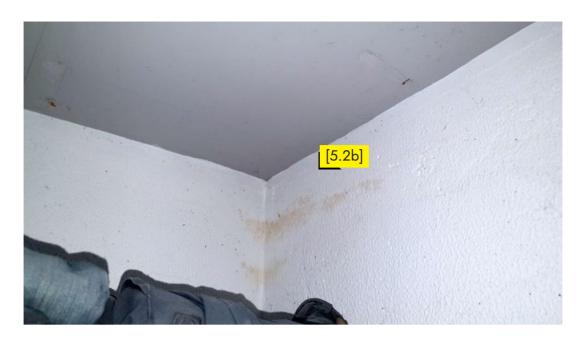
The main problem in the basement is dampness [5.2a]. There are stains on the floor, damp patches on the walls – mainly in inner walls. Poor horizontal damp protection of the floor and walls thus capillary seepage through the walls are responsible for this dampness.

There are also some traces od water soaking the walls in the garage top corner (near the ceiling) [5.2b].

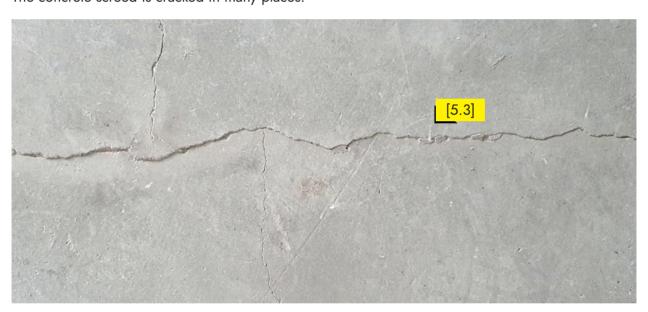
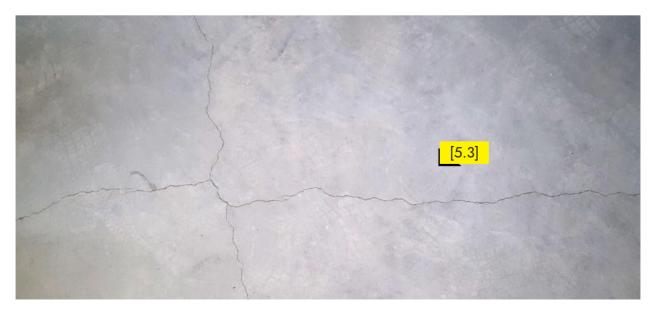
**5.3. Cracked floor**The concrete screed is cracked in many places.

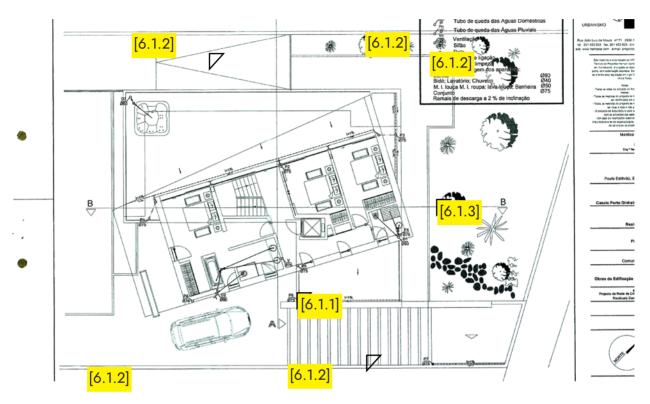
External walls have defects in design and workmanship, resulting in cracking and and damp patches. Walls and fences are ckracked and have no copings. Plasters and paints appear to be of poor quality.

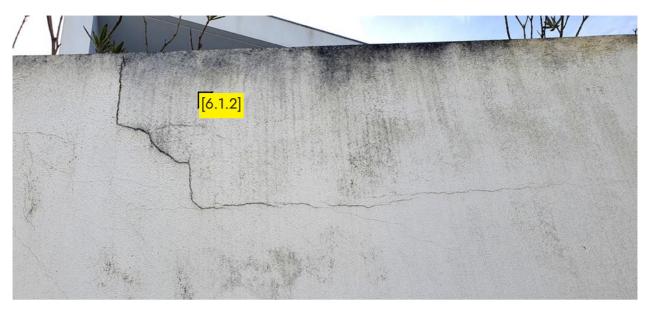
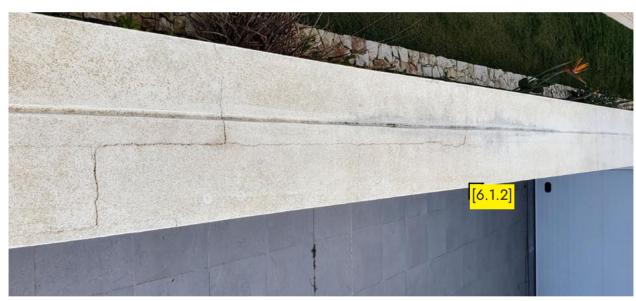
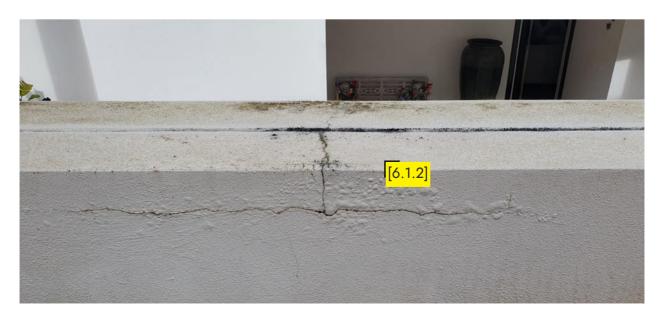
**6.1.2.** Cracks below top of walls and masonry.

Caused by water penetration due to missing or poorly executed copings, wall settlement and stresses arising at the boundary between different materials.

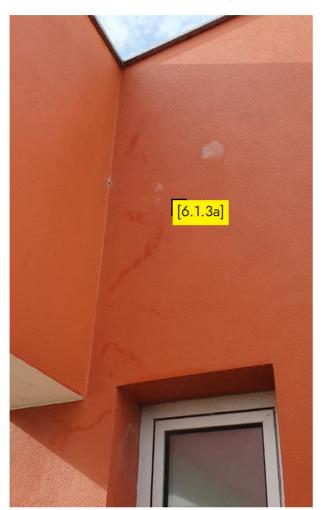
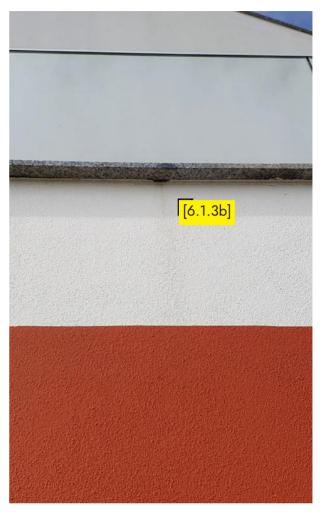
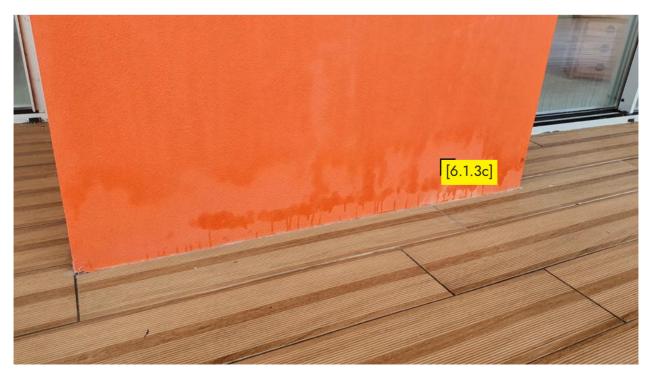
- **6.1.3.** Discolouration and staining on the facade.
- **6.1.3a** This is a possible exudation of water from a leaking balcony.
- 6.1.3b Staining from rainwater due the lack of throating (drip channels) in the copings.
- **6.1.3c** Stains from rainwater sipping up from the patio floor.

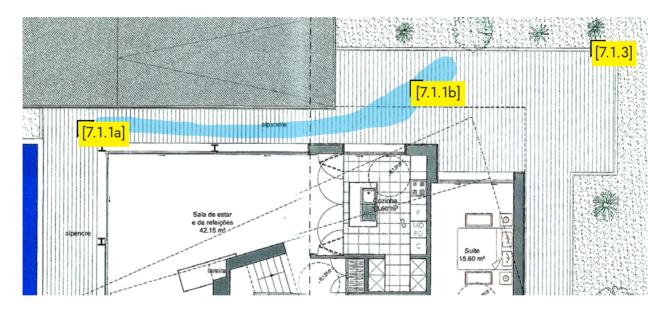
Patio surface on wrong profile – it forms a trough, there is no slope [7.1.1a] or even worse - the slope is slightly to the bulding direction [7.1.1a]. As a result, rainwater floods the patio in puddles [7.1.2]. Excess water running off the patio is not drained anywhere. It is likely that some of the water flows freely from the terrace near the wall and infiltrates into the garage - hence the stains in the corner under the ceiling [7.1.3], and some run off at the edge of the patio and pool, as well as in the area of the underground pool pump room.

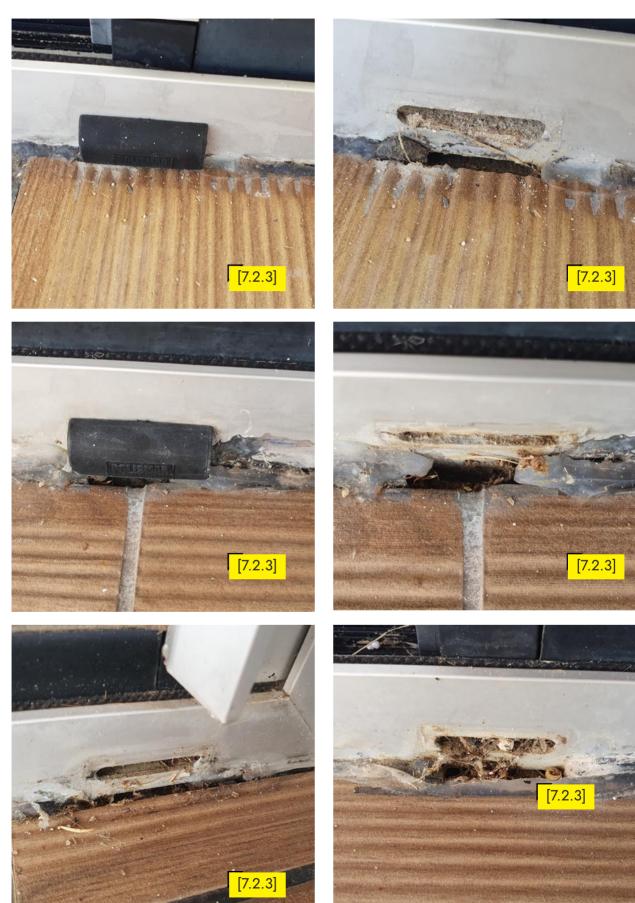
There is a lack of tile sealing directly under the water outlets of the window frames, where most water flows out.

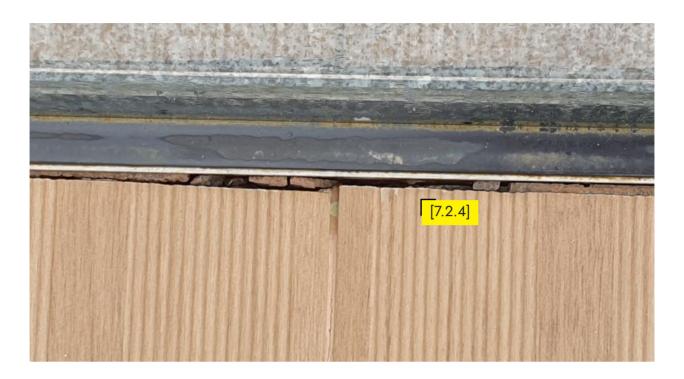
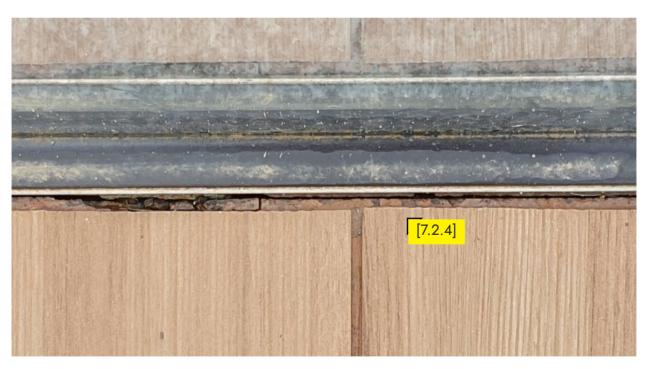
7.2.4. The connection between the terrace surface and the balustrade is cracked or absent in many places. This creates the possibility of water penetrating into the balustrade attachment points and further erosion.

The connection between the balustrade and the patio floor should be both watertight flexible.

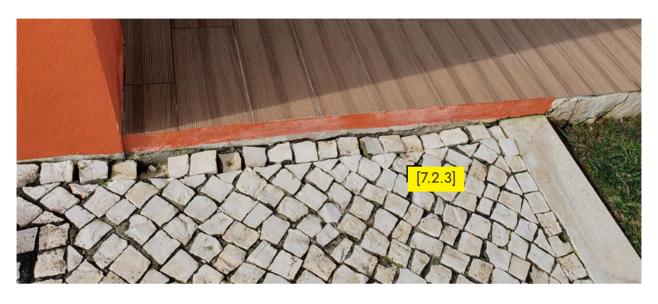
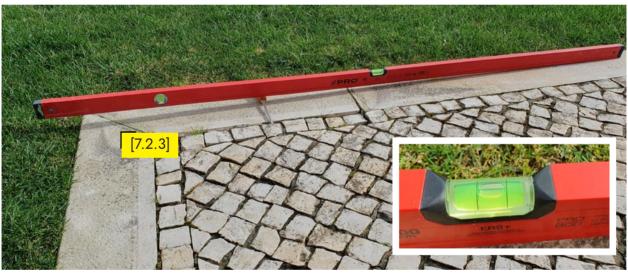
The part of the pavement adjacent to the patio floor is very crooked. The likely cause is that the ground is being washed out by water running off the patio, which is not drained anywhere. Loose paving stones can be seen.

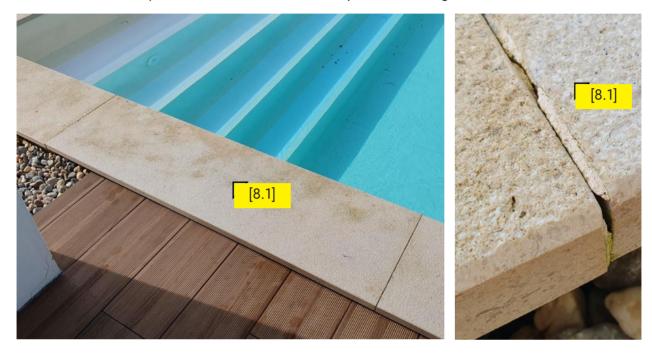
The stone slab in the pool frame are loose and wobbly. Cracked out grout can be observed.

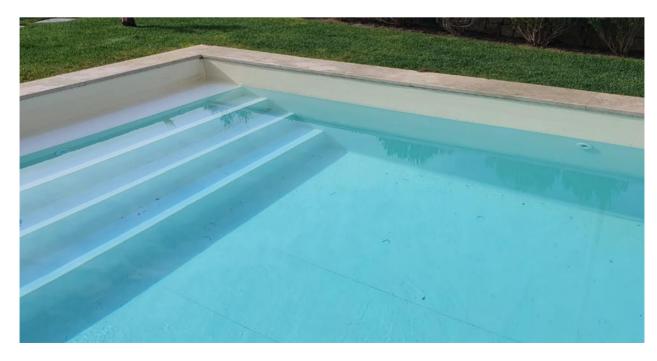
The pool has a leak - water escapes from the pool.

Despite topping up, water reaches at most the first step of the stairs.

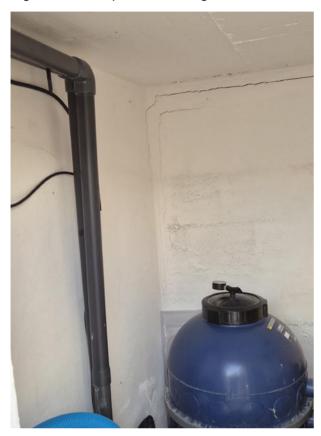
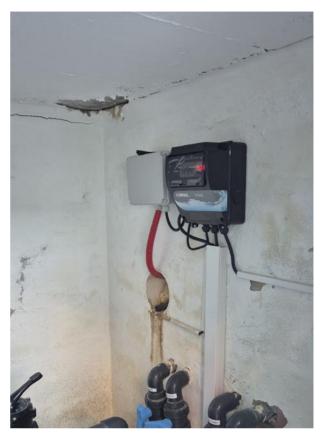
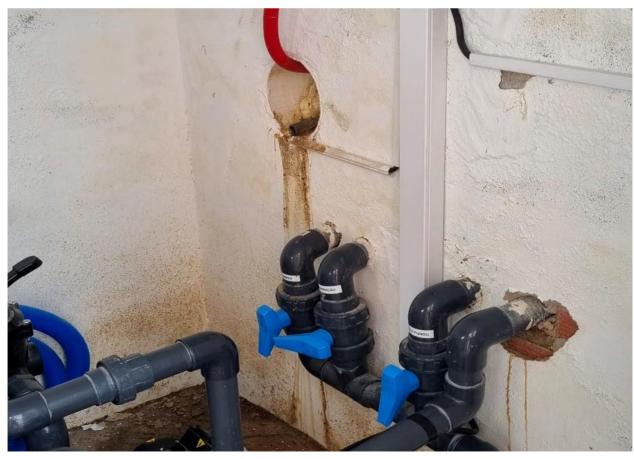
In the pool pumping compartment, the walls are damp and cracks are showing on the walls and ceiling. Plaster and paint are falling off the walls.

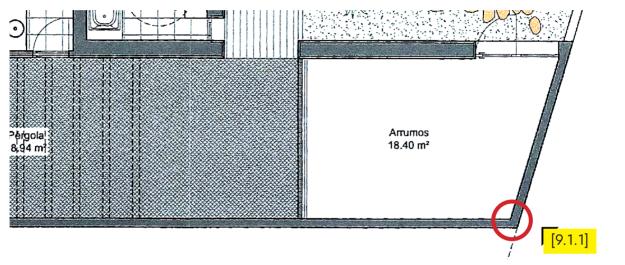
A small house is built next to the house. It is connected to the main house by a concrete pergola. A number of anomalies were discovered in this building, such as rainwater leaks from the roof, dampness in the walls, cracks in the walls.

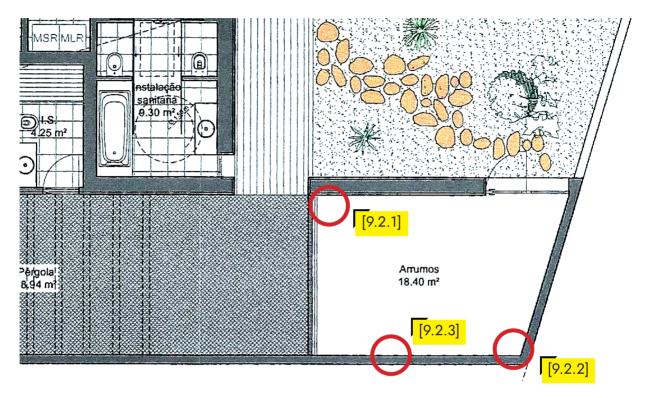
The humidity is high throughout the room and there is a distinct smell of mould. Furniture and furnishings left here are covered in mould and mildew. The covers of the garden furniture have an unpleasant musty smell.

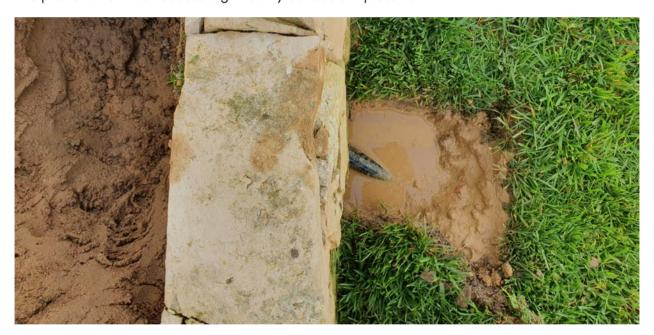
10.2.2. A water leak was detected from the main supply pipes located in the ground and repaired. The phenomenon had reduced significantly but was still present.

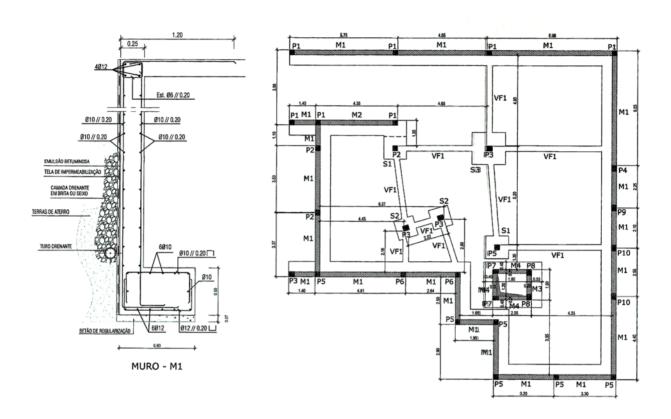
No drainage outlets were found during the inspection - neither in the manholes nor outside within the stone slope on the northern boundary of the plot.
