# The Report

House No 9

*March 2025*

This report systematises and organises the numerous construction and workmanship errors occurring in the private residential house located in Lote 3 - Casais Porto Dinheiro.

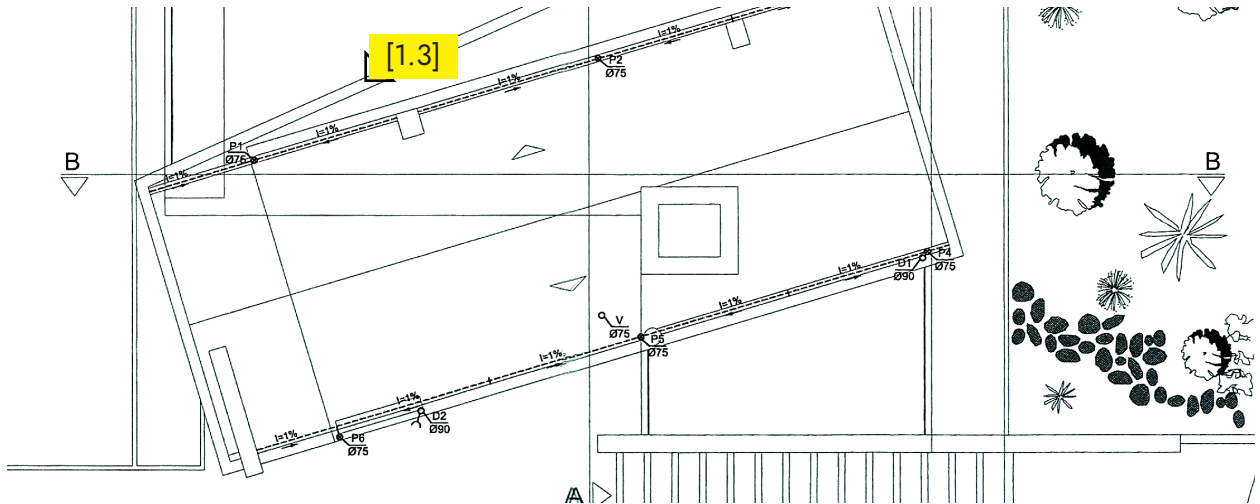
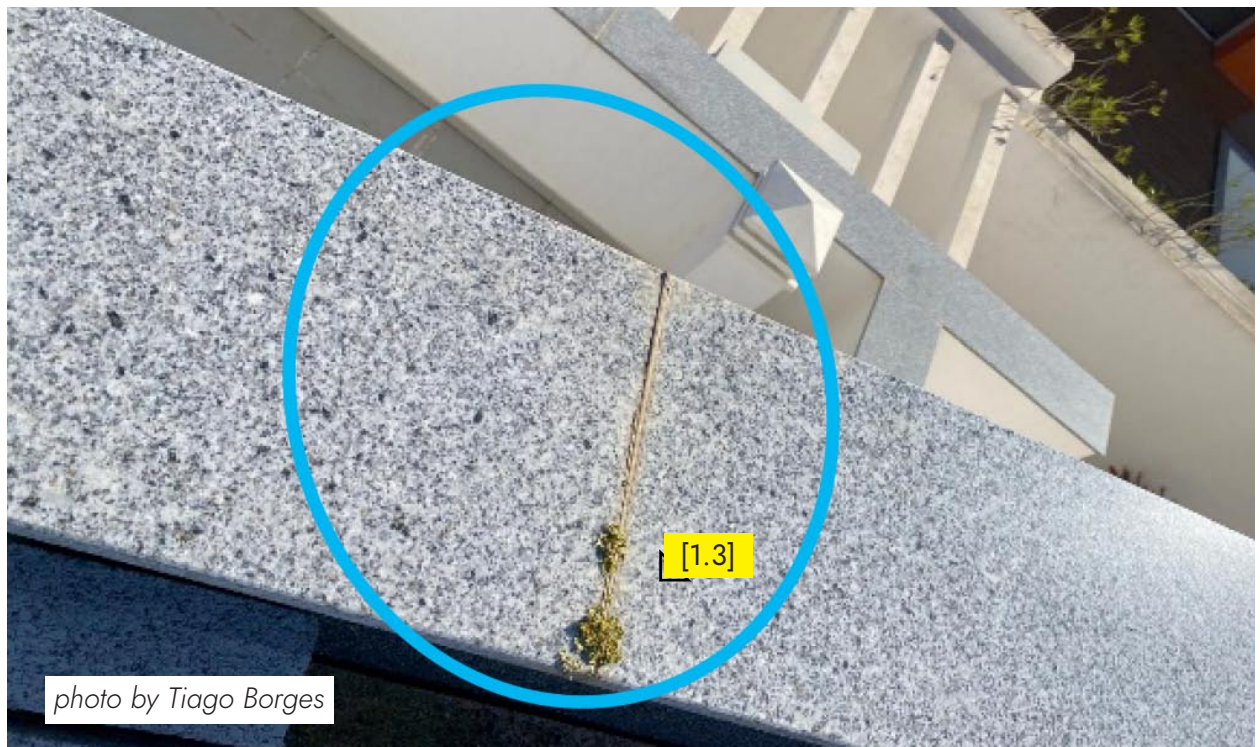
### 1.3. Cracks and other defects

1.3. The roof attic walls have copings made of stone, with many defects also lack of the grout on connections. Cracks and leaks in the copings joints promote the nesting of vegetation, resulting in further degradation.

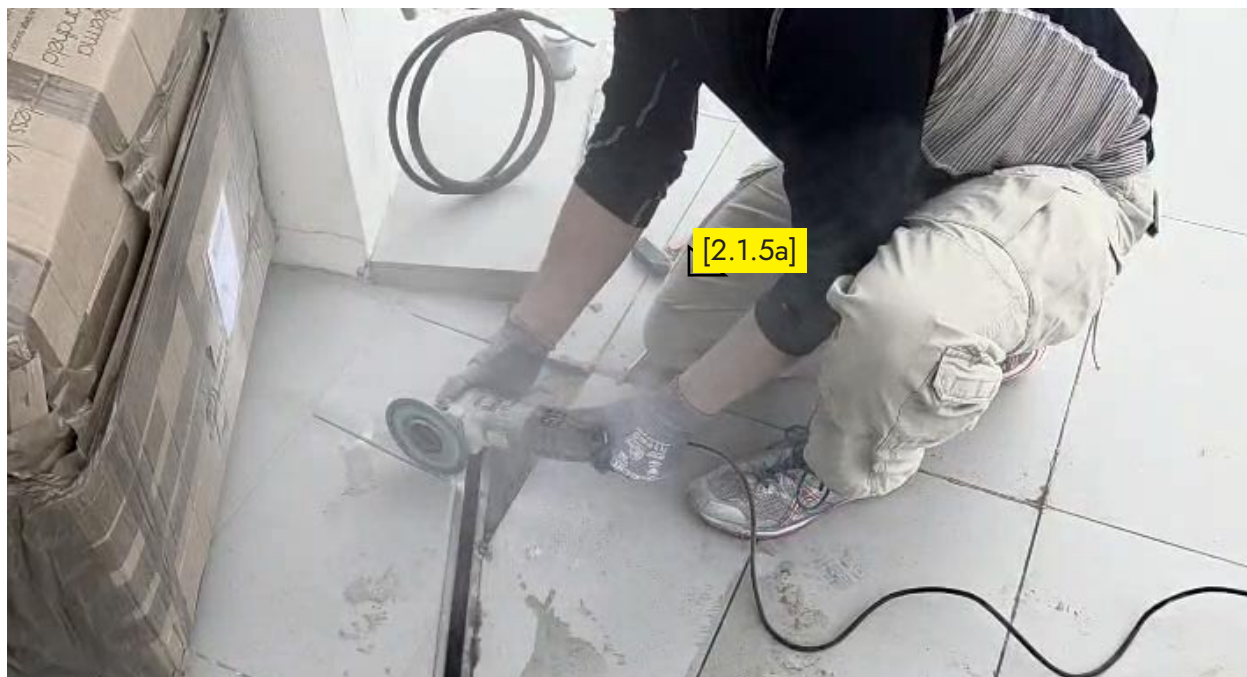
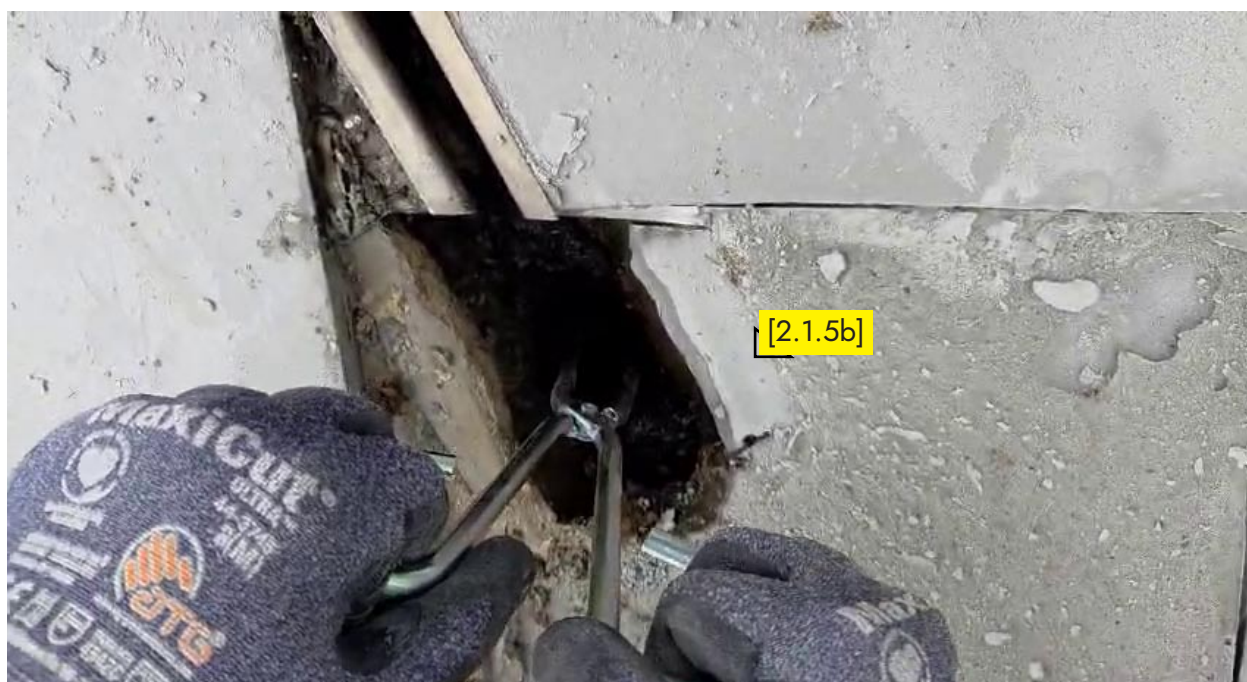
To prevent the drain from becoming completely blocked, the owner decided to take off part of the terrace covering [2.1.5a] and remove the debris that had accumulated there [2.1.5b].

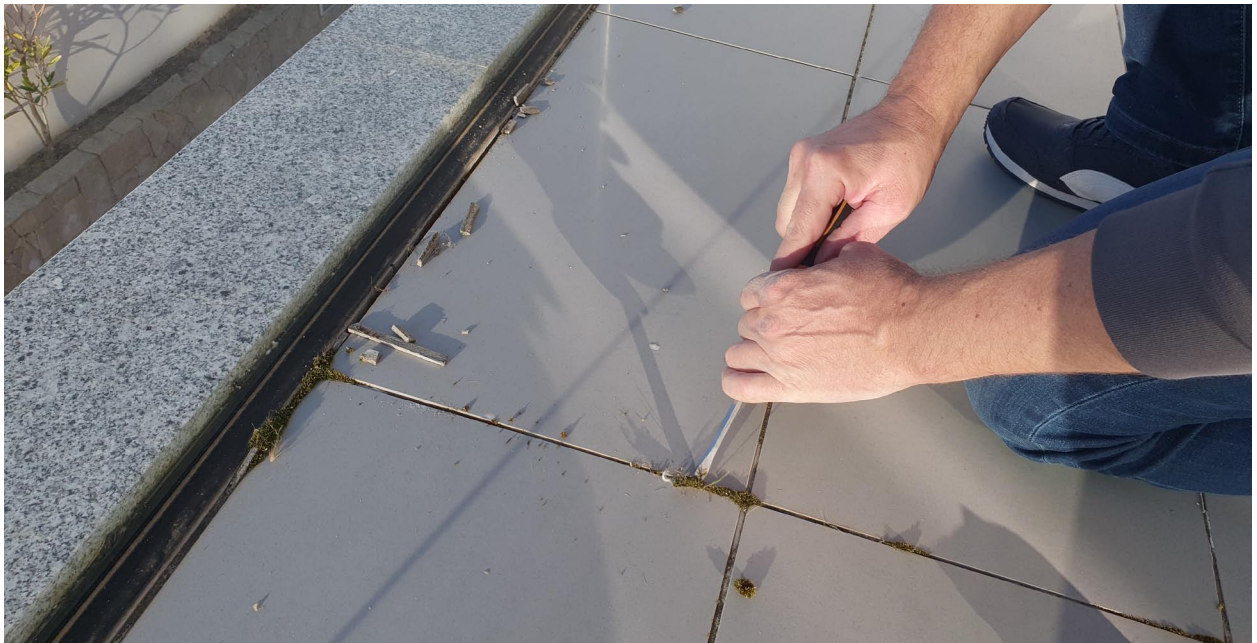
**Total lack of expansion joints, which causes the joints between the tiles to crumble and the tiles to detach from the substrate.**

A section of the terrace covering was dismantled to ascertain the quality of the work and the materials and technology used. The tiles came off easily, without cutting or hammering, just using simple tools such as a screwdriver.

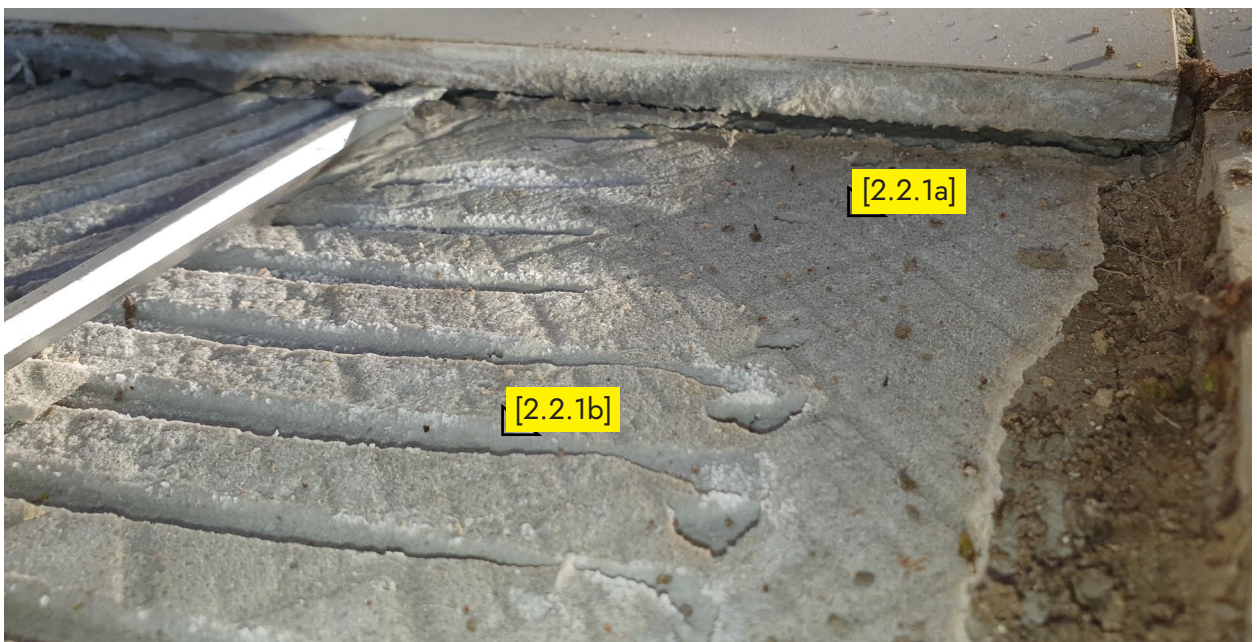
### 2.2.1. Defective terrace covering.

The tile was very poorly bonded to the screed and was easily removed when levered.

The adhesive mortar is not bonded to the tile over a significant area [2.2.1a]. Insufficient adhesive and voids between the adhesive layer and the tile are revealed [2.2.1b].

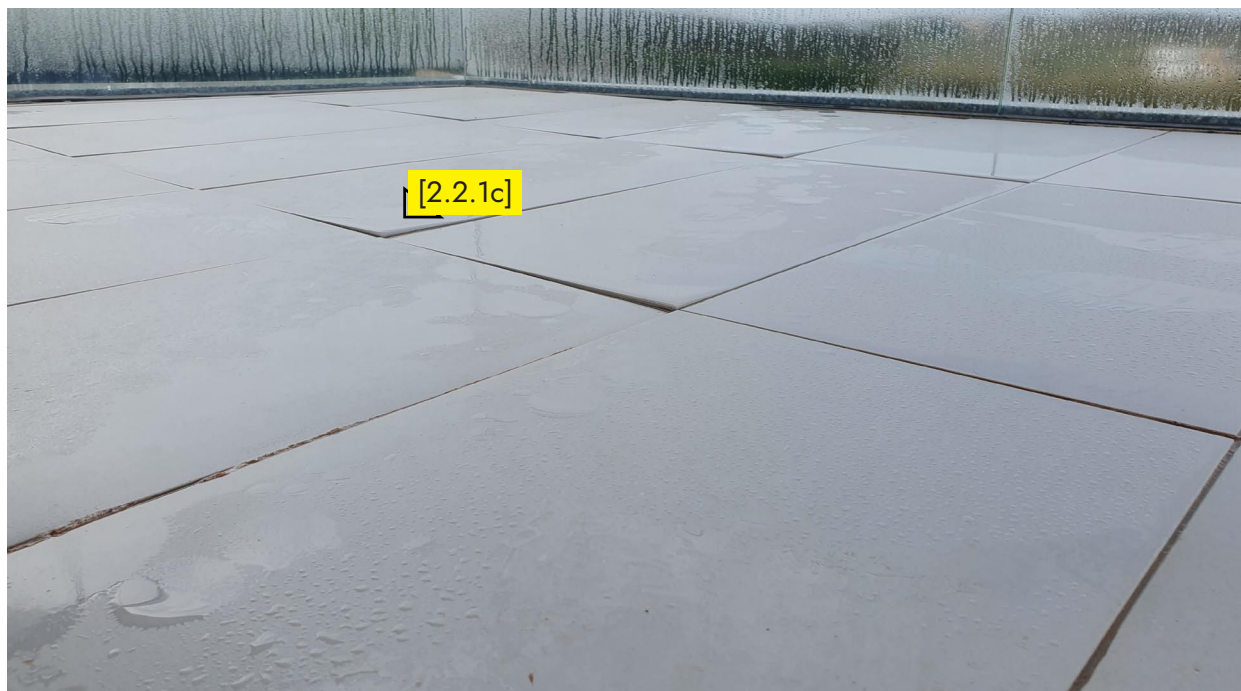
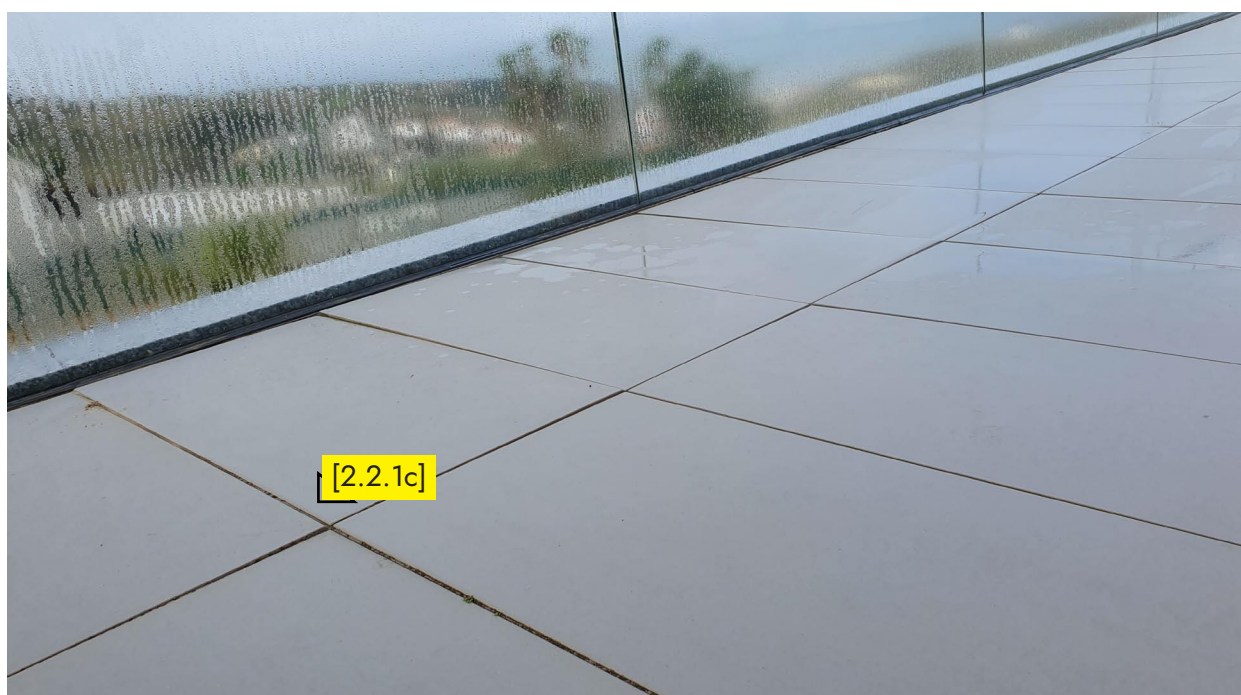
Numerous tiles are defectively laid, their edges standing out from the surface. [2.2.1c].

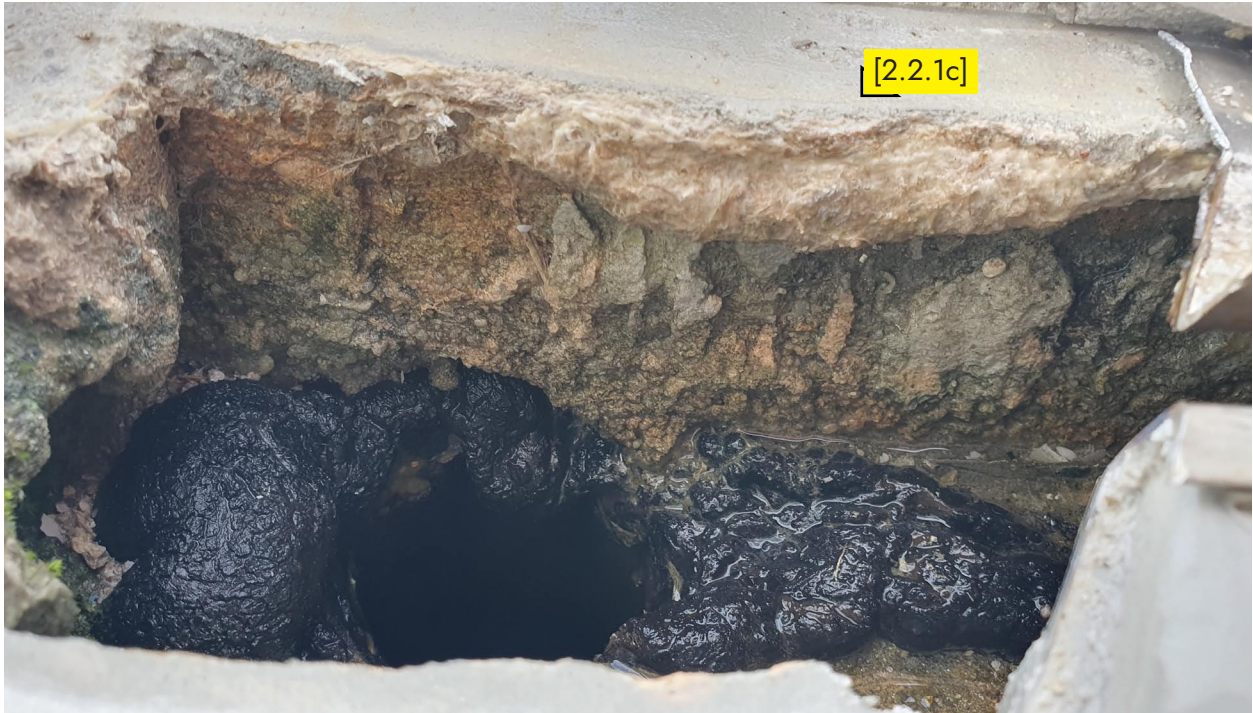
No waterproofing was found to protect the screed from water penetration [2.2.1c]. The only insulation against the water is the tar fabric on the concrete slab. This causes all the above layers to be penetrated by the rain water sipping thru the grout cracks.

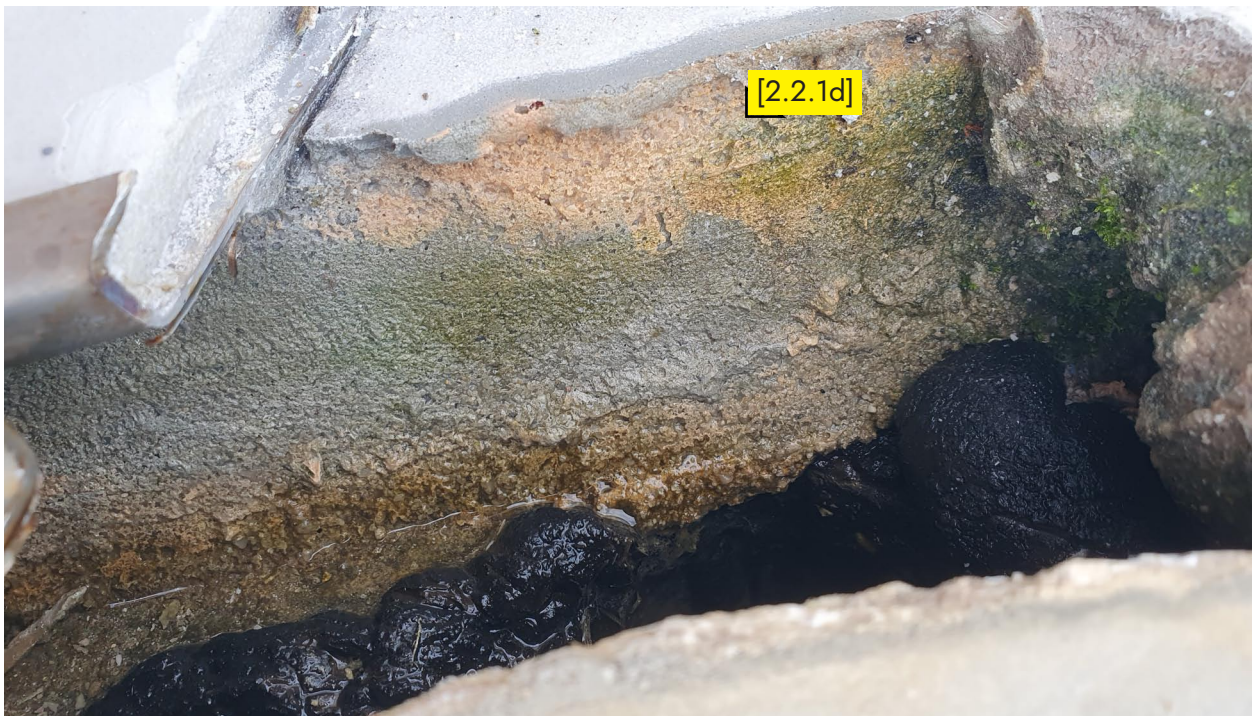
The concrete screed is yellow in places, very crumbly and resembles wet sand in texture. [2.2.1d].

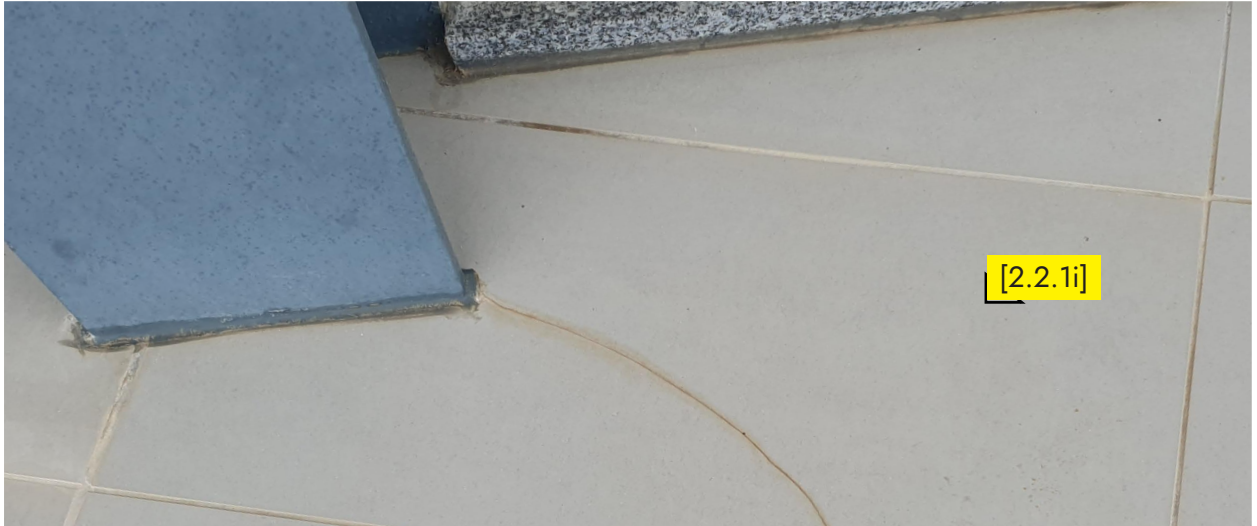
Stress cracks were found in the tiles around the steel pillars of the buildings' superstructure [2.2.1i].

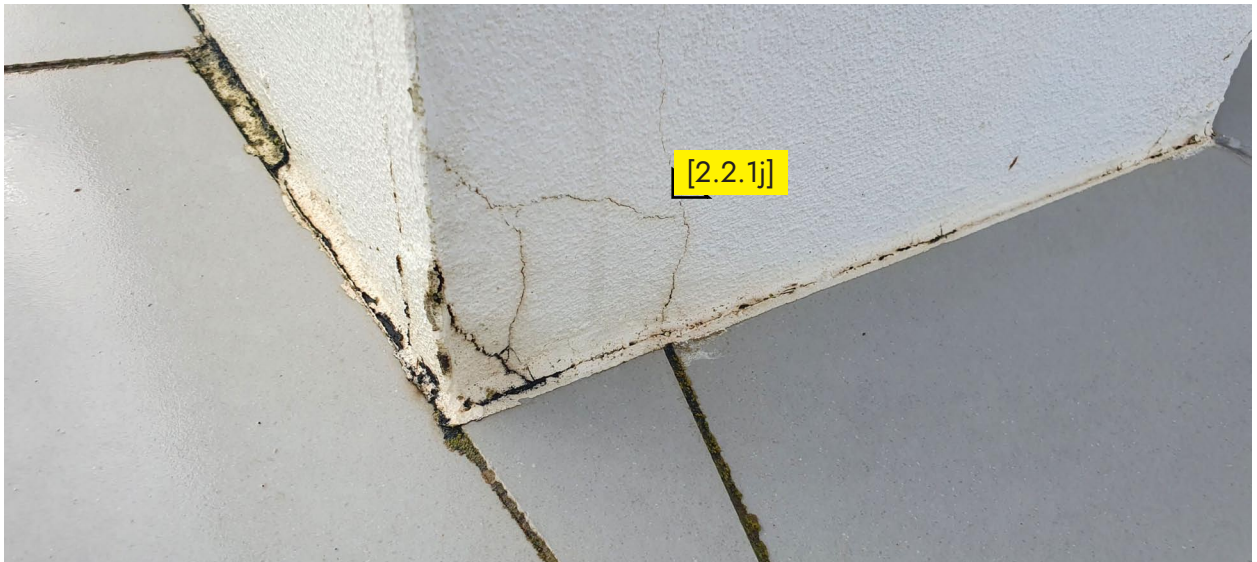
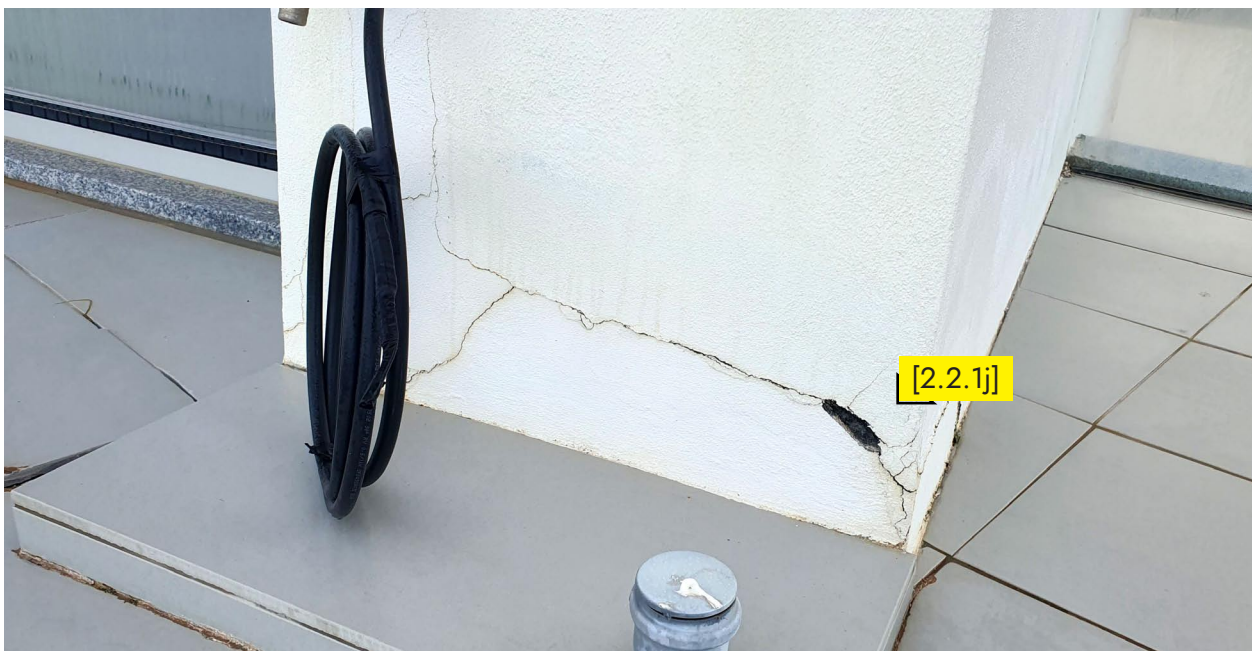
Stress cracks in the area of the connection between the terrace and the wall [2.2.1j].

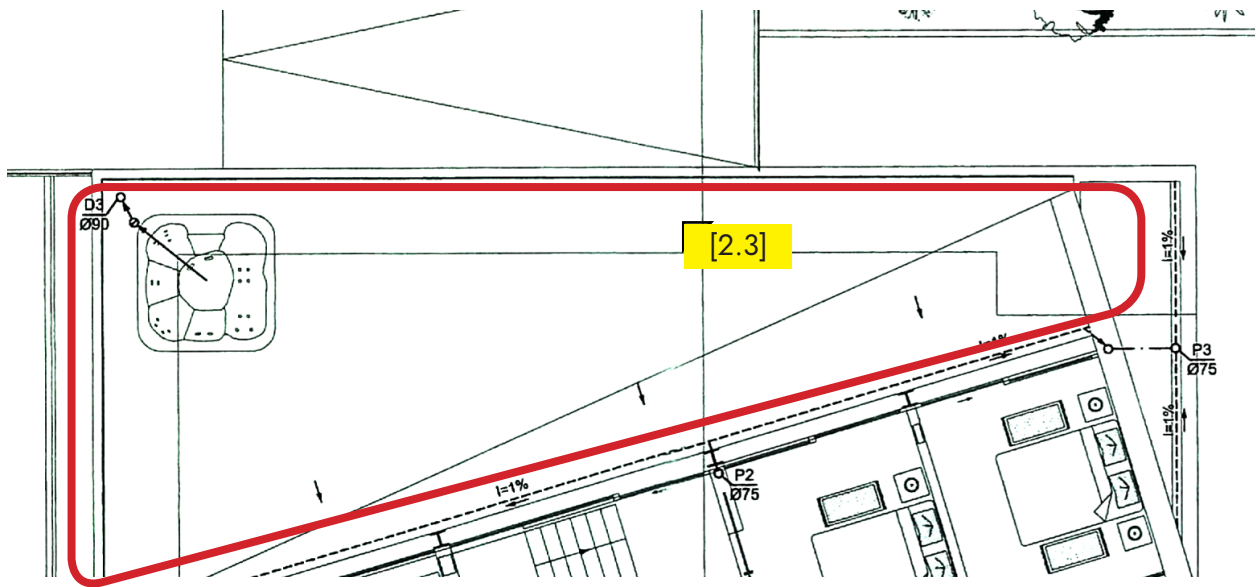
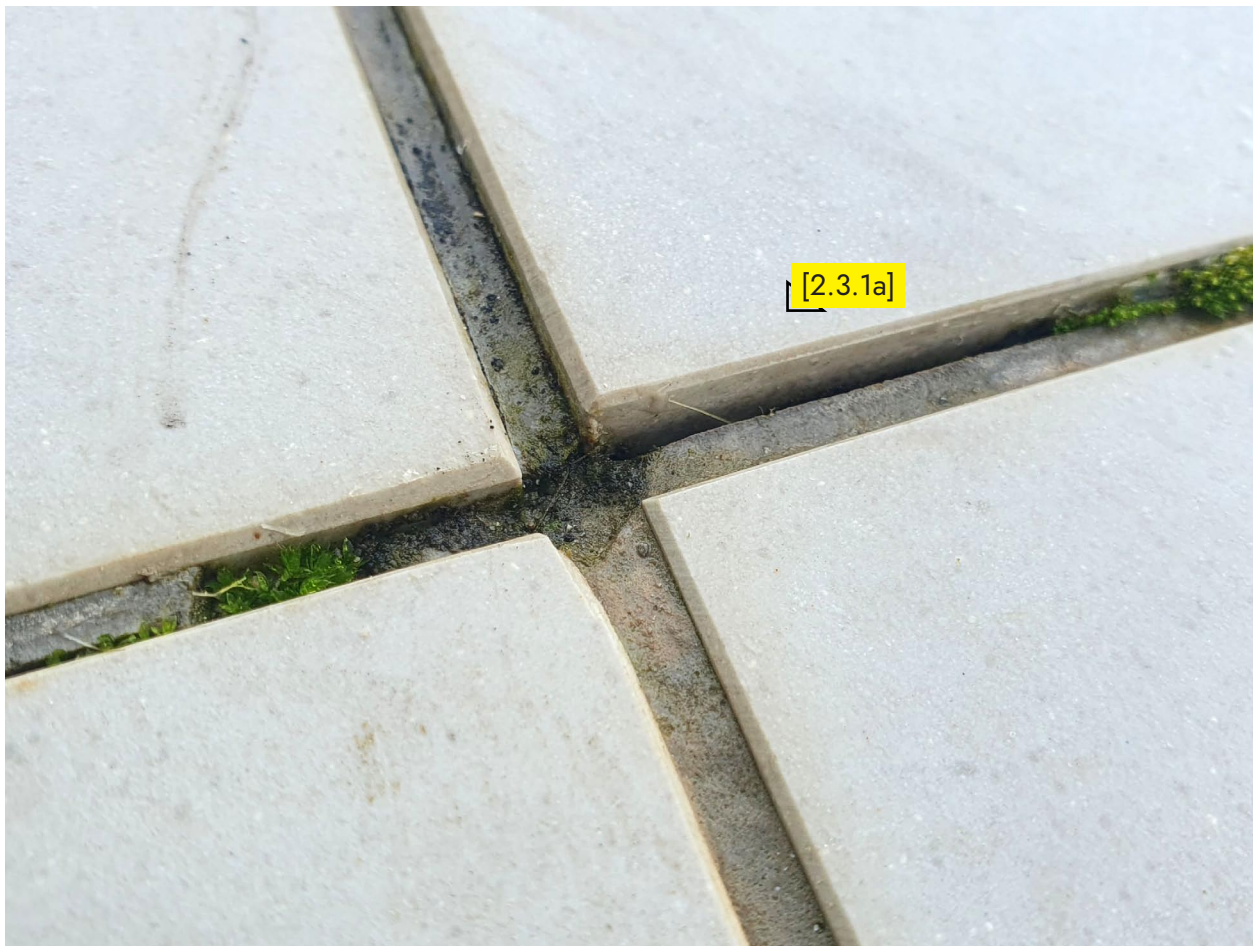
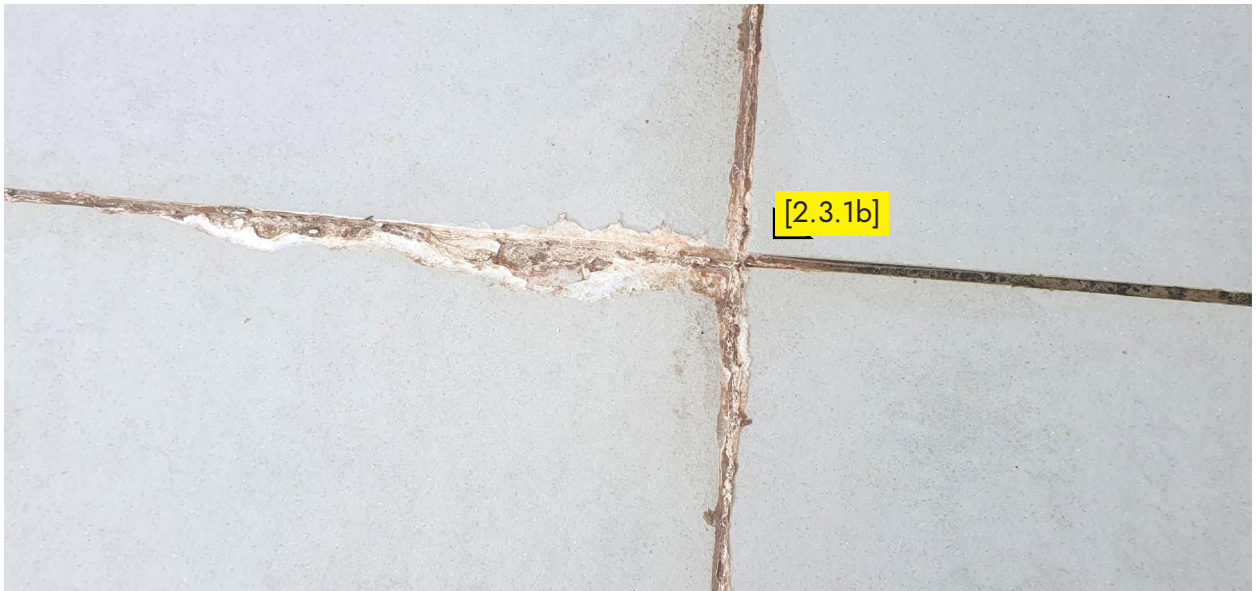
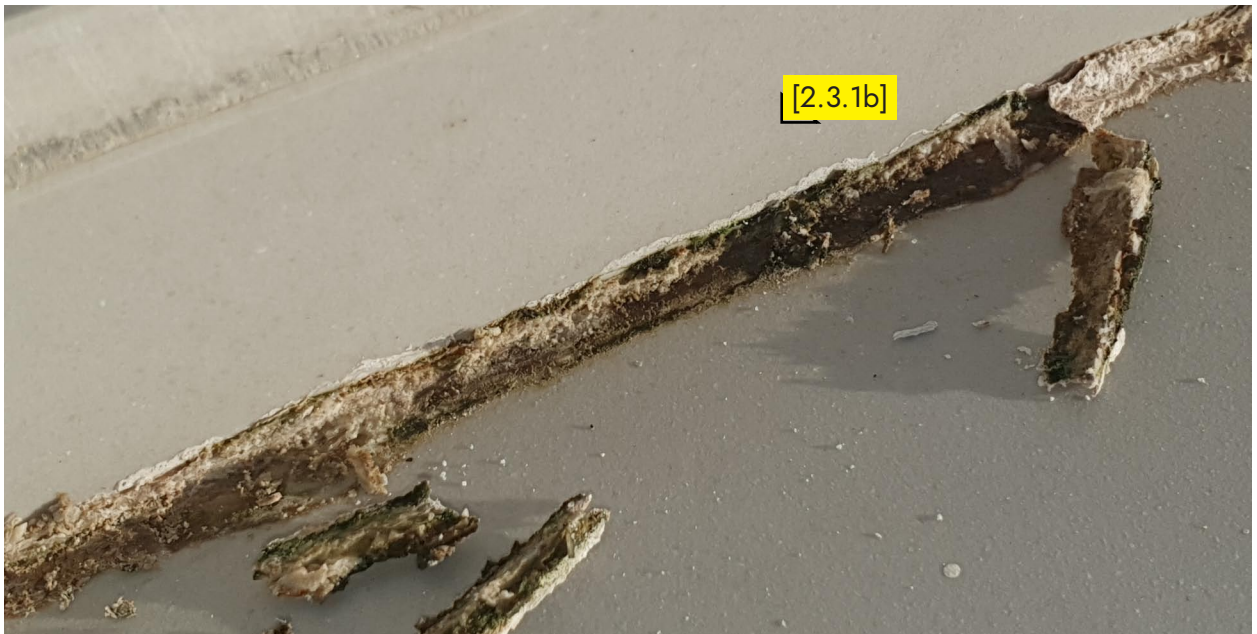
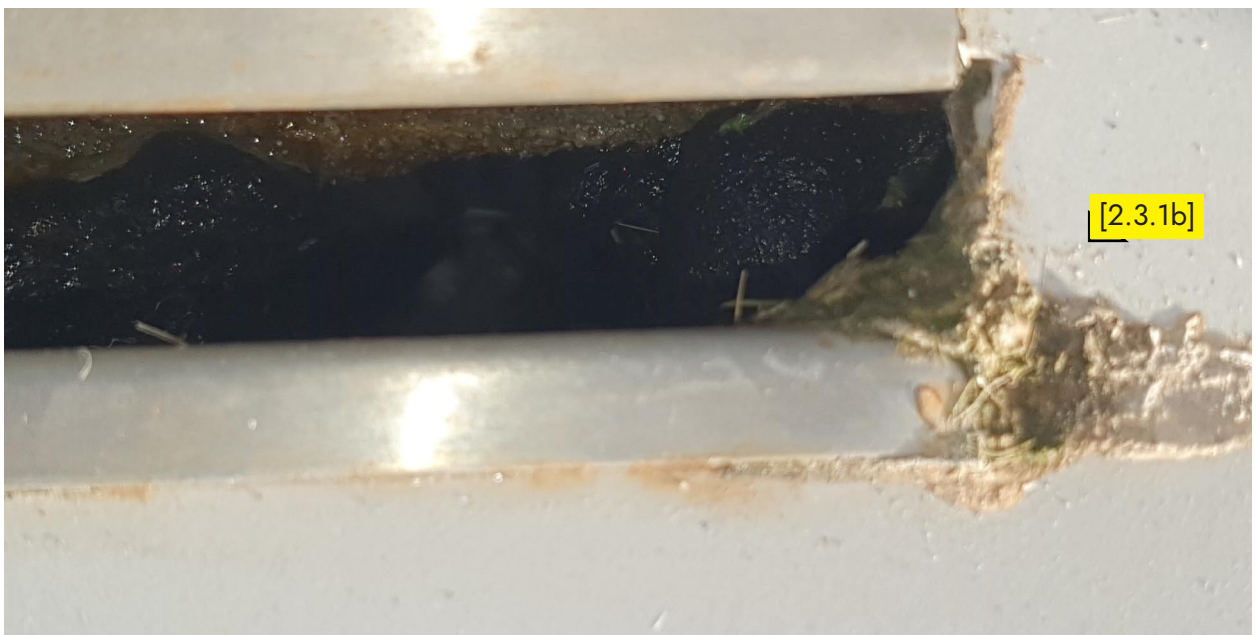
2.3.1. Numerous cavities and discolouration in the tile grouts were found on the overall terrace surface. There are many visible instances of grout erosion [2.3.1a].

The connection between the terrace surface and the balustrade is cracked or absent in many places. This creates the possibility of water penetrating into the balustrade attachment points and further erosion. The connection between the balustrade and the terrace should be both watertight flexible.

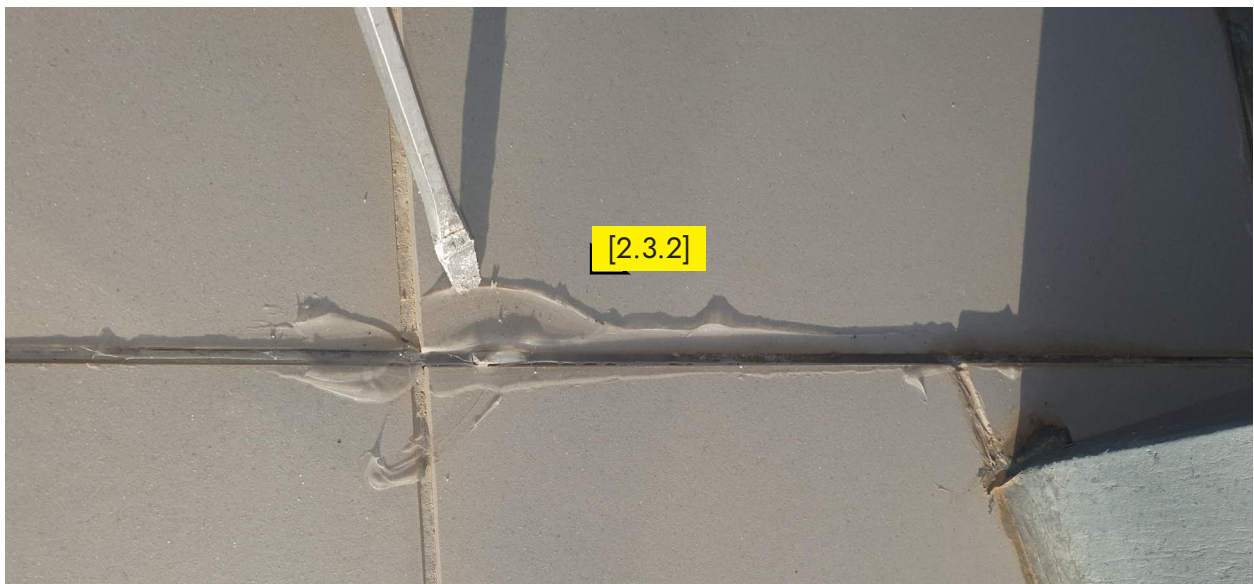
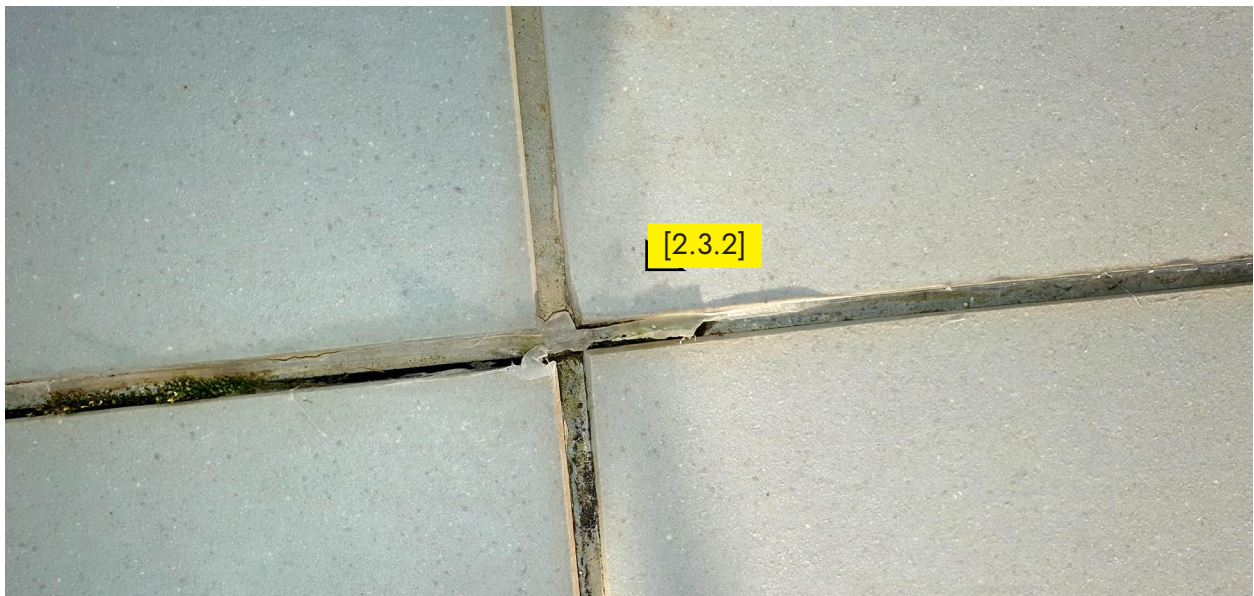
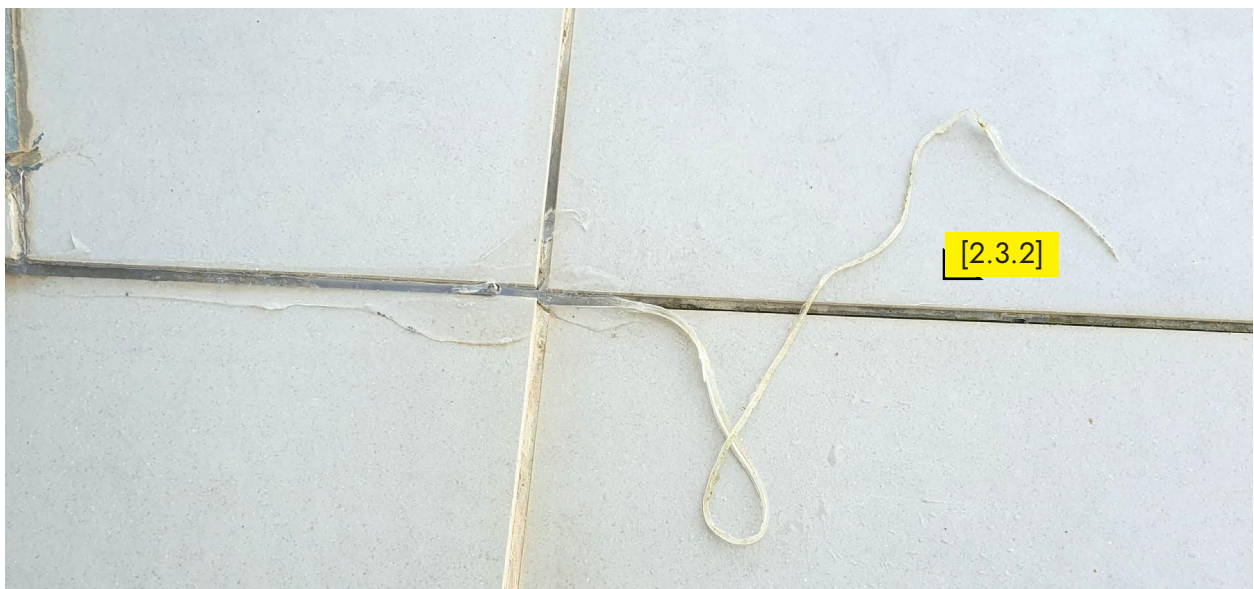
**2.3.2.** Some joints show signs of repair and sealing. These are ineffective treatments because the wrong technology and materials were used. Significant degradation of repaired joints can be seen.

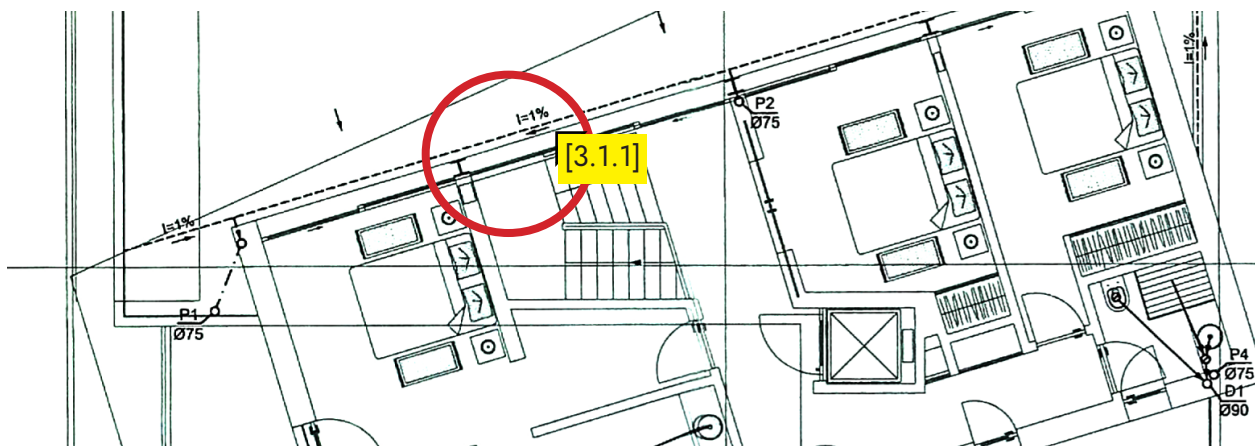
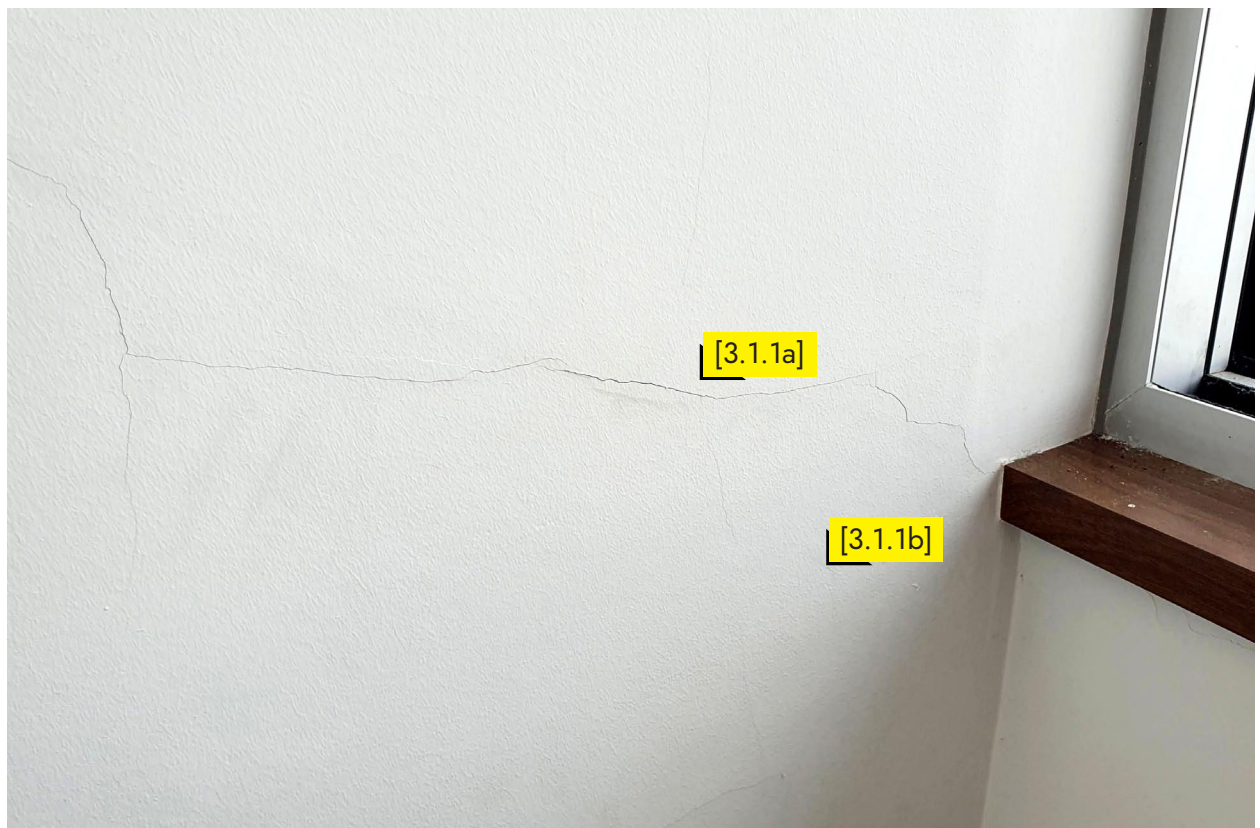
3.1.1. The walls in the stairwell are cracked

Numerous cracks running from the terrace lintel [3.1.1a].

From under the layer of paint, previous cracks in the same area can be seen. [3.1.1b].

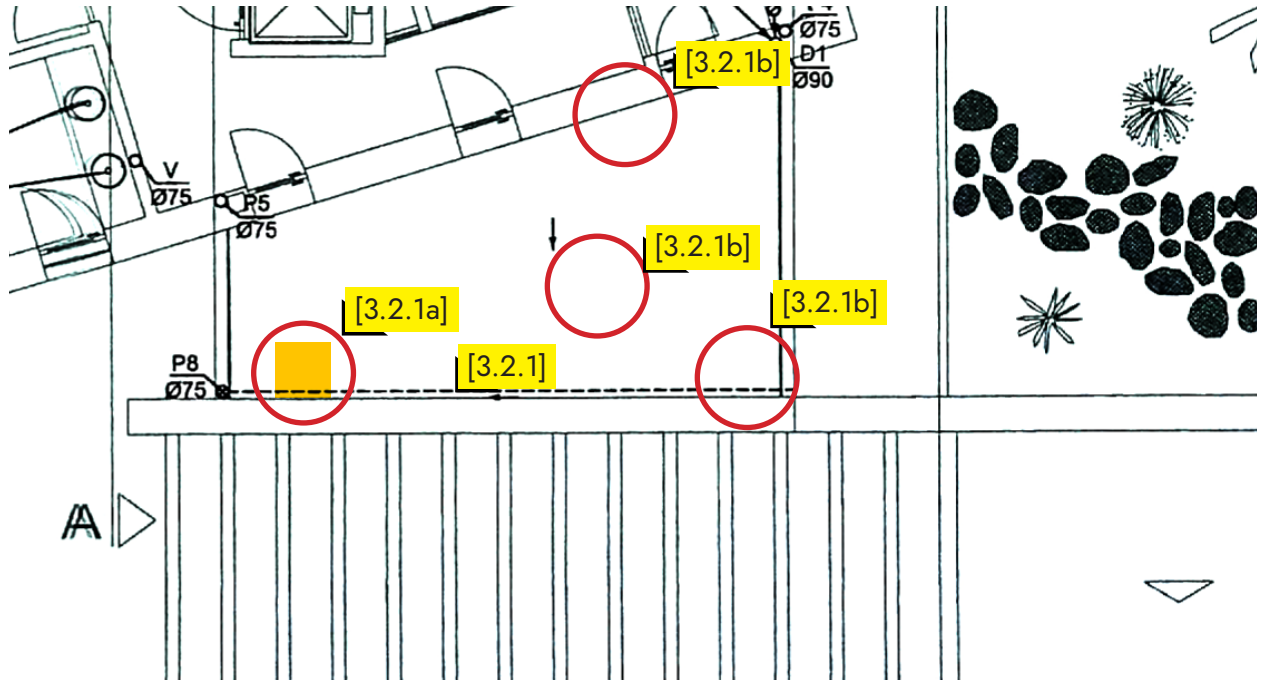
The diameter of the P8 drain pipe is 50 mm whereas by the building design it should be 75 mm. In addition, the P8 drain has been placed behind the chimney of the grill located on the patio below. This location of the drain results in the accumulation of debris and plant elements and makes cleaning the drain much more difficult. It should be mentioned that the grill chimney (highlighted in orange) is not present in the building design. [3.2.1a].

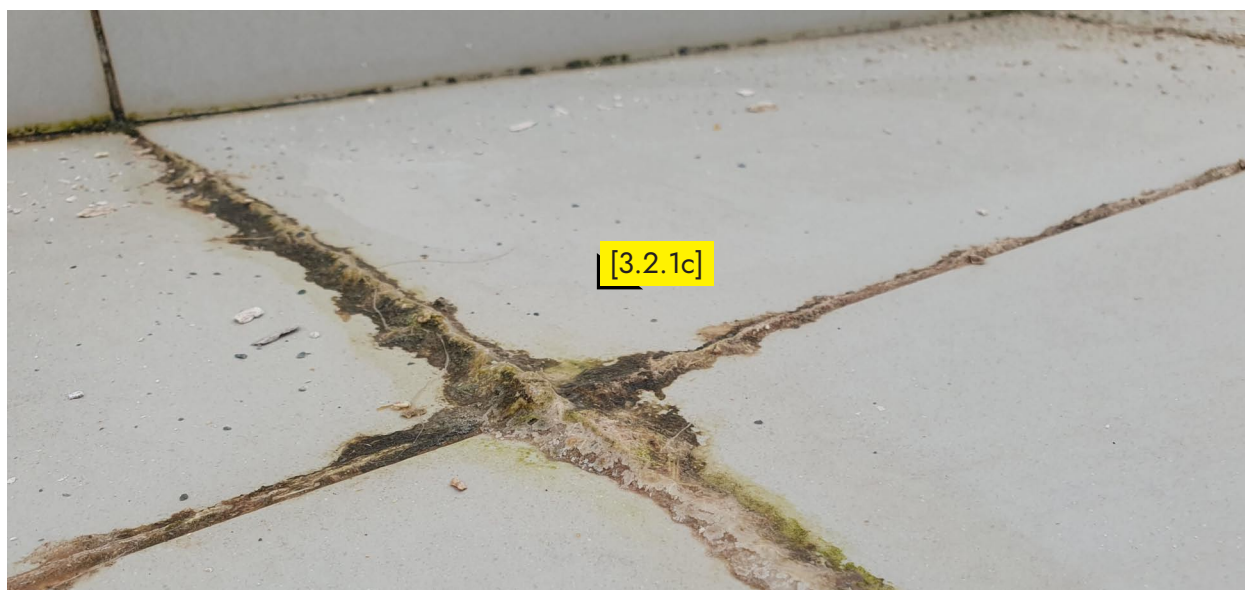
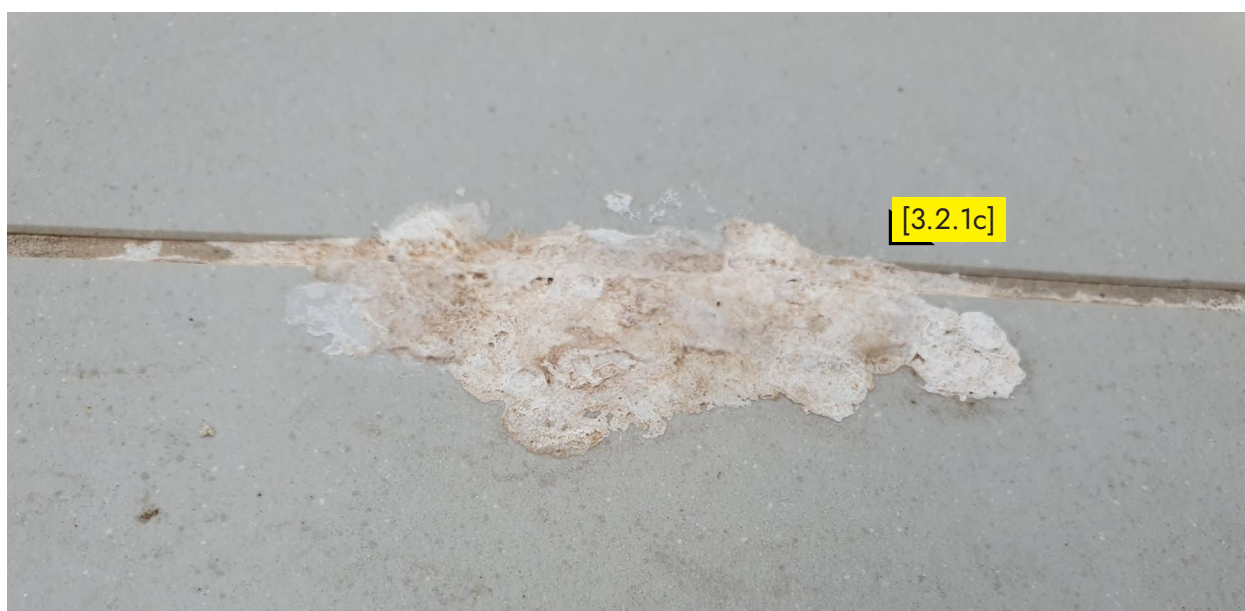
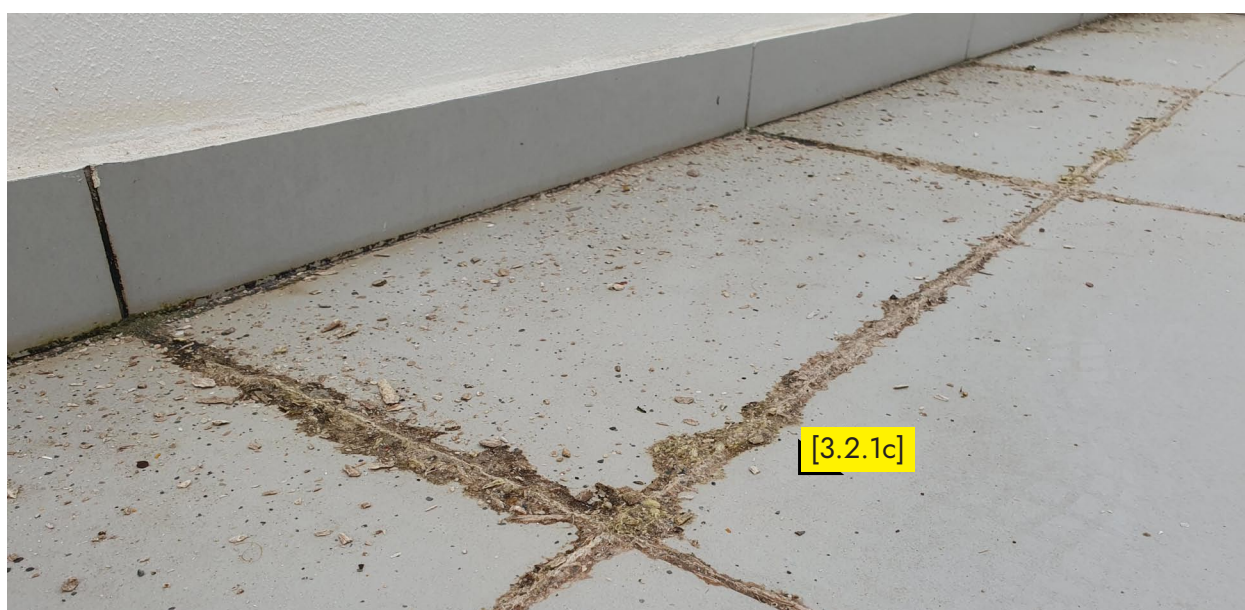
Cracks in the masonry fence of the balcony [3.1.1b].

Degraded grouts [3.1.1c].
