# The Report

House No 9

*March 2025*

This report systematises and organises the numerous construction and workmanship errors occurring in the private residential house located in Lote 3 - Casais Porto Dinheiro.

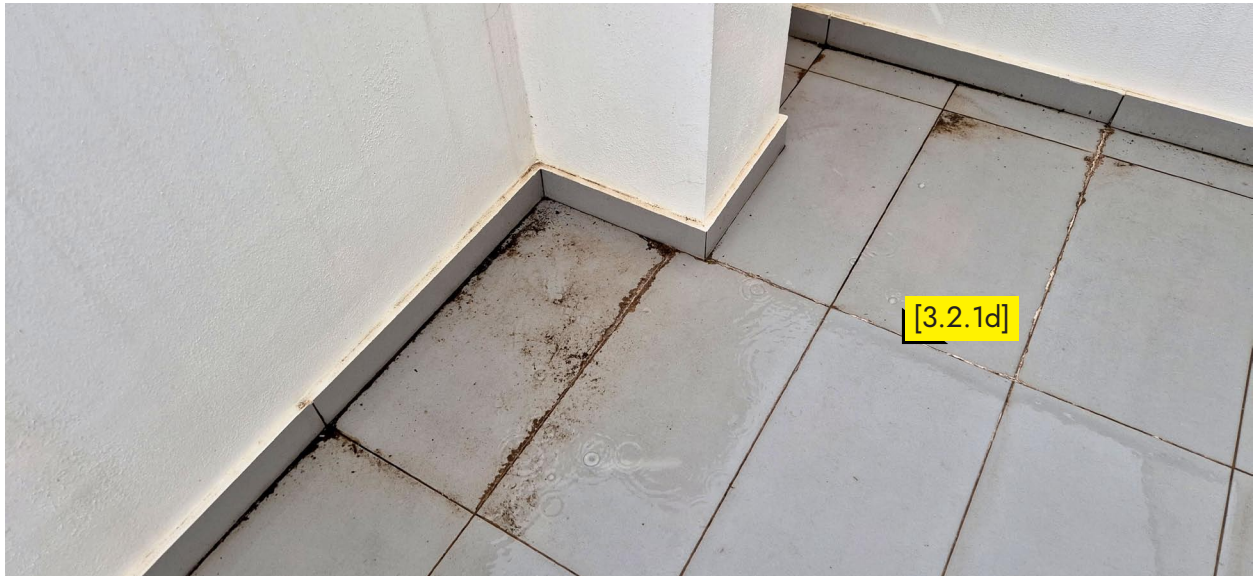
Rainwater deposited on the balcony as a result of incorrect surface profile [3.1.1d].

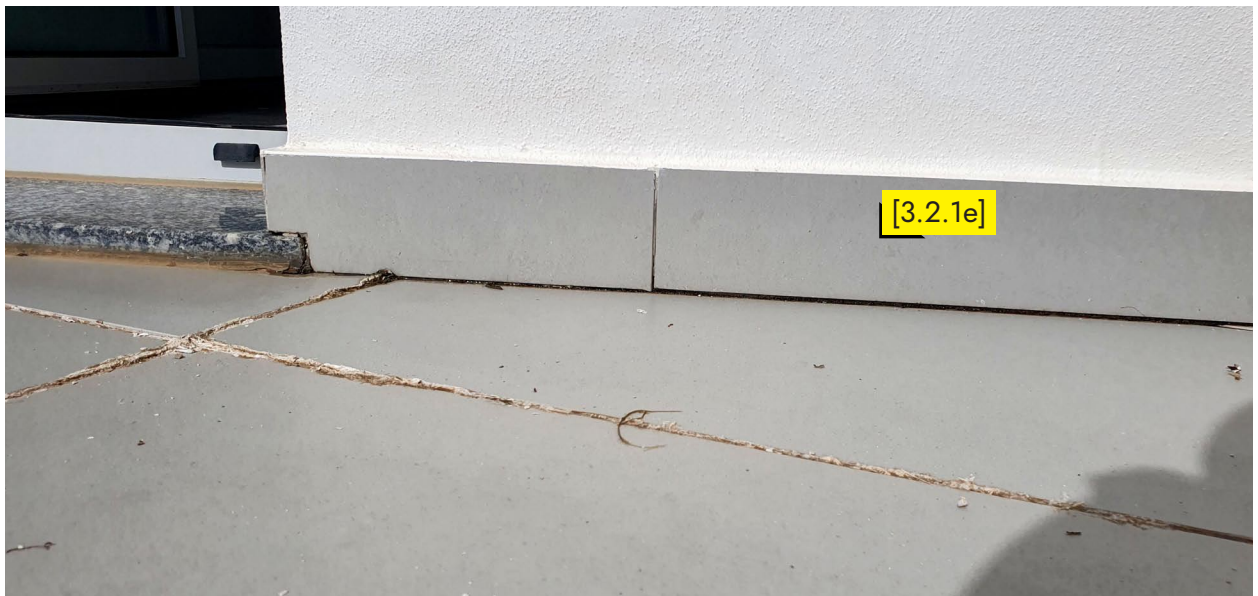
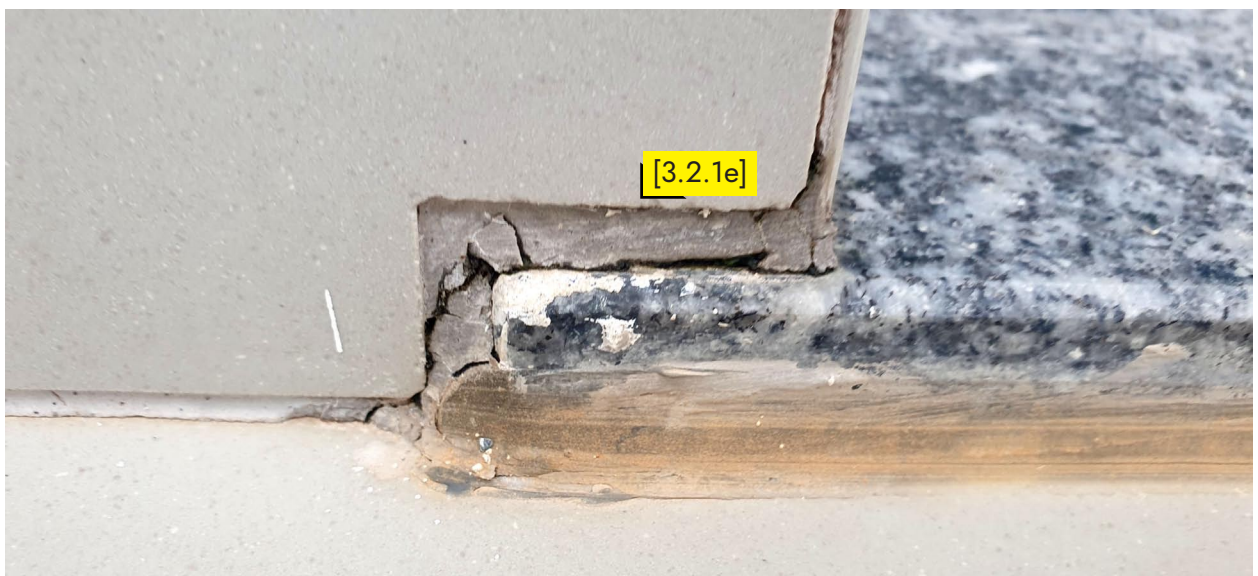
Cracks at the junction between balcony and house wall [3.1.1e].

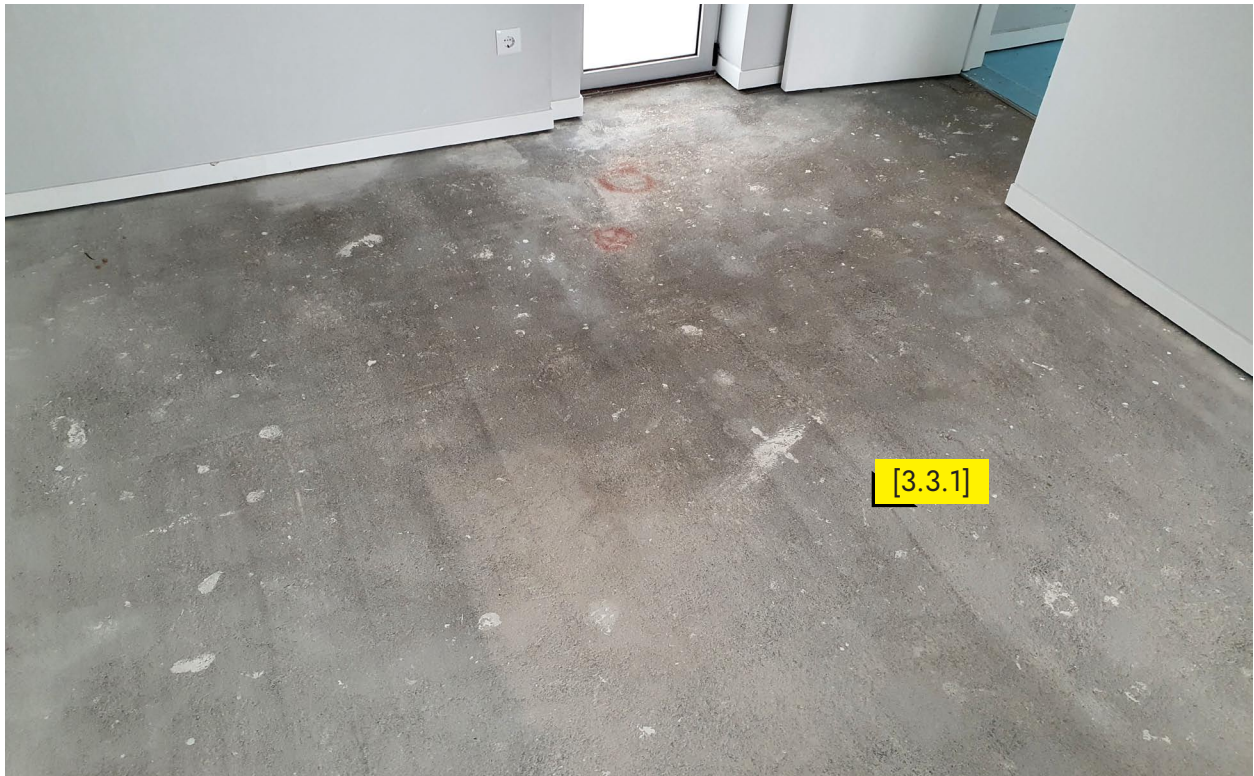
There is a distinct musty smell in the northern bedroom and the nearby corridor, despite the fact that the air conditioner has been running in the room in dehumidification mode every day for the past six months.

3.3.1. The floor boards had been removed. Clear traces of dampness covering almost half of the room were noted on the screed. The probable cause of the dampness is rainwater leaking from the balcony on the east side of the house. It can be assumed that there is also no waterproofing on the balcony and rainwater is seeping into the screed in the bedroom.

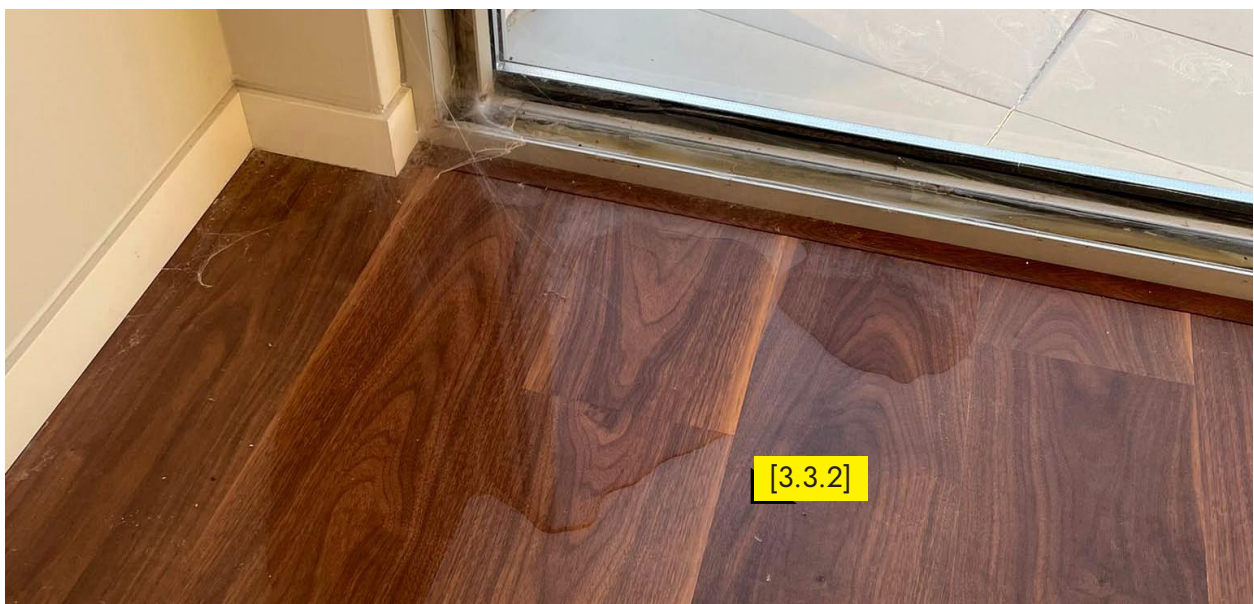
3.3.2. The bedroom on the south side has developed leaks around the patio window. The window frame was covered with green algae, there was water in the floor and in the window frame. The skirting board is slightly swollen from the dampness.

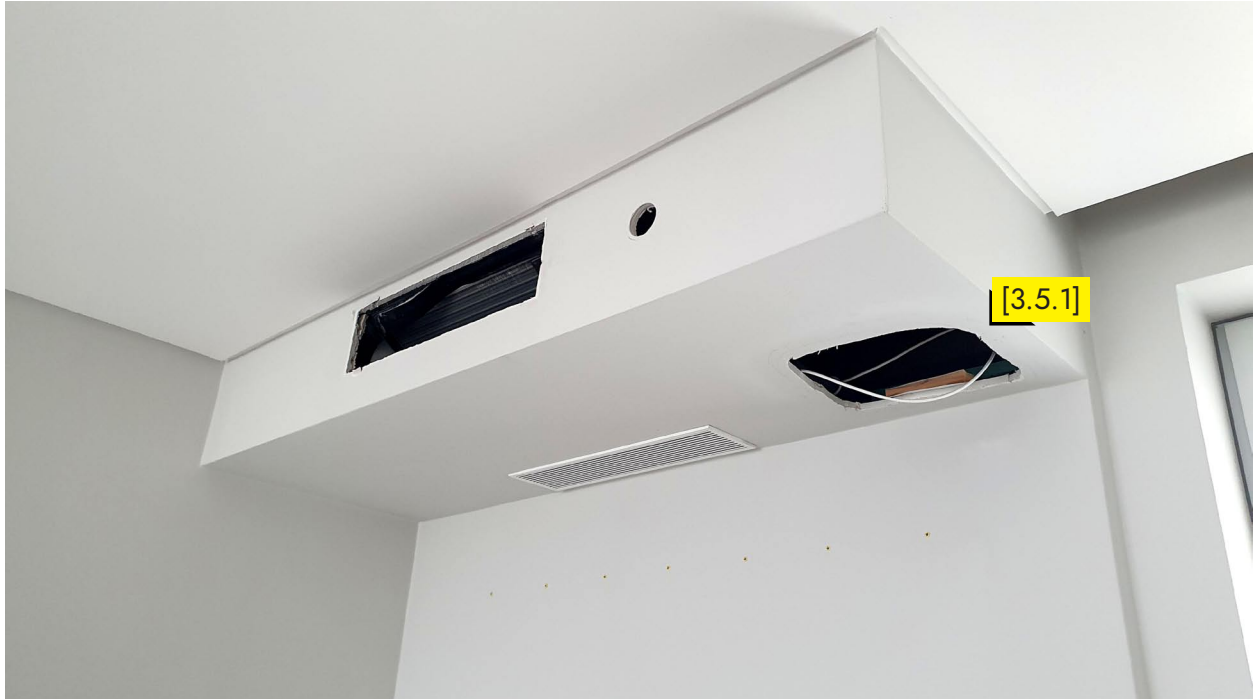
**3.5.1.** On the first floor, three air-conditioning systems were installed built-in in the walls, the false ceiling and in the wardrobes. None of them has an inspection opening to access the junction box. In the event of a malfunction or the need to make adjustments, it will be necessary to dismantle the wardrobe or to drill a hole in the wall. The owner was forced to do so in this case.

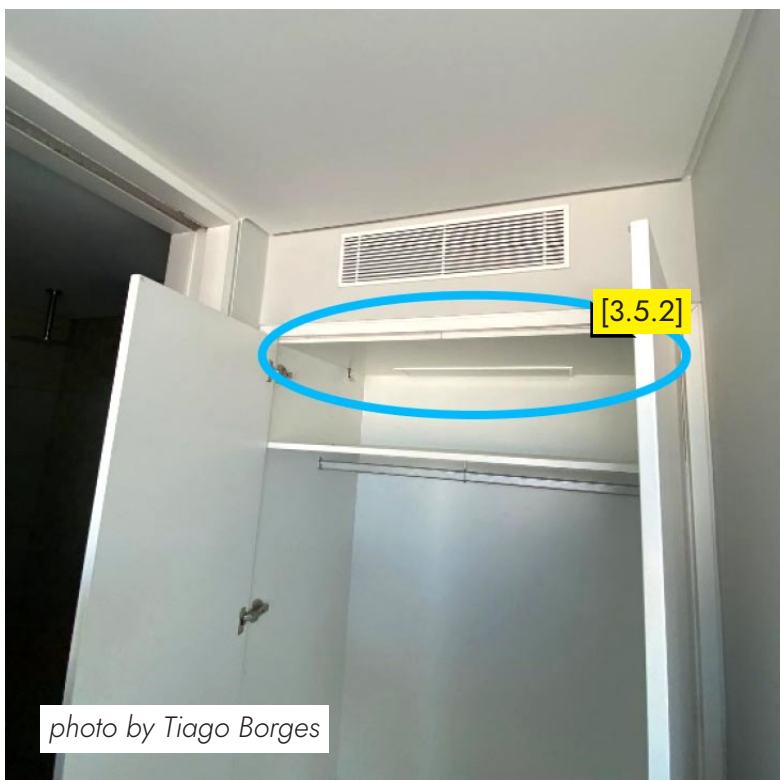
**3.5.2.** In the middle bedroom in the center of the house, the air conditioner have air intake hidden in lockable wardrobes. For this reason, it is impossible to use them properly. For the air conditioner to work effectively, the wardrobe doors must be open.

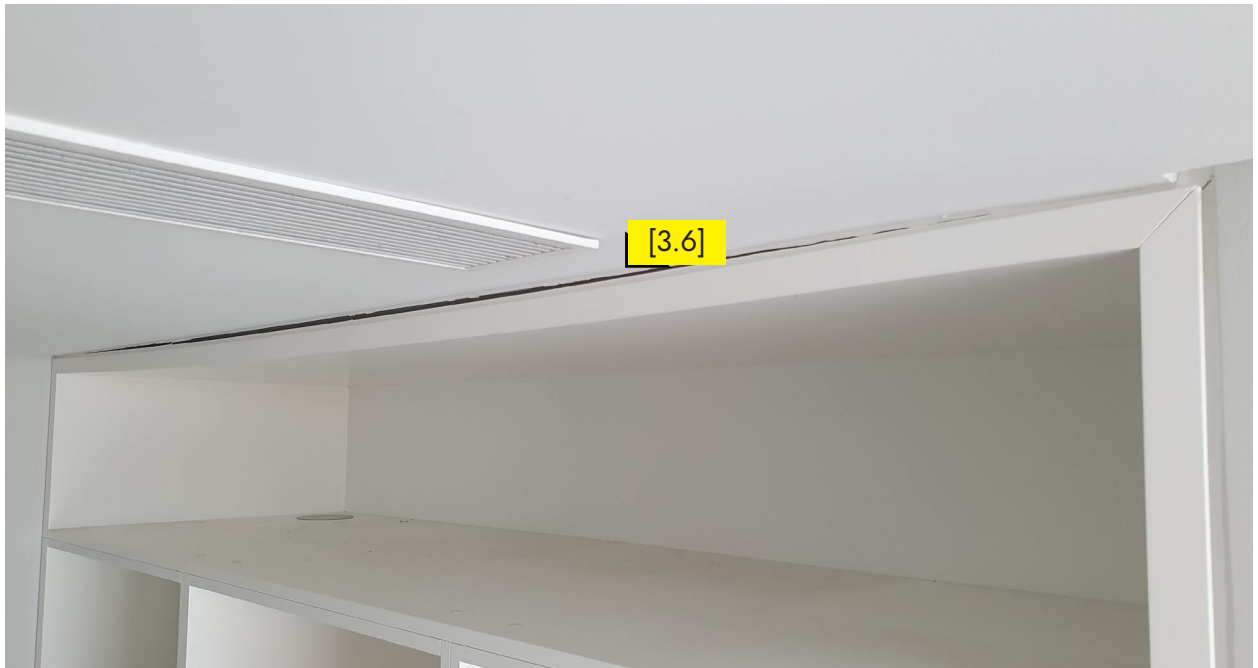
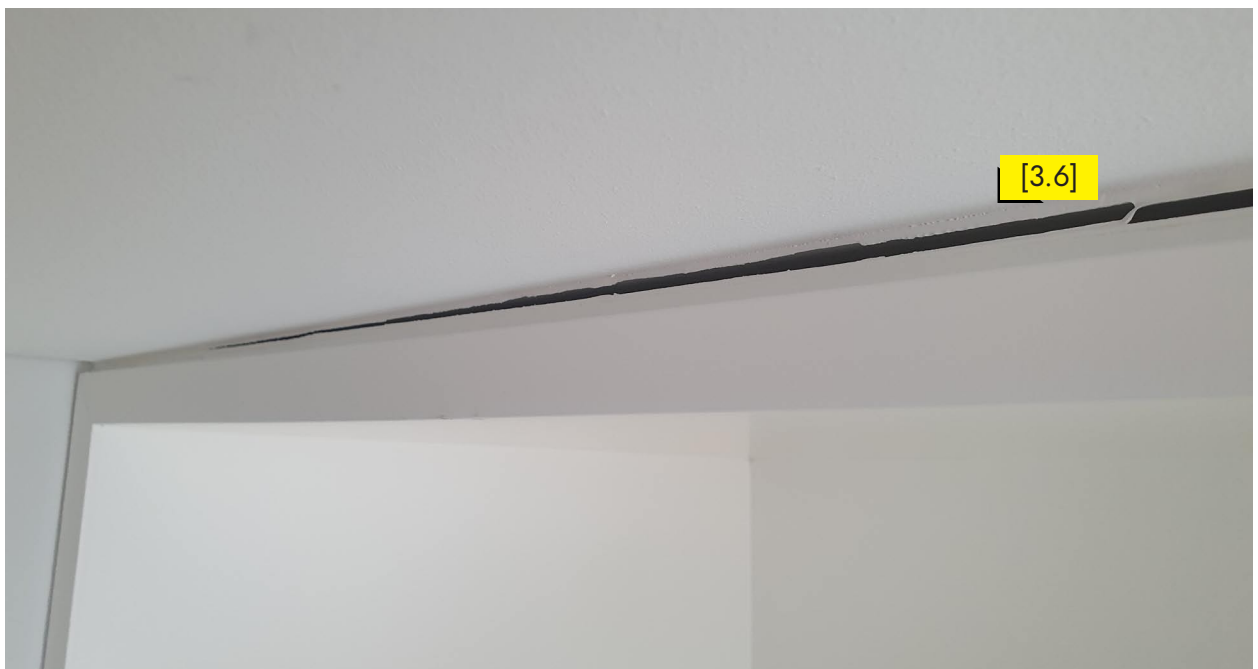
### 3.6. Wardrobe defects

The wardrobe in the south bedroom is bulging and a large gap has been created between the wardrobe and the ceiling.

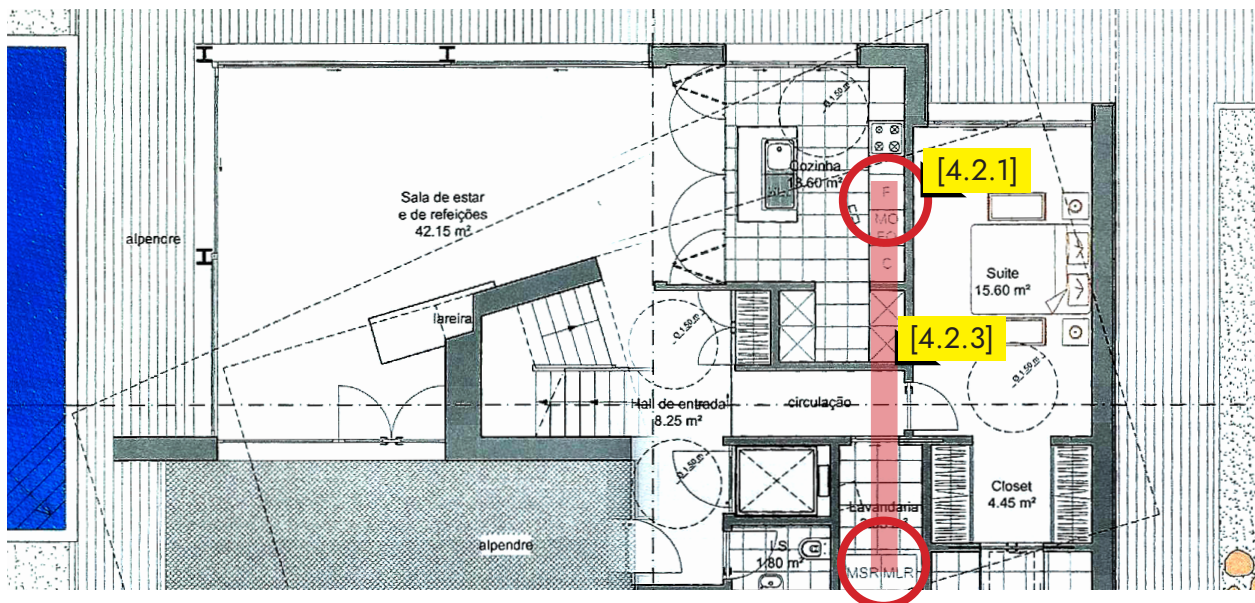
### 4.2.1. The cooker hood was not connected to the ventilation duct!

The pipe from the cooker hood was led into the space between the concrete slab and the false ceiling [4.2.2]. A few metres of ventilation pipe are missing between the cooker and the ventilation duct [4.2.3].

All cooking fumes, odours and moisture are introduced into the hollow space below the false ceiling and spread throughout the flat.

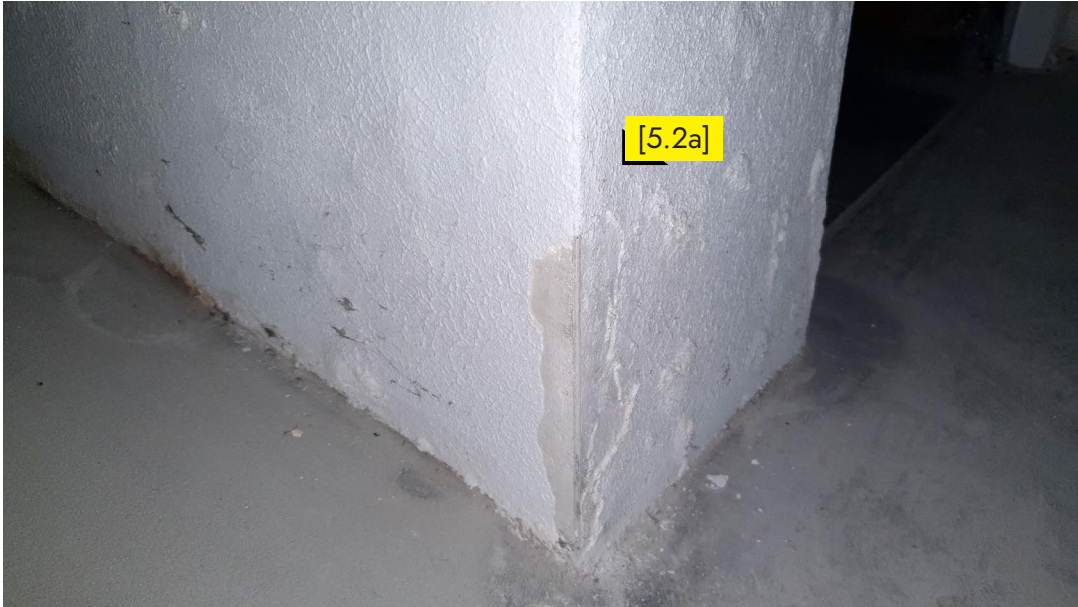
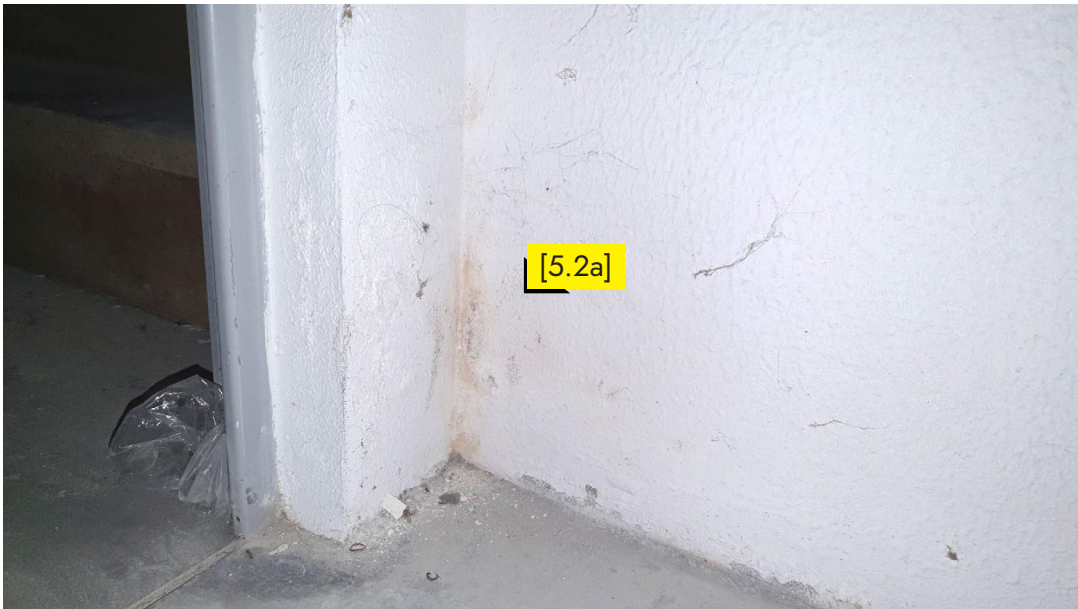
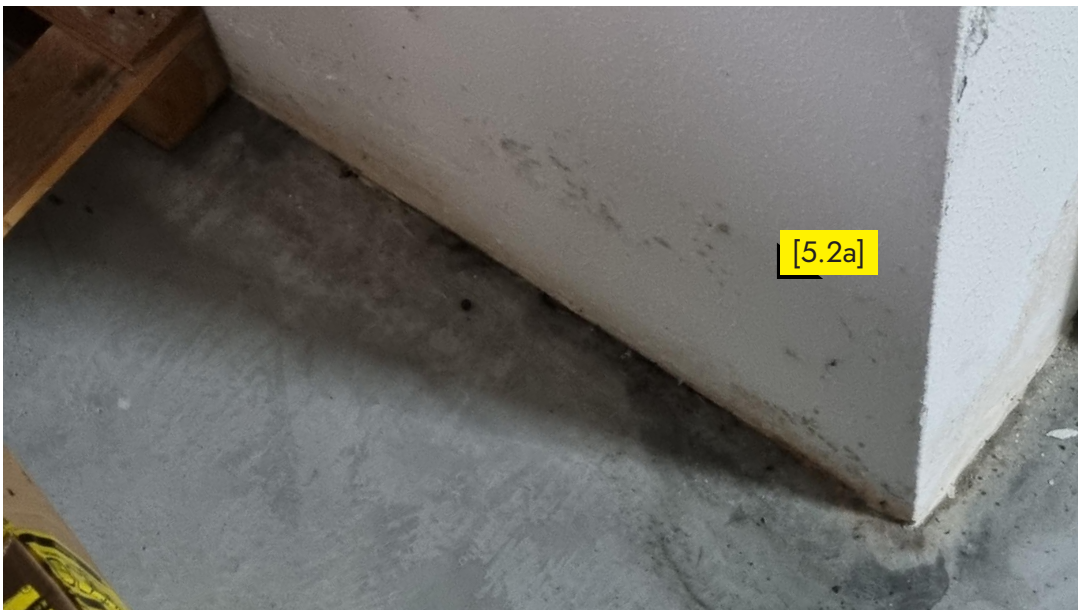
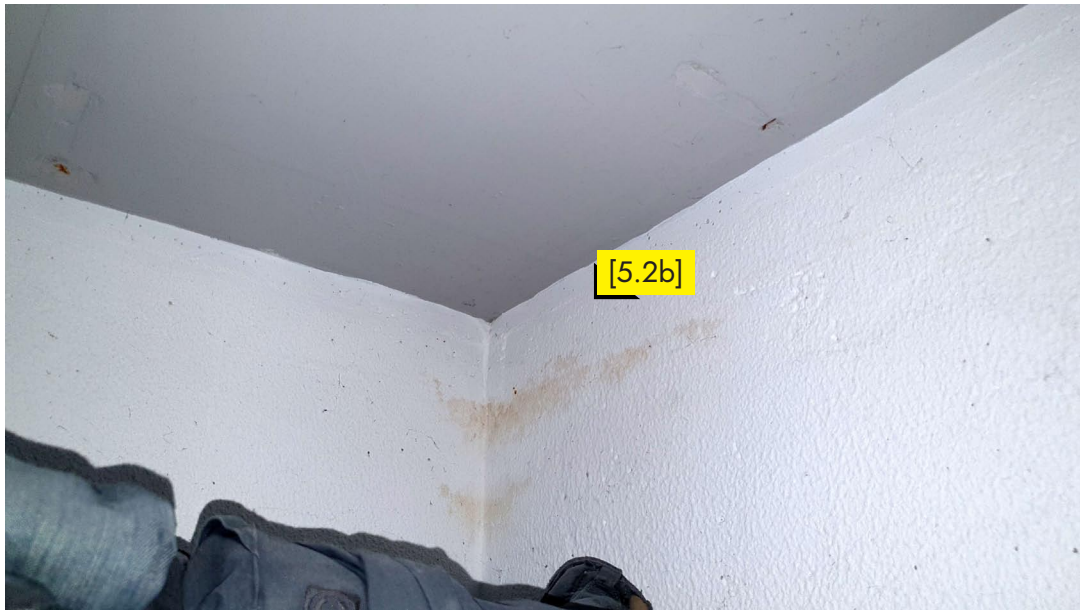
### 5.2. Moisture in walls and floors

The main problem in the basement is dampness [5.2a]. There are stains on the floor, damp patches on the walls – mainly in inner walls. Poor horizontal damp protection of the floor and walls thus capillary seepage through the walls are responsible for this dampness.

There are also some traces of water soaking the walls in the garage top corner (near the ceiling) [5.2b].

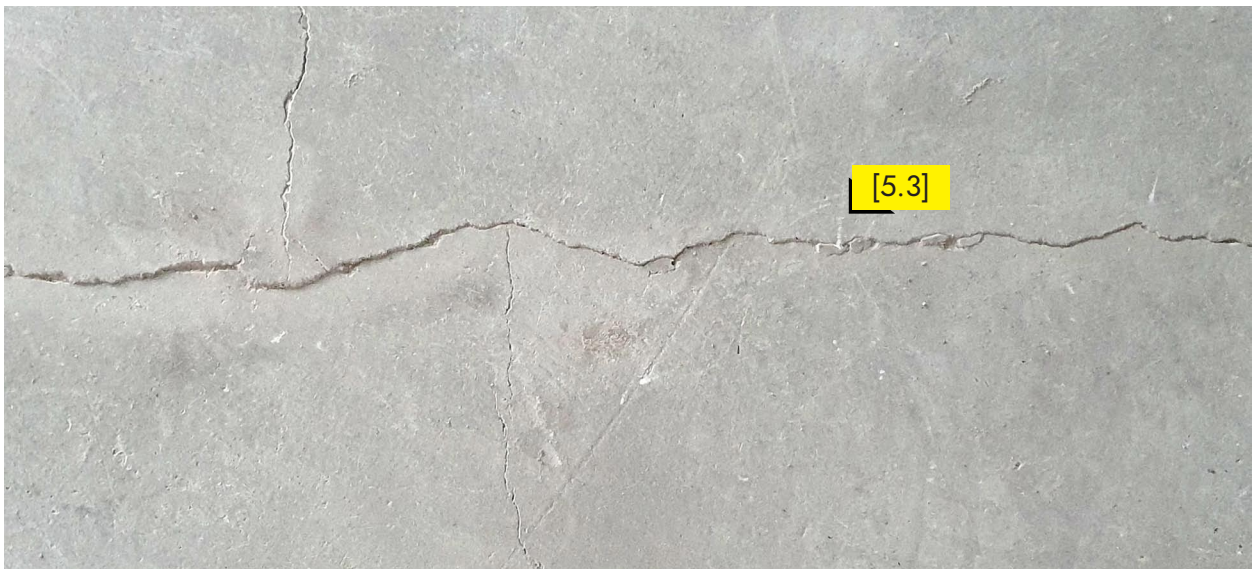
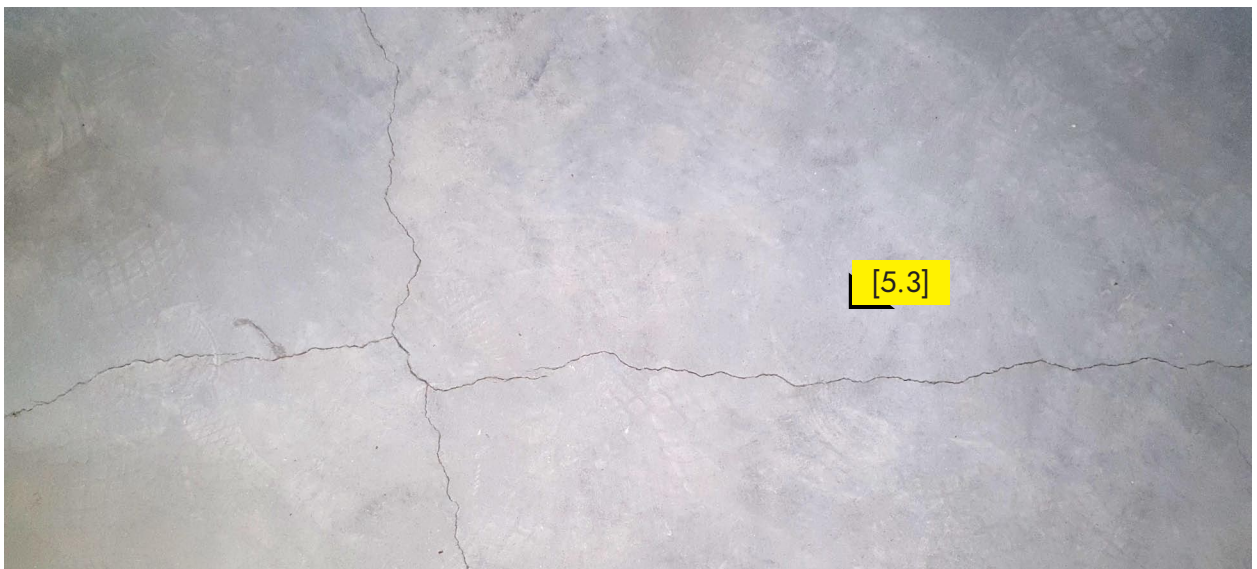
### 5.3. Cracked floor

The concrete screed is cracked in many places.

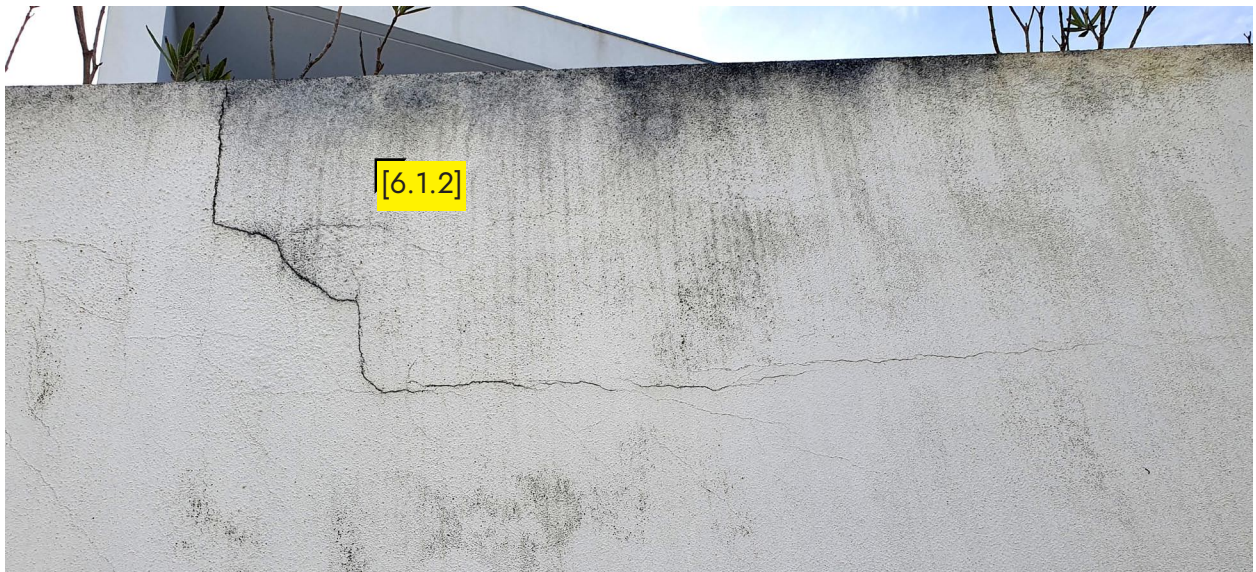
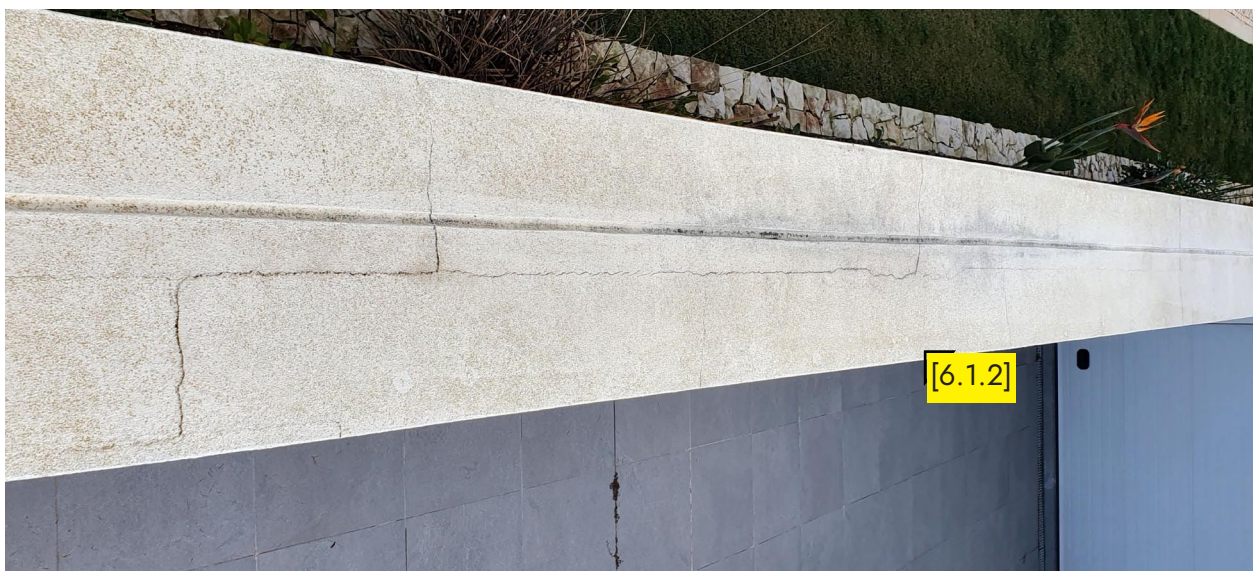
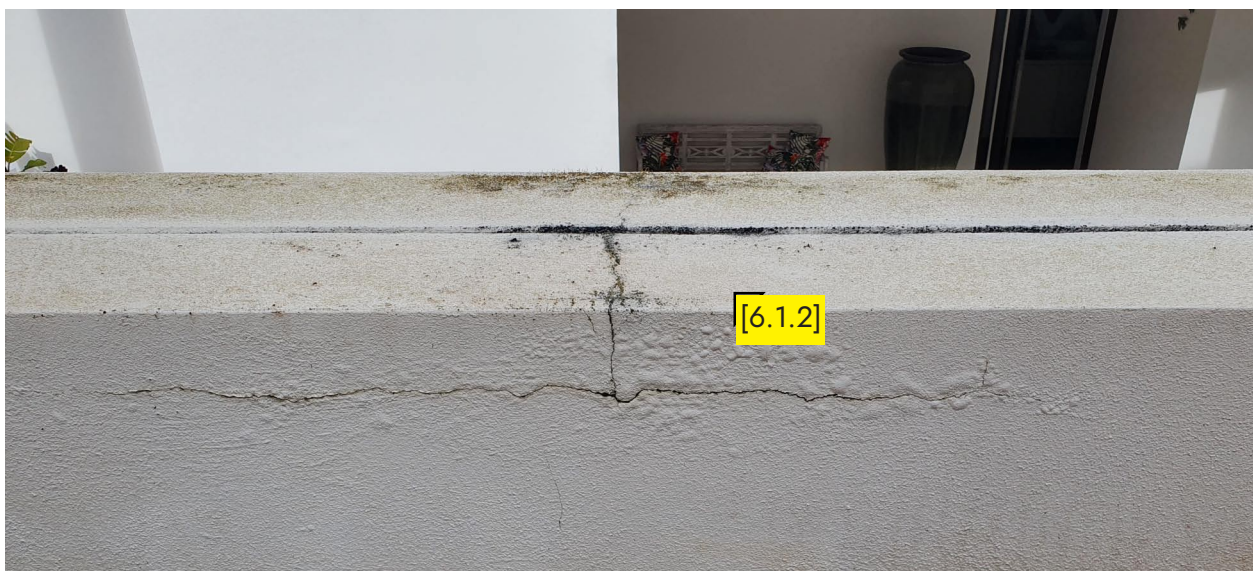
### 6.1.2. Cracks below top of walls and masonry.

Caused by water penetration due to missing or poorly executed copings, wall settlement and stresses arising at the boundary between different materials.

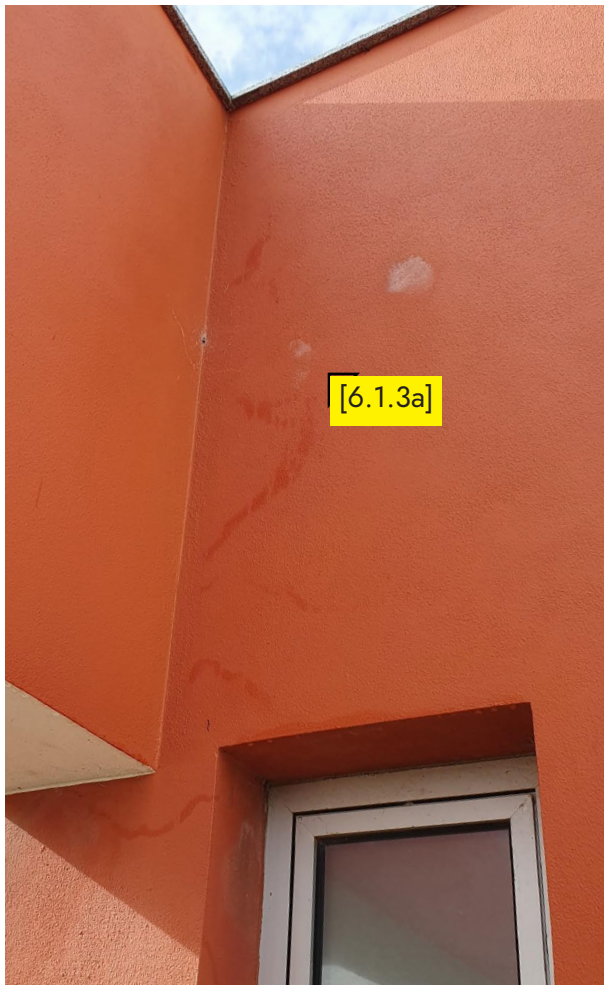
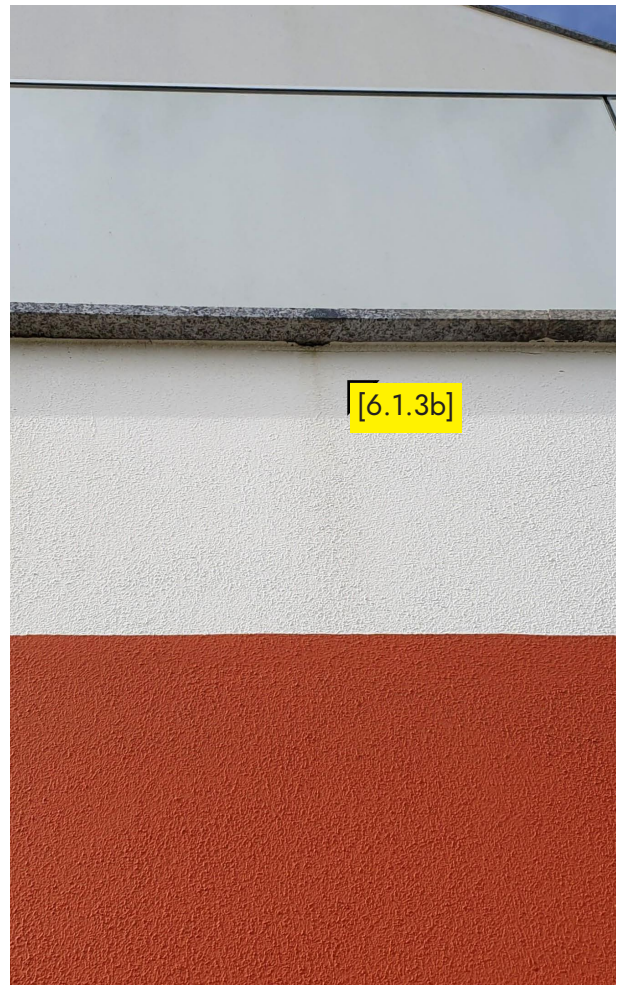
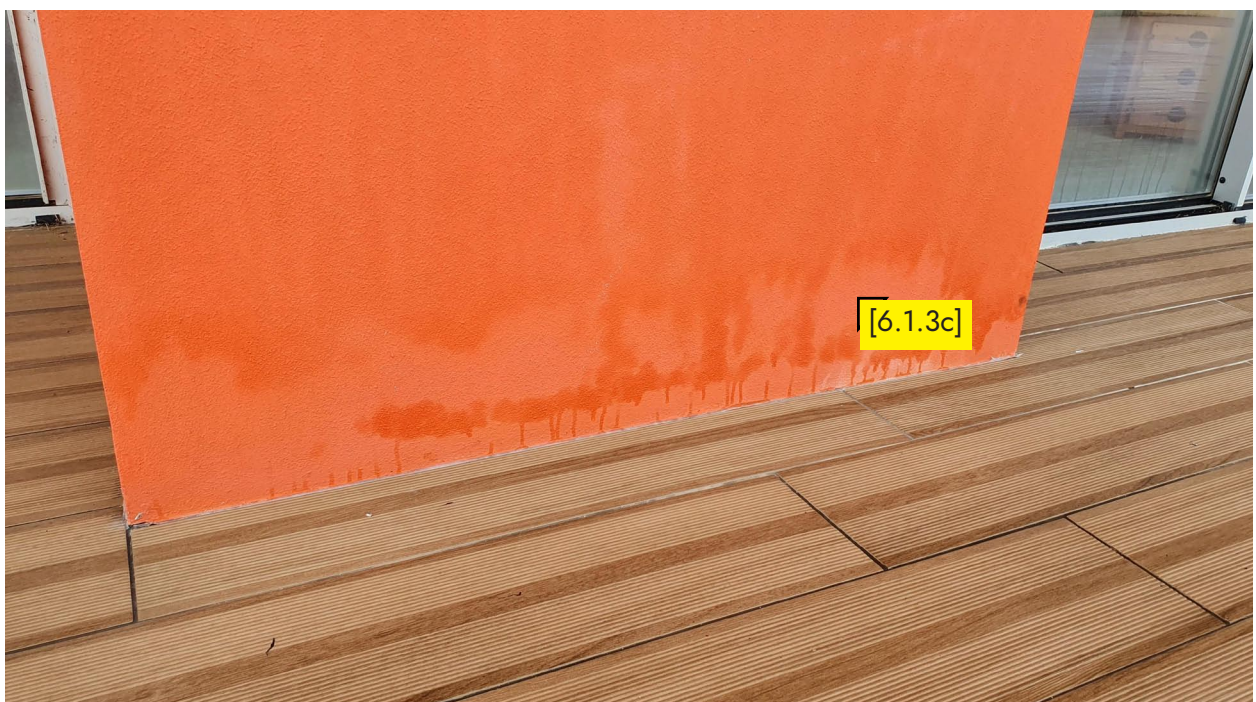
6.1.3. Discolouration and staining on the facade.

6.1.3a This is a possible exudation of water from a leaking balcony.

6.1.3b Staining from rainwater due the lack of **throating (drip channels)** in the copings.

6.1.3c Stains from rainwater sipping up from the patio floor.

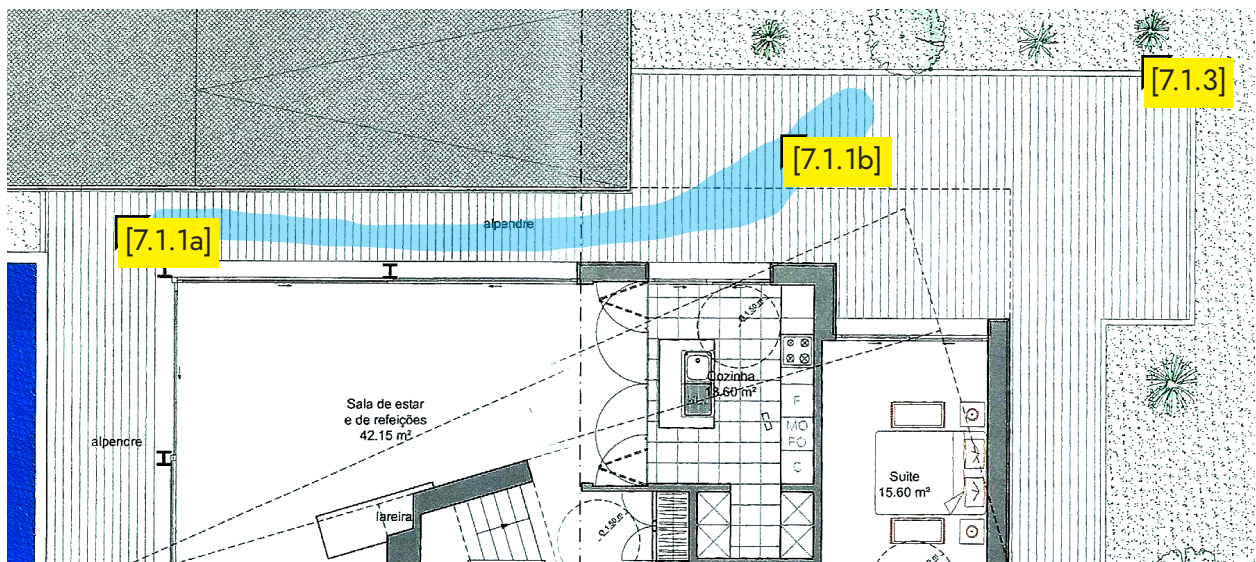
### 7.1. Patio profile and drainage

Patio surface on wrong profile – it forms a trough, there is no slope [7.1.1a] or even worse - the slope is slightly to the building direction [7.1.1a]. As a result, rainwater floods the patio in puddles [7.1.2]. Excess water running off the patio is not drained anywhere. It is likely that some of the water flows freely from the terrace near the wall and infiltrates into the garage - hence the stains in the corner under the ceiling [7.1.3], and some run off at the edge of the patio and pool, as well as in the area of the underground pool pump room.

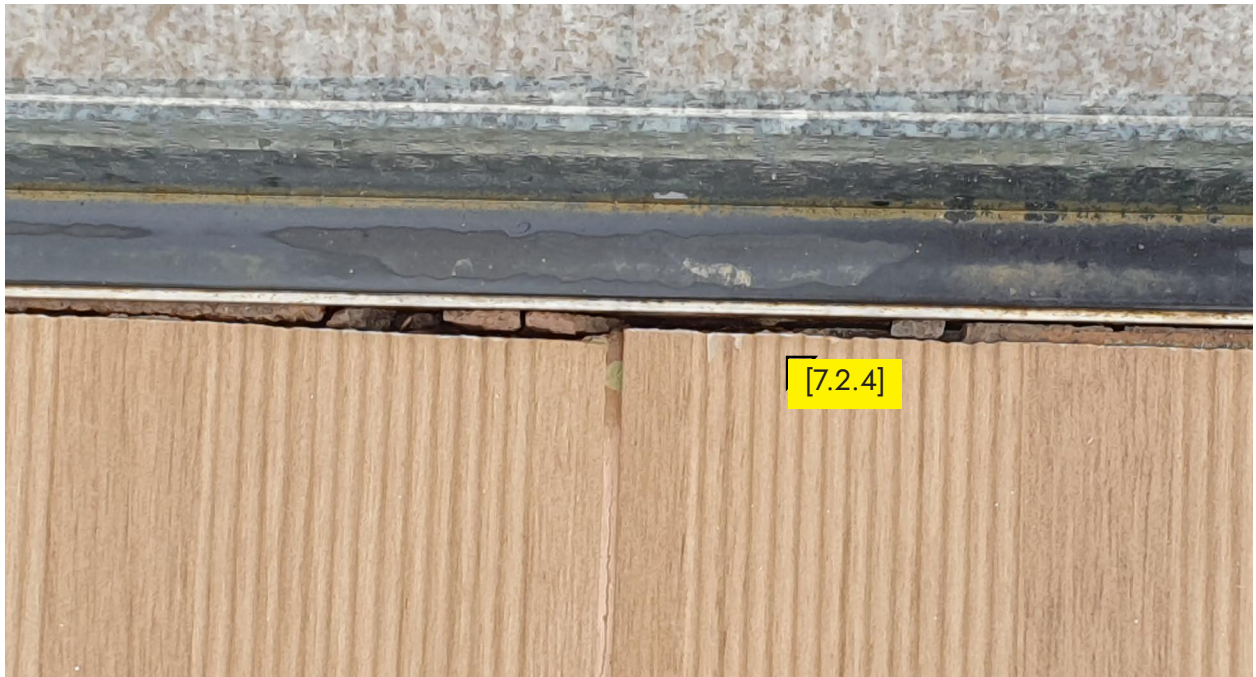
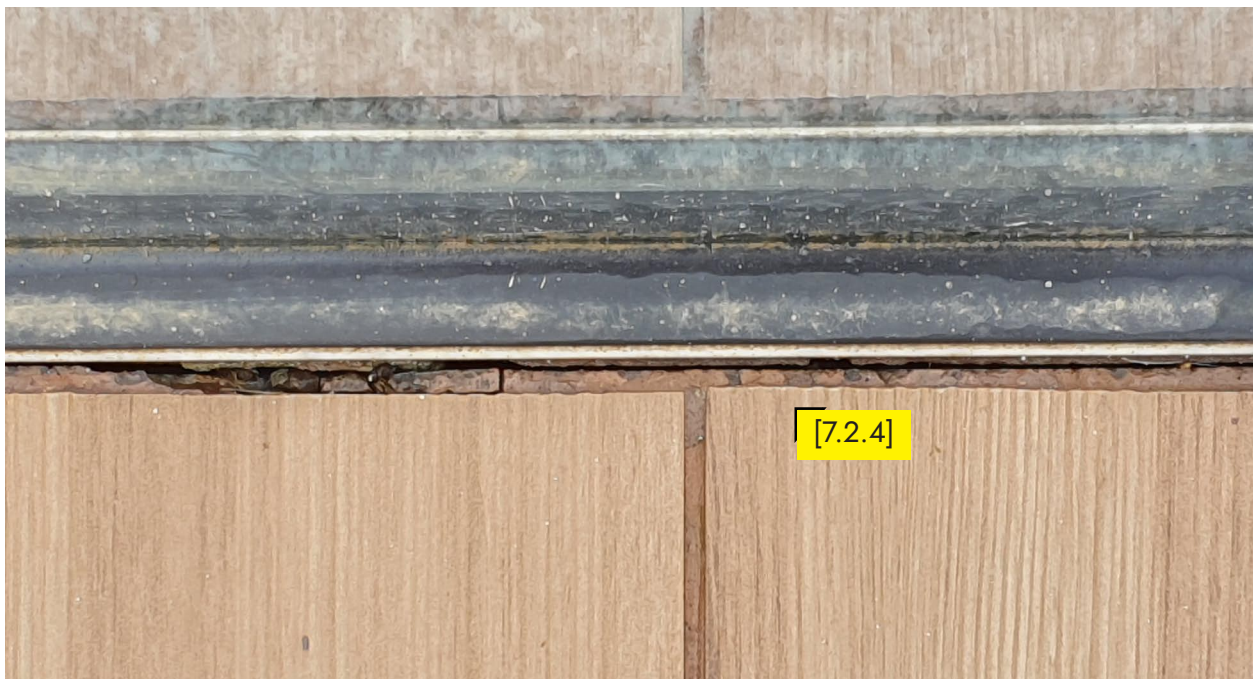
7.2.4. The connection between the terrace surface and the balustrade is cracked or absent in many places. This creates the possibility of water penetrating into the balustrade attachment points and further erosion.

The connection between the balustrade and the patio floor should be both watertight flexible.

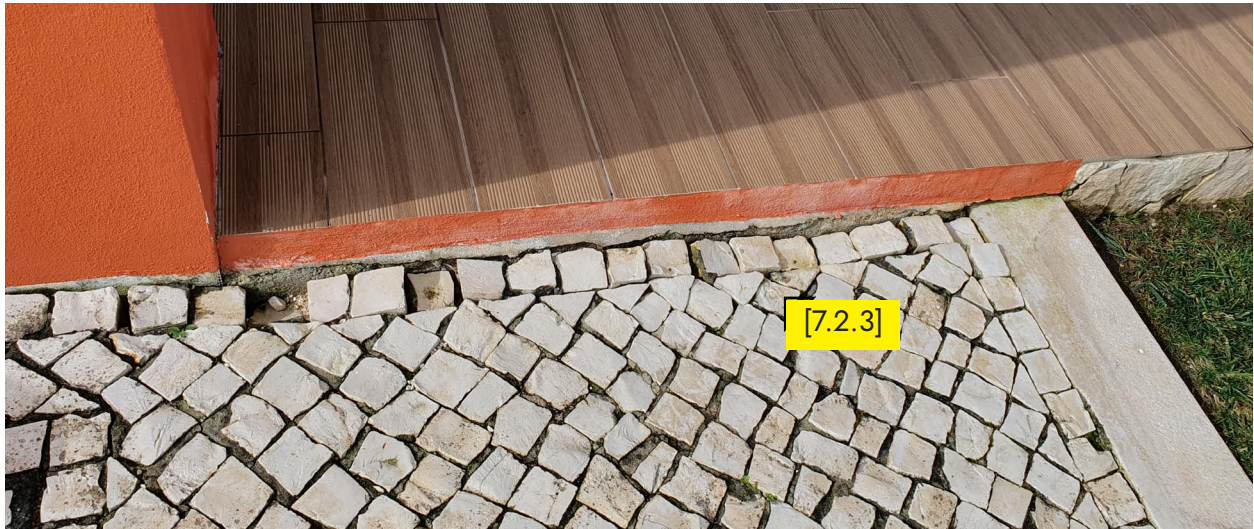
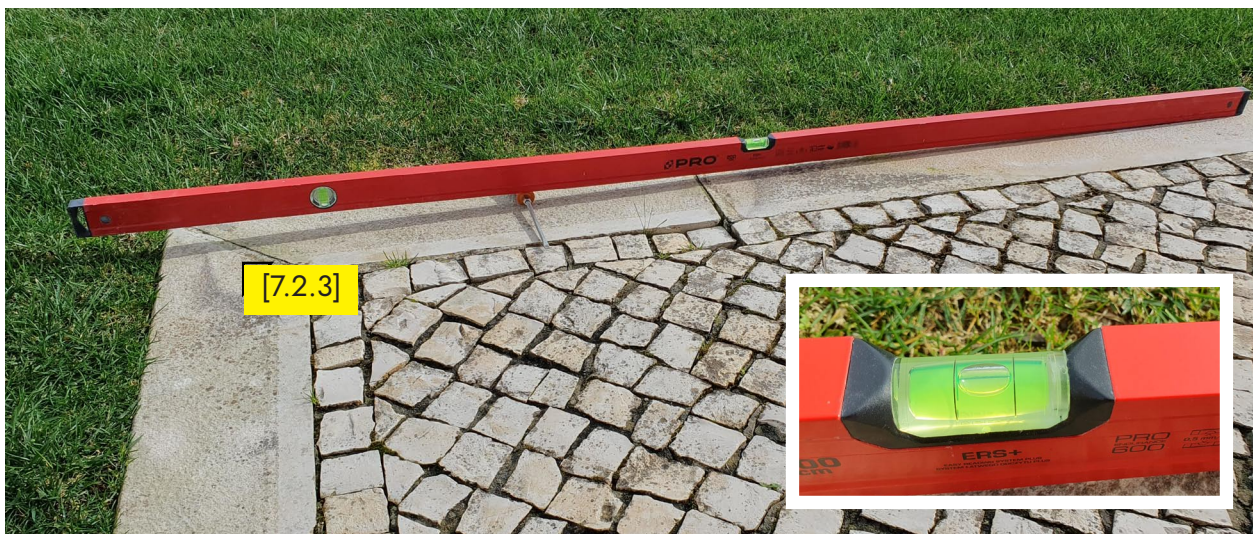
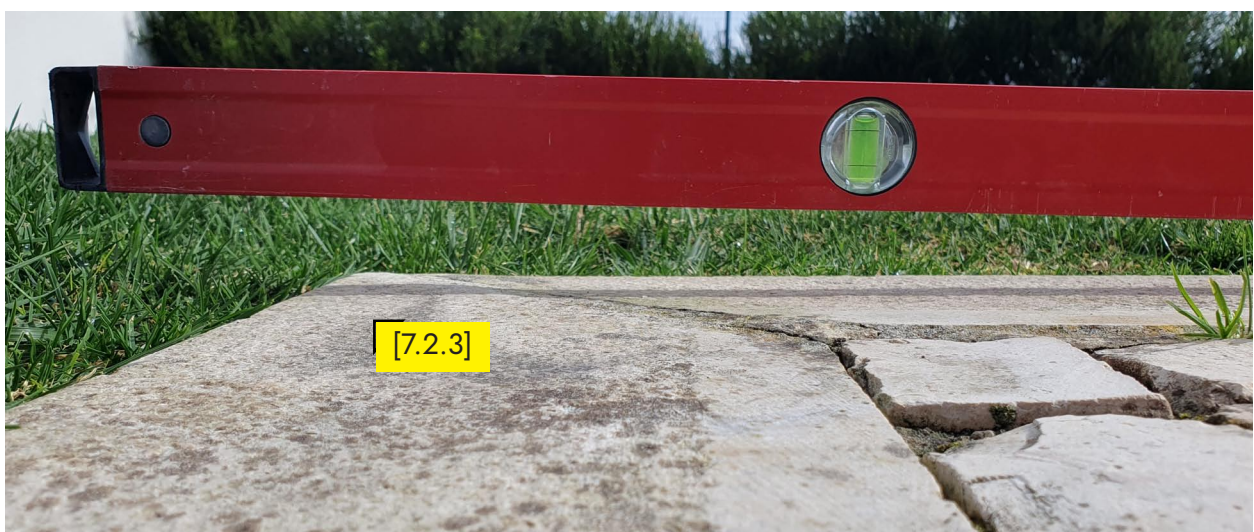
### 7.3. Crooked pavement

The part of the pavement adjacent to the patio floor is very crooked. The likely cause is that the ground is being washed out by water running off the patio, which is not drained anywhere. Loose paving stones can be seen.

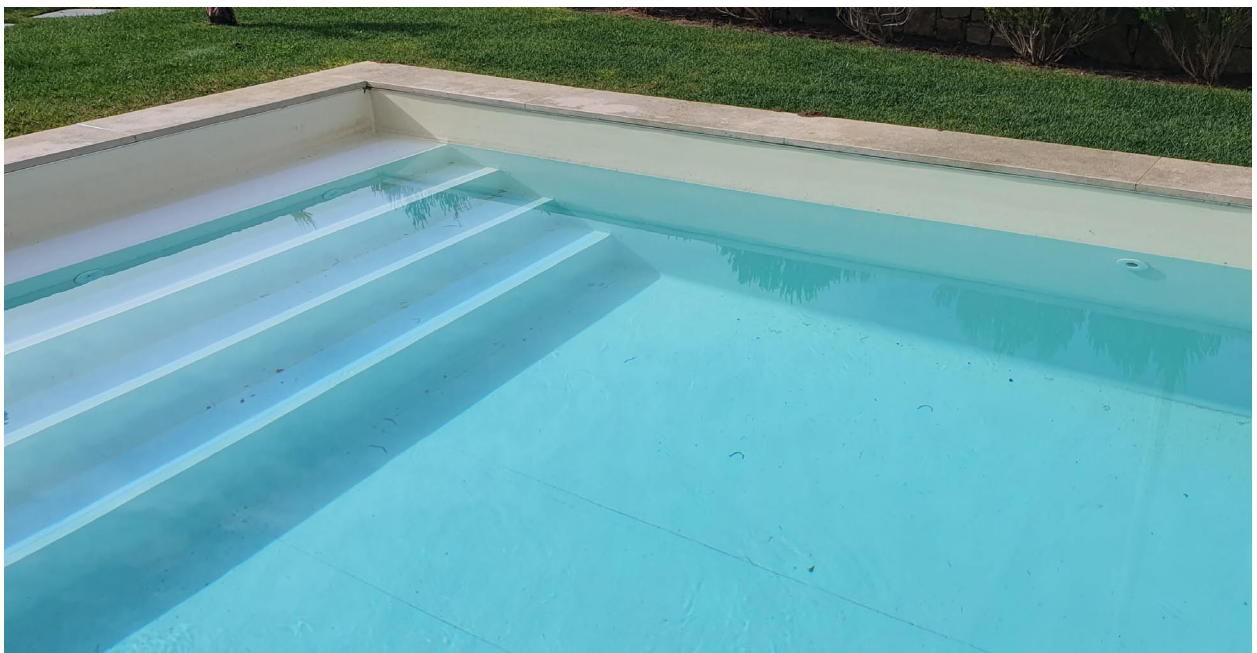
### 8.2. The leakage

The pool has a leak - water escapes from the pool.  
Despite topping up, water reaches at most the the first step of the stairs.
