# The Report

House No 9

*March 2025*

This report systematises and organises the numerous construction and workmanship errors occurring in the private residential house located in Lote 3 - Casais Porto Dinheiro.

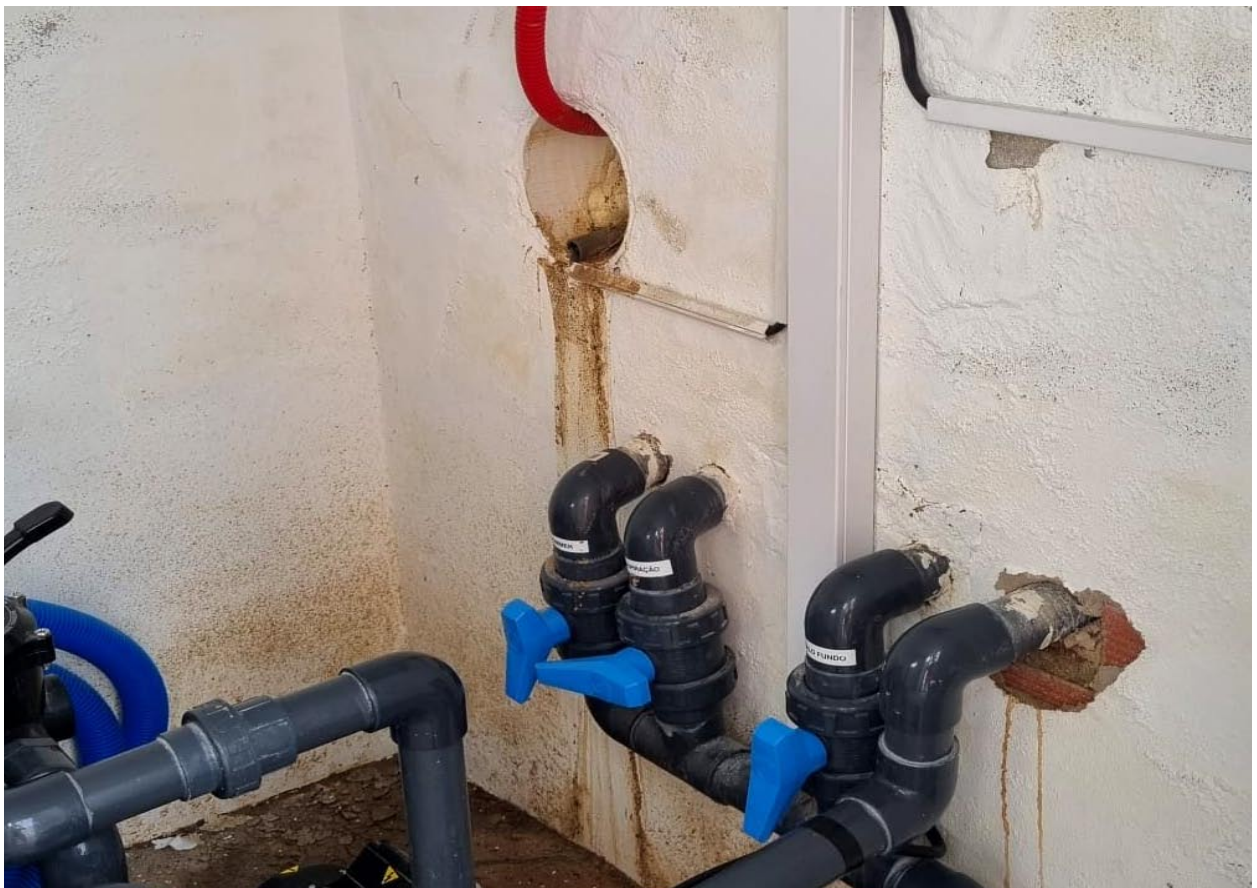
### 8.3. The pumping compartment

In the pool pumping compartment, the walls are damp and cracks are showing on the walls and ceiling. Plaster and paint are falling off the walls.

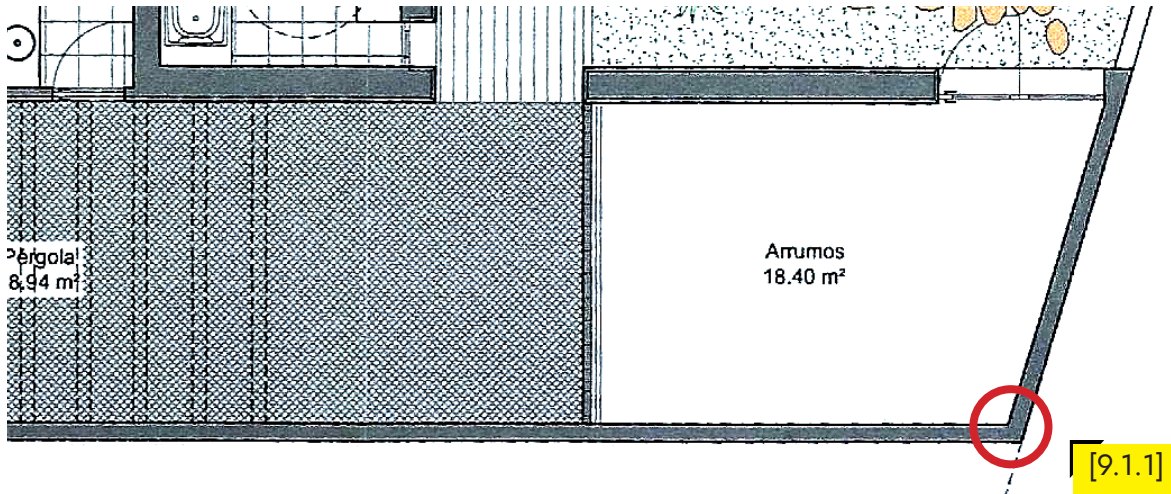
A small house is built next to the house. It is connected to the main house by a concrete pergola. A number of anomalies were discovered in this building, such as rainwater leaks from the roof, dampness in the walls, cracks in the walls.

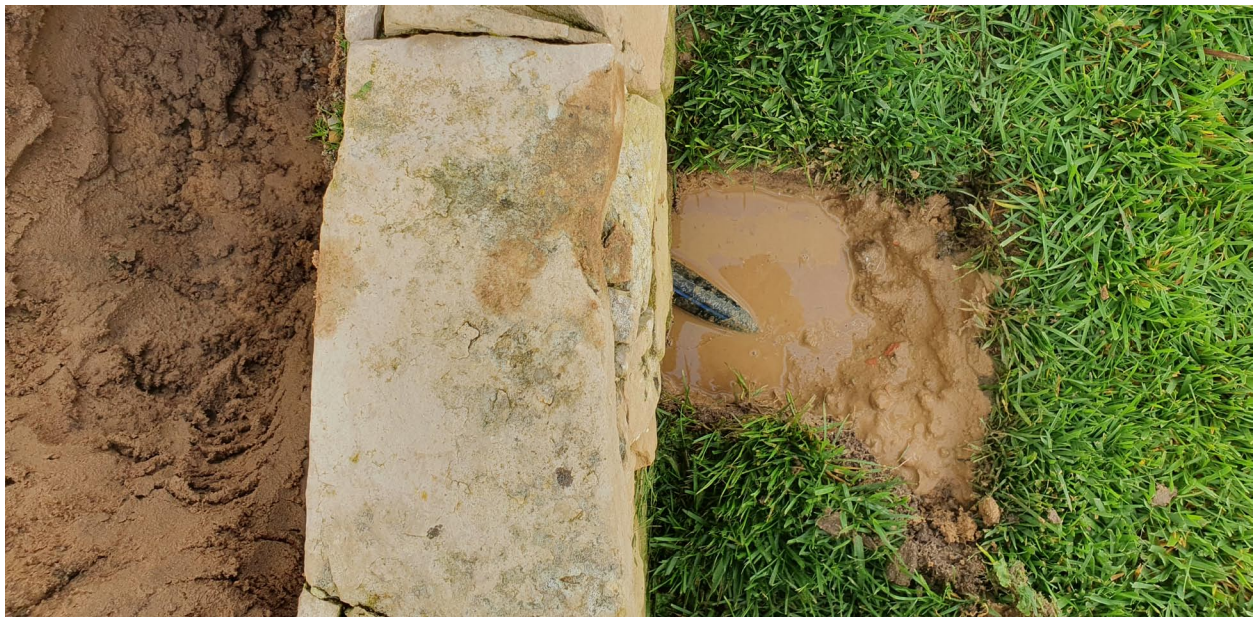
10.2.2. A water leak was detected from the main supply pipes located in the ground and repaired. The phenomenon had reduced significantly but was still present.
