# The Report

*February 2025*

This report systematises and organises the numerous construction and workmanship errors occurring in the private residential house located in Lote 2 - Casais Porto Dinheiro.

The discrepancies were identified based on the construction project of the residential building 12146/2017, hereinafter referred to as The Project.

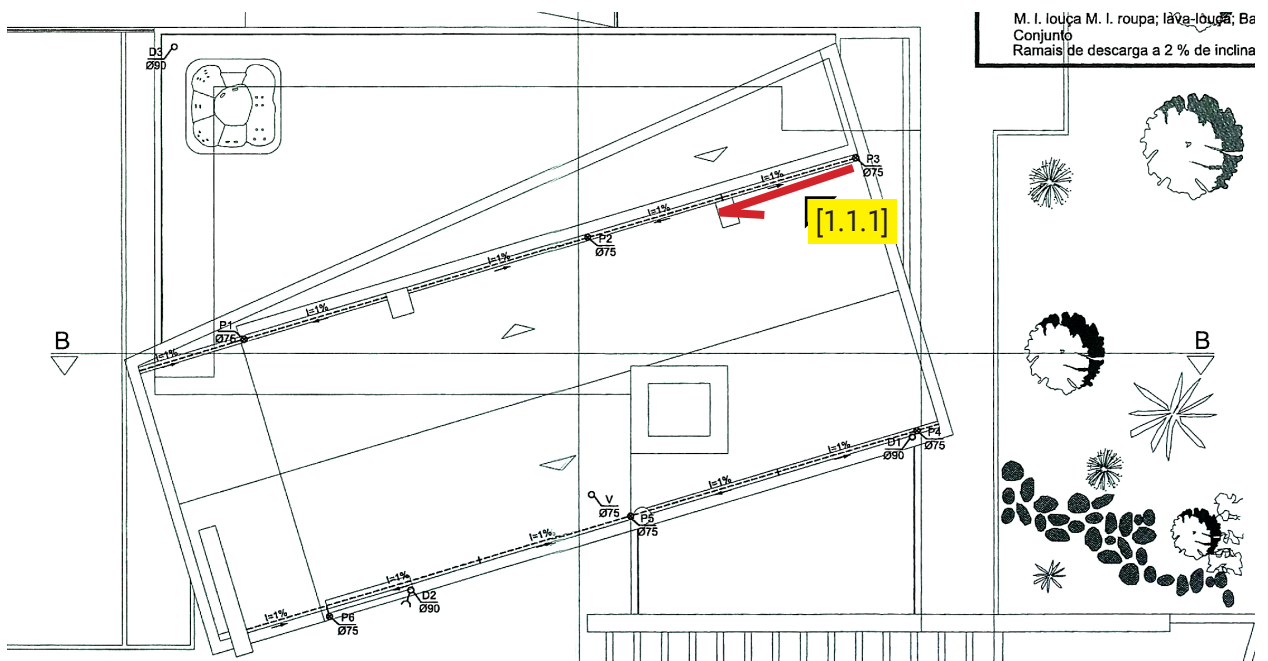
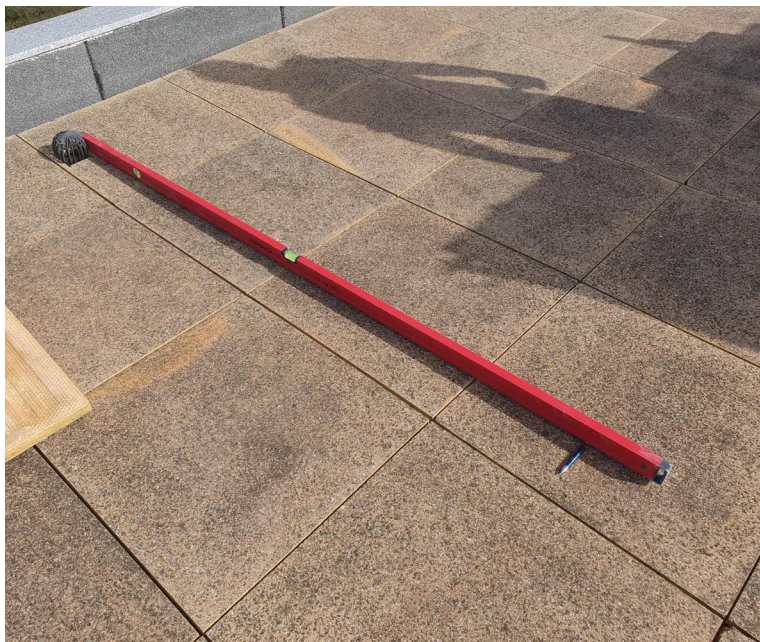
1.1.1. Roof profiling discrepancies were detected in relation to The Project. In some cases, the roof slope is the opposite of the design. Instead of a slope of about 1% towards the drain holes, a counterslope of about 0.5% was detected, which causes water to flow away from the drain hole.

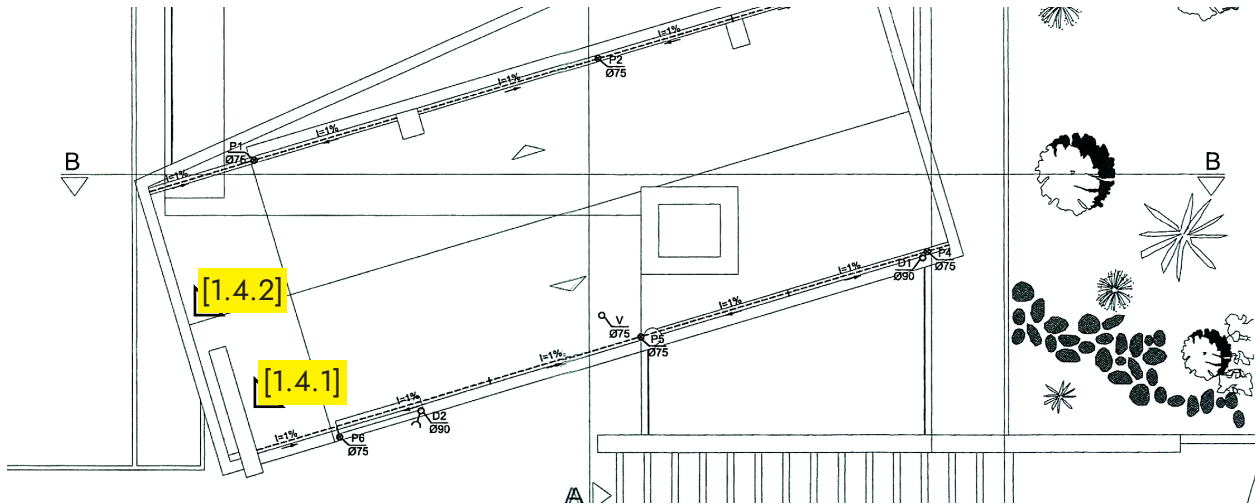
1.4.1. The orange attic wall is all ckracked on top, with vegetation and water penetration inside. Lack of wall copings.

1.4.2. The other roof attic walls have copings made of stone, with many defects also lack of the grout on connections, improper connection with orange plastered wall and even a wooden dowel left behind.

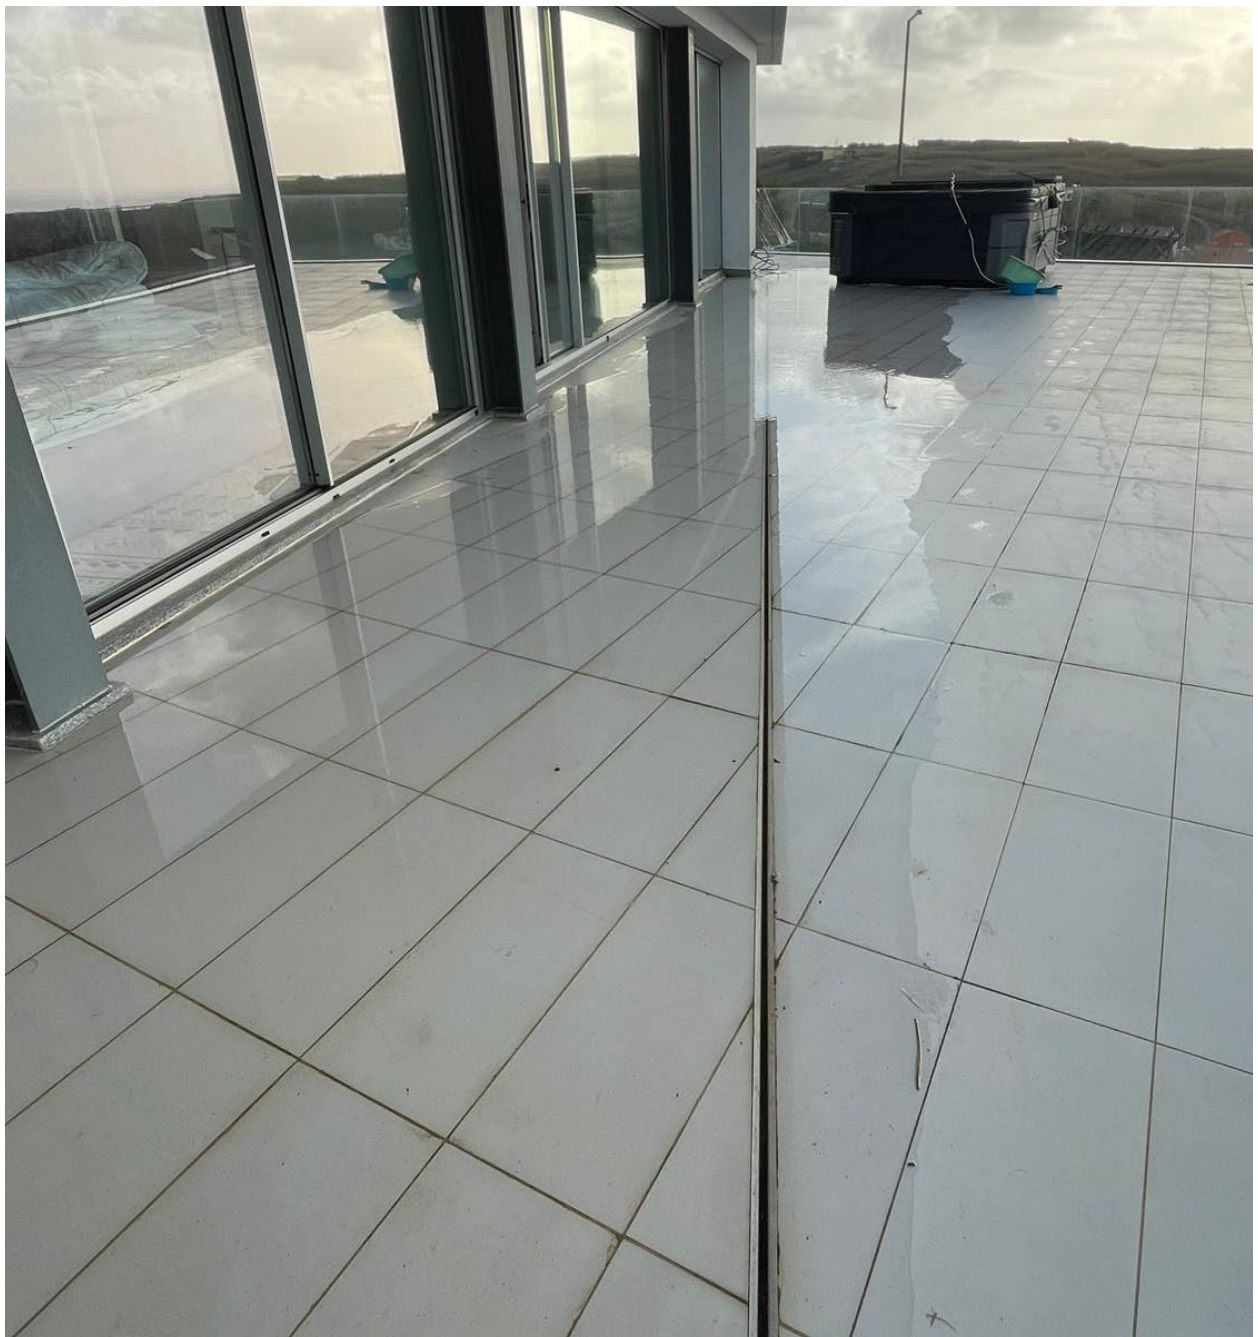
On the day of the inspection, a significant amount of water was found ponding on the terrace and numerous floods in the rooms below, as discussed later in the report.

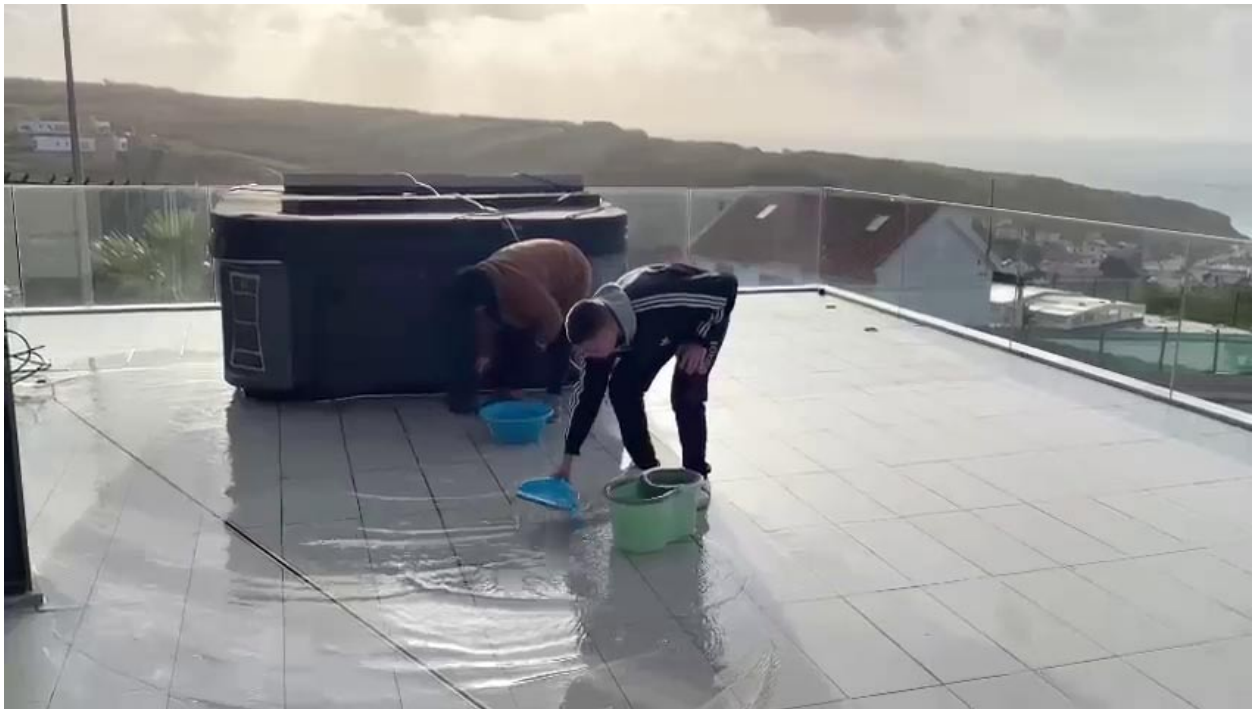
Despite exposing the drain hole and many attempt to unclog it, the water stored on the terrace could not be drained.

It was necessary to mechanically remove the water from the terrace.

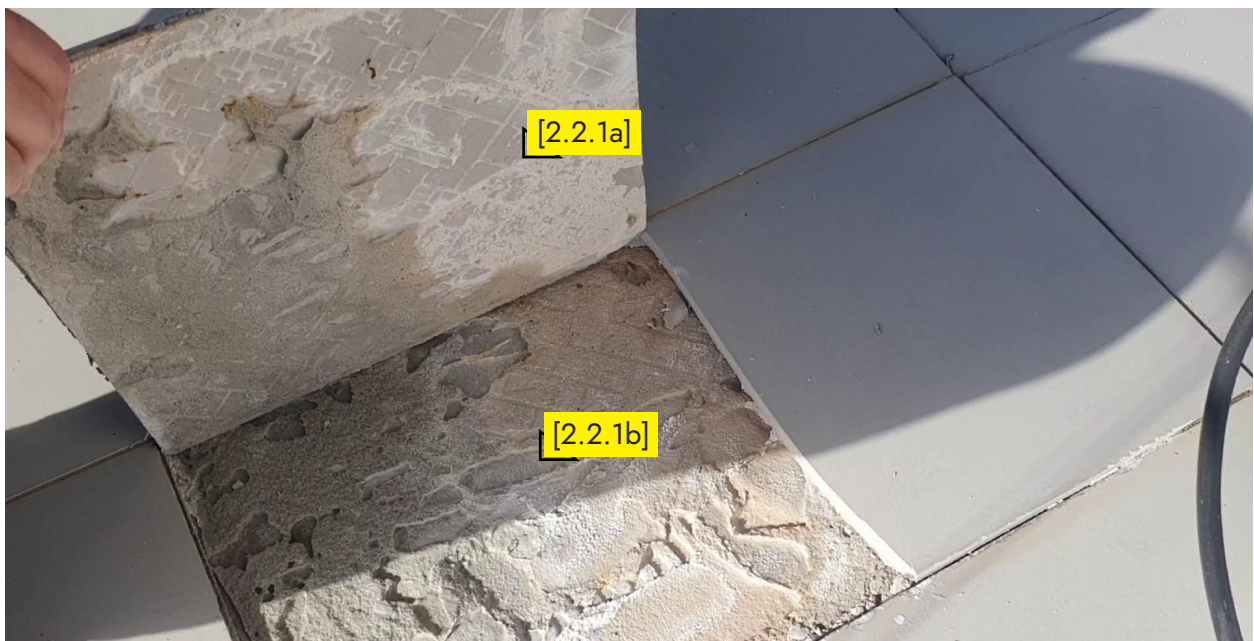
The adhesive mortar is not bonded to the tile over a significant area [2.2.1a]. Insufficient adhesive and voids between the adhesive layer and the tile are revealed [2.2.1b].

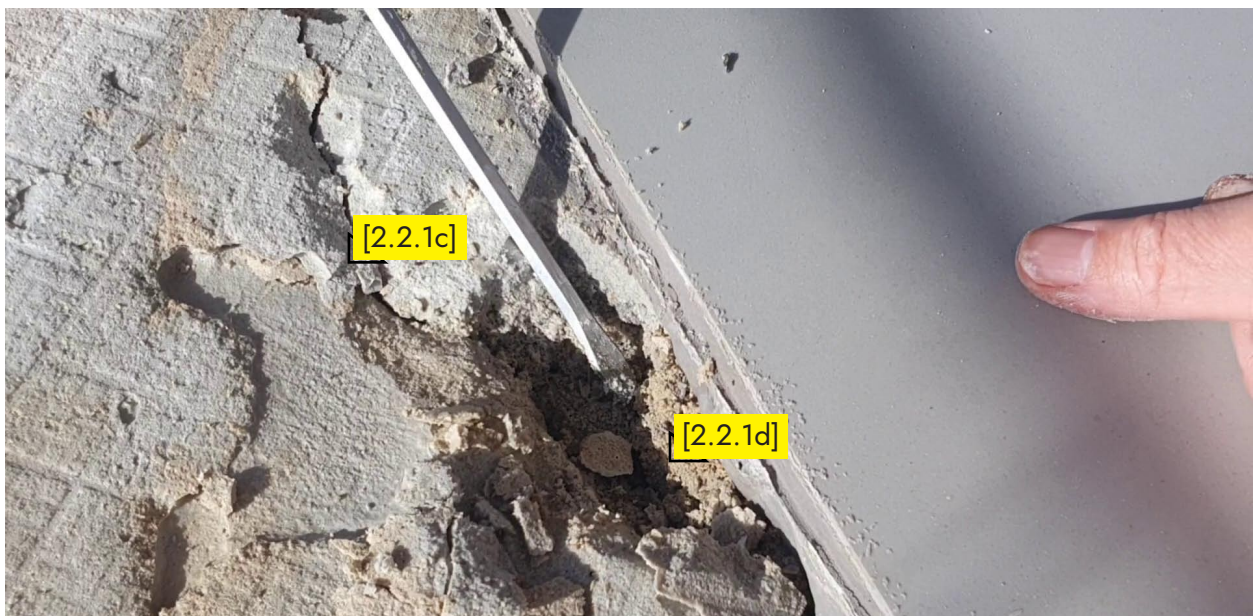
The adhesive layer under the tile was patchy and very cracked [2.2.1c]. The tile adhesive was very brittle and came off easily when undermined with a screwdriver [2.2.1d].

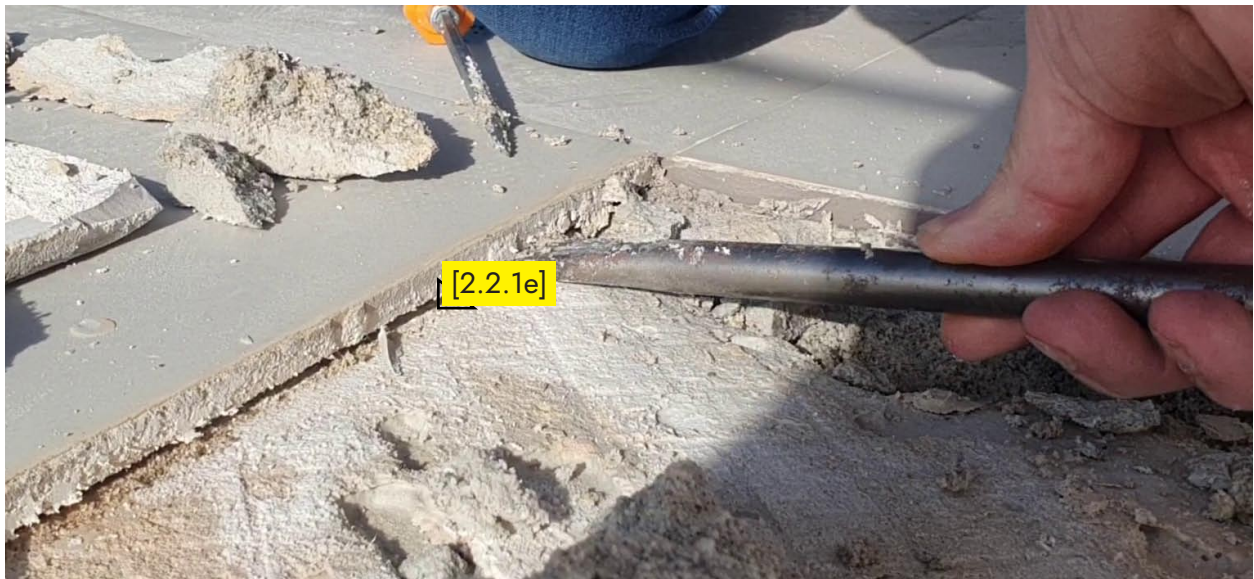
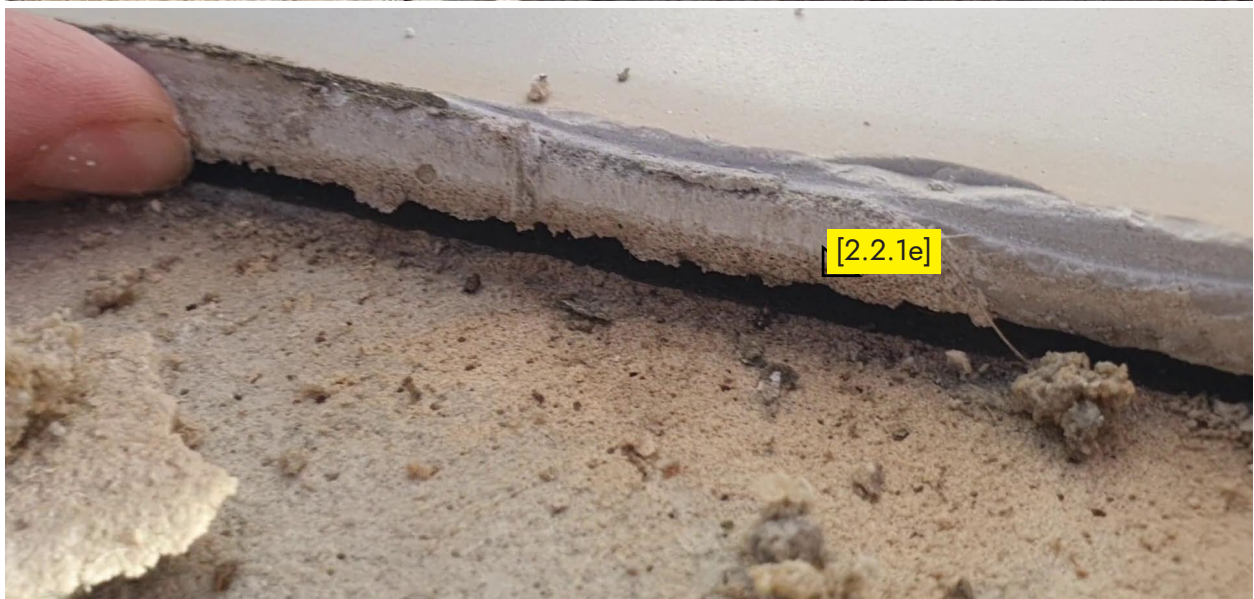
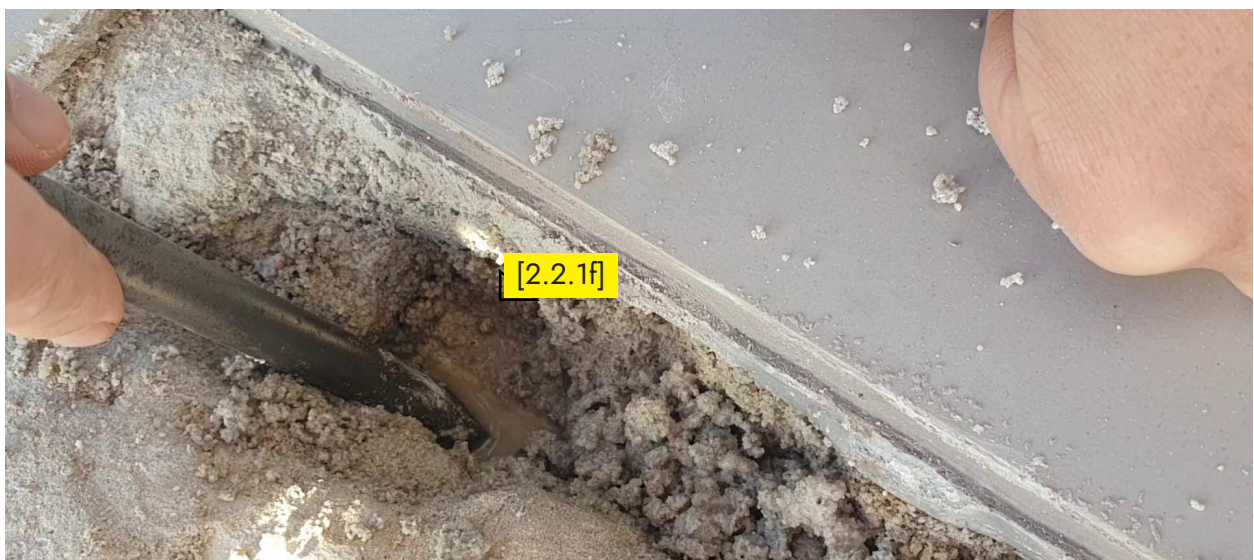
The adjacent tiles were also poorly attached to the substrate and could easily be undermined and torn off [2.2.1e].

Once the adhesive was easily removed, the xps foam layer was exposed and water appeared in the hole [2.2.1f].

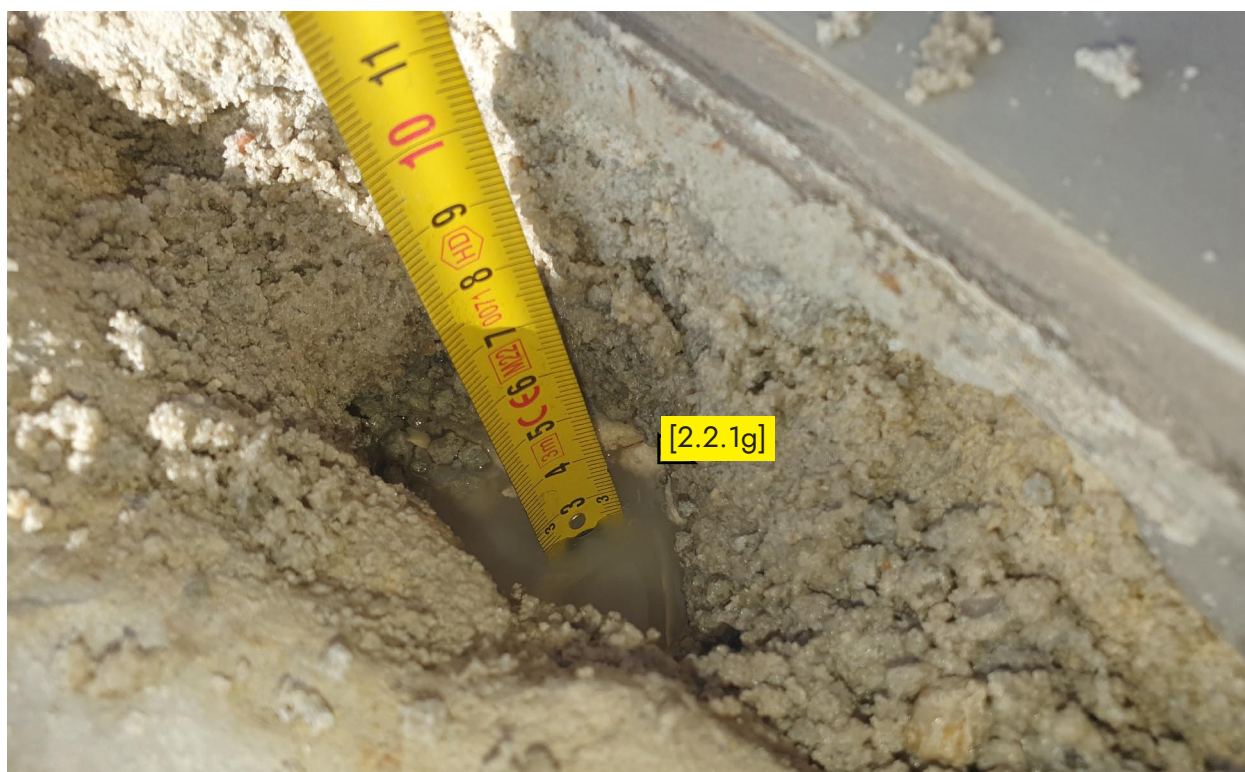
No waterproofing was found to protect the screed from water penetration.  
A water layer of approximately 30 mm was found in the xps insulation, directly on the floor slab [2.2.1g].

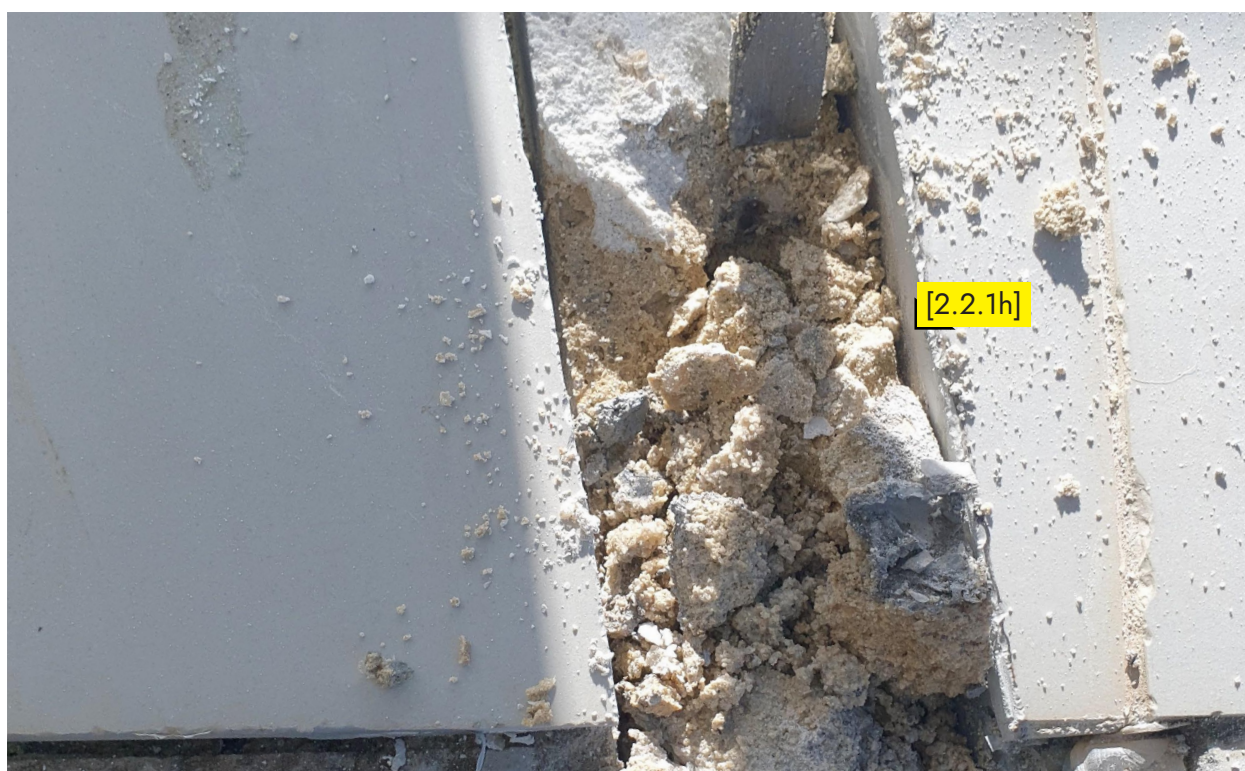
The adhesive layer was exposed elsewhere on the terrace and the situation was very similar: the mortar was very crumbly, non-cohesive and crumbled very easily in the hands. In colour and texture it resembled wet sand [2.2.1h].

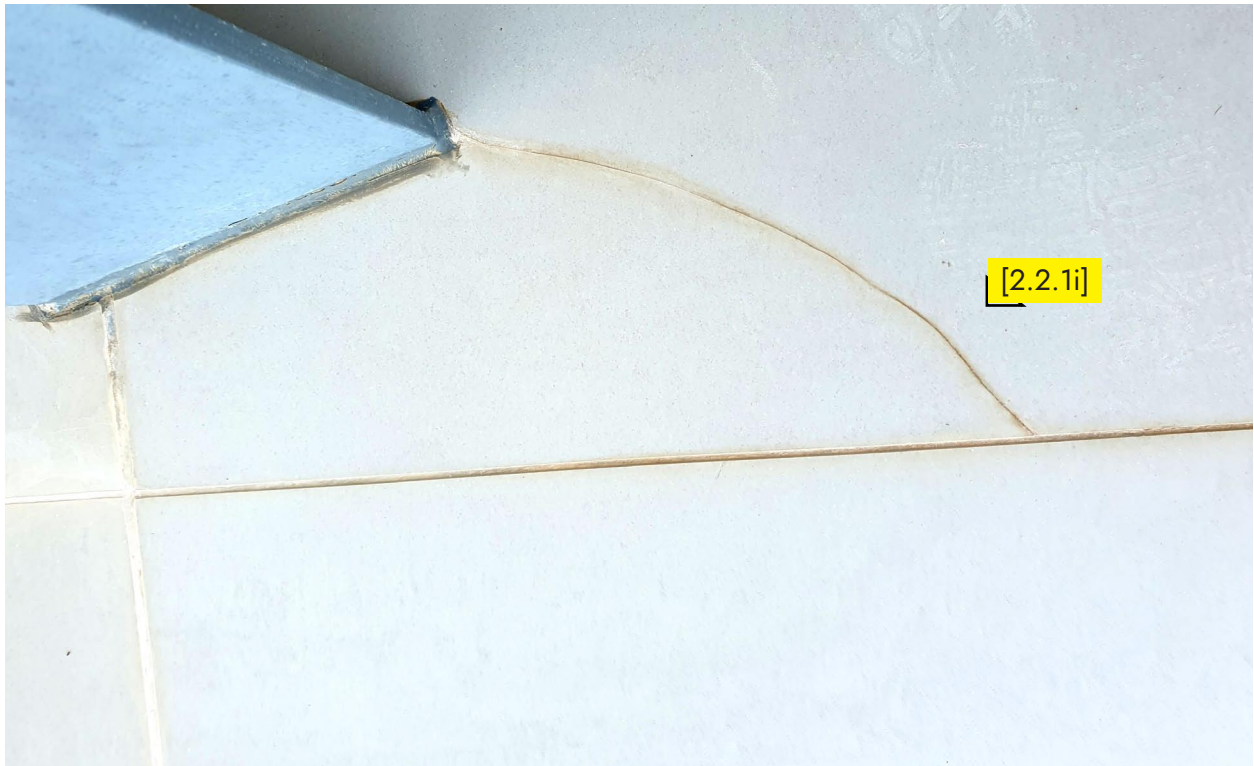
Stress cracks were found in the tiles around the steel pillars of the buildings' superstructure [2.2.1i].

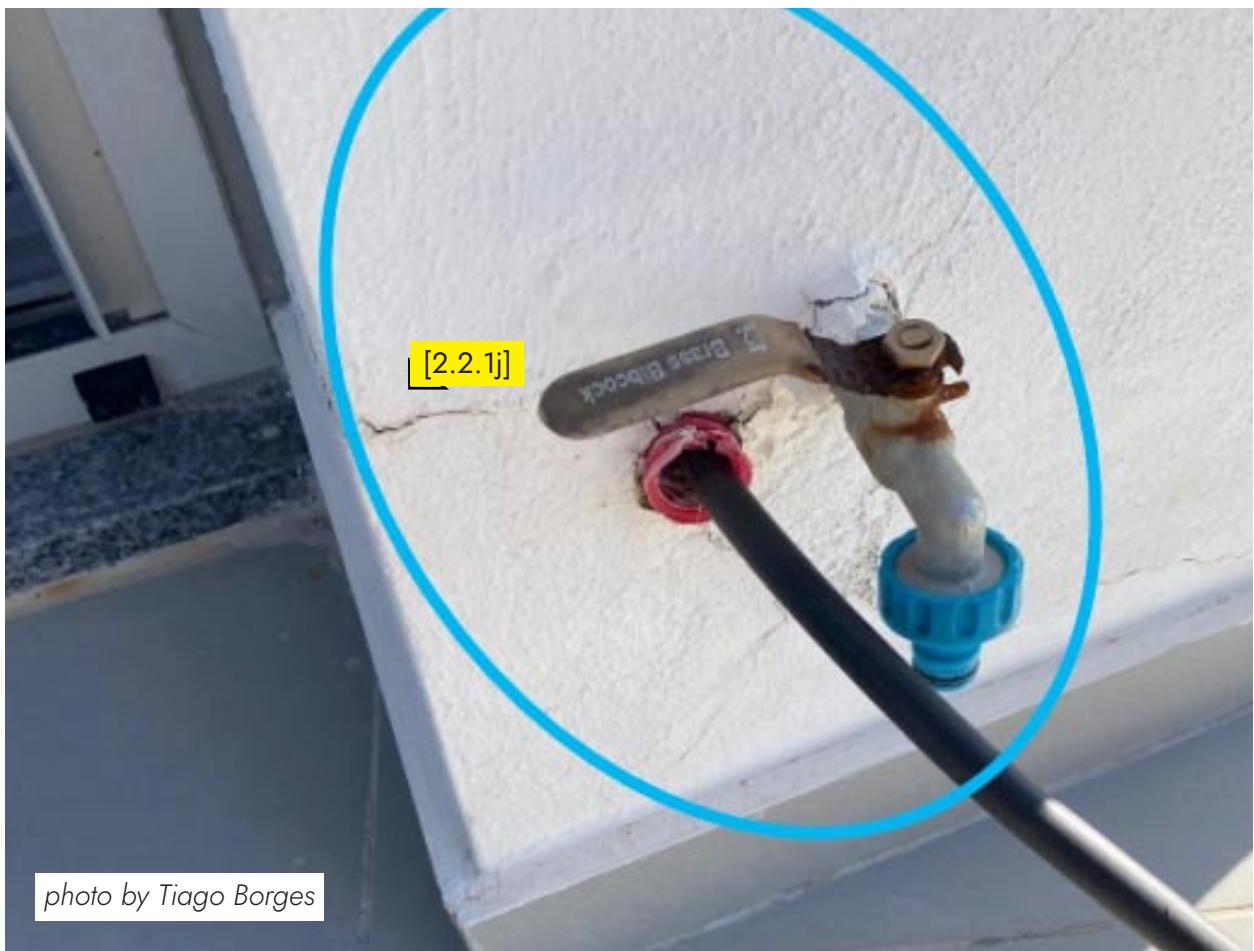
Stress cracks in the area of the connection between the terrace and the wall [2.2.1j].

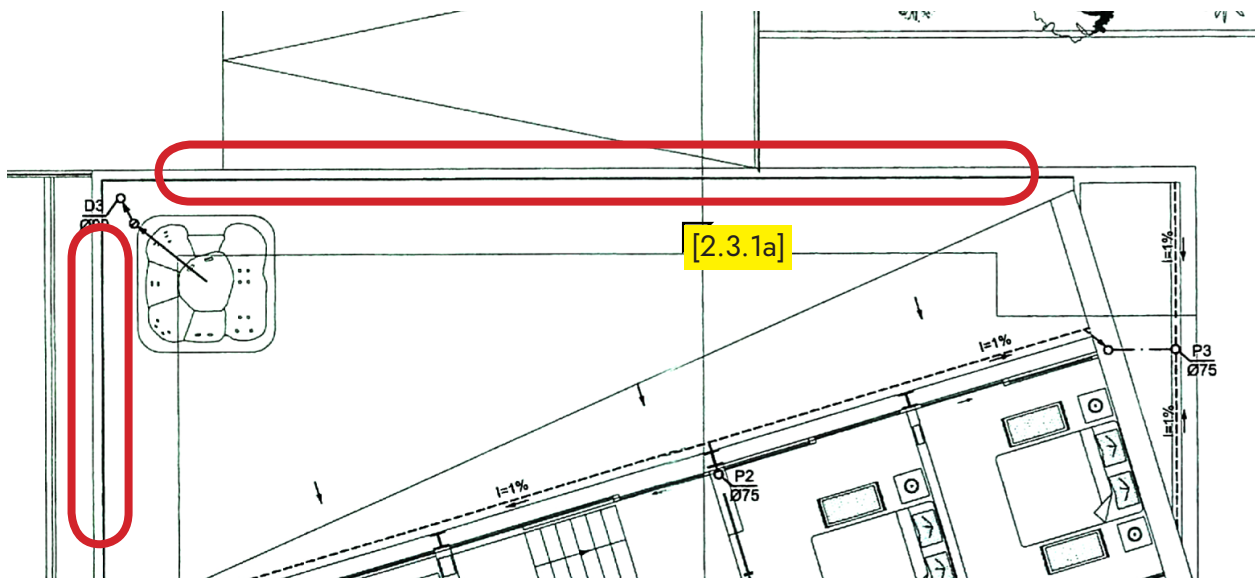
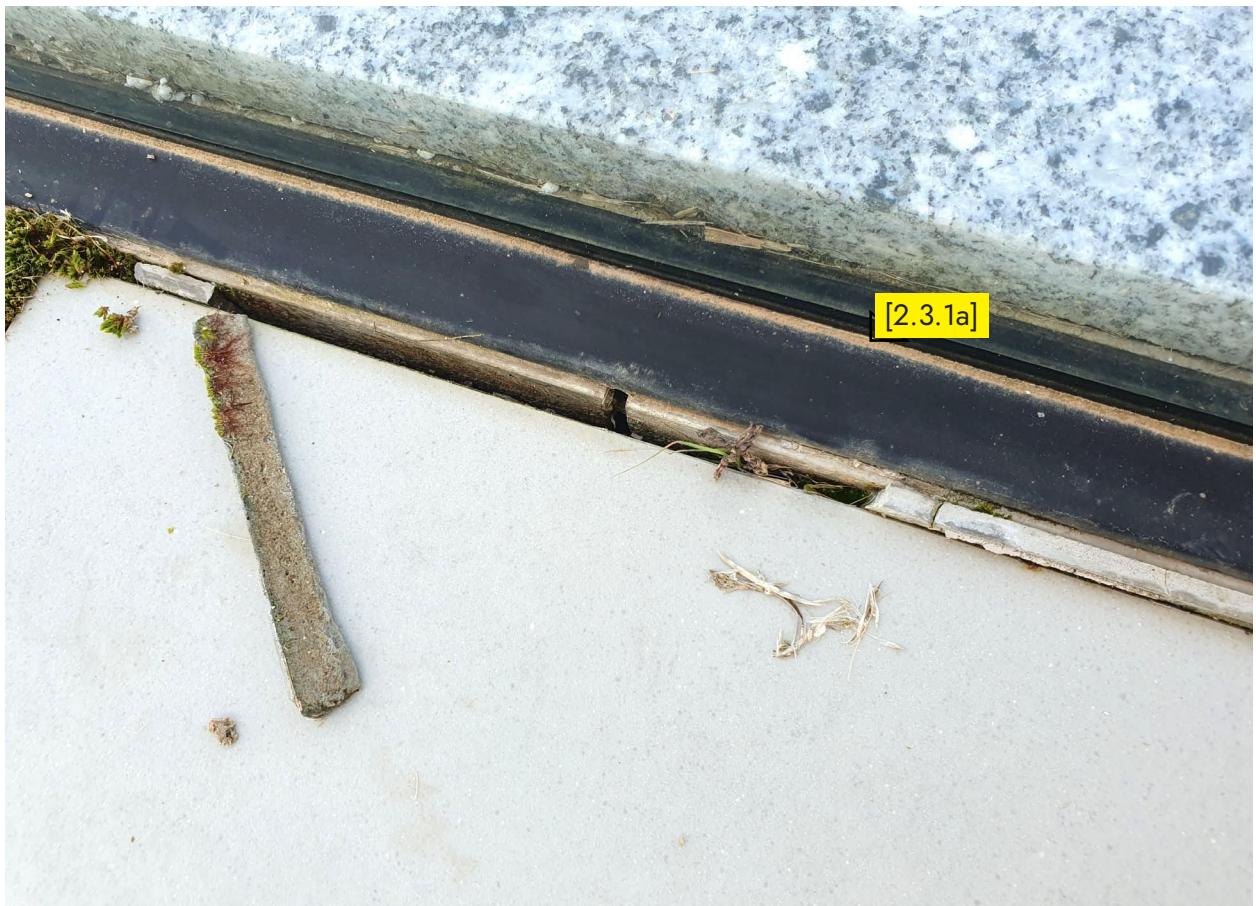
2.3.1. Numerous cavities and discolouration in the tile grouts were found on the overall terrace surface. There are many visible instances of grout erosion [2.3.1b].

The connection between the terrace surface and the balustrade is cracked or absent in many places. This creates the possibility of water penetrating into the balustrade attachment points and further erosion. Numerous vegetation can be seen nestled in the cracks [2.3.1a].

The connection between the balustrade and the terrace should be both watertight flexible.

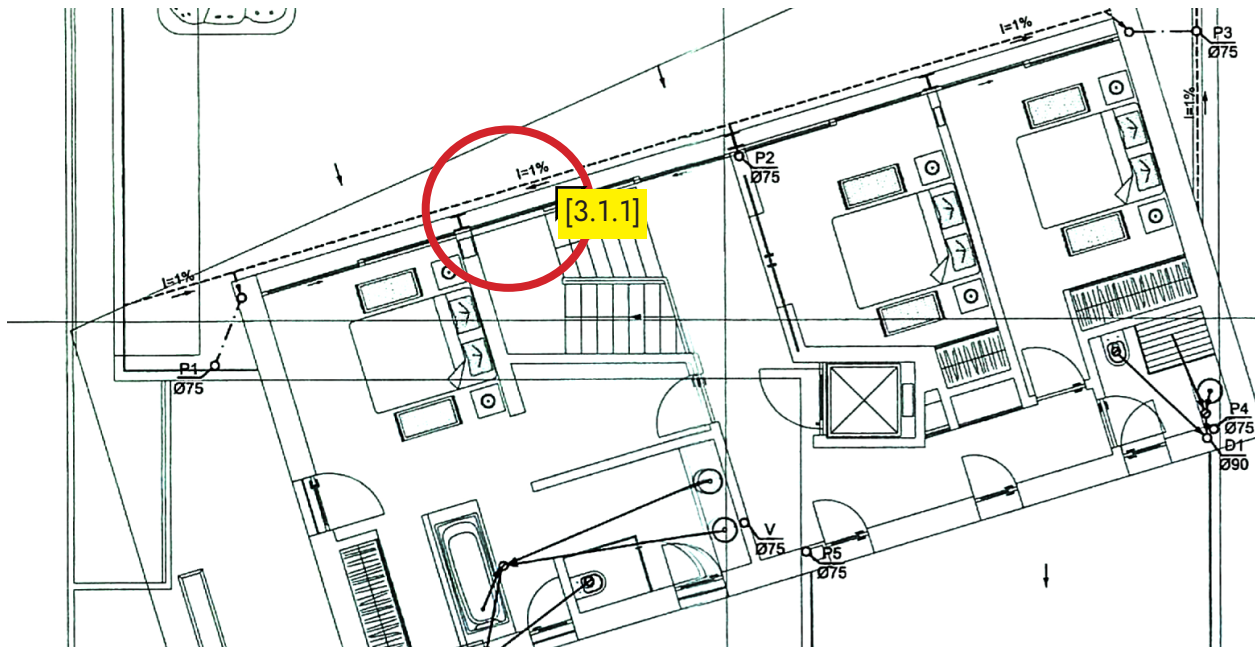
Using a thermal imaging camera, dampness was detected in the west wall of the stairwell [3.1.1a]. Discolouration, cracks, paint chipping and plaster degradation can be seen in the area where the terrace floor slab meets the wall [3.1.1b].

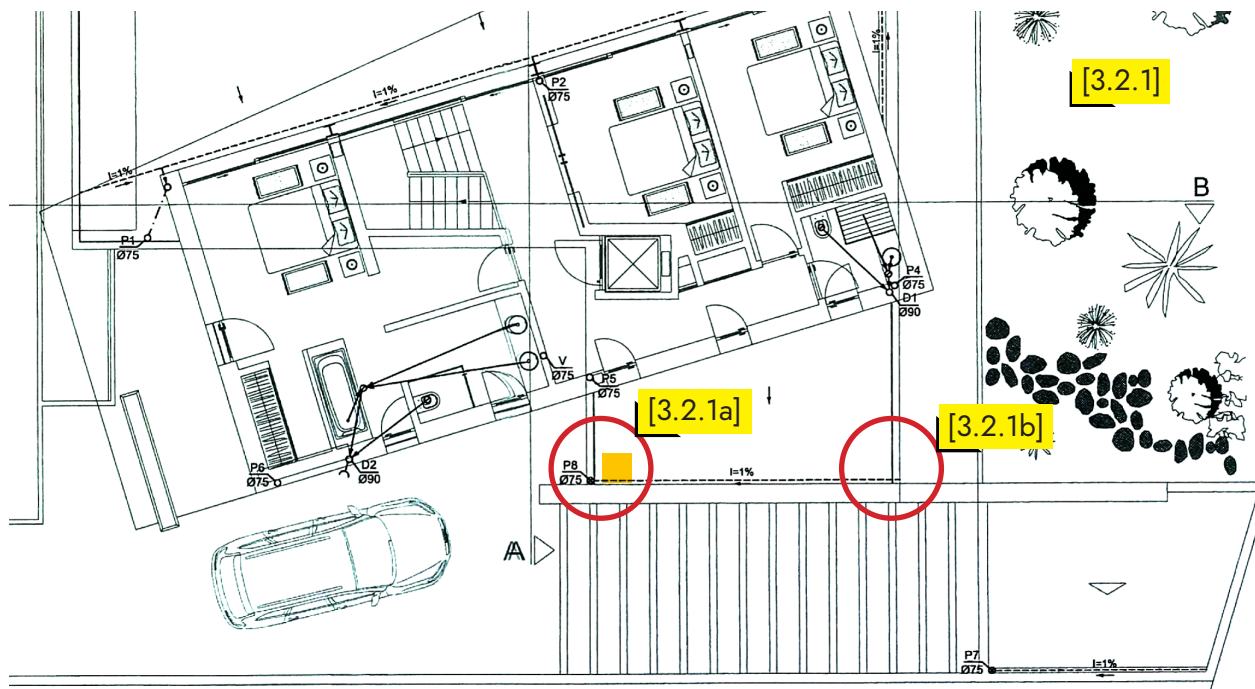
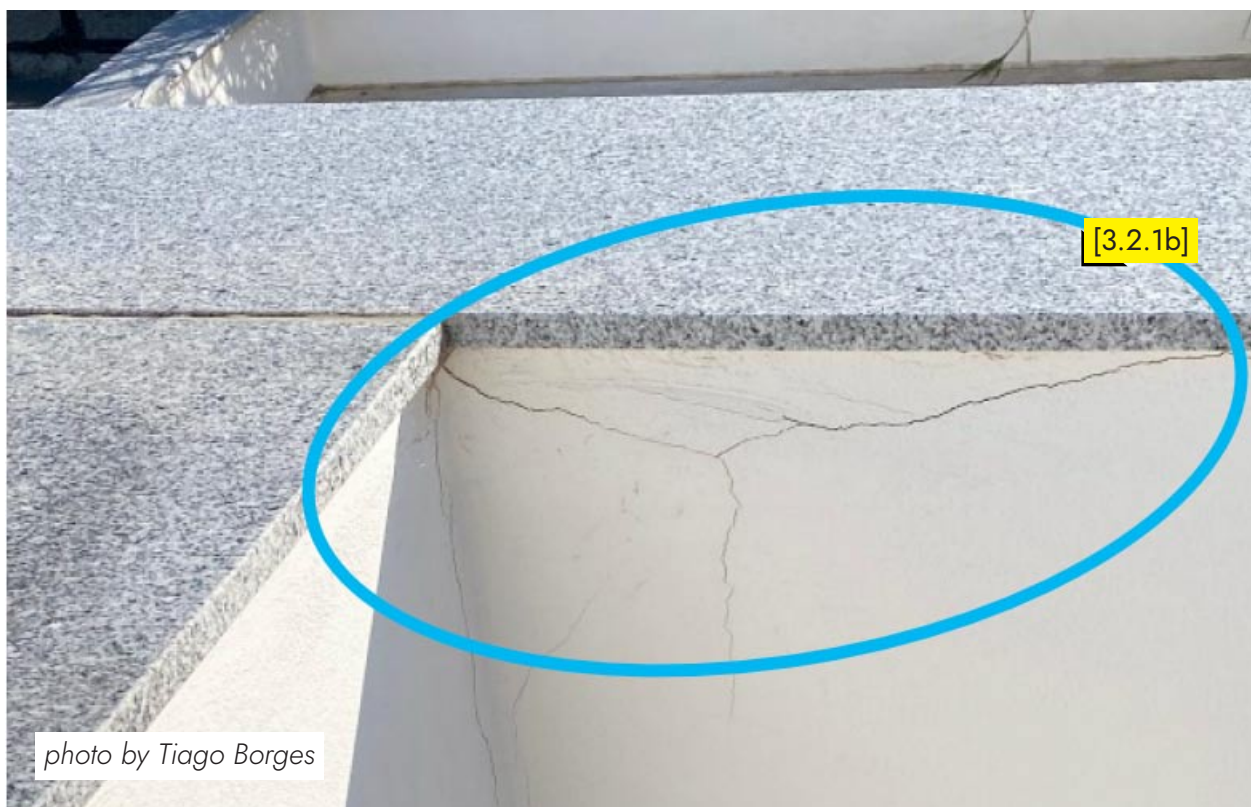
Cracks in the masonry fence of the balcony [3.1.1b].

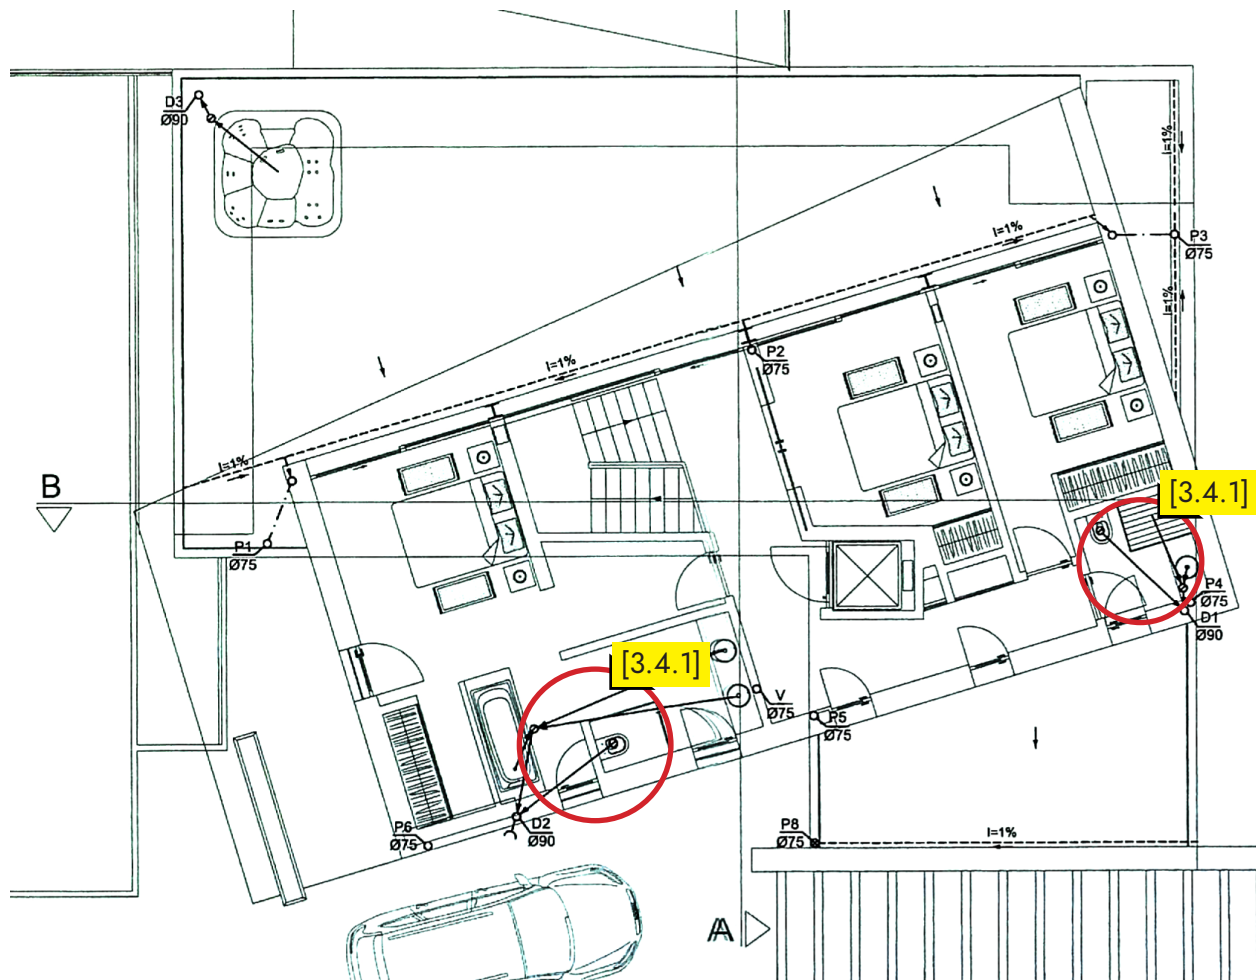
In the upstairs bathrooms [3.4.1], hot water does not appear until about 4 minutes after turning on the tap. This causes a wait and wastes a considerable amount of water, which uselessly flows down the drain during this time.

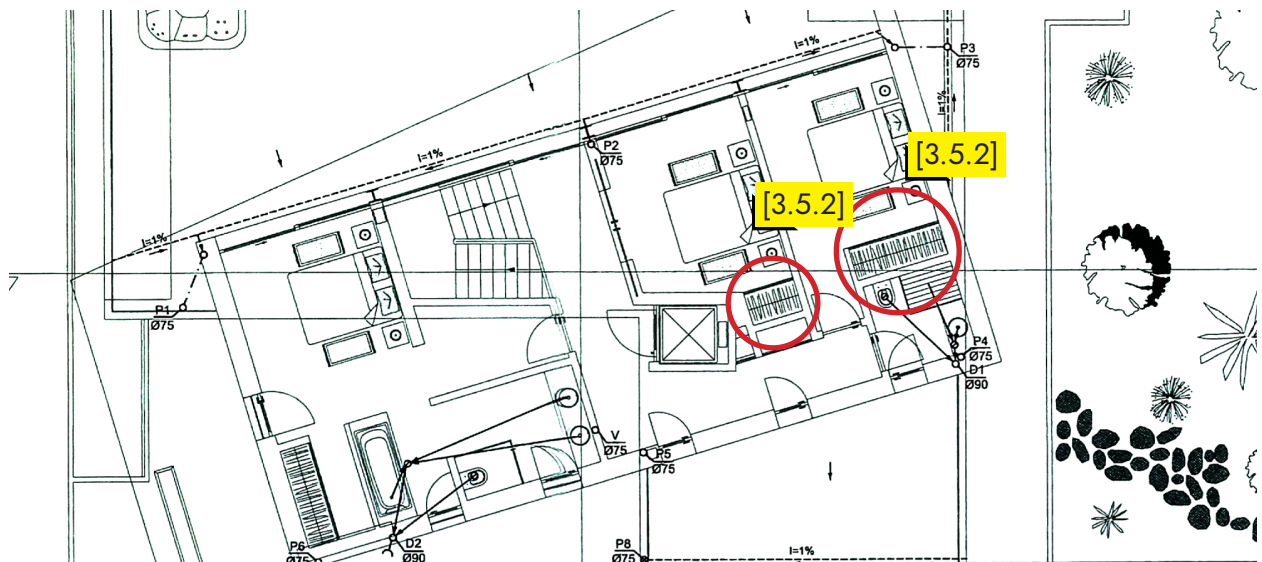
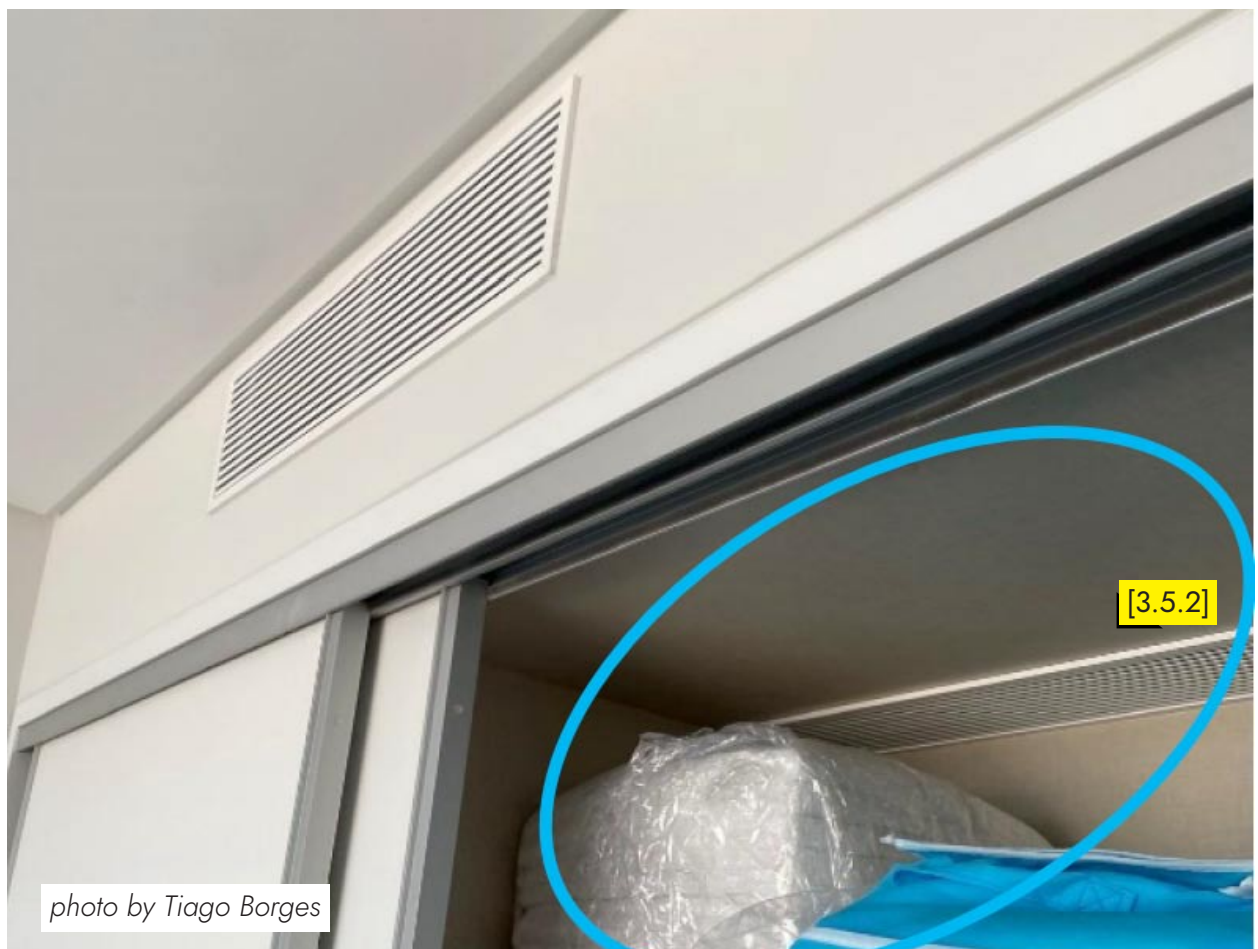
3.4.1. On the first floor, three air-conditioning systems were installed built-in in the walls, the false ceiling and in the wardrobes. None of them has an inspection opening to access the junction box. In the event of a malfunction or the need to make adjustments, it will be necessary to drill a hole in the wall or dismantle the wardrobe.

3.4.2. In the two bedrooms on the north side of the house, the air conditioners have air intakes hidden in lockable wardrobes. For this reason, it is impossible to use them properly. For the air conditioner to work effectively, the wardrobe doors must be open.

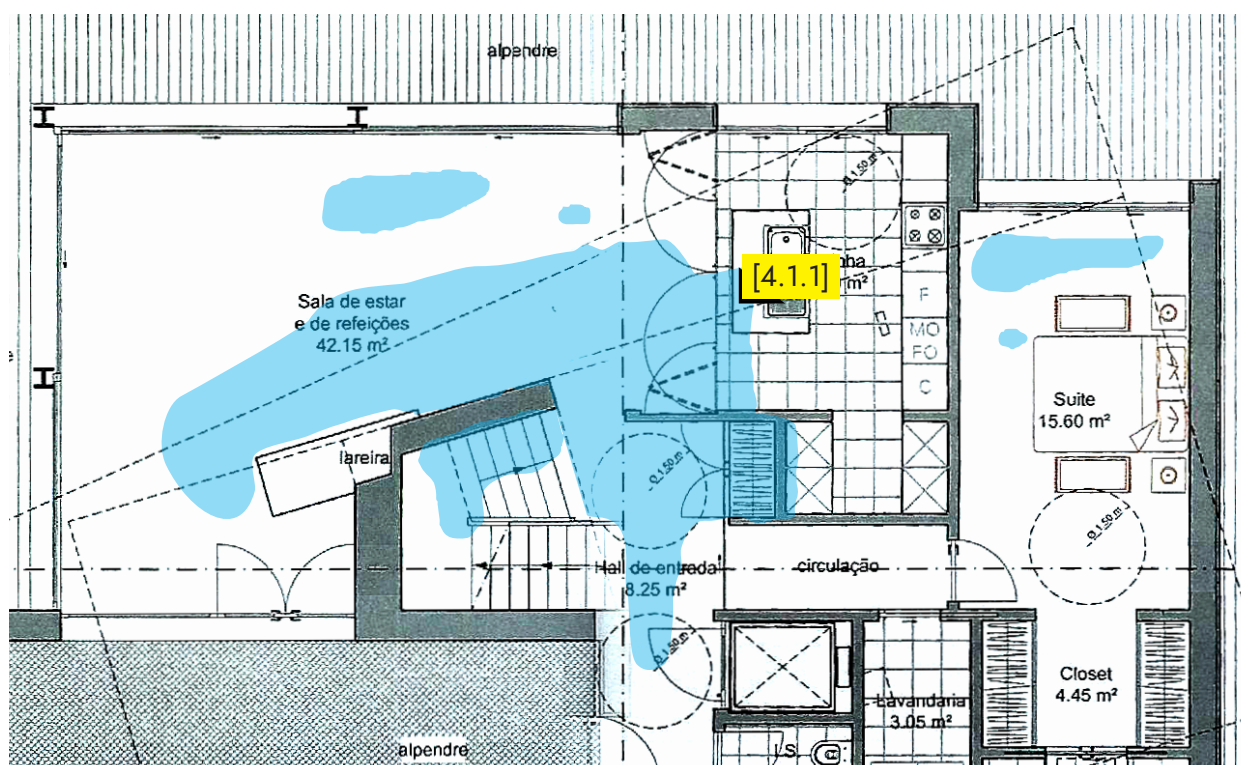
The following are the extent of the flooding that occurred in January and February 2025. The presence of water in the building's structure and equipment was determined by direct visual inspection, images from the endoscopic camera and images obtained from a thermal imaging camera. The projection below shows the areas affected by flooding including floors, walls, ceilings, furniture, wardrobe and light fixtures.
