# The Report

*February 2025*

This report systematises and organises the numerous construction and workmanship errors occurring in the private residential house located in Lote 2 - Casais Porto Dinheiro.

The discrepancies were identified based on the construction project of the residential building 12146/2017, hereinafter referred to as The Project.

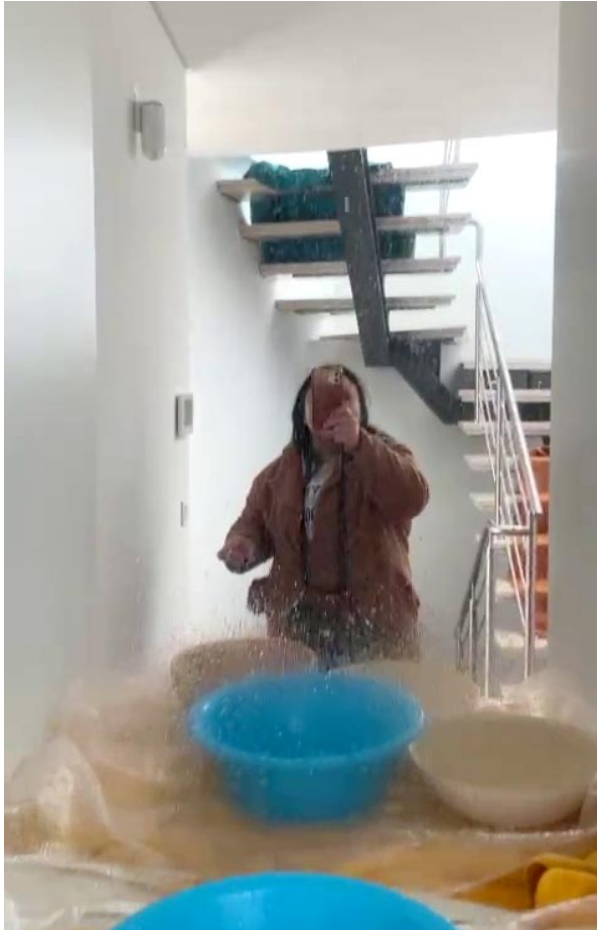
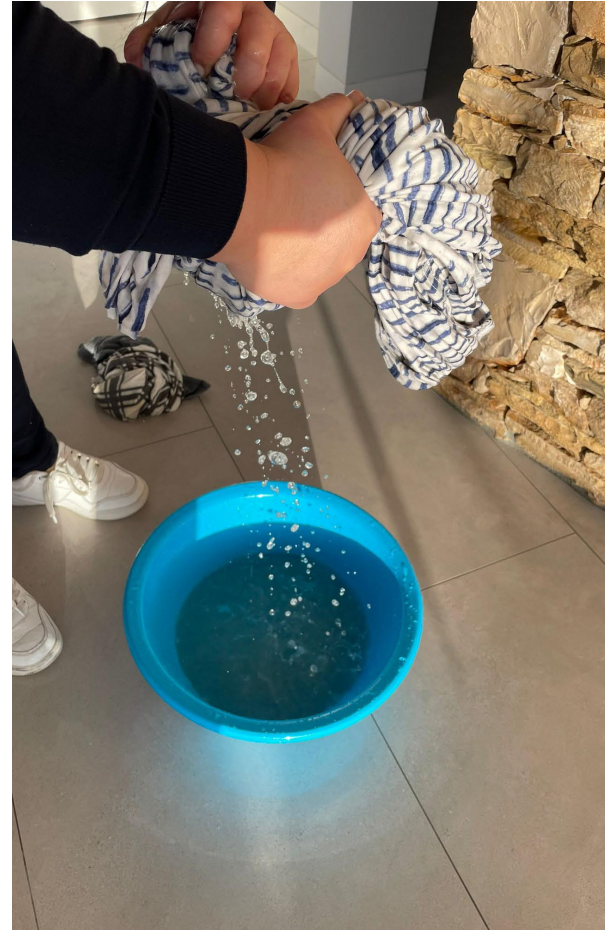
Rainwater flooding on January 2025

A consequence of the leaking terrace is the repeated flooding of the kitchen and living room with rainwater. On a number of occasions, water was observed dripping down the stone wall in the middle of the living room, water dripping from lamps suspended above the table, water dripping from light fittings on the ceiling [4.1.2a].

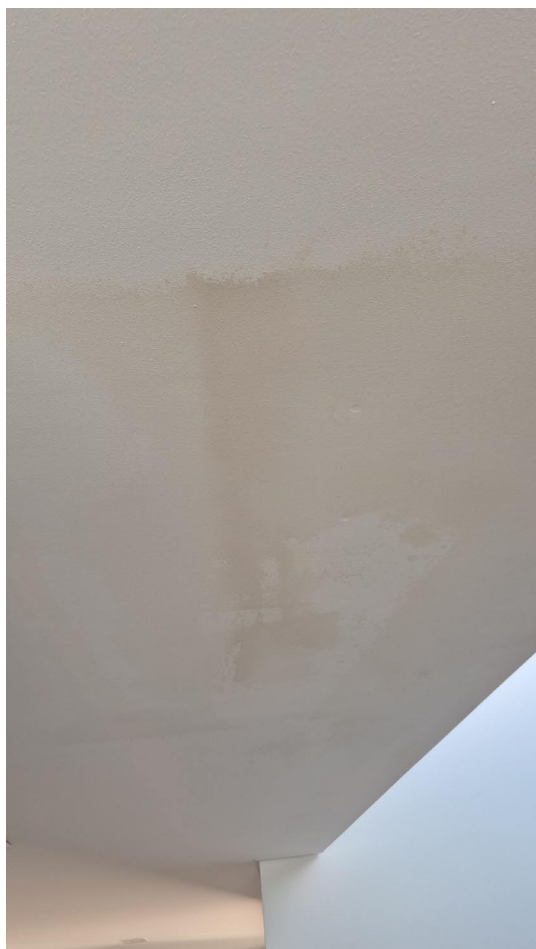
Stains on the corridor ceiling.

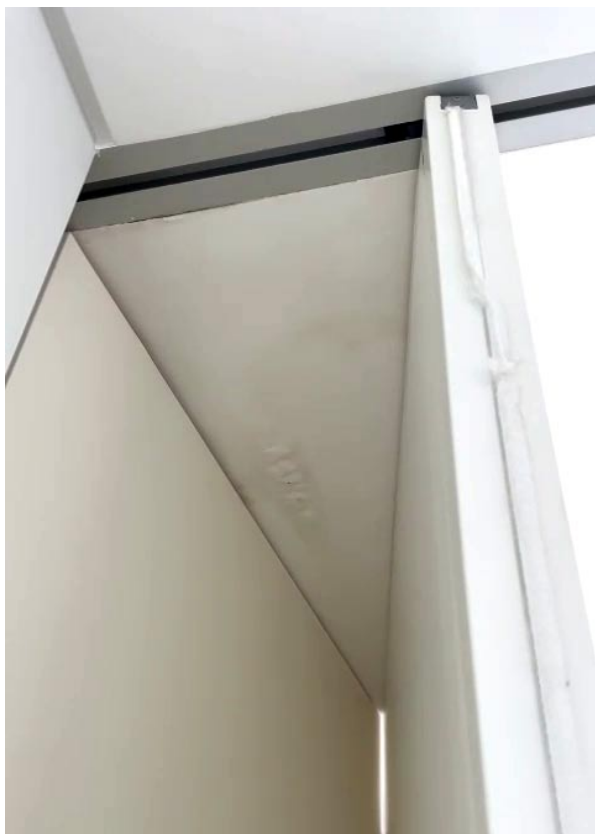
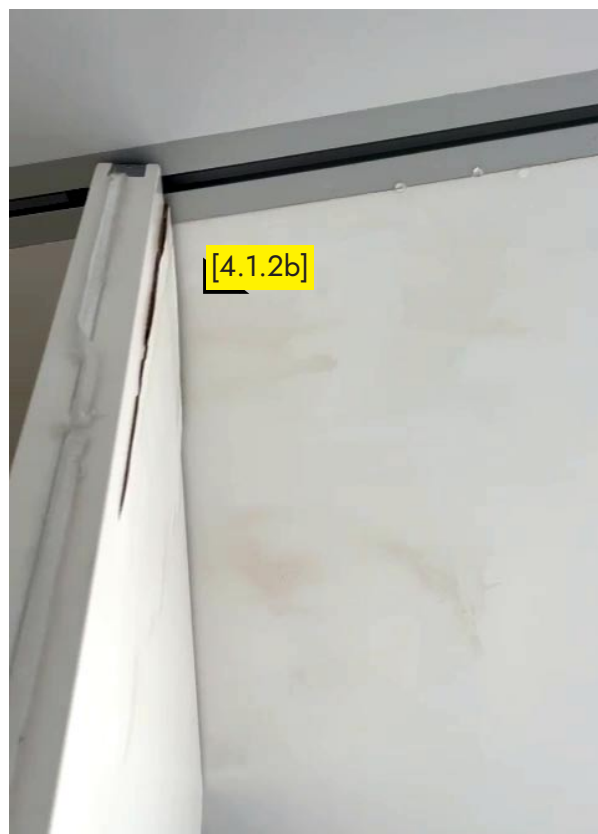
Bulged sliding doors in the kitchen.

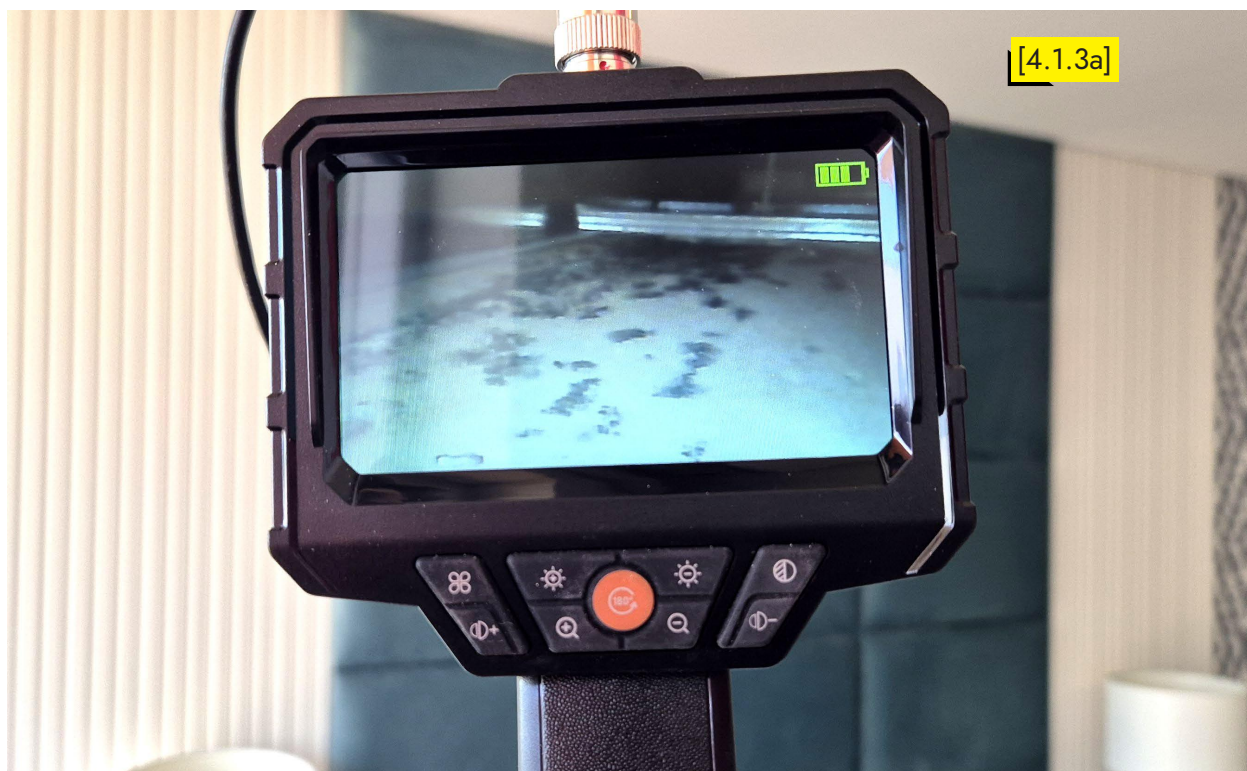
Moisture was found in the suspended ceiling of the bedroom during the inspection. Numerous mould colonies were detected on the ceiling and in the recess for the roller blinds [4.1.3a].

Endoscopic image of the suspended ceiling surface. Mould colonies are visible.

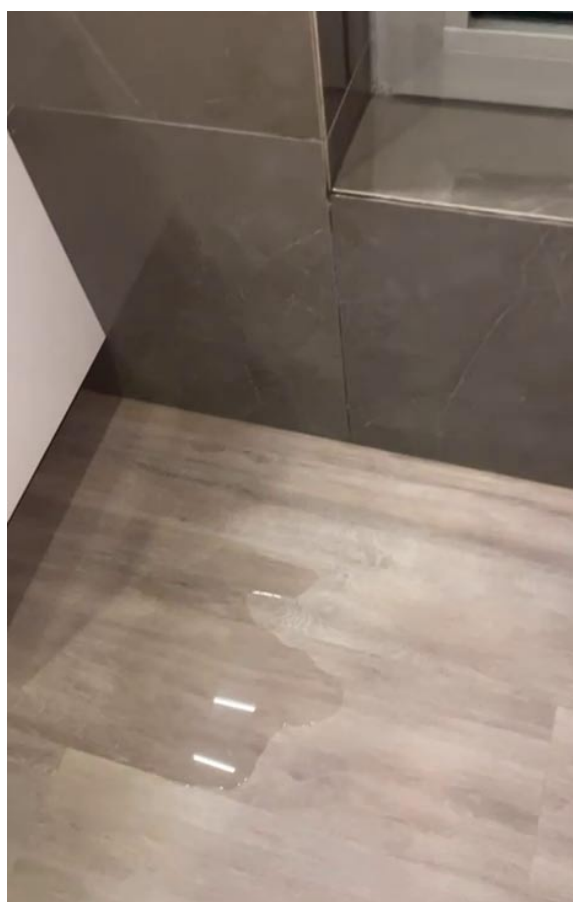
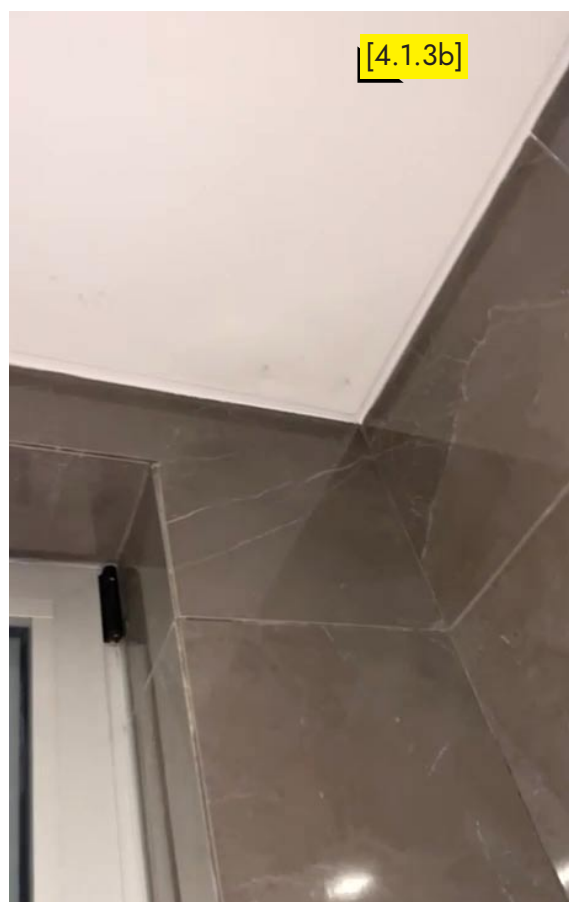
In the bathroom adjacent to this bedroom, there were repeated leaks on the ceiling and water collecting on the floor during rains. [4.1.2b].

Leaks in the nearby bathroom

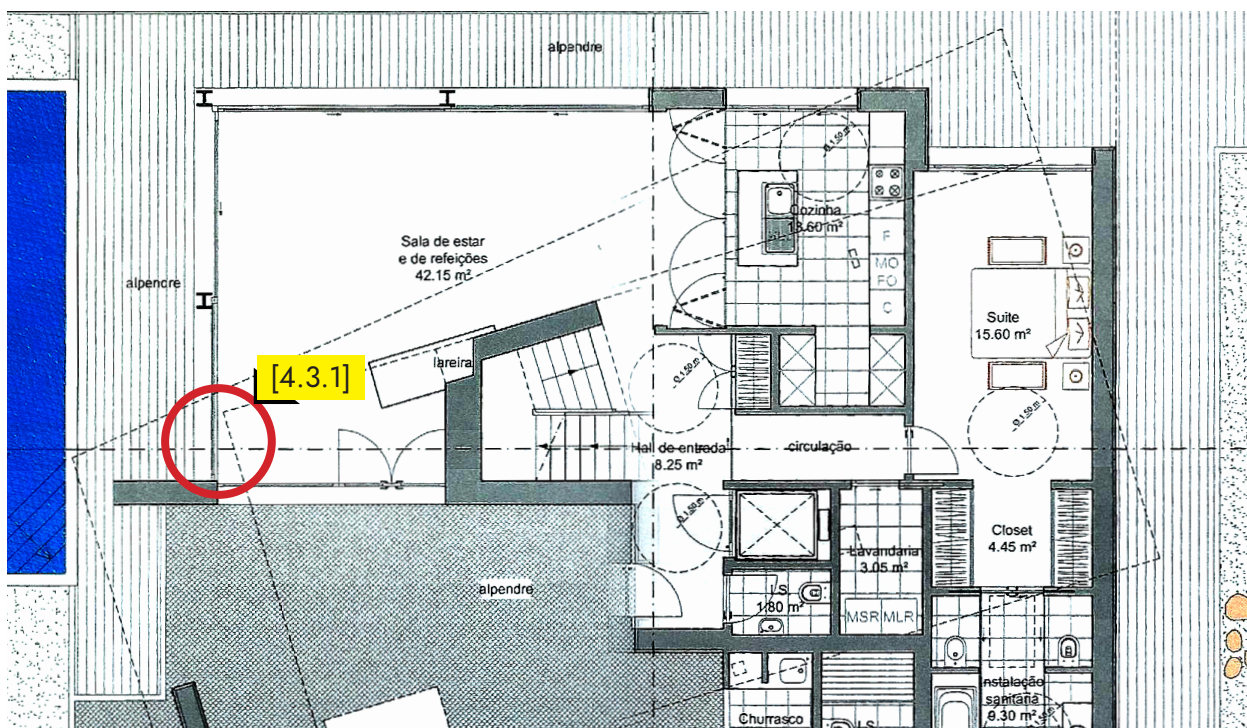
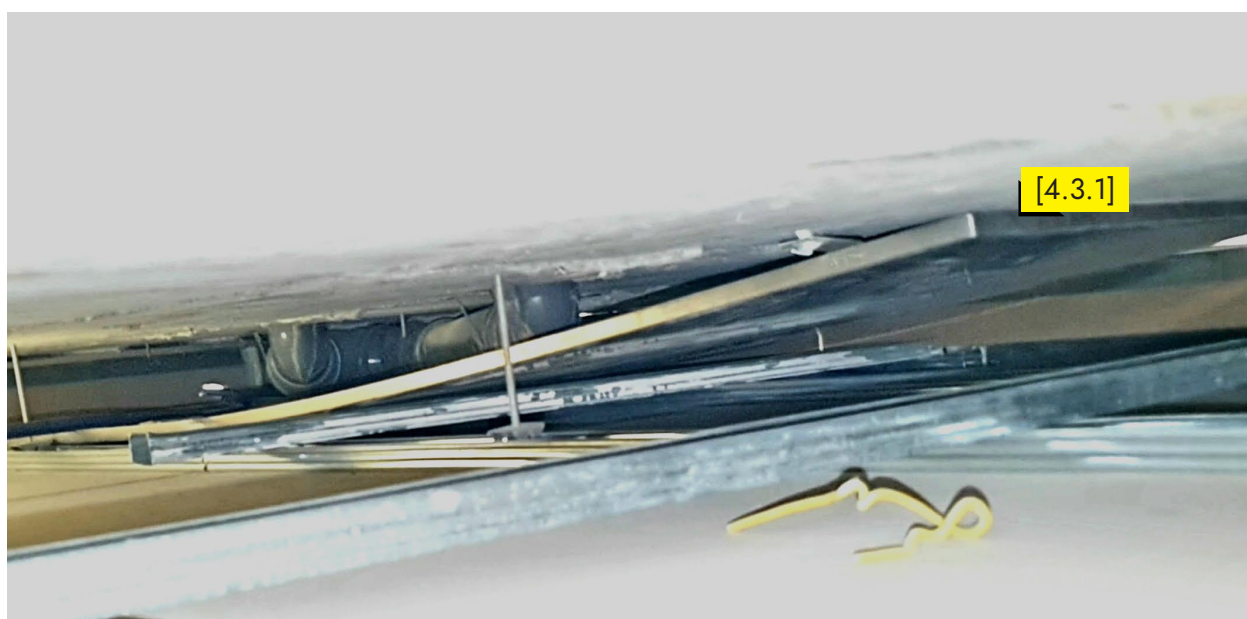
The tray is located underneath where the roof and terrace drainage pipes pass through the terrace ceiling. There are clear signs of staining on the pipes [4.3.2].

Presumably this is a device to catch leaks from the terrace that the contractor could not deal with. Instead of sealing the penetrations through the ceiling and fixing the problem, a leak masking device was installed.

This is an unprecedented, non-technological solution and should not be used in housing.

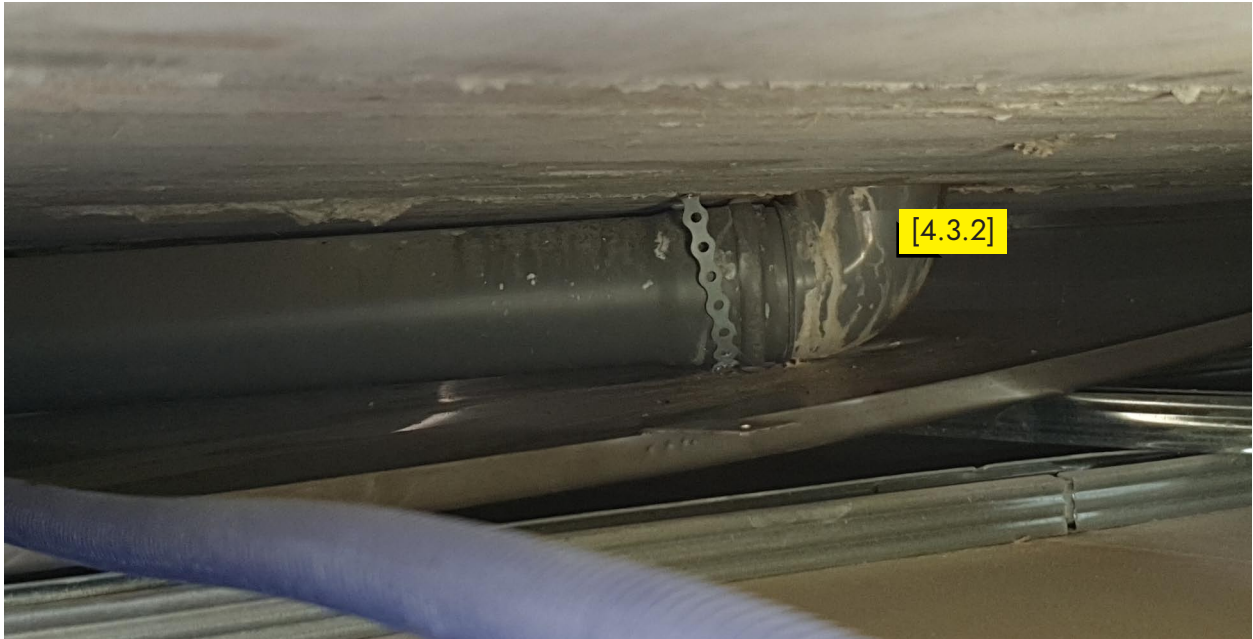
Space between slab and suspended ceiling surface. Stains streaks are visible.

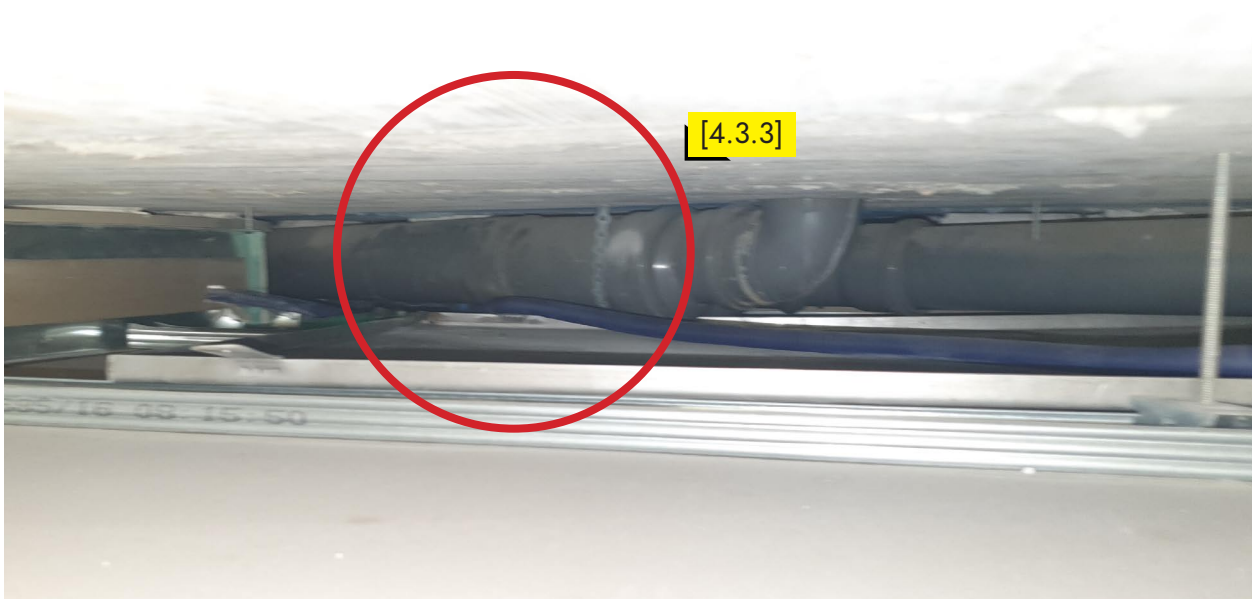
**4.3.3.** The drain pipe is bent upwards (counter-sloping), which is not acceptable. This causes dirt to settle in this area and stagnant water in the pipe. The drainage pipes used here are designed to work with a slope.

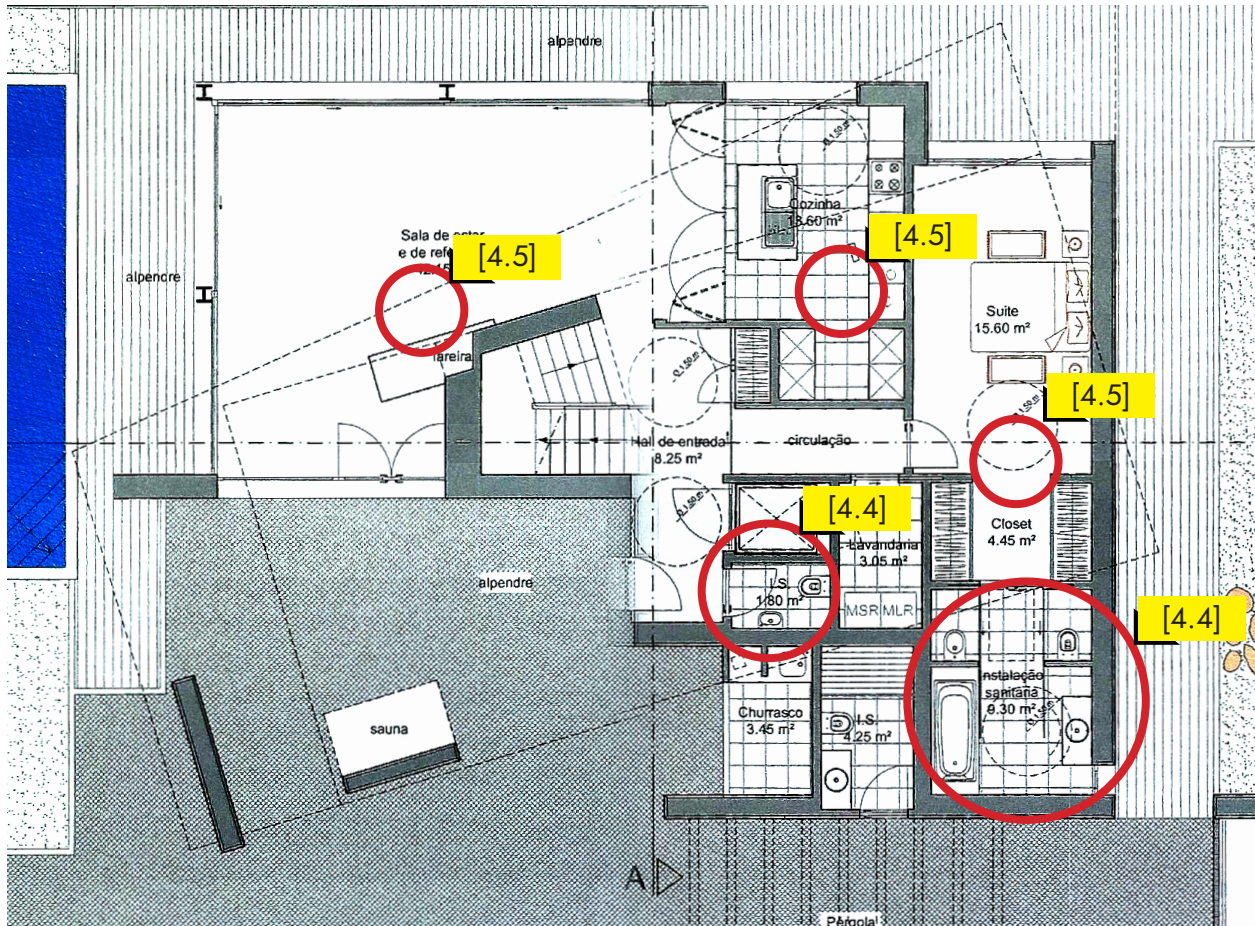
Neither of the two bathrooms on the ground floor has ventilation ducts.

The opinion that this is not required when windows are open is not true, as this would mean that during cold or rainy weather, residents would be forced face the weather elements to provide ventilation.

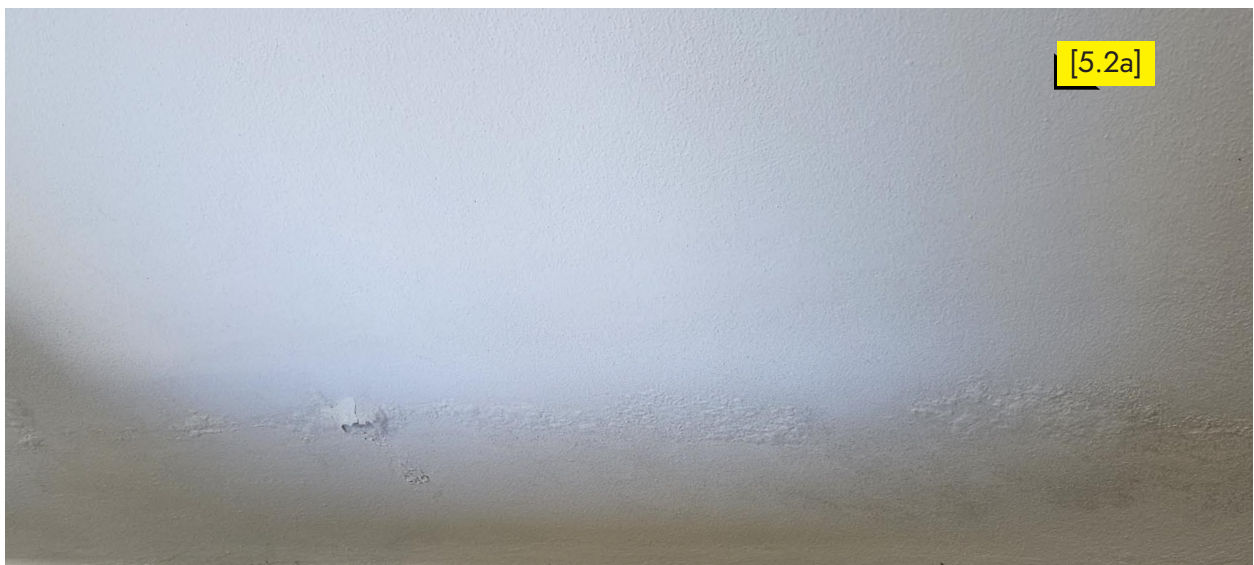
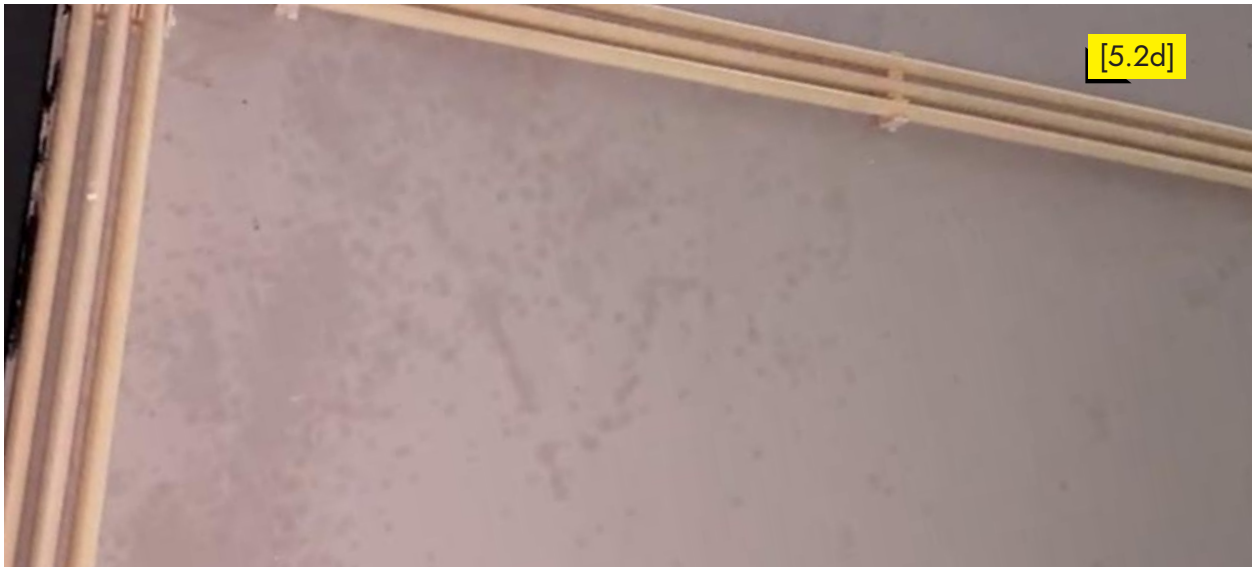
The main problem in the basement is dampness. There are stains on the floor, damp patches on the walls – mainly in the corners. Poor horizontal damp protection of the floor and walls thus capillary seepage through the walls are responsible for this dampness.

To hide the dampness on the walls, they were covered with polystyrene boards and painted [5.2c]. This solution does not solve the problem. It only traps moisture in the wall, which promotes further wall degradation and the growth of fungi and mould, the spores of which are harmful to health!

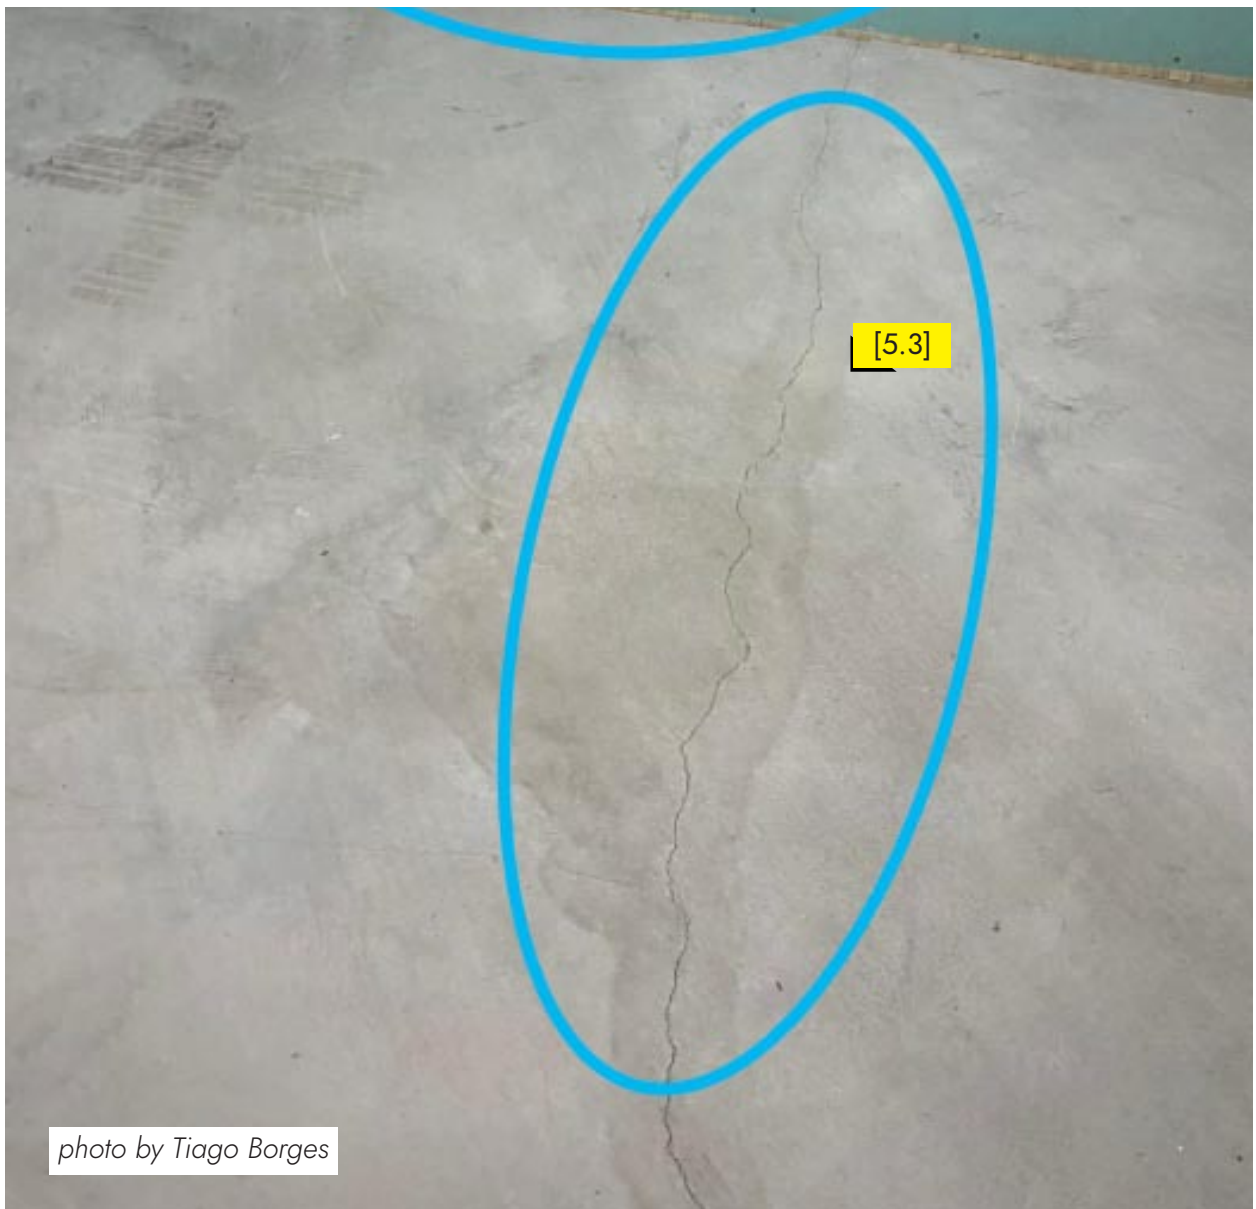
The concrete screed is cracked in many places. Moisture stains can be seen in the cracks.

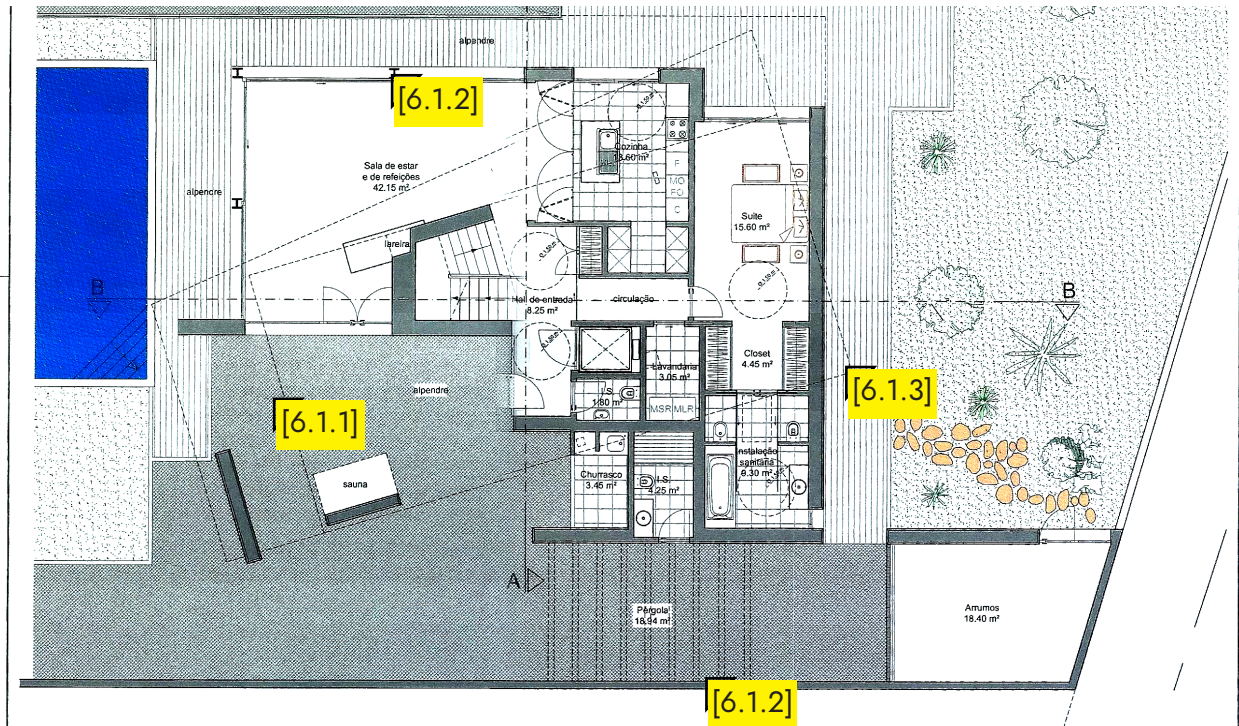
External walls have defects in design and workmanship, resulting in cracking and damp patches. Walls and fences have no copings. Plasters and paints appear to be of poor quality.

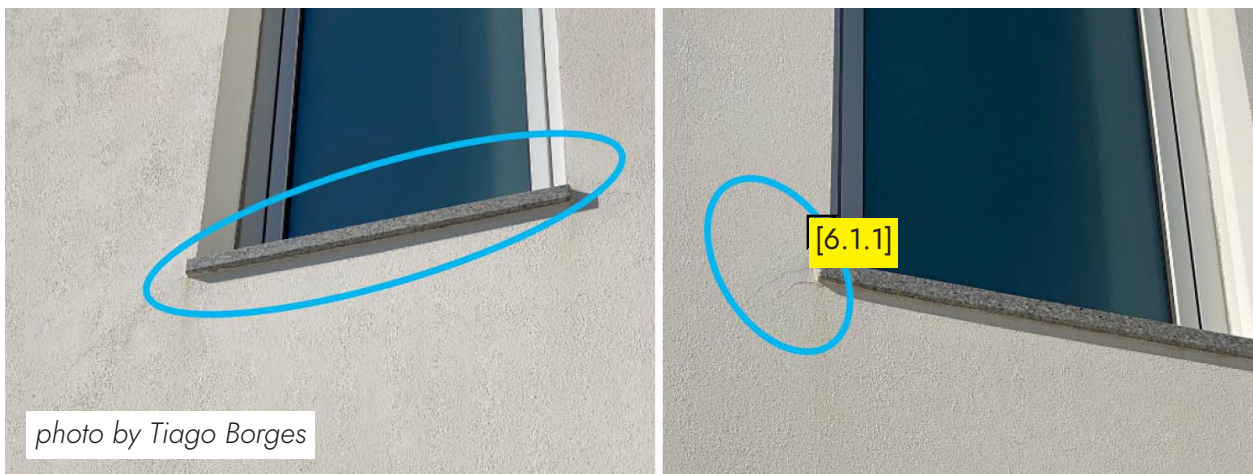
#### 6.1.1. Cracks in the façade around the window openings.

The main cause of their formation is the lack of diagonal reinforcement in the plaster layer.

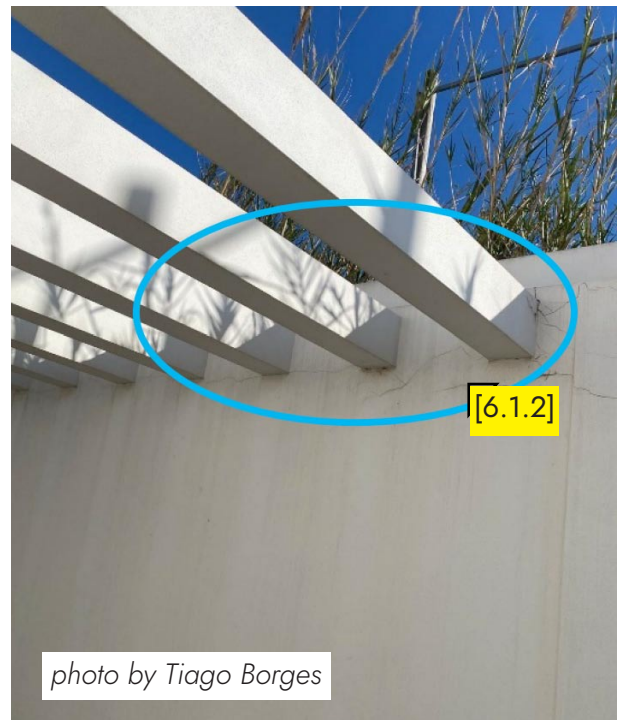
### 6.1.2. Cracks below top of walls and masonry.

Caused by water penetration due to missing or poorly executed copings, wall settlement and stresses arising at the boundary between different materials.

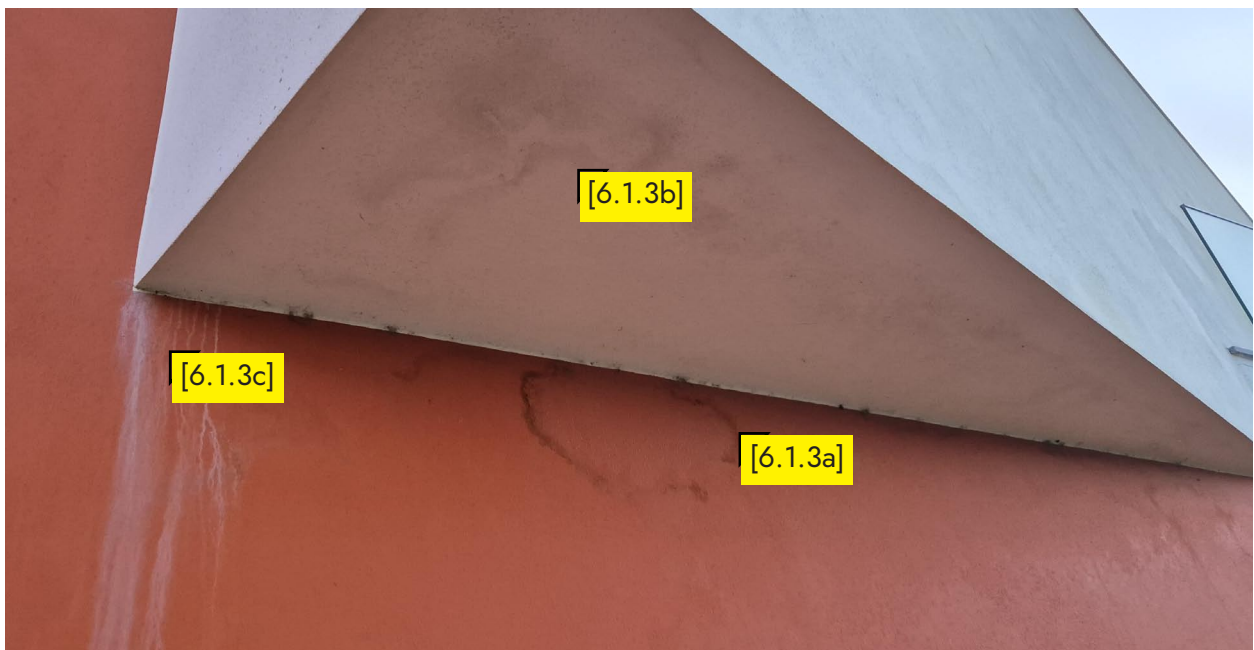
### 6.1.3. Discolouration and staining on the facade.

**6.1.3a** This is a possible exudation of water accumulated on the ceiling from a leaking terrace.

**6.1.3b** Stains from rainwater running off the walls. The water from the rain streaming down onto the horizontal surface instead of dripping off the edge of the wall.

**6.1.3c** Staining from rainwater washing out plaster/paint. Possible site of leaking water accumulated on the ceiling from leaking terrace covering.

The greenery and fungus in the north is either faulty plaster or a lack of a fungicide and algacide, the use of which is currently standard in the building industry.

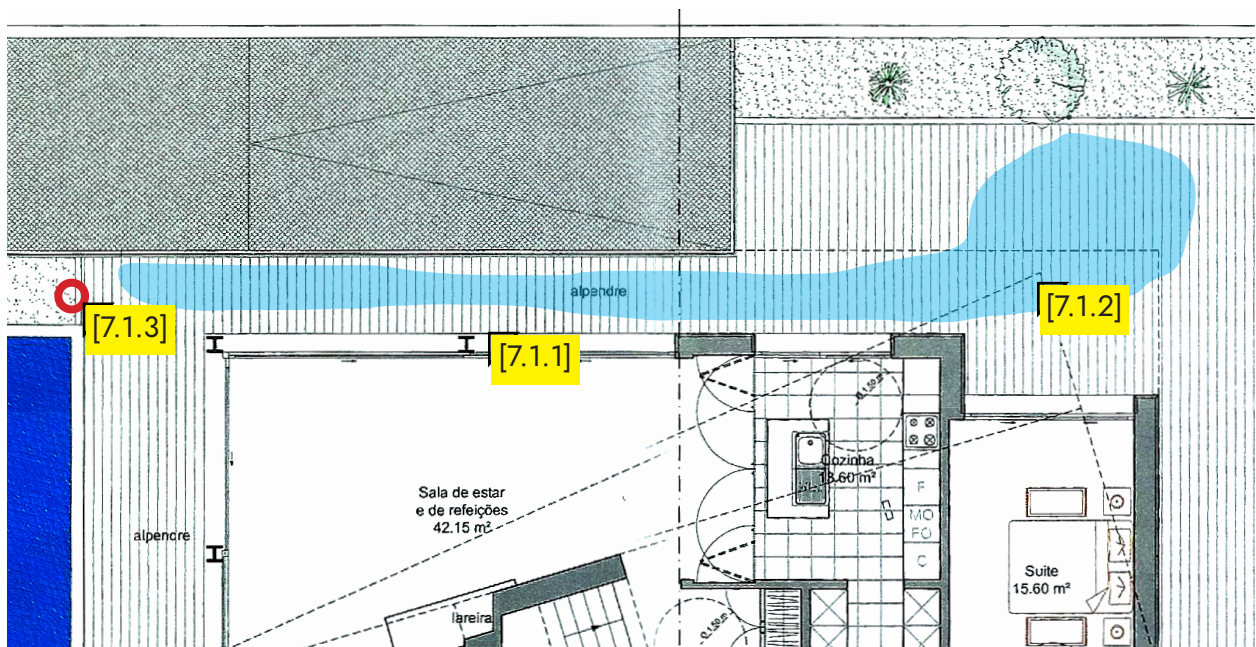
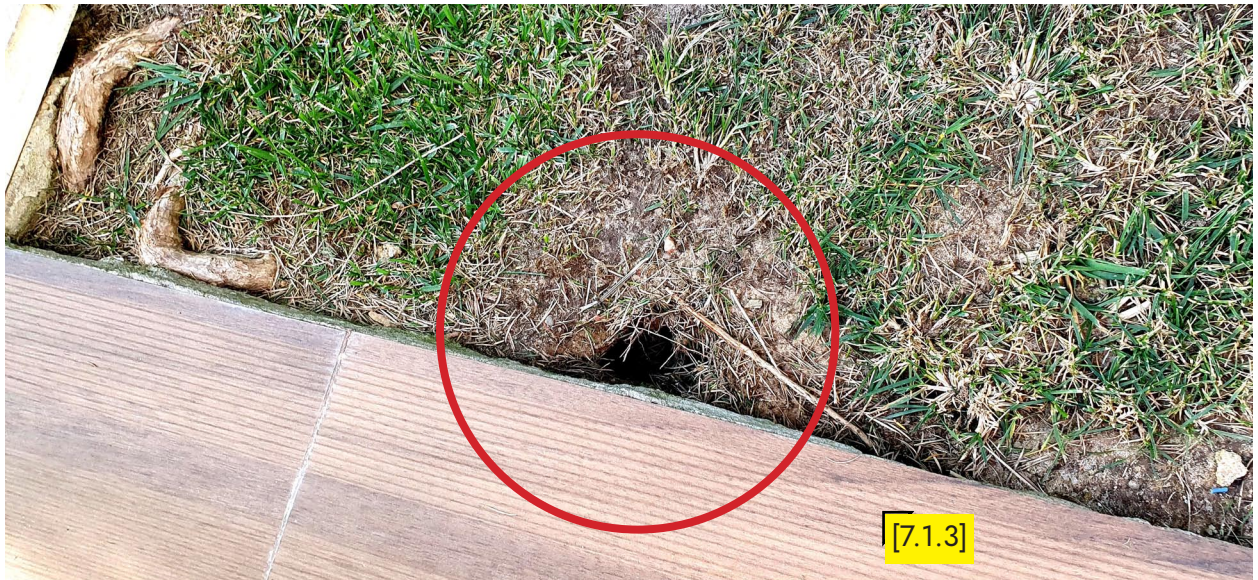
Patio surface on wrong profile – it forms a trough, there is no slope [7.1.1]. As a result, rainwater floods the patio in large puddles [7.1.2]. Excess water running off the patio is not drained anywhere. Therefore, the water has washed out a hole in the lawn [7.1.3], through which it runs off, washing up on the edges of the patio and the pool and on into the area of the underground pool pumping station room.

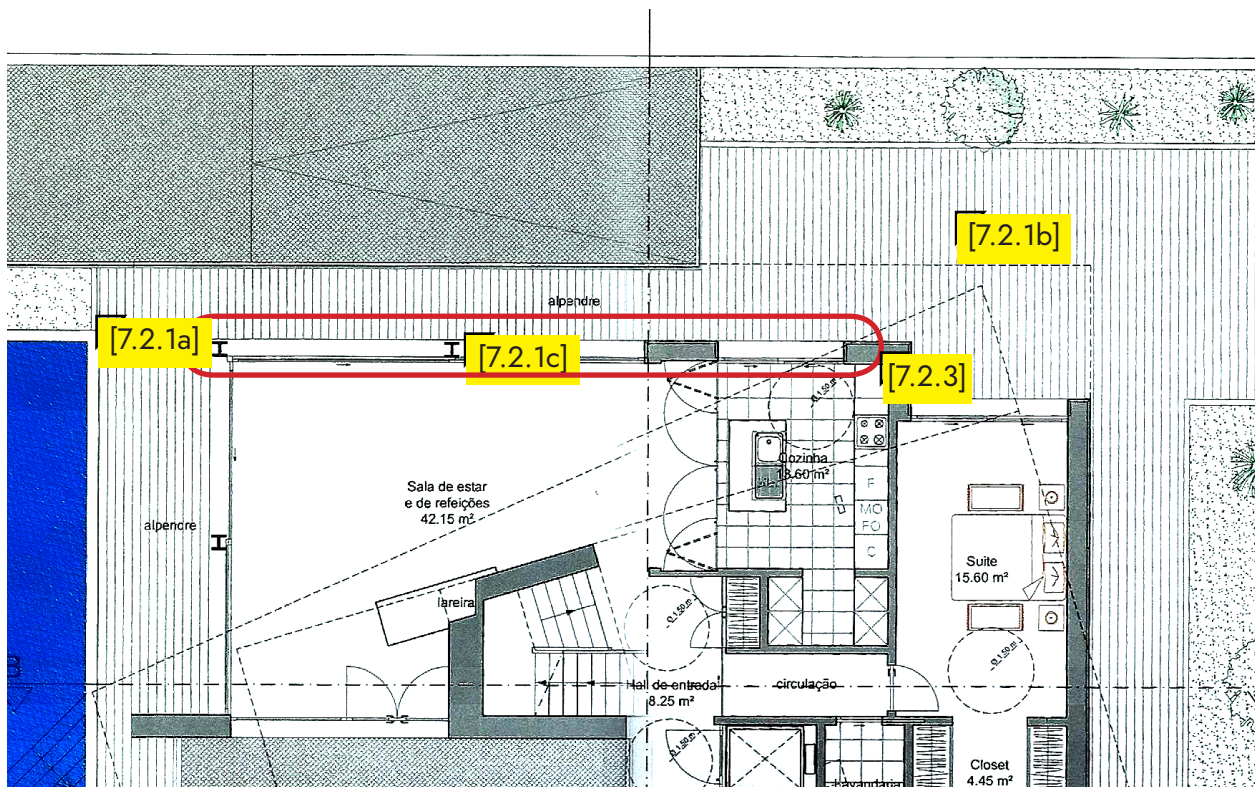
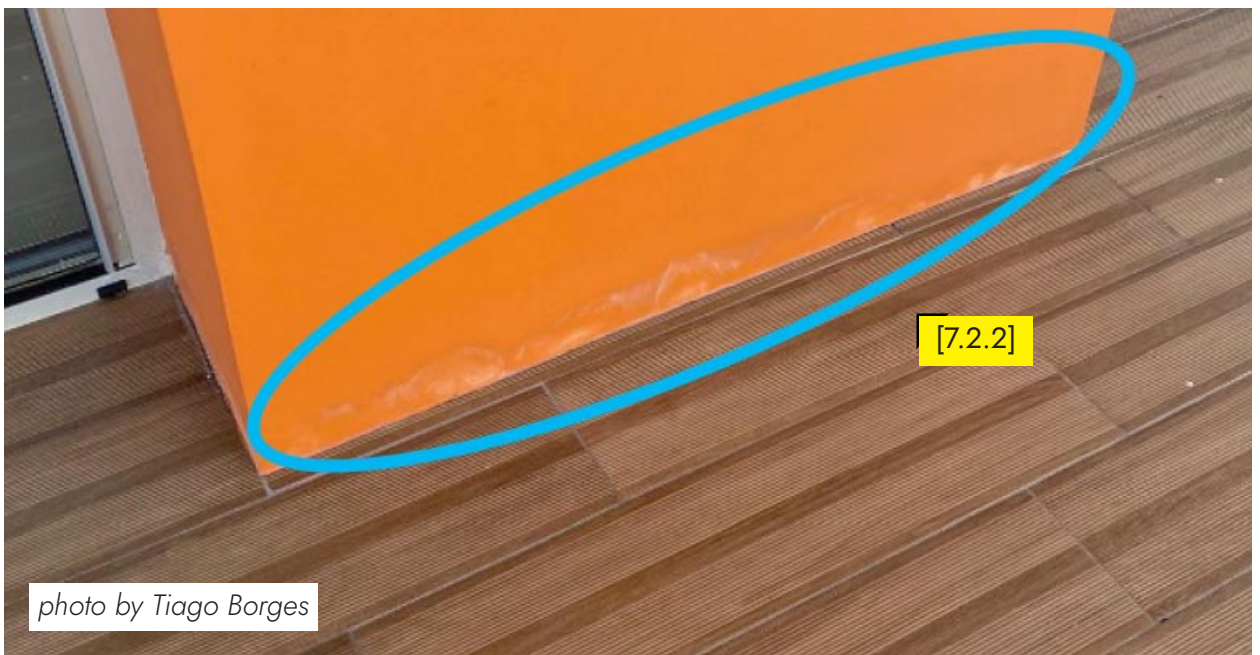
Grout is chipping all over the patio and water is seeping into the adhesive layer. Some tiles are falling off. [7.2.1a] Tile cracks are visible on the structural pillars [7.2.1b]. There are also visible signs of corrosion around the pillars [7.2.1b]. Water stains are visible on the walls of the building [7.2.2].

7.2.3 The sealing of the window openings is done extremely carelessly and in an extremely damaging way. Sealing is missing in all areas where the window drains are located! Thus, all the water that runs off the surface of the windows is introduced directly between the wall and the tiles!

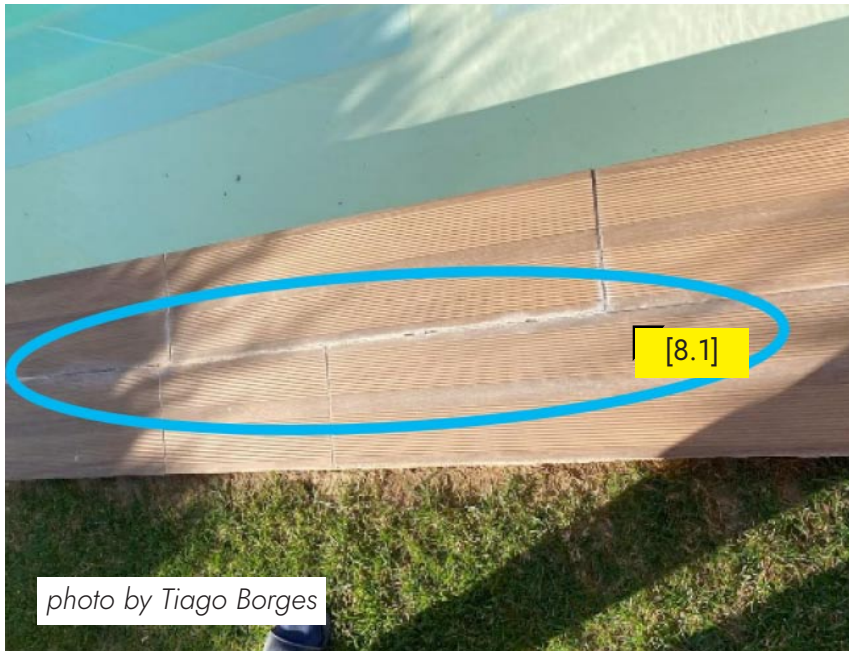
The edge of the pool is tiled in the same way as the patio. The same mistakes as on the patio are repeated - the tiles are coming off, the joints are chipped.

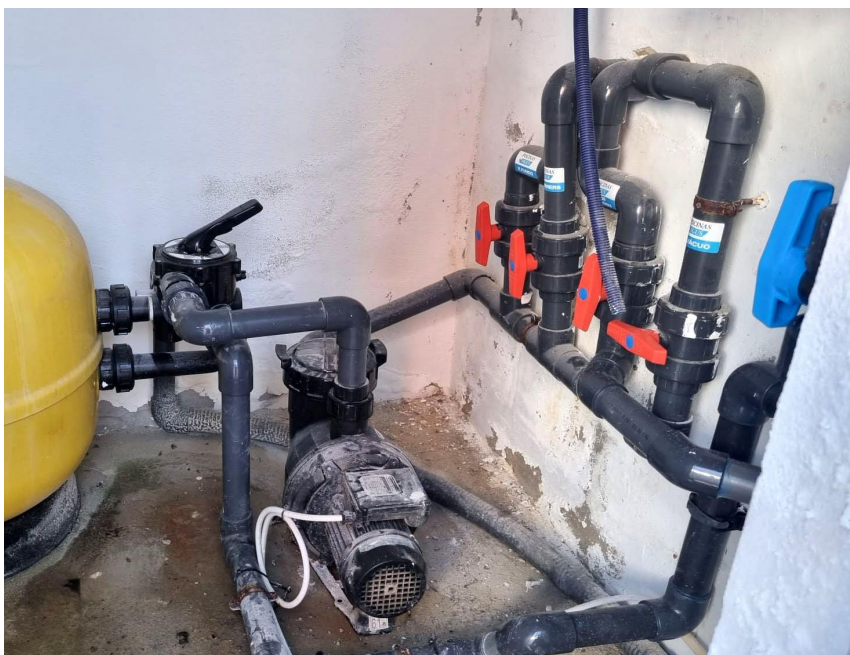
In the pool pumping compartment, the walls are damp and cracks are showing on the walls and ceiling. Plaster and paint are falling off the walls.

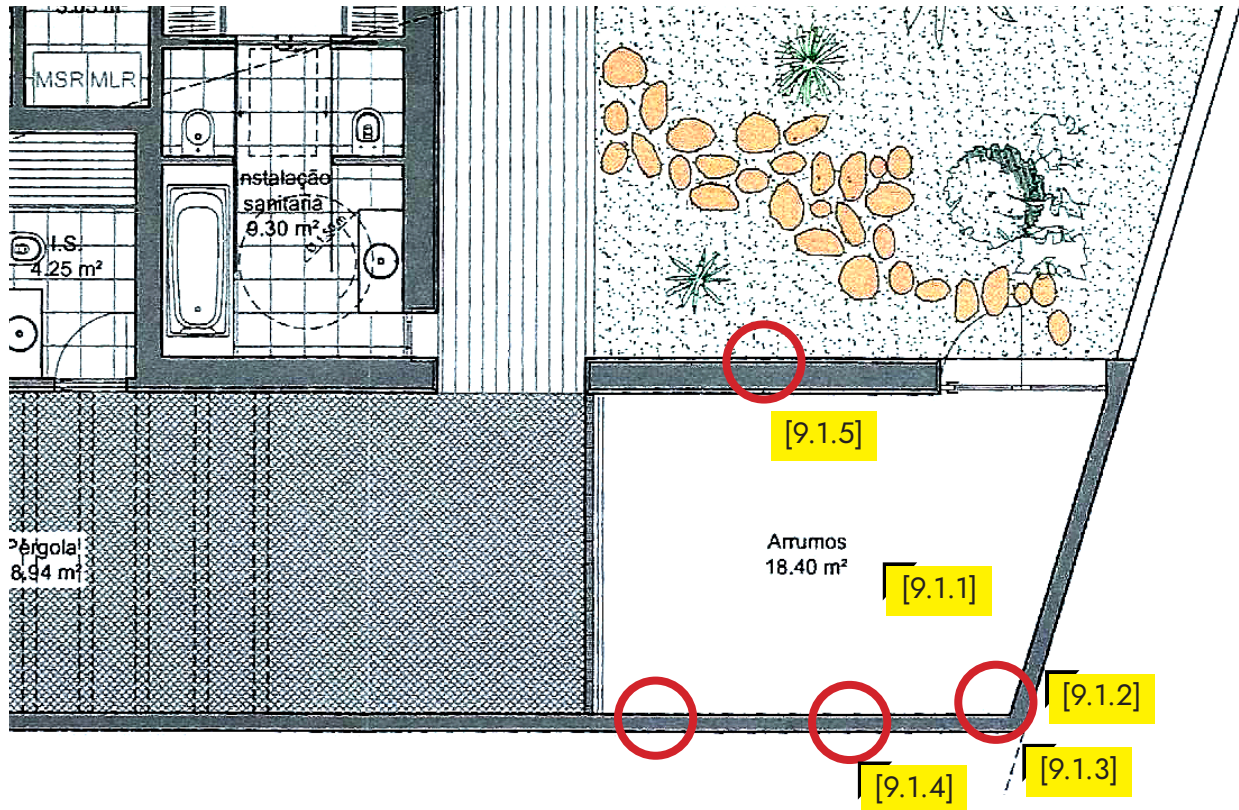
A small house is built next to the house. It is connected to the main house by a concrete pergola. A number of anomalies were discovered in this building, such as rainwater leaks from the roof, dampness in the walls, cracks in the attic copings and roofing errors.

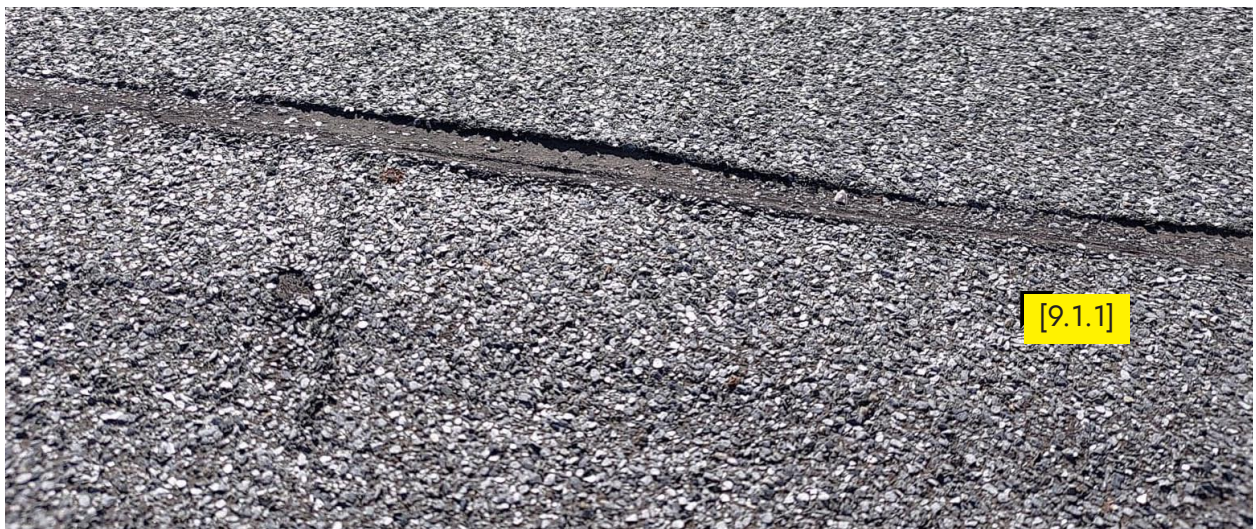
9.1.1. Improperly welded roofing felt. The visible strip without mineral sprinkling is the overlap for welding and should be welded across the width.
