# The Report

*February 2025*

This report systematises and organises the numerous construction and workmanship errors occurring in the private residential house located in Lote 2 - Casais Porto Dinheiro.

The discrepancies were identified based on the construction project of the residential building 12146/2017, hereinafter referred to as The Project.

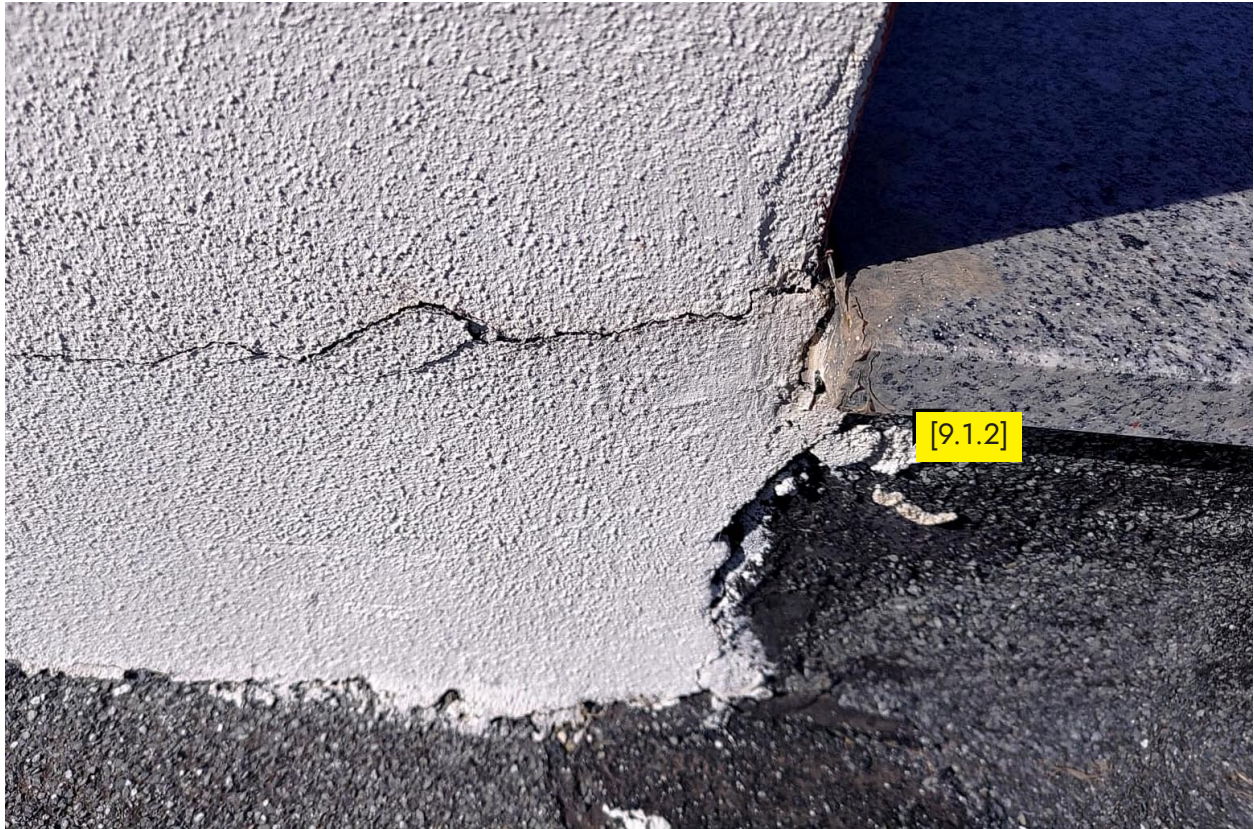
9.1.2. Cracks at the connection of the attic to the walls of the pergola and the house.

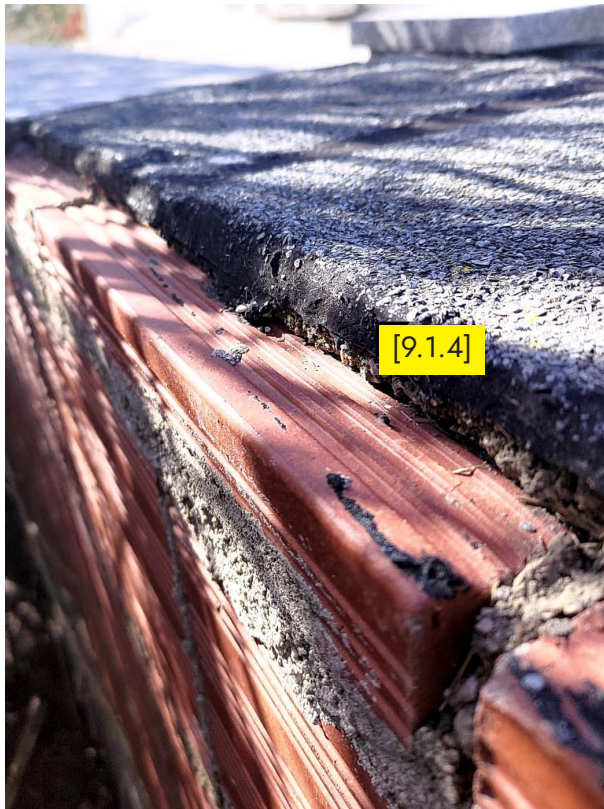
9.1.4. Lack of proper capping on the wall on the east side, unprotected areas where water penetrates the wall.

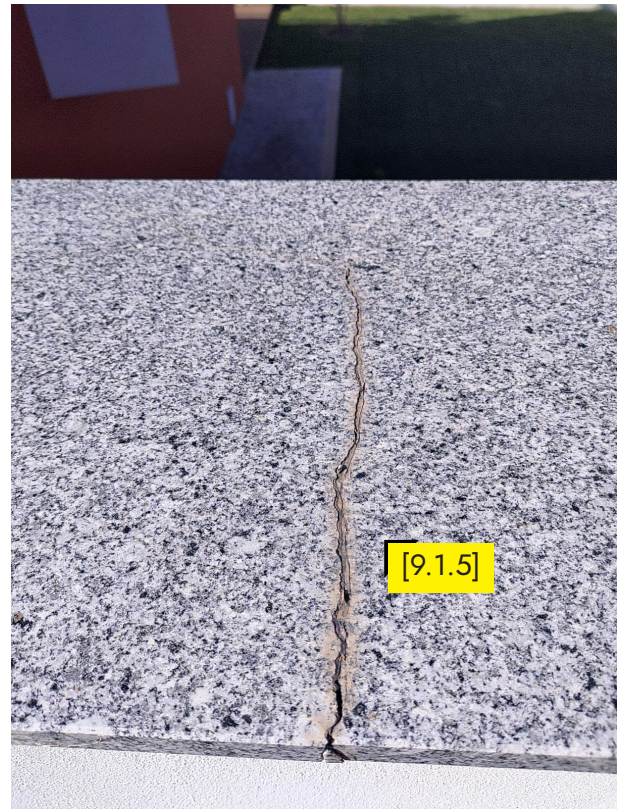
9.1.5. Cracks on the stonework on the attic wall.

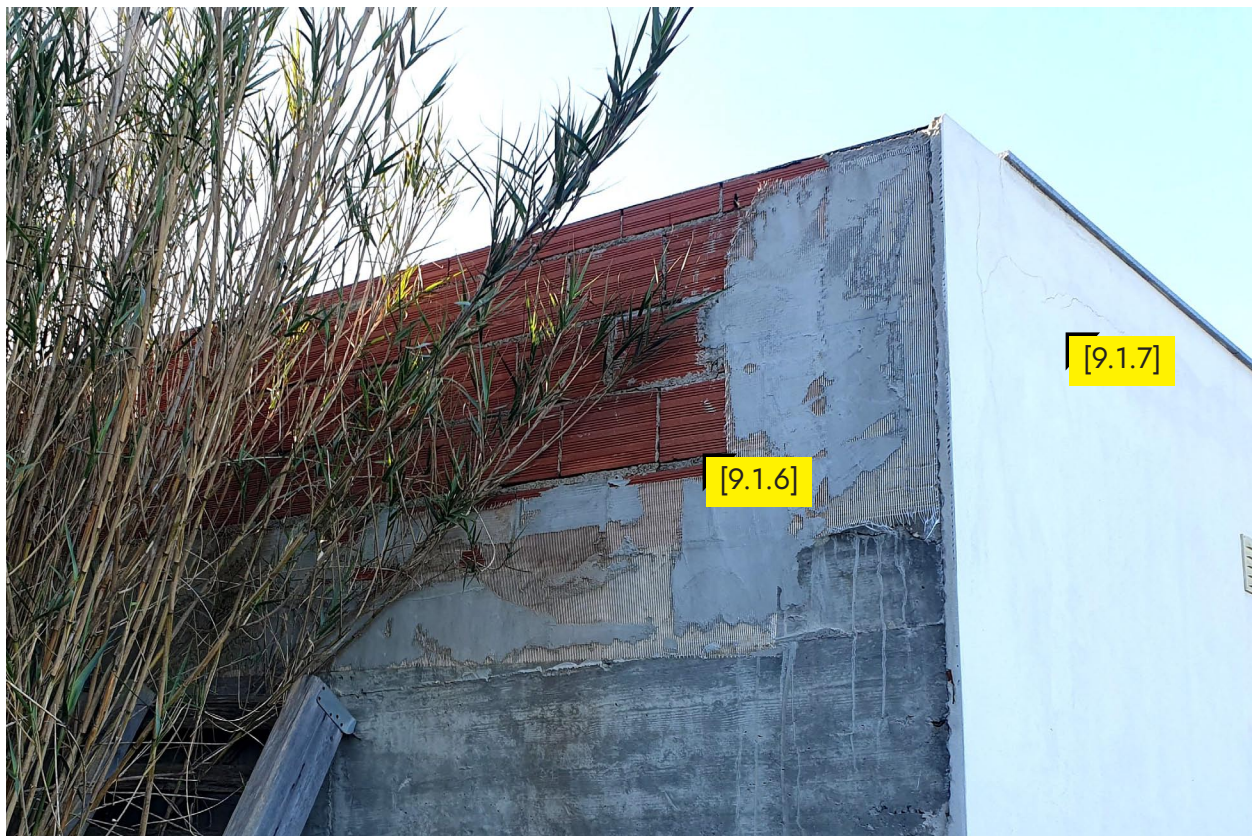
9.1.6. Complete lack of plaster and waterproofing on the east wall.

9.1.7. Cracks in the north-east corner.

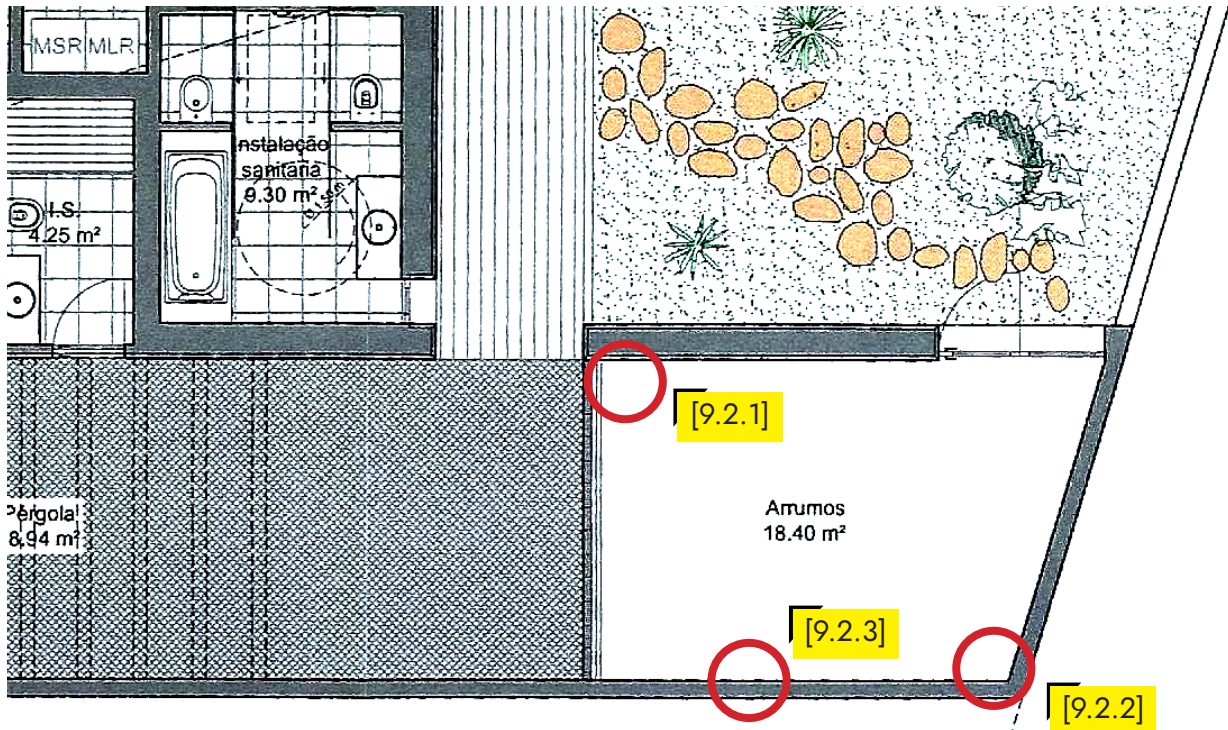
The humidity is high throughout the room and there is a distinct smell of mould. Furniture and furnishings left here are covered in mould and mildew. The covers of the garden furniture have an unpleasant musty smell.

9.2.1. Visible signs of flooding - the rainwater is penetrating from the roof. Fungus and mould developing on the walls and ceiling.

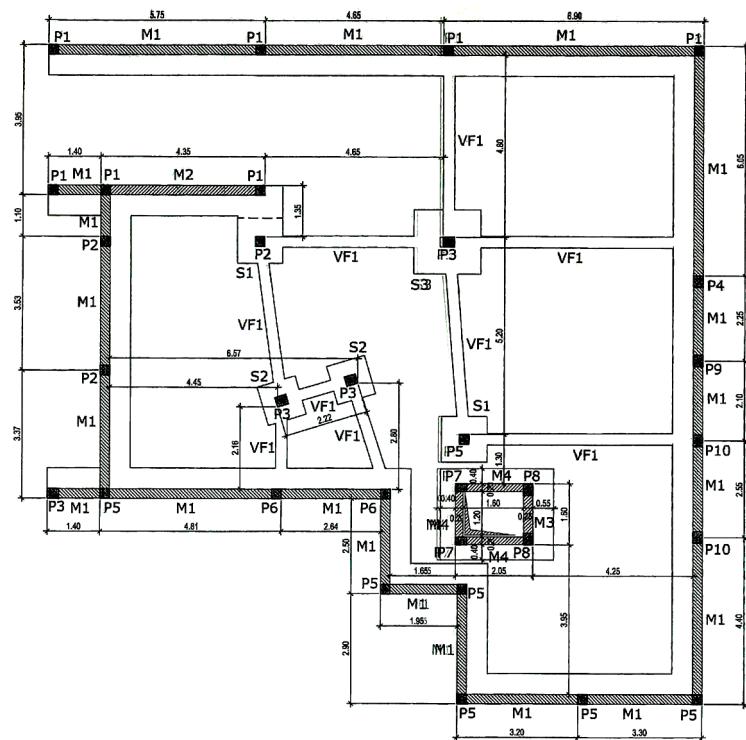
It is likely that the perimeter drainage around the house was not built as envisaged in The Project. The large amount of dampness in the basement walls and floor seems to confirm this. No drainage outlets were found during the inspection - neither in the manholes nor outside within the stone slope on the northern boundary of the plot.
