# The Report

House No 9

March 2025

This report systematises and organises the numerous construction and workmanship errors occurring in the private residential house located in Lote 3 - Casais Porto Dinheiro.

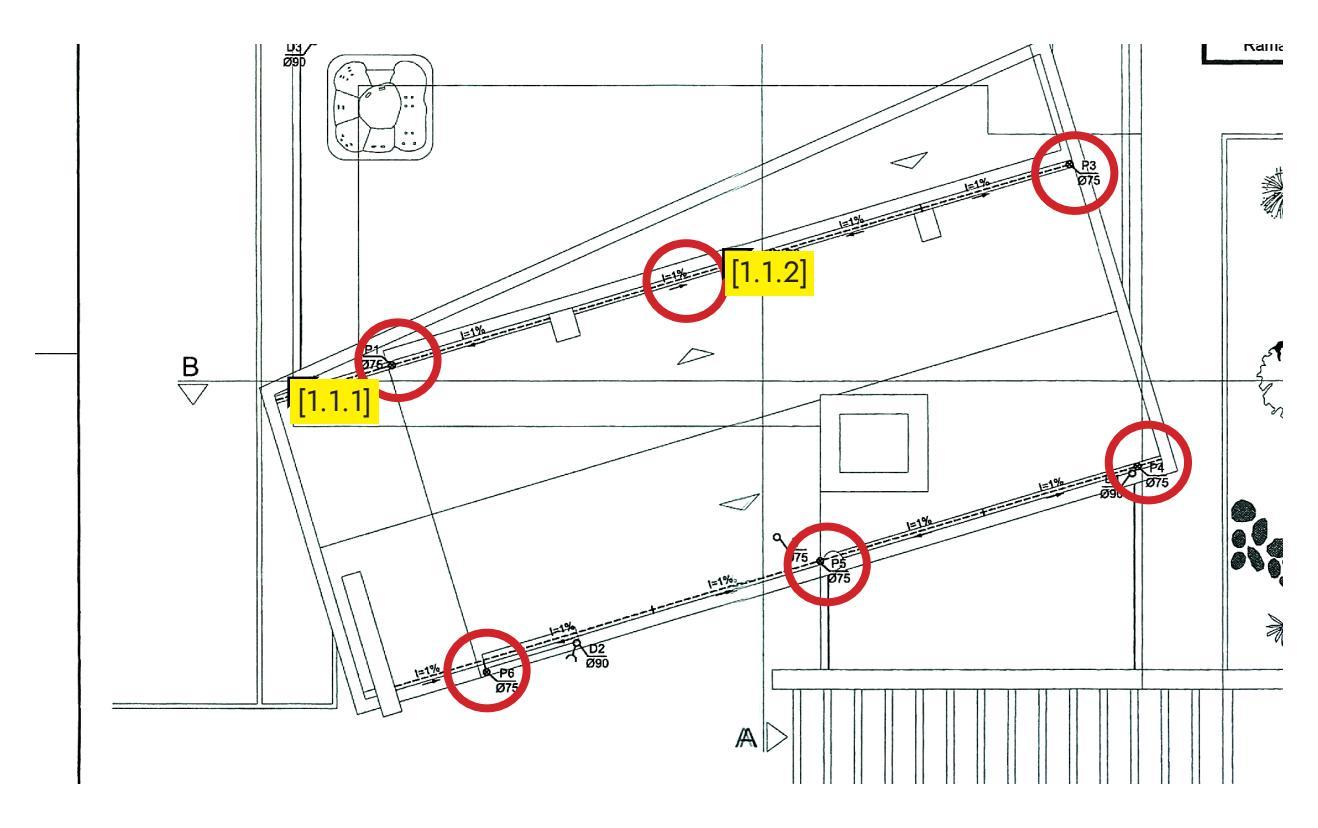
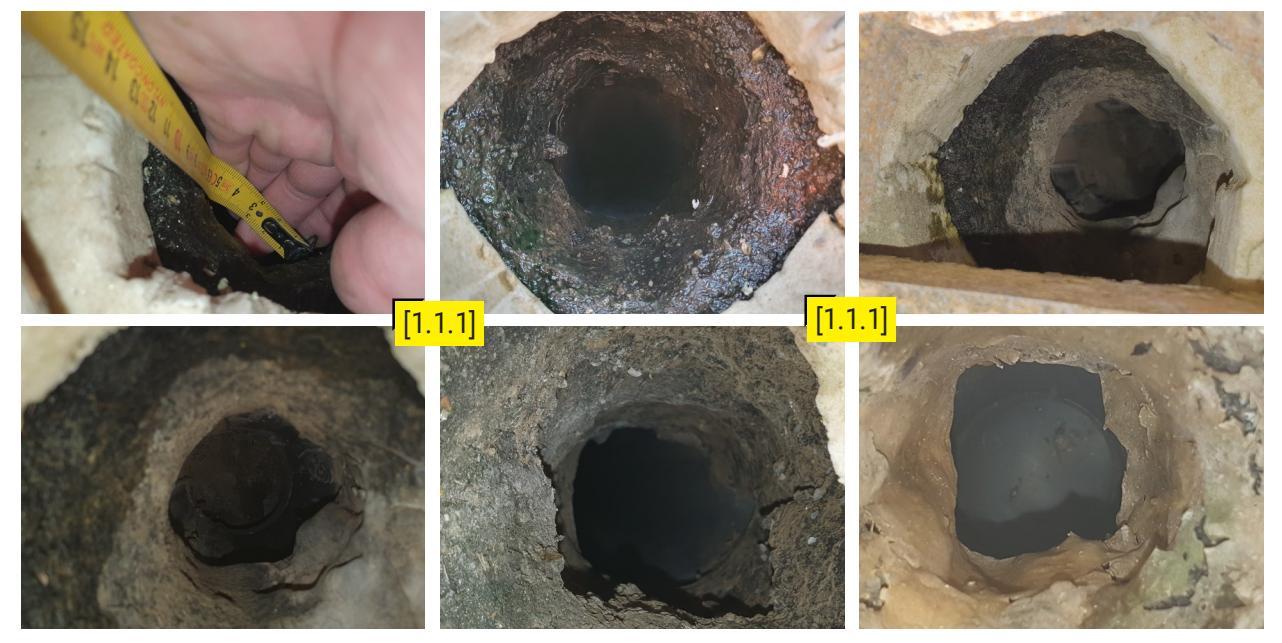
**1.1.1.** All the downpipes from the roof are of insufficient diameter.

In the design, the pipe diameter was specified as 75 mm, while in reality the pipes have a diameter of less than 50 mm (their diameter was reduced by the layers of roofing felt rolled inwards).

**1.1.2.** There were also no horizontal gutters (ditches) detected on the roof, which were shown in the design.

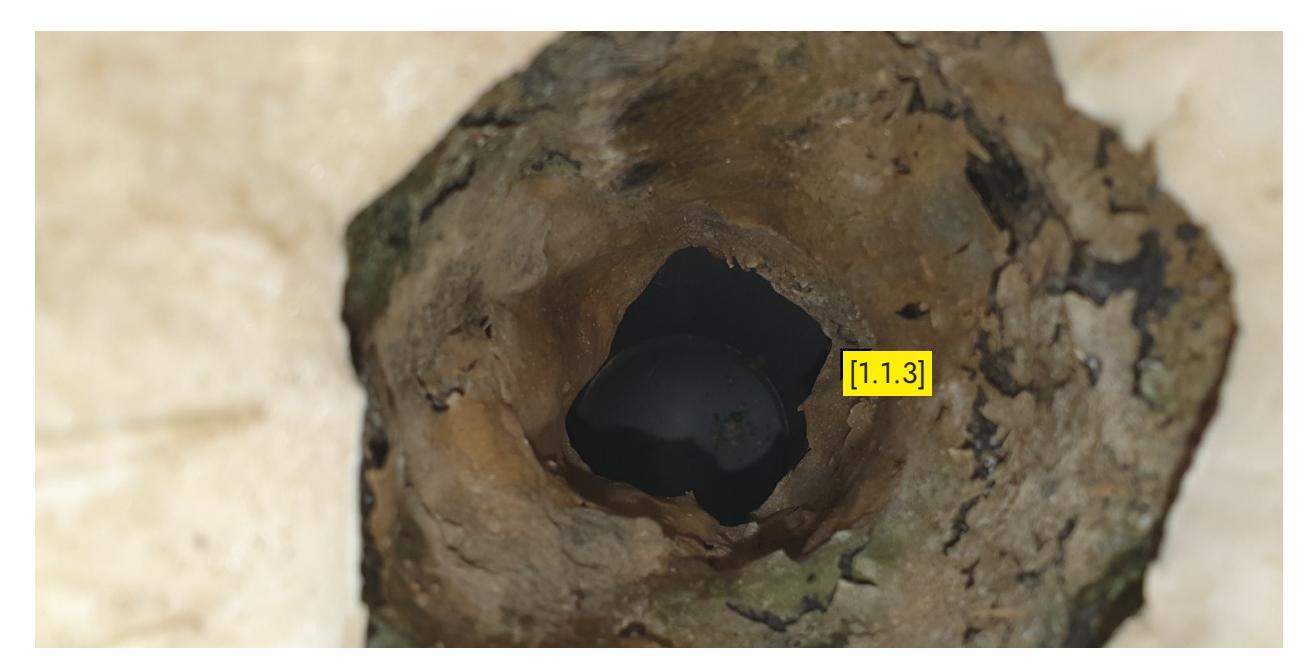
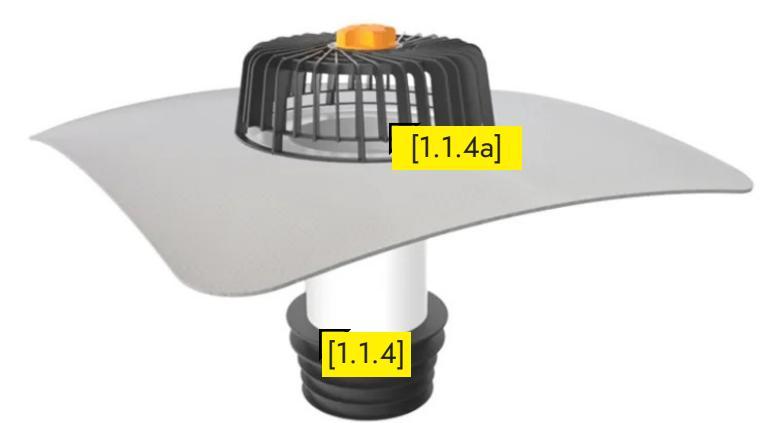
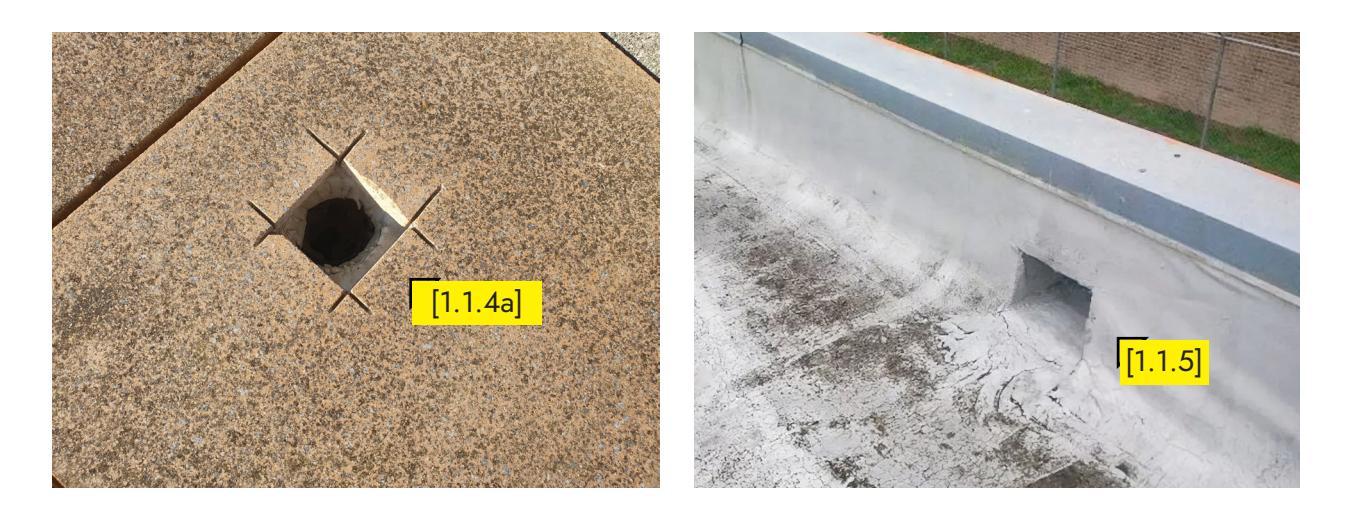
**1.1.3.** The water drainage through the roof ceiling was done incorrectly, as the bare ceiling slab is visible in the drainage holes. It is only partially covered by roofing felt bent inwards. This allows water to penetrate through cracks in the concrete and further flood the house.

1.1.4a. None of the drains have a basket to protect the drainpipes from clogging with small objects.

**1.1.4.** Drainage holes should be fitted with an appropriate outlet fitting. Its apron should be welded to the roofing felt and the drain should be sealed in the downpipe.

**1.1.5.** The roof should also be equipped with **thru-wall overflow scuppers** that could drain excess water from the roof in the event of extremely heavy rain or clogged drainage holes.

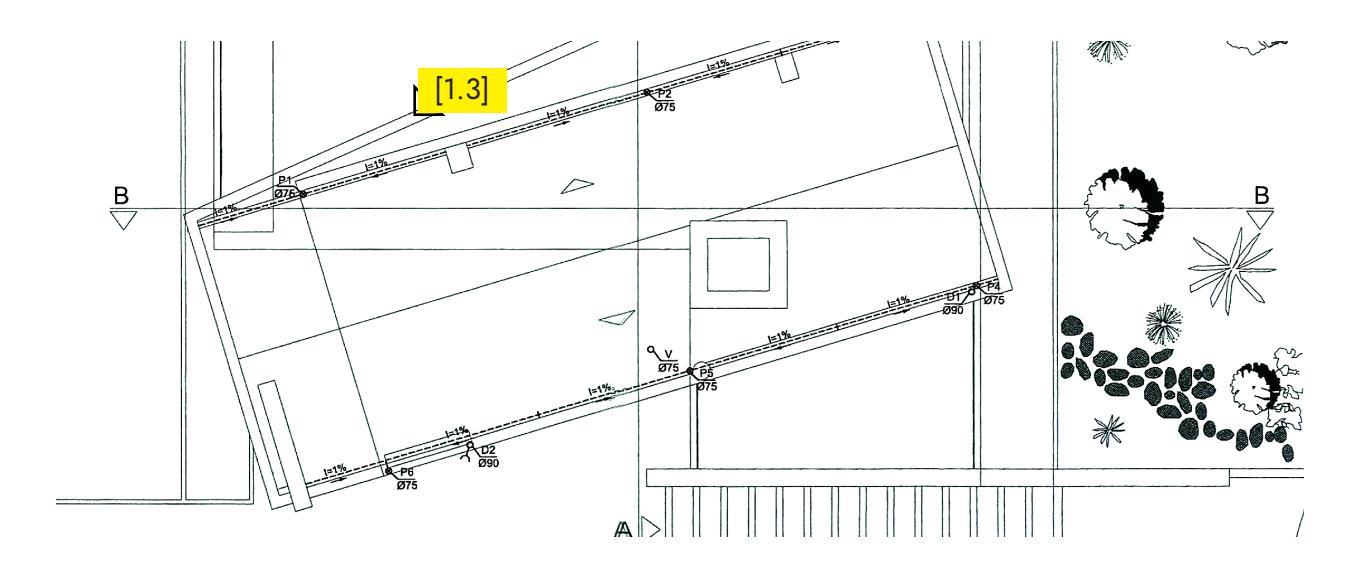
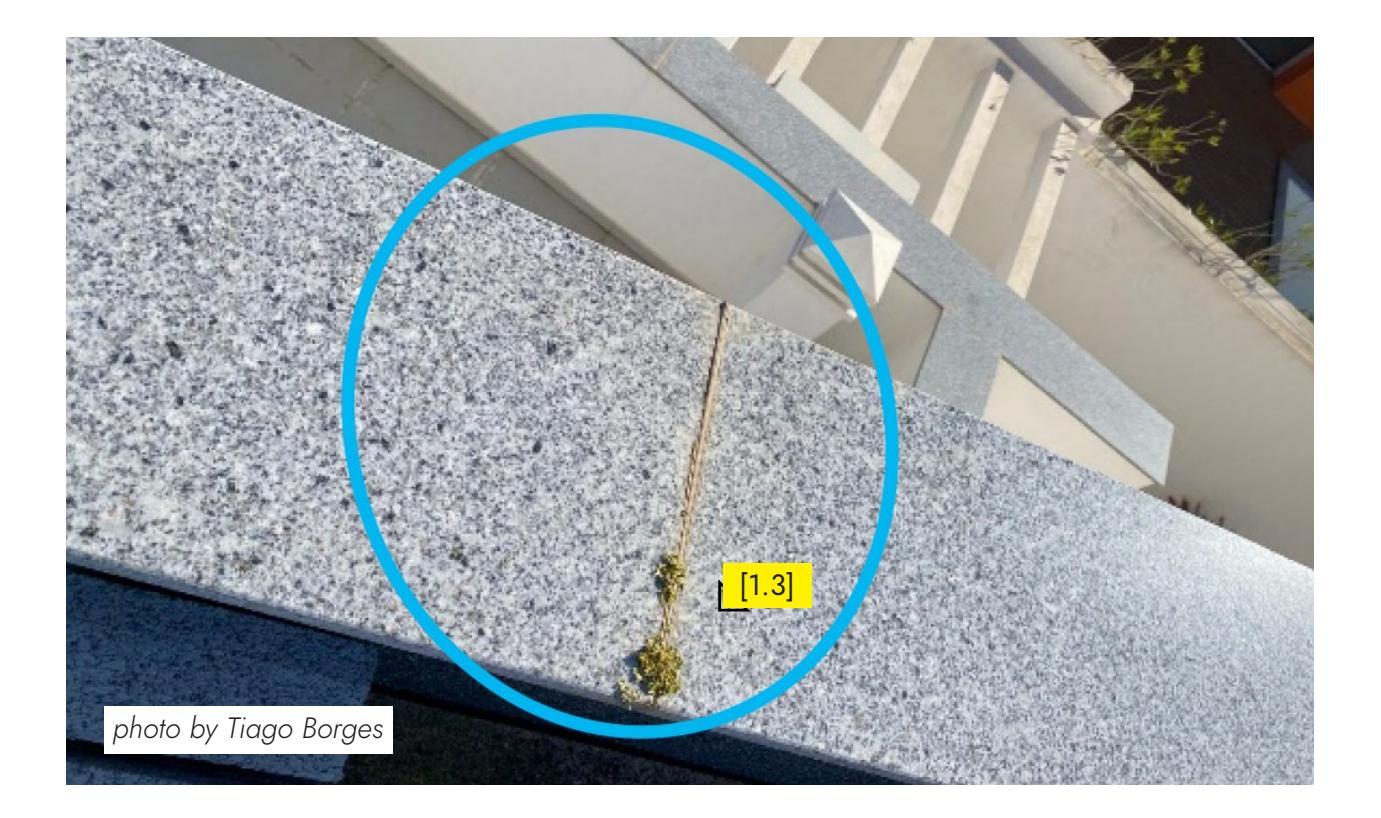
**1.3.** The roof attic walls have copings made of stone, with many defects also lack of the grout on connections. Cracks and leaks in the copings joints promote the nesting of vegetation, resulting in further degradation.

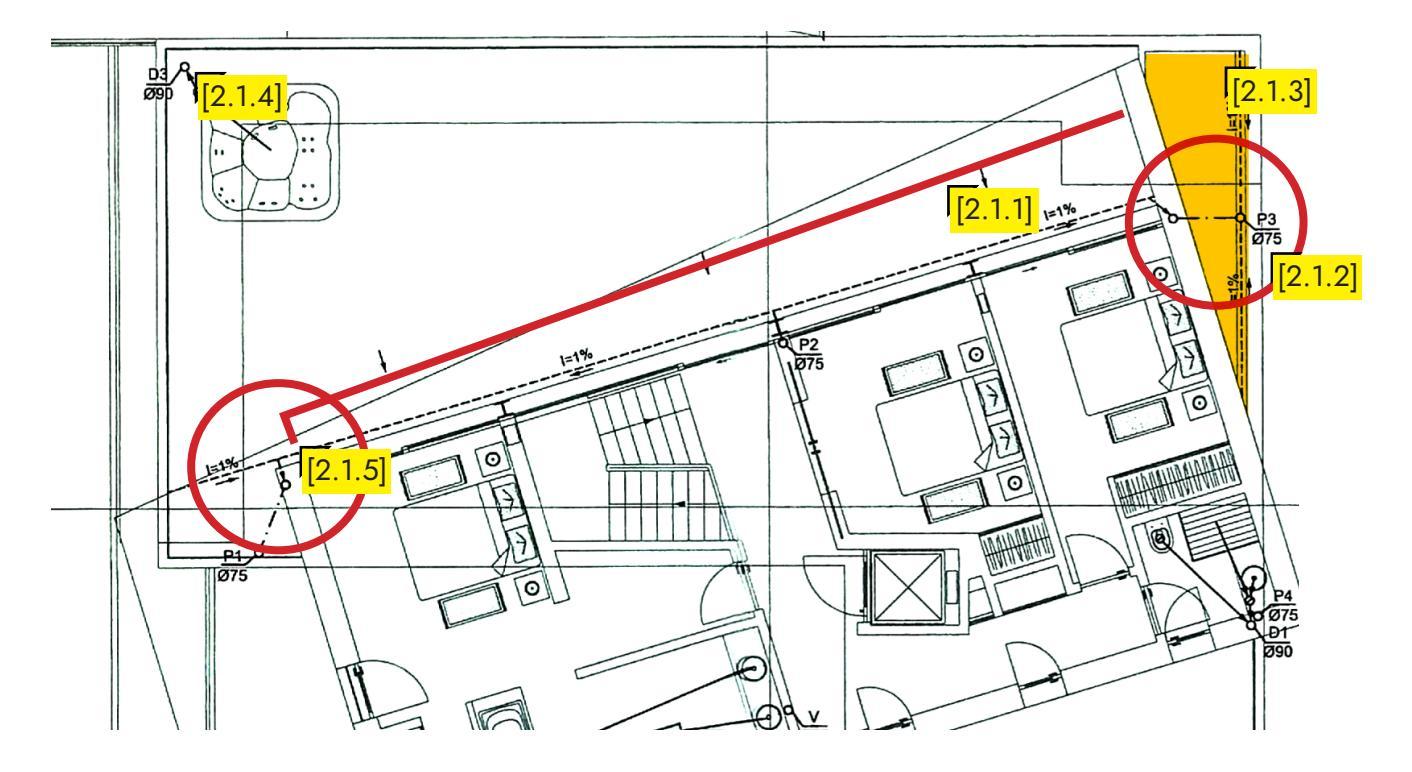
2.1.1. The terrace drainage trough is not located in accordance with the building design.

According to the building design, the terrace should have a slope towards the wall. Instead, a drainage trough was laid diagonally across the centre of the terrace surface.

Its inlet is only a few millimetres wide. The walls and the bottom of the trough are simply concrete of the screed - the trough is in no way protected by a system insert or other barrier to prevent water from seeping into the screed under the tiles.

**2.1.2.** The northern end of the drainage trough was not connected to drain P3 as shown on the building design. The drain marked on the building design as P3 should have a diameter of 75 mm, when in fact the diameter of the drain is 50 mm.

**2.1.3.** Furthermore, the drainage trough at P3 cannot serve as a support for the terrace drainage, as the part marked in orange is about 8-10 cm higher than the rest of the terrace!

2.1.4. The drainage for the jacuzzi pool (D3, 90 mm) was not made at all.

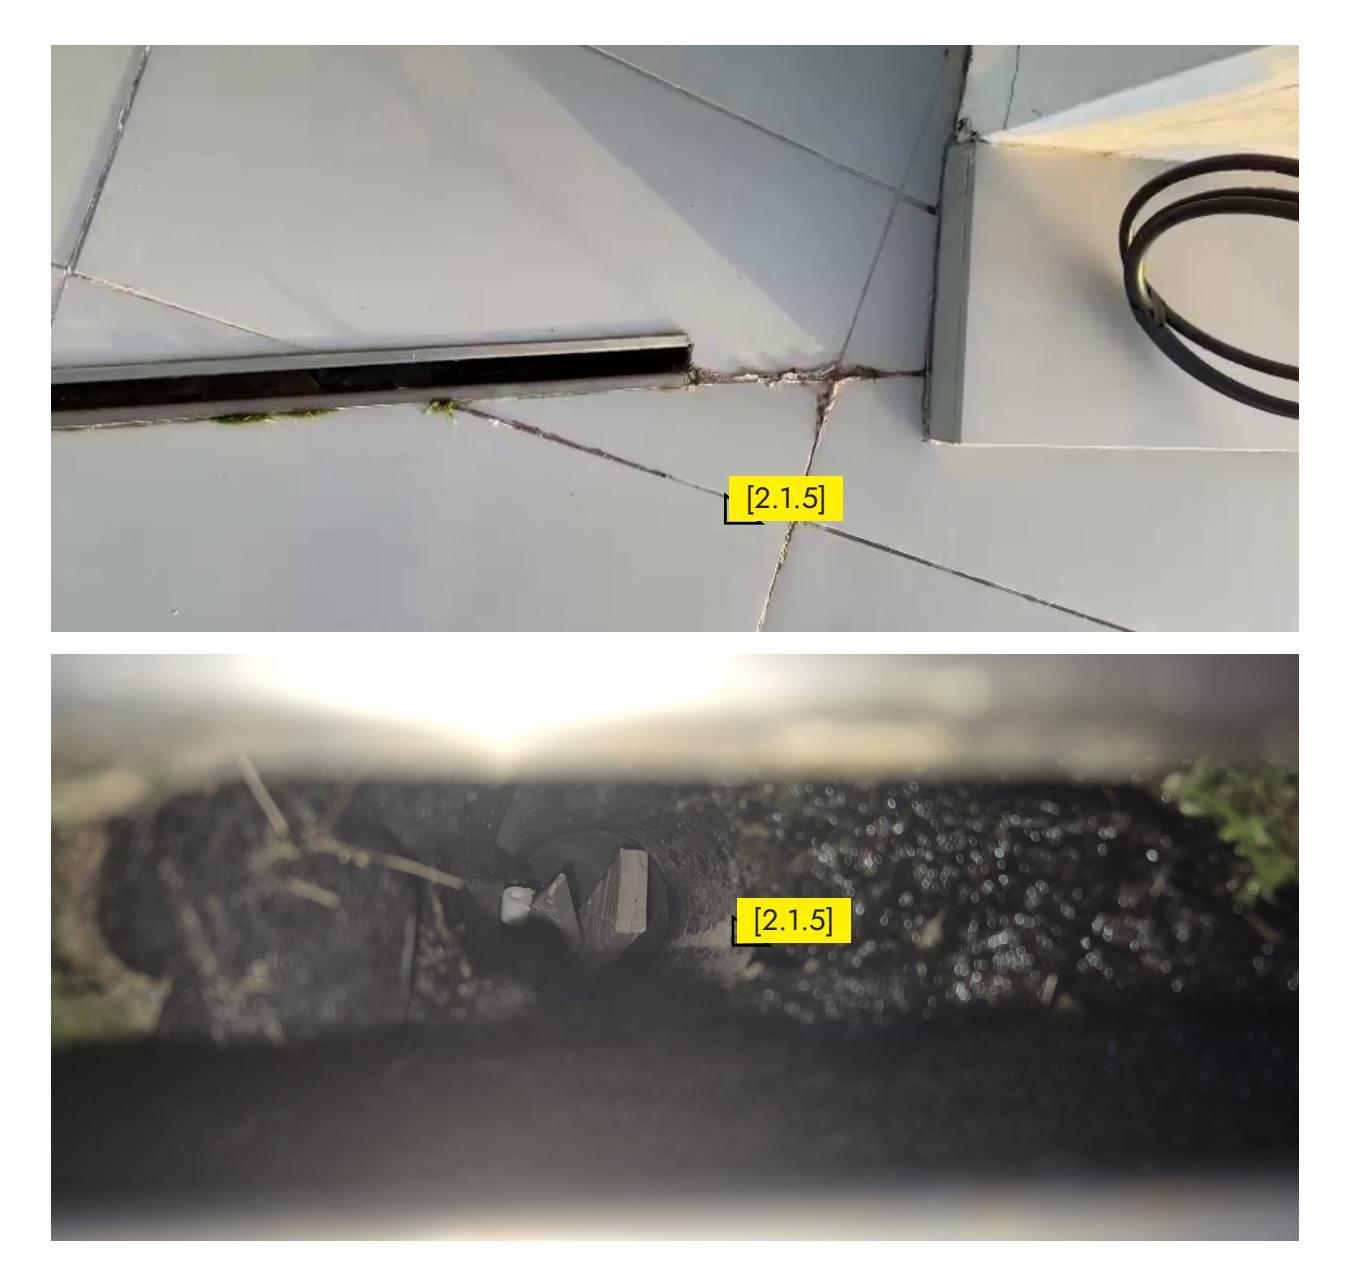
2.1.5. The drain on the south side was filled with pieces of tile and other construction waste. As these pieces were larger than the original size of the hole, it is not possible that they got in there after the construction was completed.

This kind of negligence could easily have led to the drain becoming clogged and consequently filling the terrace with water with all its consequences.

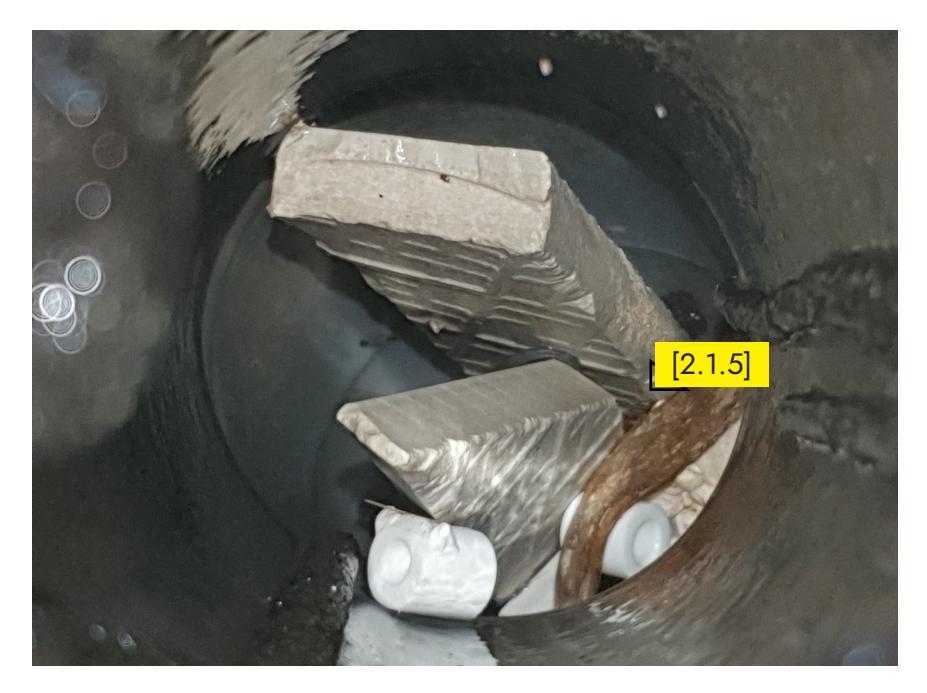
Endoscopic image of the debris in the terrace drrainage pipe

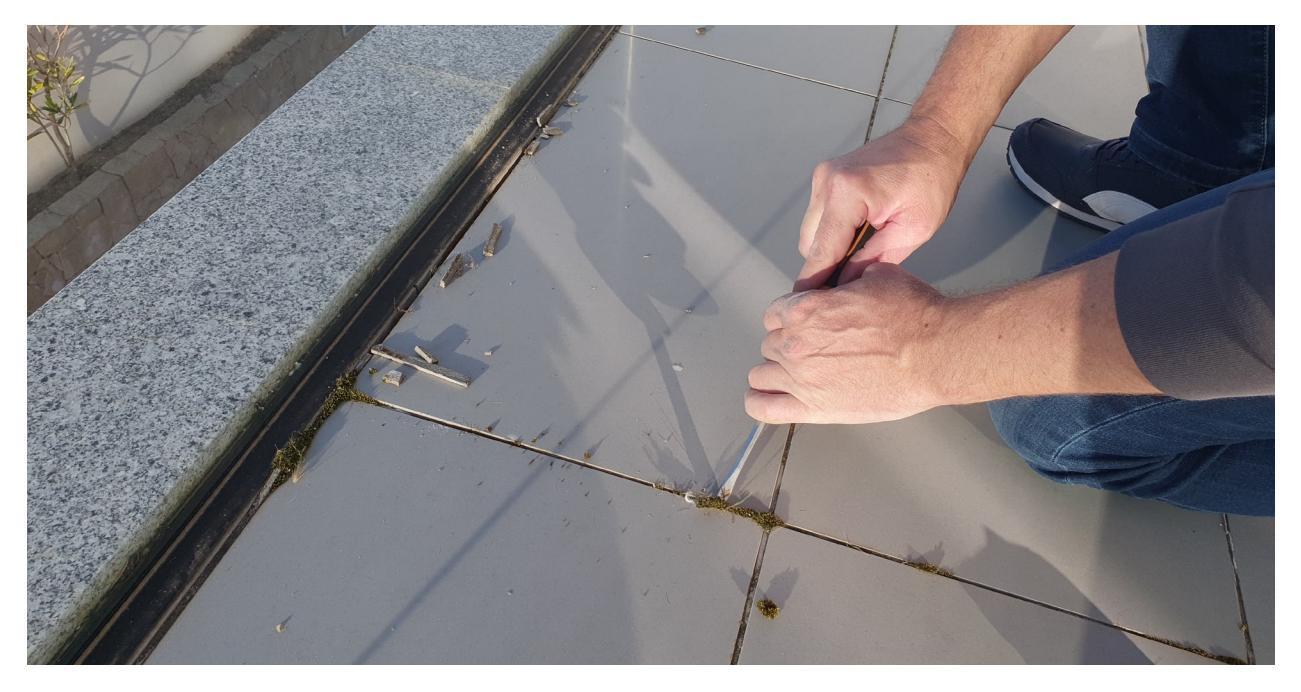
The terrace covering was made of ceramic/gres tiles, attached by adhesive mortrar. The majority of the tiles are hollow - detached from the screed, and in places the tiles stand out clearly from the terrace plane. A significant number of joints are cracked, cracks and cavities are visible.

Total lack of expansion joints, which causes the joints between the tiles to crumble and the tiles to detach from the substrate.

A section of the terrace covering was dismantled to ascertain the quality of the work and the materials and technology used. The tiles came off easily, without cutting or hammering, just using simple tools such as a screwdriver.

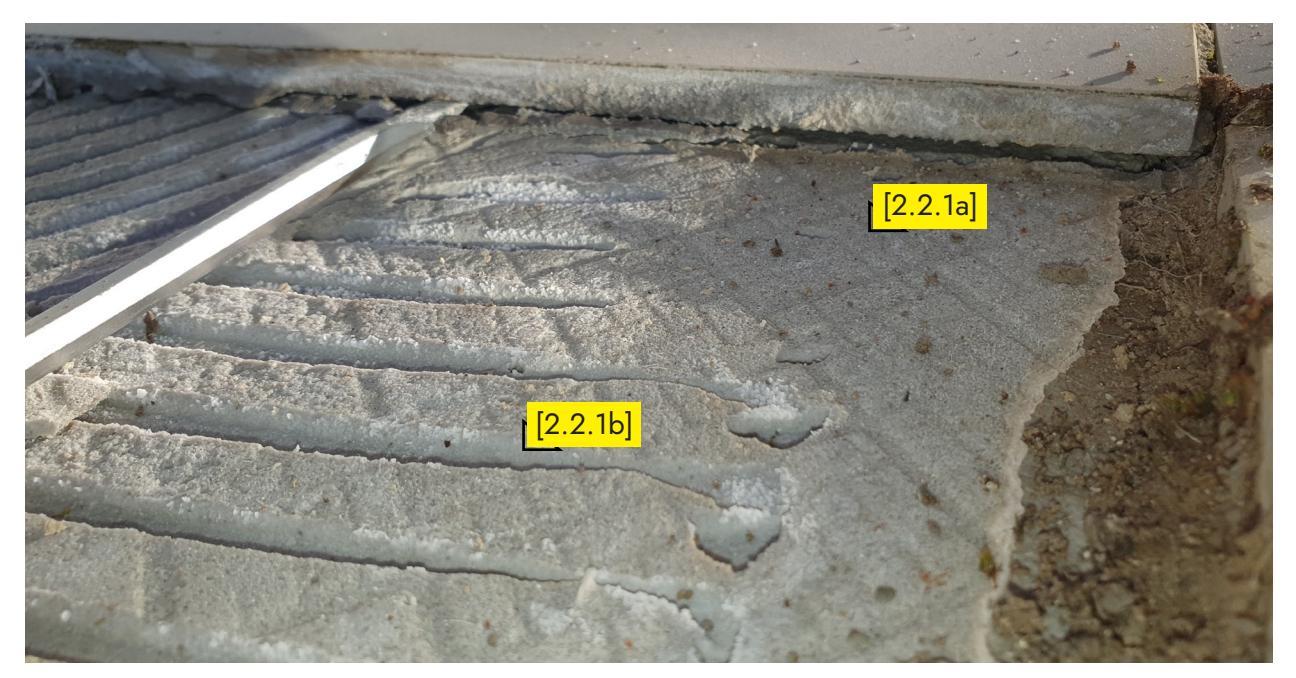
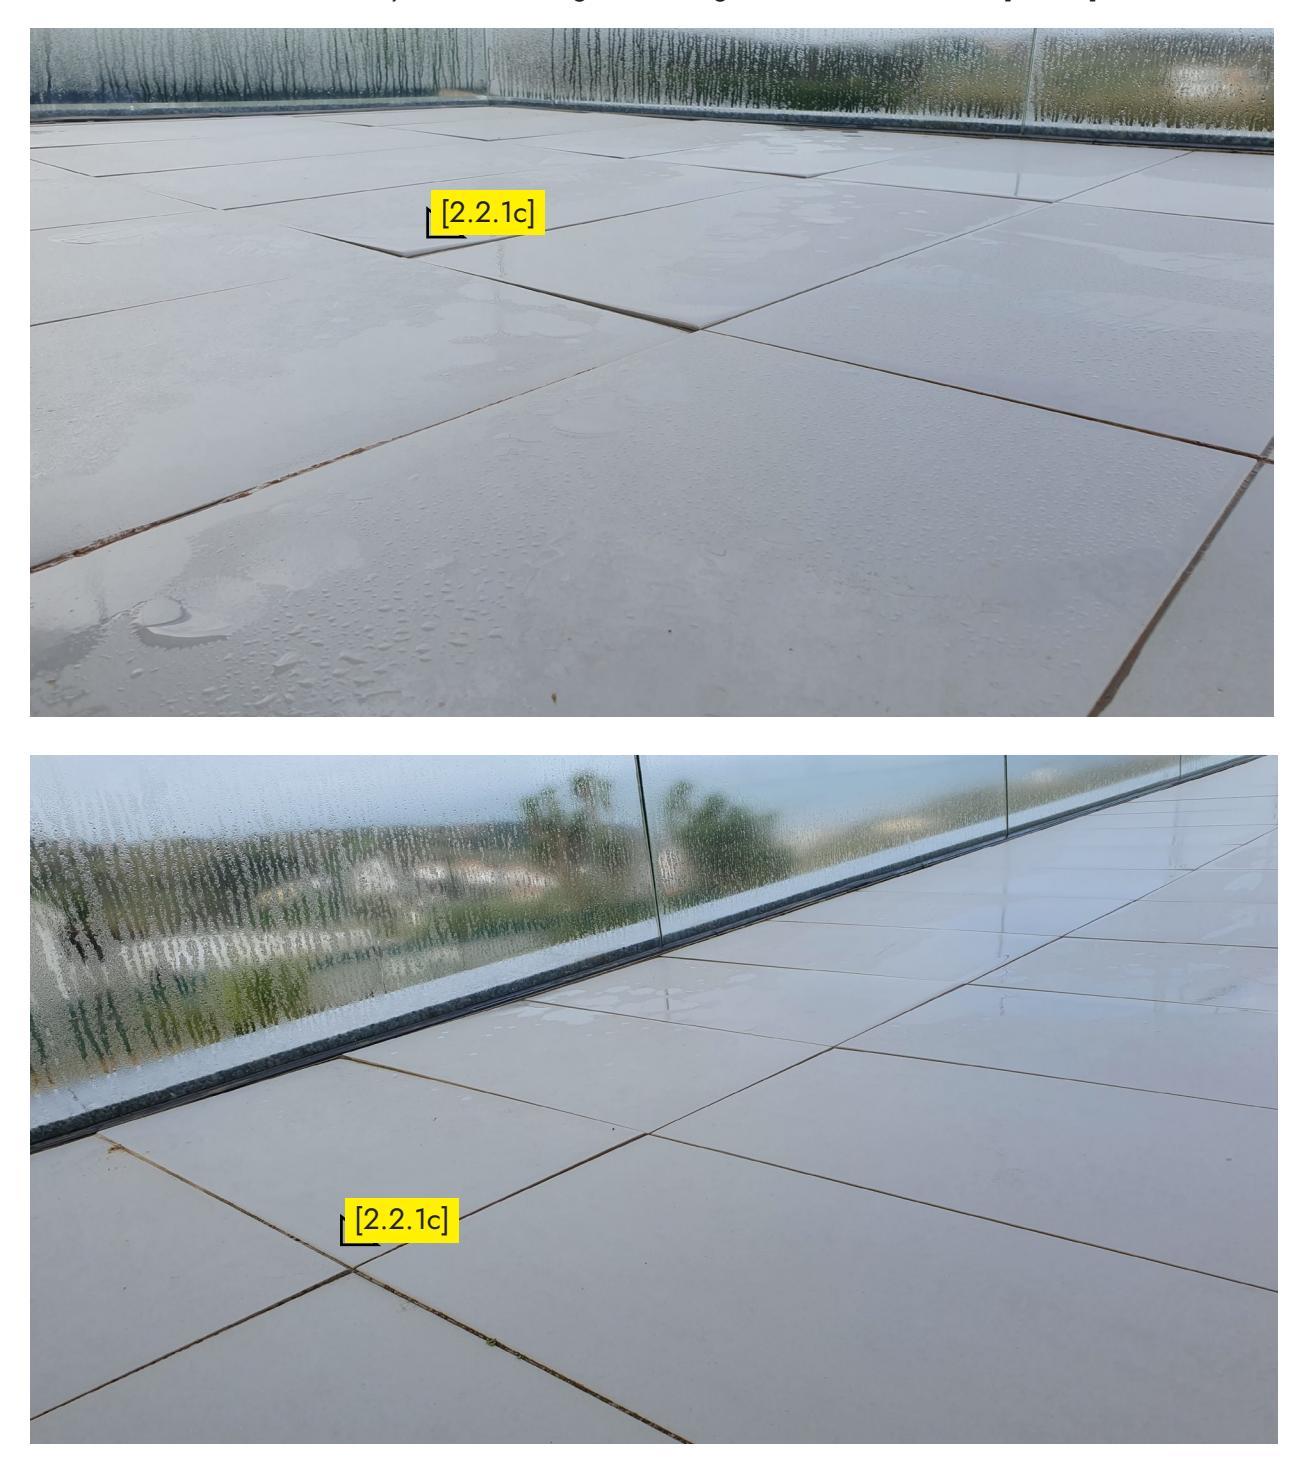
The tile was very poorly bonded to the screed and was easily removed when levered.

The adhesive mortar is not bonded to the tile over a significant area [2.2.1a]. Insufficient adhesive and voids between the adhesive layer and the tile are revealed [2.2.1b].

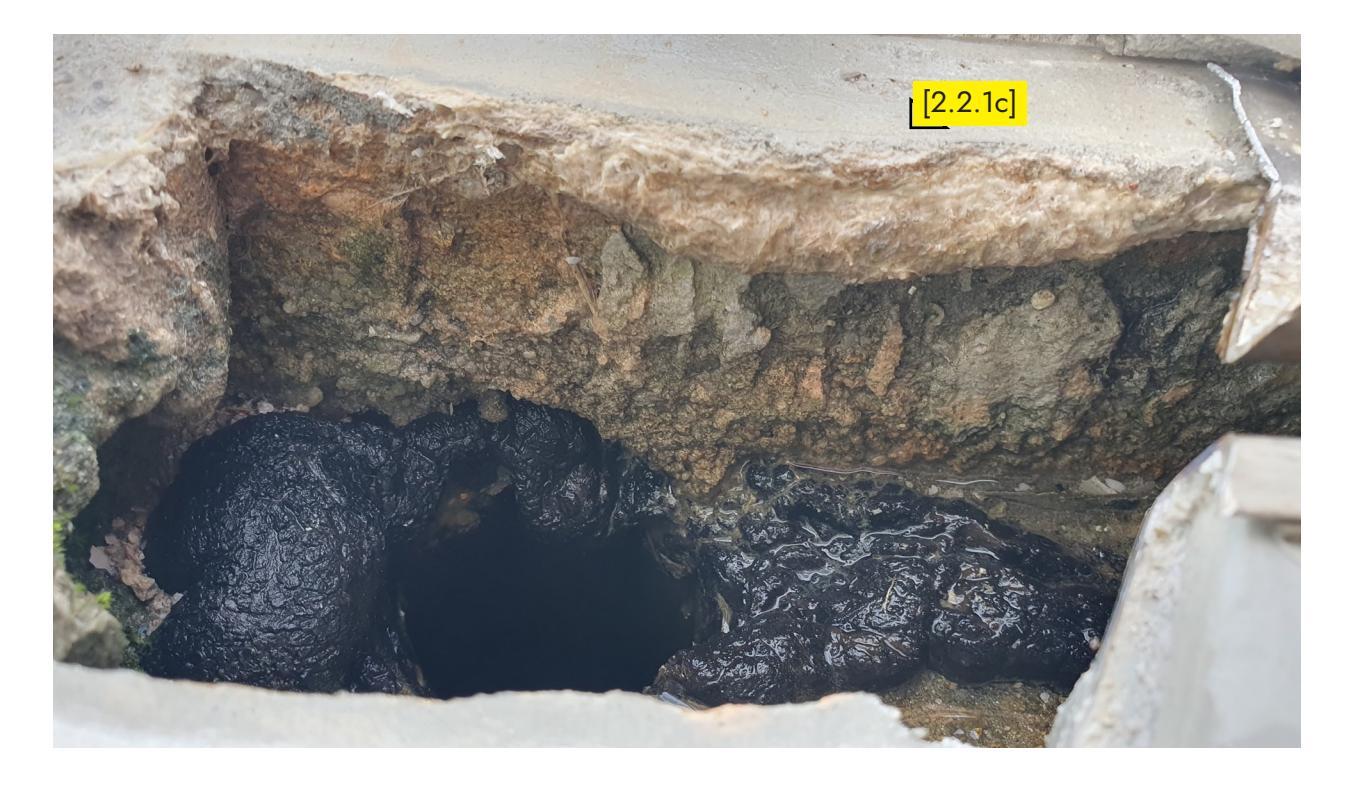
Numerous tiles are defectively laid, their edges standing out from the surface. [2.2.1c].

No waterproofing was found to protect the screed from water penetration [2.2.1c]. The only insulation against the water is the tar fabric on the concrete slab. This causes all the above layers to be penetrated by the rain water sipping thru the grout cracks.

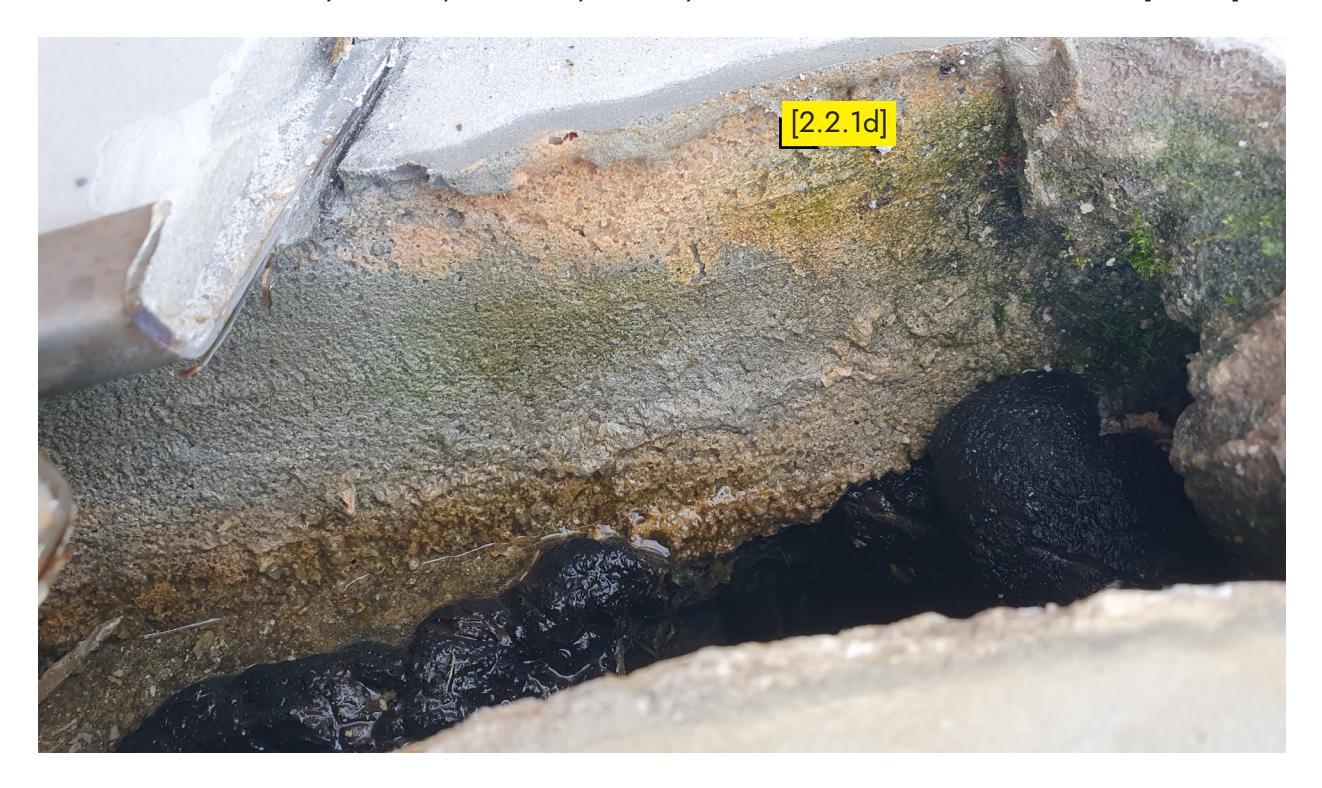
The concrete screed is yellow in places, very crumbly and resembles wet sand in texture. [2.2.1d].

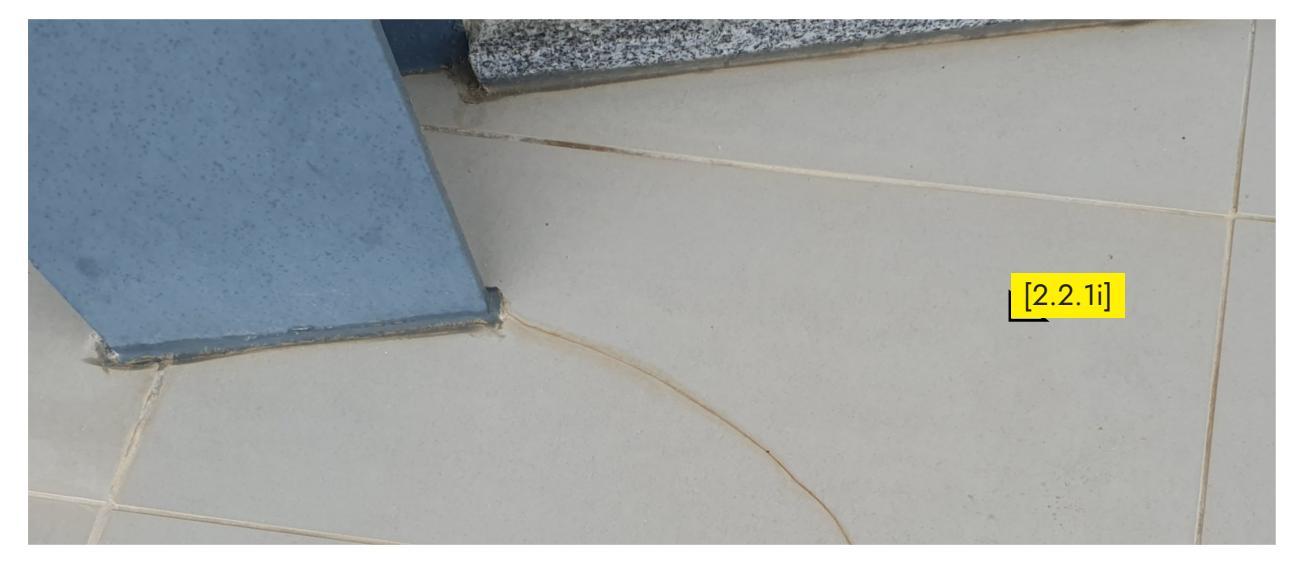
Stress cracks were found in the tiles around the steel pillars of the buildings' superstructure [2.2.1i].

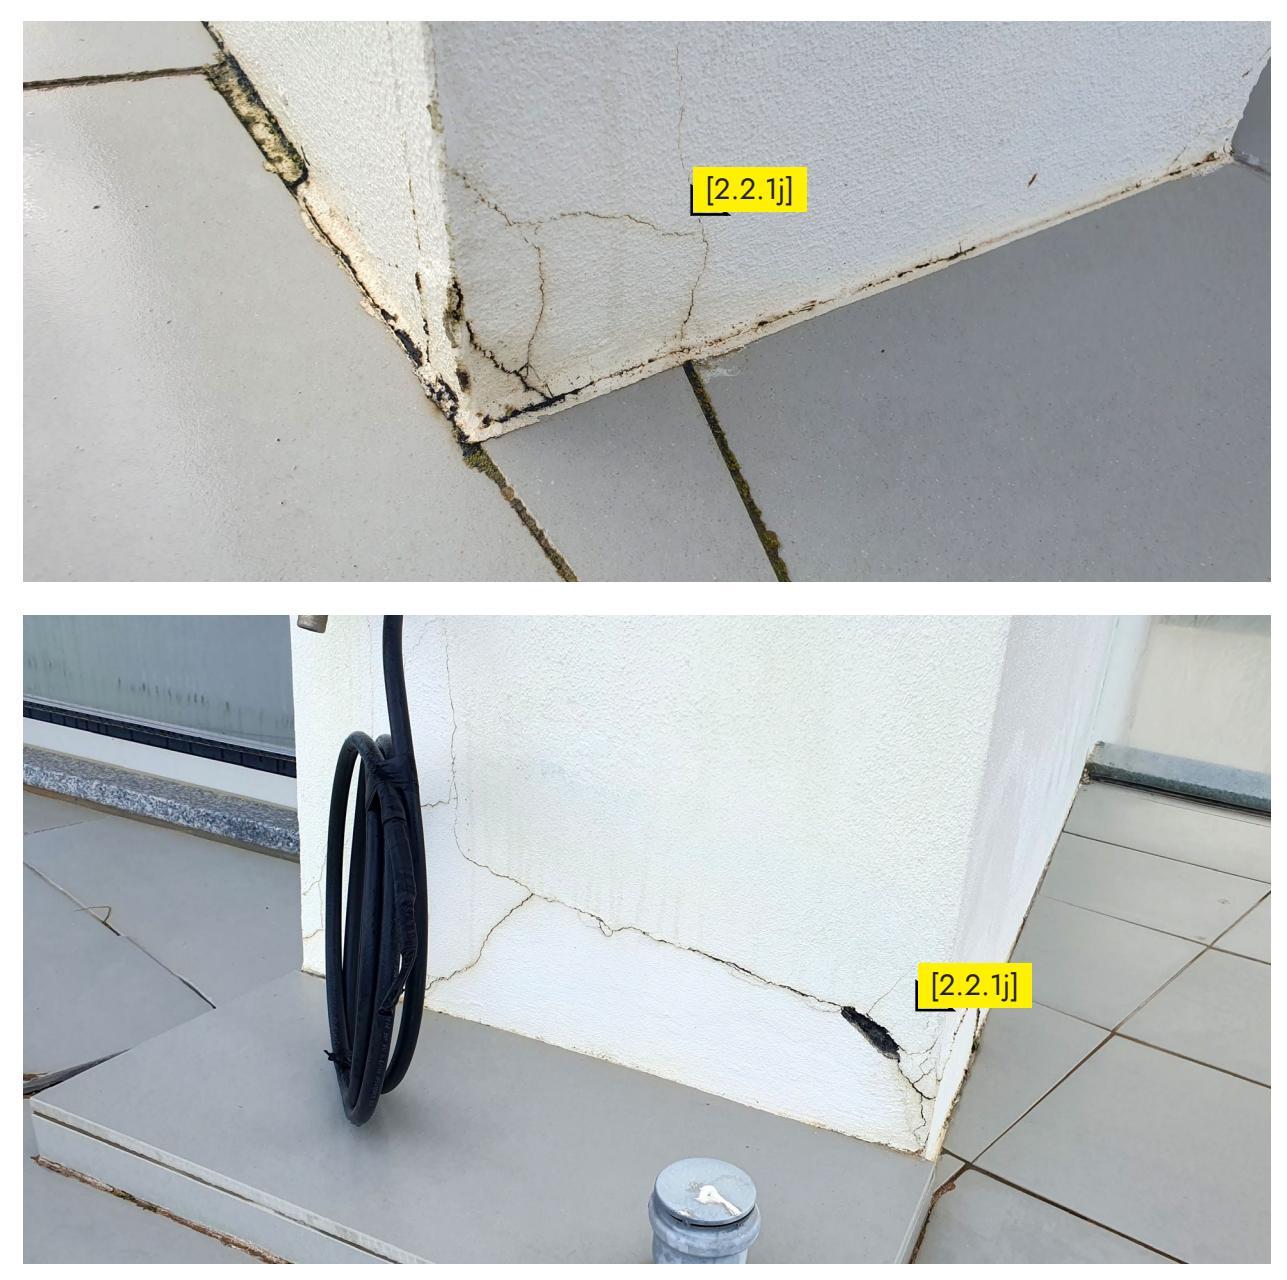
Stress cracks in the area of the connection between the terrace and the wall [2.2.1j].
