# The Report

House No 9

March 2025

This report systematises and organises the numerous construction and workmanship errors occurring in the private residential house located in Lote 3 - Casais Porto Dinheiro.

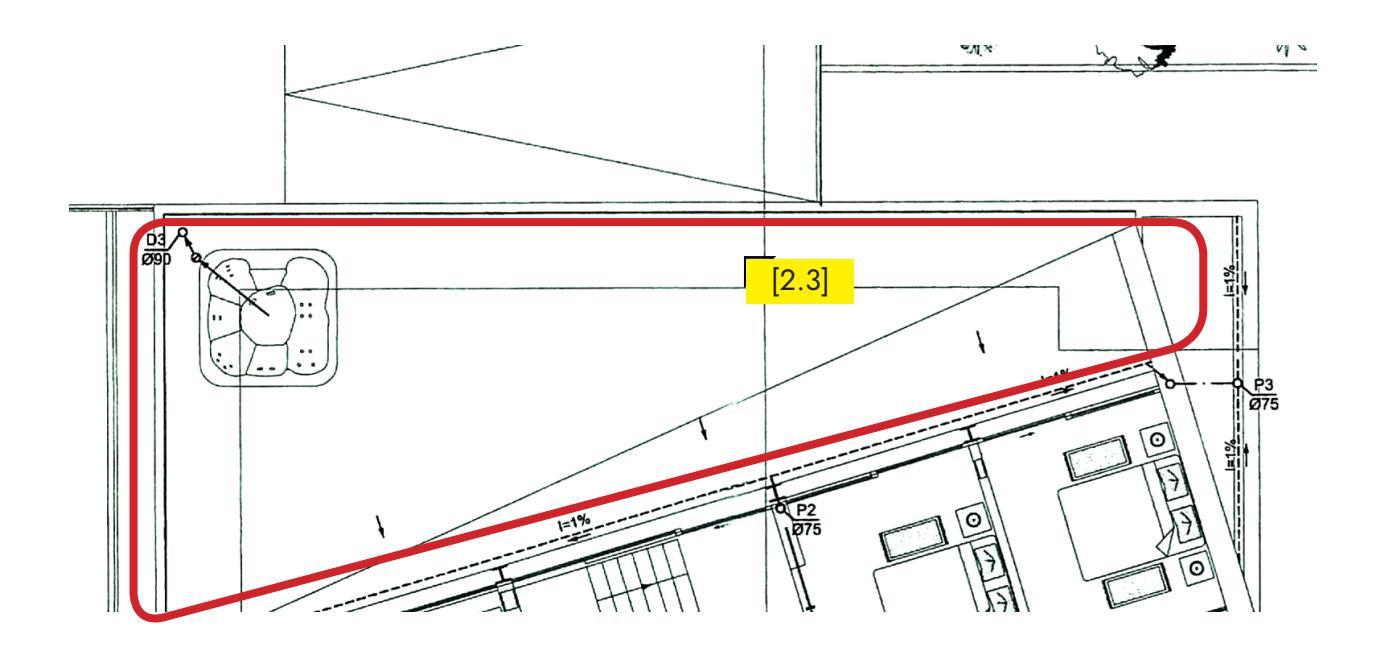
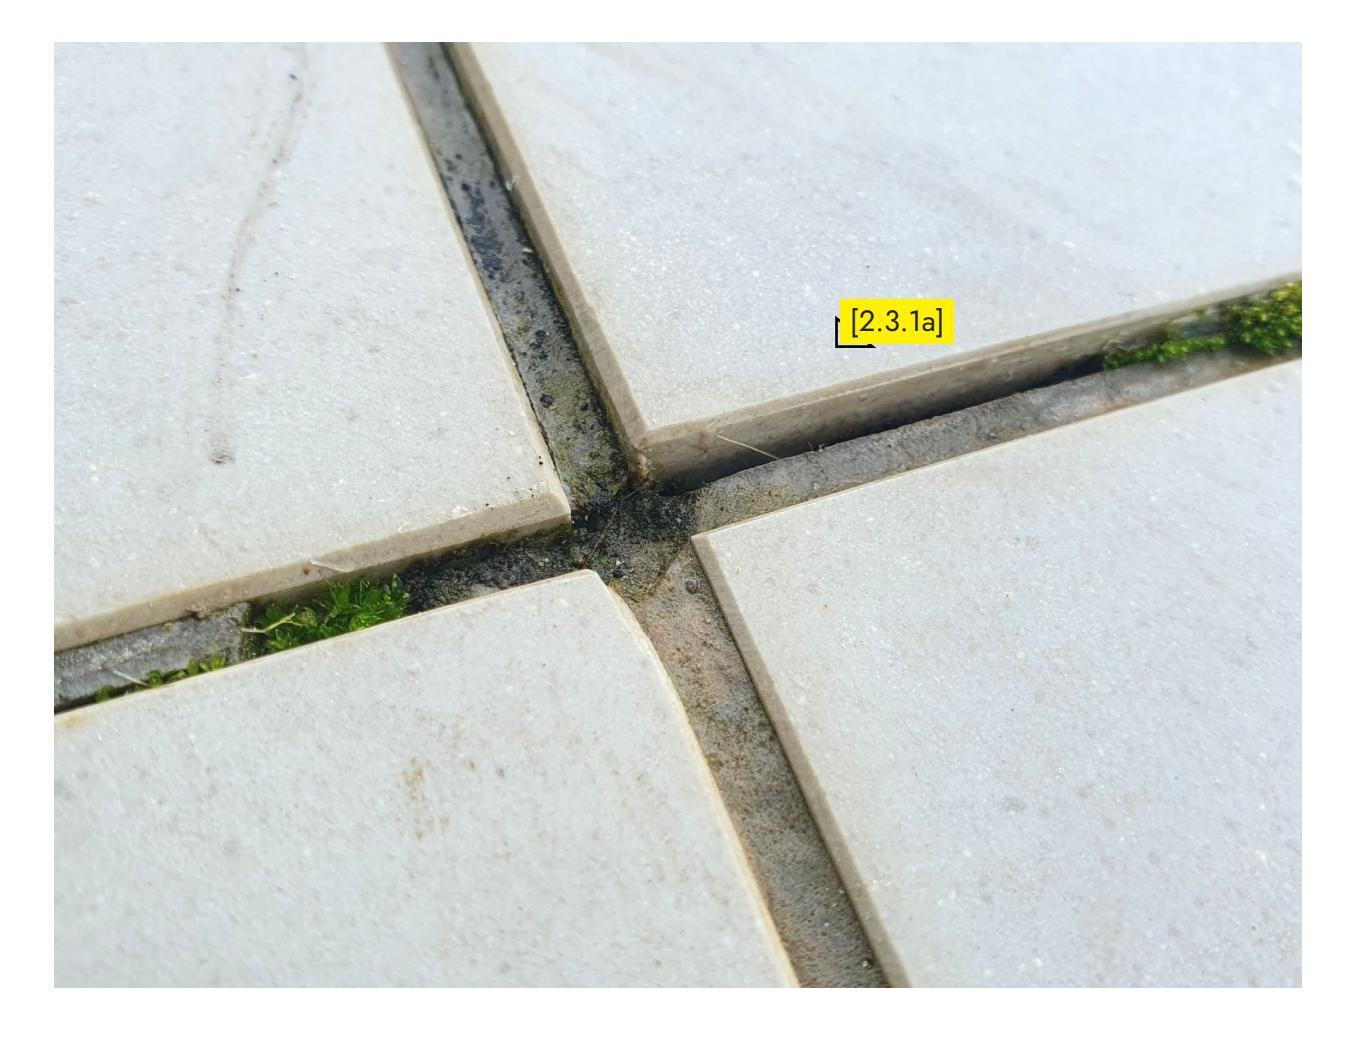
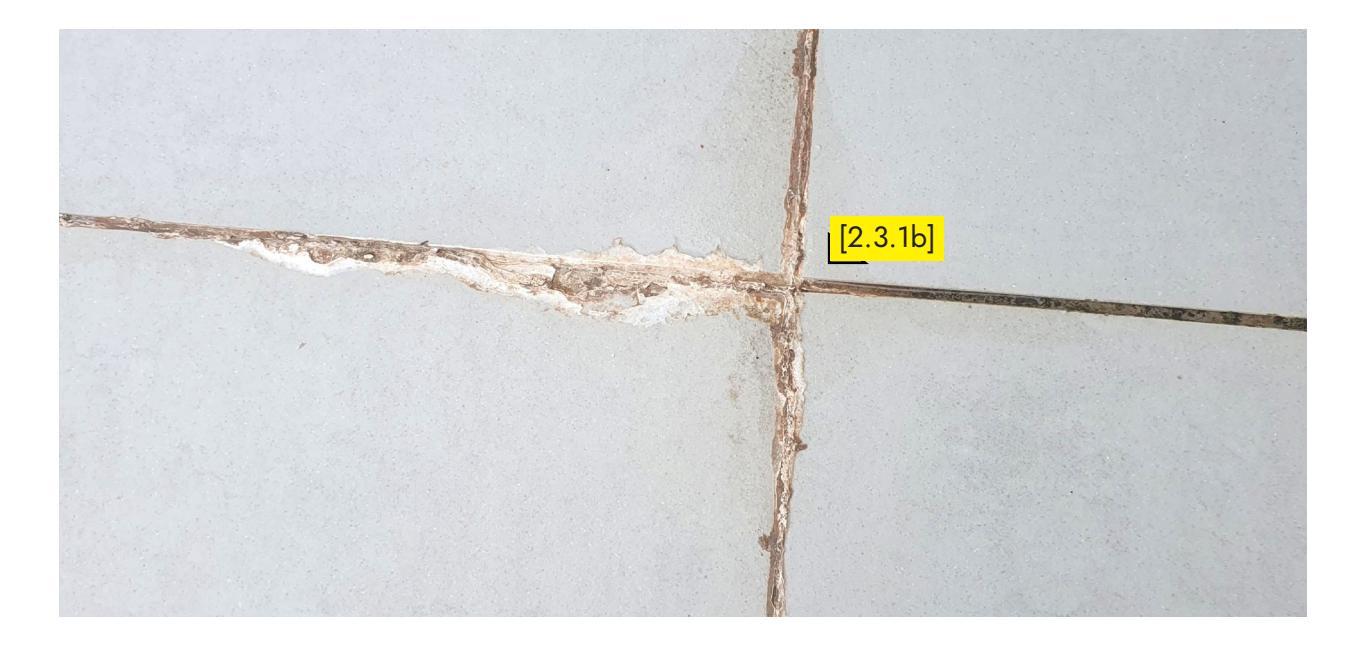
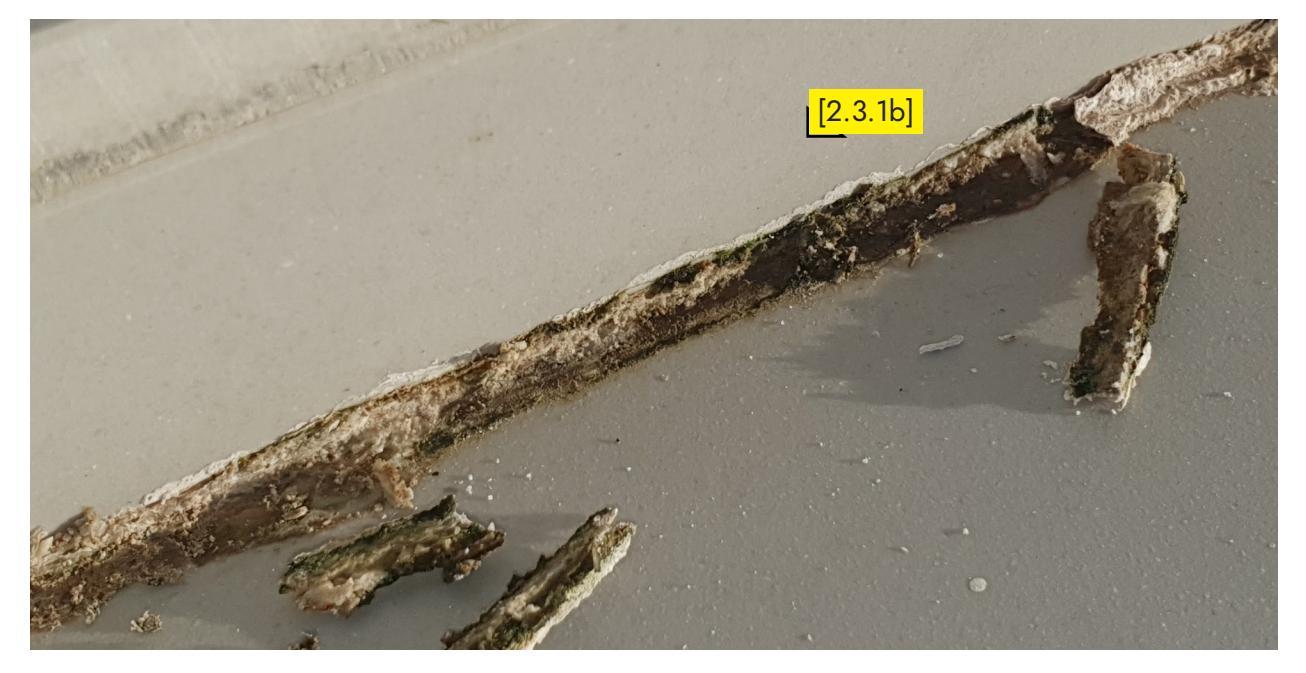
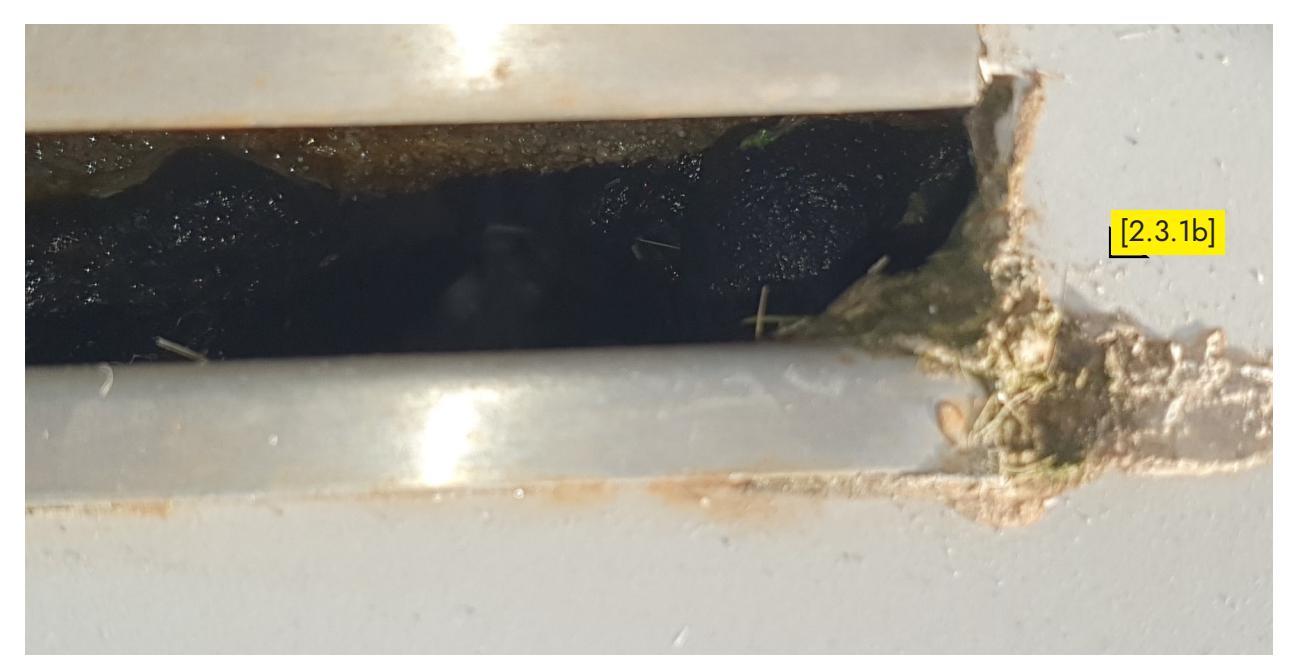
**2.3.1.** Numerous cavities and discolouration in the tile grouts were found on the overall terrace surface. There are many visible instances of grout erosion [2.3.1a].

The connection between the terrace surface and the balustrade is cracked or absent in many places. This creates the possibility of water penetrating into the balustrade attachment points and further erosion. The connection between the balustrade and the terrace should be both watertight flexible.

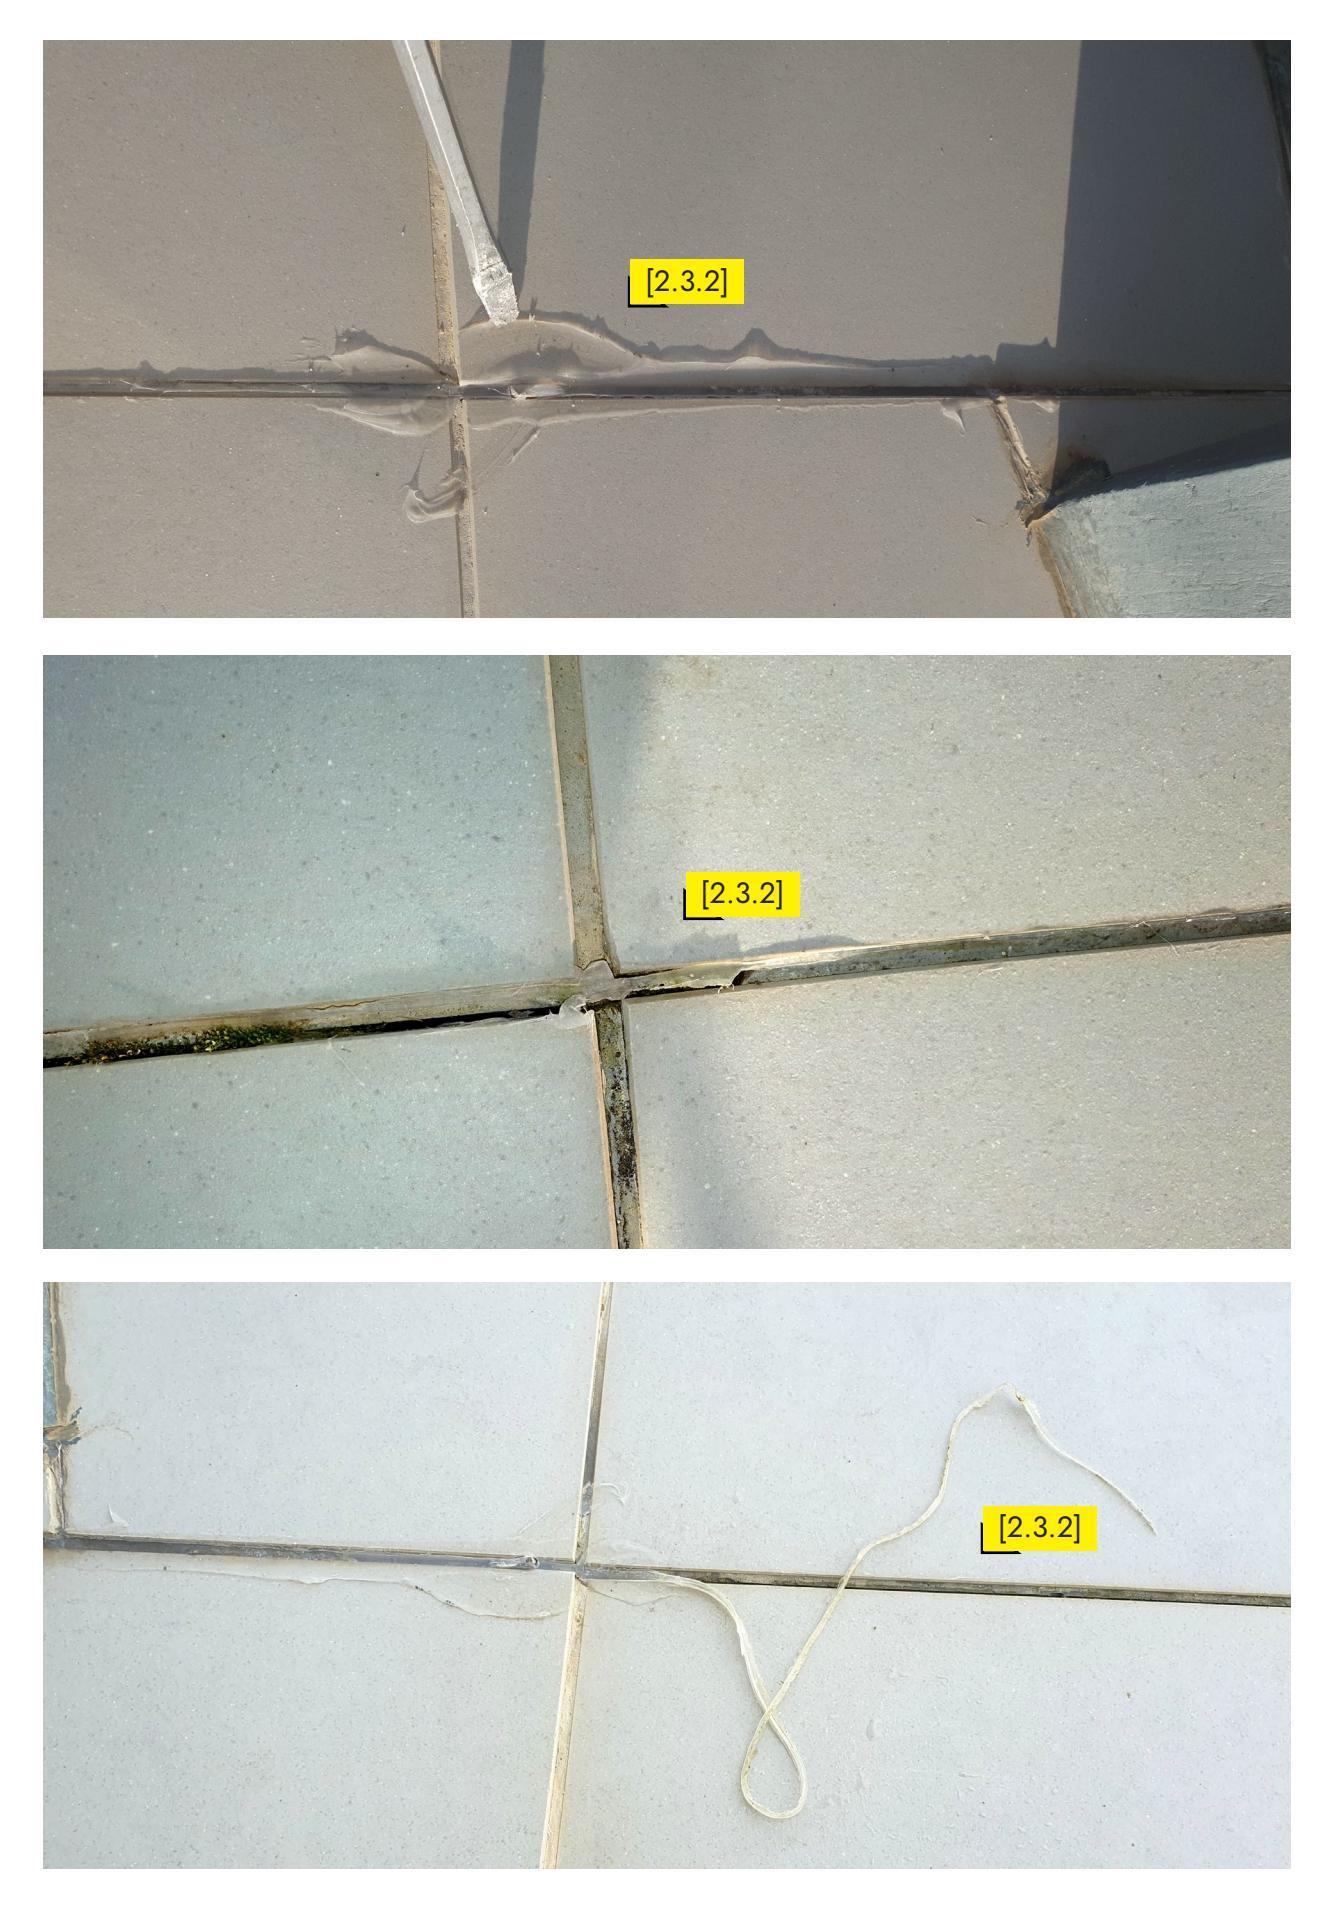
**2.3.2.** Some joints show signs of repair and sealing. These are ineffective treatments because the wrong technology and materials were used. Significant degradation of repaired joints can be seen.

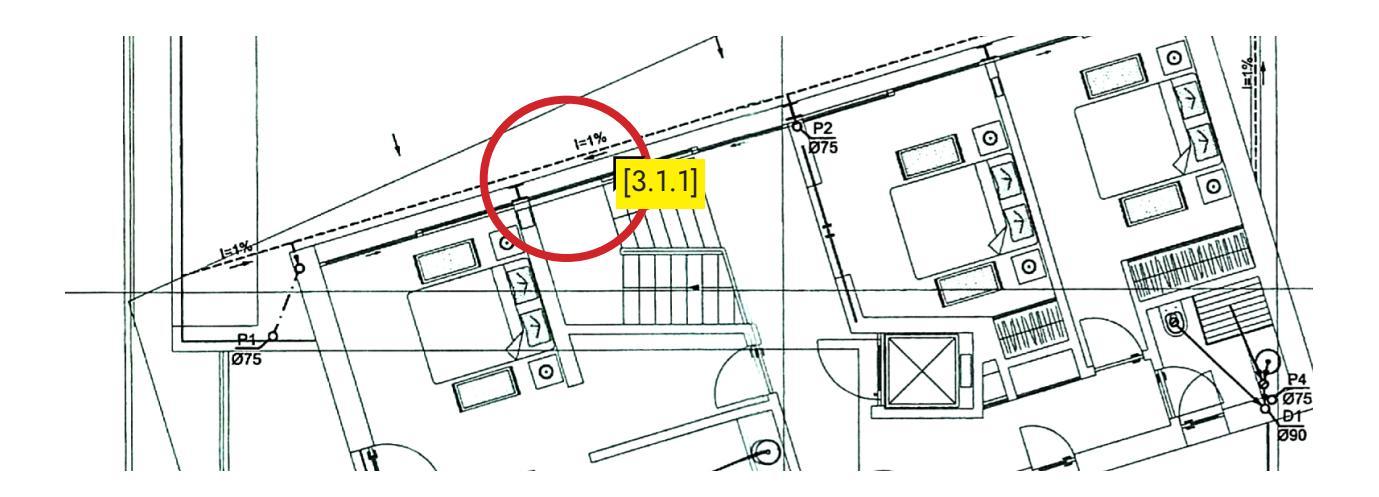
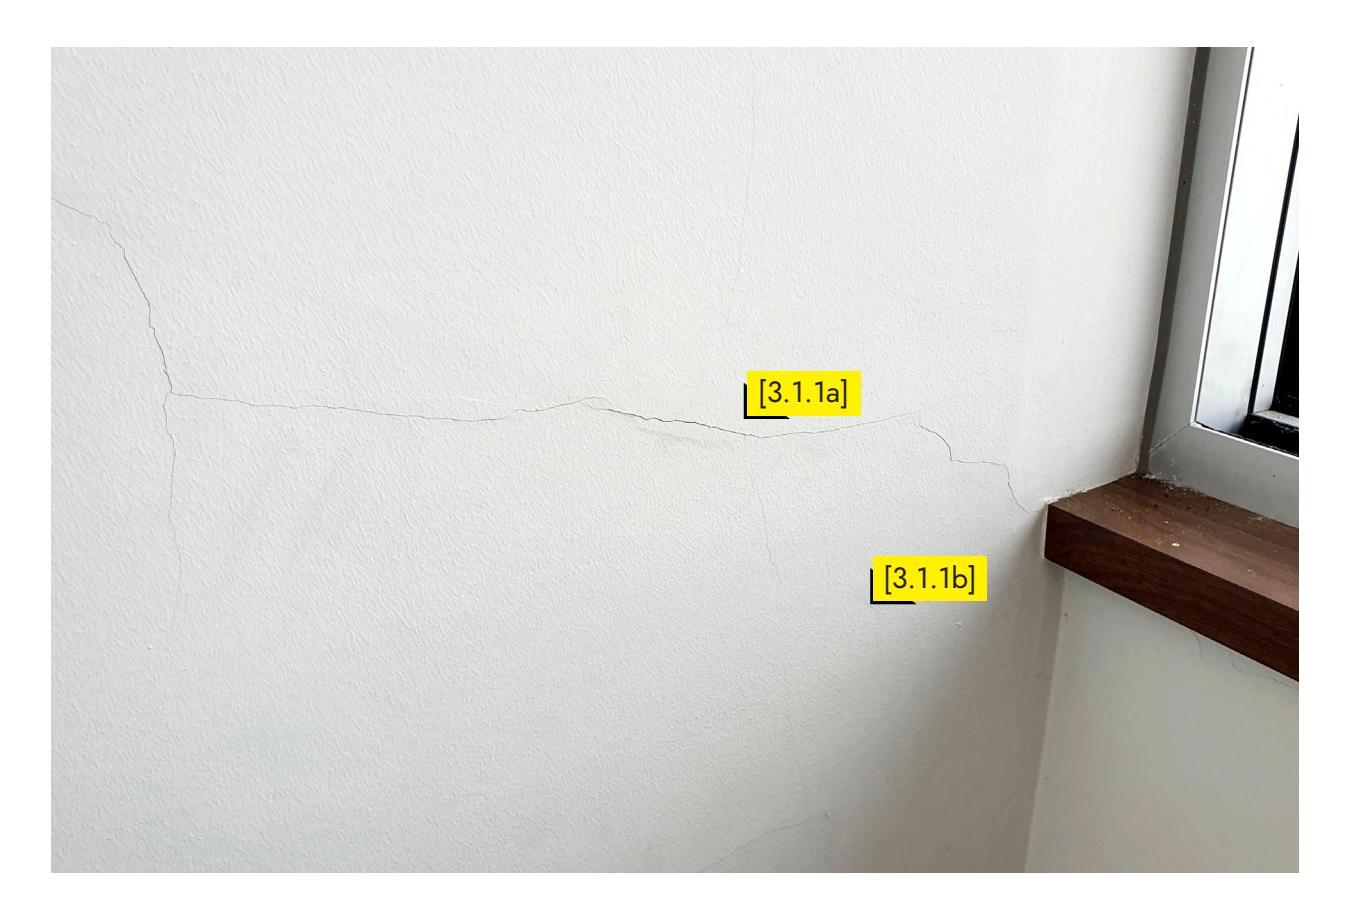
3.1.1. The walls in the stairwell are cracked

Numerous cracks running from the terrace lintel [3.1.1a].

From under the layer of paint, previous cracks in the same area can be seen. [3.1.1b].

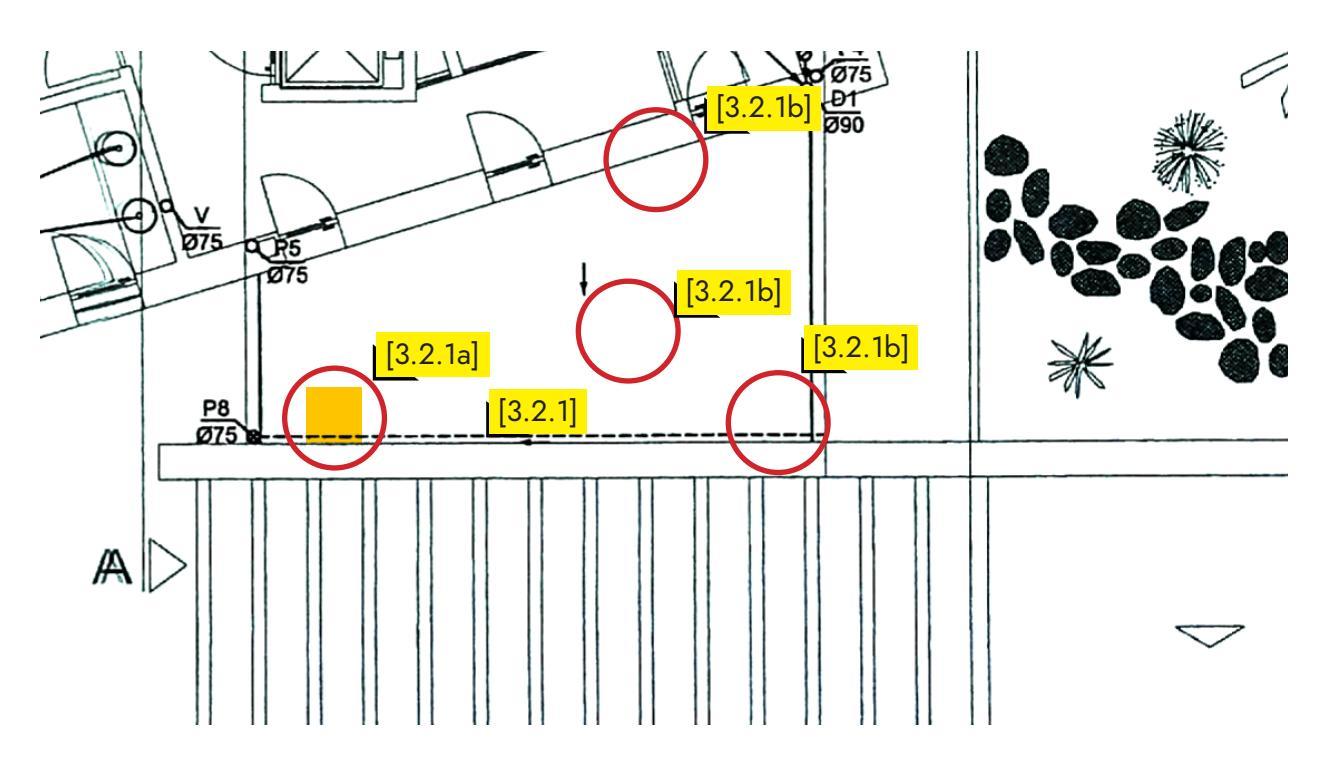
3.1.1. Improperly constructed rainwater drainage from balcony.

The diameter of the P8 drain pipe is 50 mm whereas by the building design it should be 75 mm. In addition, the P8 drain has been placed behind the chimney of the grill located on the patio below. This location of the drain results in the accumulation of debris and plant elements and makes cleaning the drain much more difficult. It should be mentioned that the grill chimney (highlighted in orange) is not present in the building design. [3.2.1a].

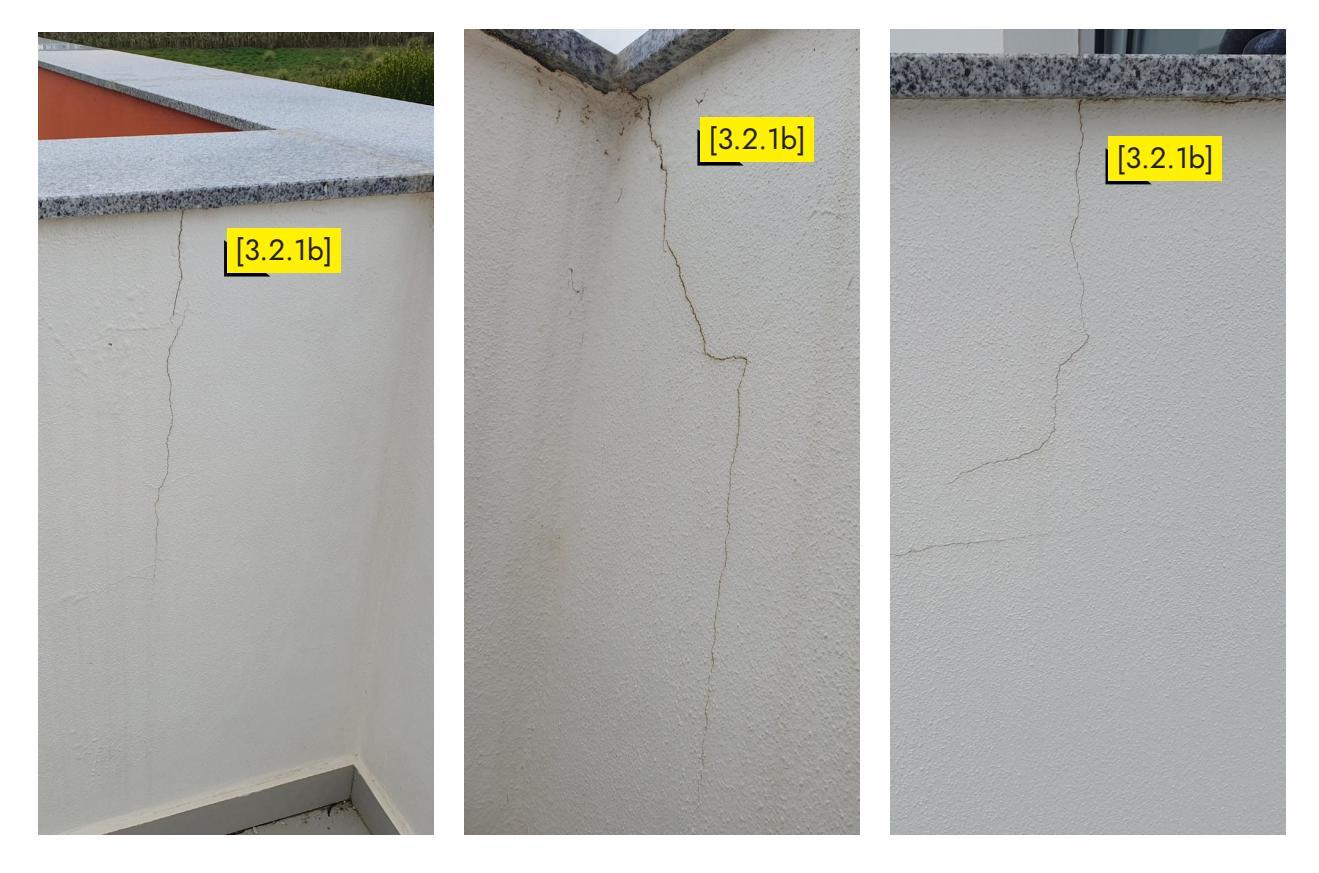
Cracks in the masonry fence of the balcony [3.1.1b].
