Inspection Report of 3 Houses – Ribamar

Case 1573/24

Date of Inspection:  
December 11, 2025

Technical Responsible Tiago  
Borges (Eng.)

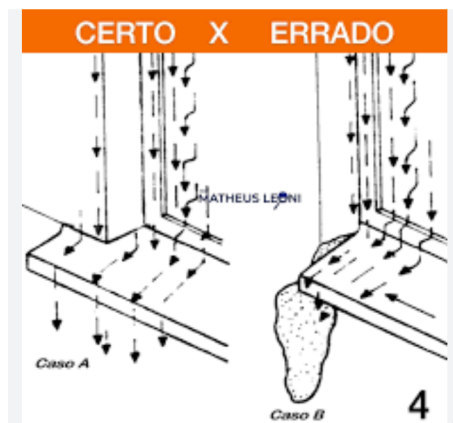
Still on the façade cladding, it is possible to observe that the lower corners of some glazed openings already have some cracking, revealing possible infiltrations on the part of the window and its threshold, as well as deficient application in this area of fiberglass, which obeys a different application from the rest, precisely to avoid this type of cracks, as shown below.

The thresholds of the glazed openings also seem to have insufficient delivery, which can contribute to infiltrations and consequently this type of cracking.

At the corners of doors and windows it is necessary to insert diagonal reinforcement nets to be applied to the bracket before applying the reinforced bar and to be fixed so that the edges of the strips are directly at the corner with an inclination of about 45 °. Network strips typically have a size of approximately 200 x 300 mm. Precast nets can be used.

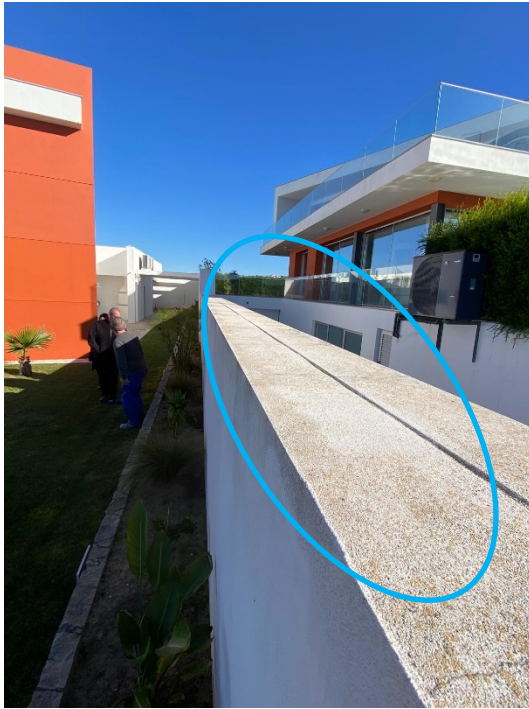
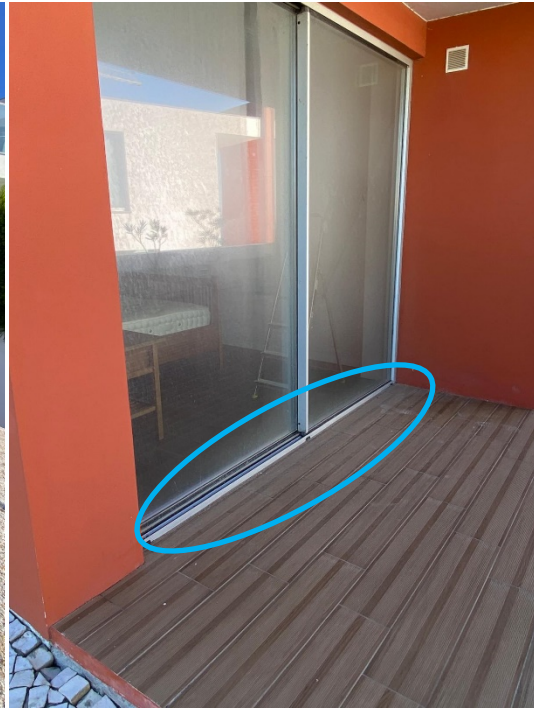
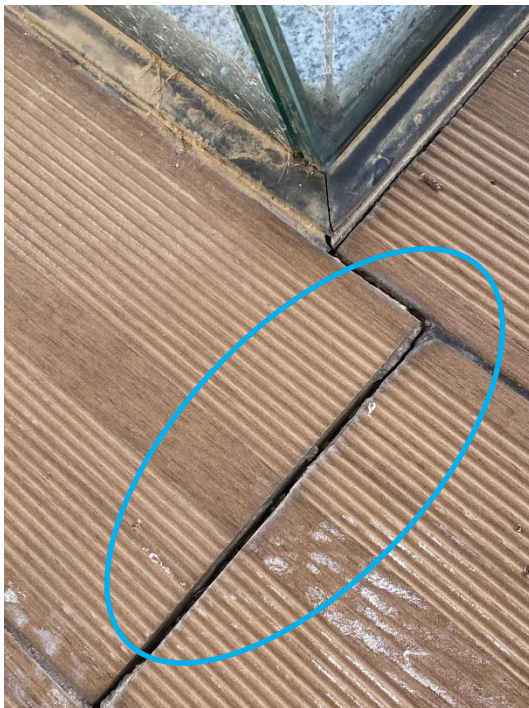
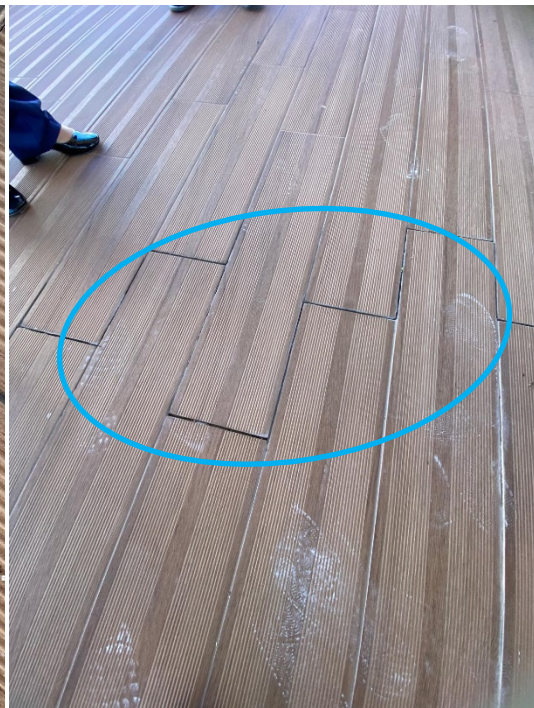
Fotos 43 a 69 – Anomalias indicadas nas fotos

All the capping of the walls of the terraces and roof were executed in stonework, and these stone pieces do not have any drip pan, promoting drainage along the walls where they are applied. In addition to the above, the stonework solution is not the most effective because there is the possibility of infiltrations in the joints of the pieces, it is already possible to observe the presence of organic matter in these joints indicating the presence of water. Once again, aiming at a higher quality, sheet metal capping should have been chosen, as they are more effective in promoting the watertightness of the walls and the overall building.

Regarding the outdoor units of air conditioners, the lack of protection of their cables through a technical rail stands out, to ensure more effective tightness and a more adequate finish, the same happens with the wiring of solar panels.

Some exterior walls also already have some cracking, namely next to some external beams that form a kind of pergola. These cracks are not worrisome, given their size, although they need to be repaired.
