The Report

February 2025

This report systematises and organises the numerous construction and workmanship errors occurring in the private residential house located in Lote 2 - Casais Porto Dinheiro.

The discrepancies were identified based on the construction project of the residential building 12146/2017, hereinafter referred to as The Project.

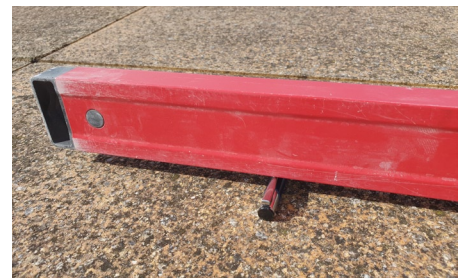
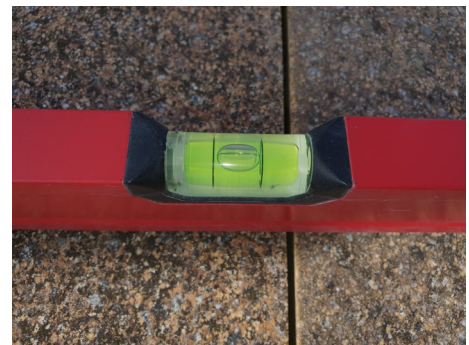
1.1. Roof profile

1.1.1. Roof profiling discrepancies were detected in relation to The Project. In some cases, the roof slope is the opposite of the design. Instead of a slope of about 1% towards the drain holes, a counterslope of about 0.5% was detected, which causes water to flow away from the drain hole.

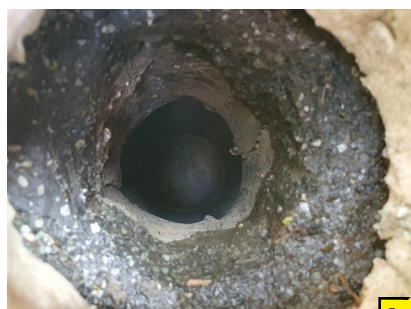
[1.2.1]

1.2.1. All the downpipes (P1-P4) from the roof are of insufficient diameter.

In the Project, the pipe diameter was specified as 75 mm, while in reality the pipes have a diameter of less than 50 mm (their diameter was reduced by the layers of roofing felt rolled inwards).

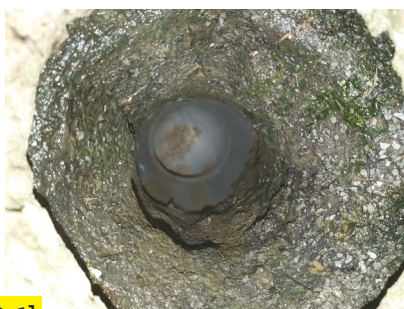
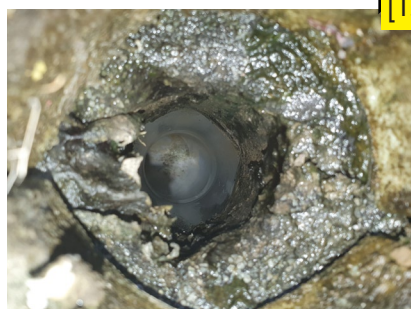
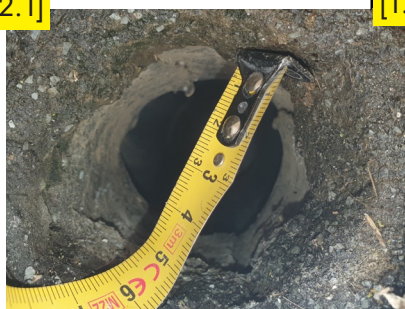
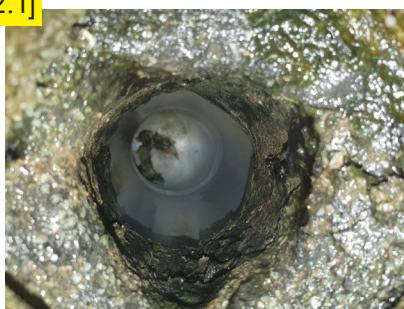
1.2.3. The water drainage through the roof ceiling was done incorrectly, as the bare ceiling slab is visible in the drainage holes. It is only partially covered by roofing felt bent inwards.

This allows water to penetrate through cracks in the concrete and further flood the house.

1.2.4. Drainage holes should be fitted with an appropriate outlet fitting. Its apron should be welded to the roofing felt and the drain should be sealed in the downpipe.

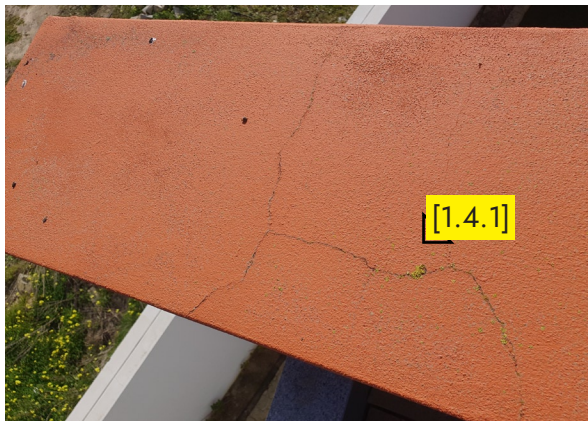
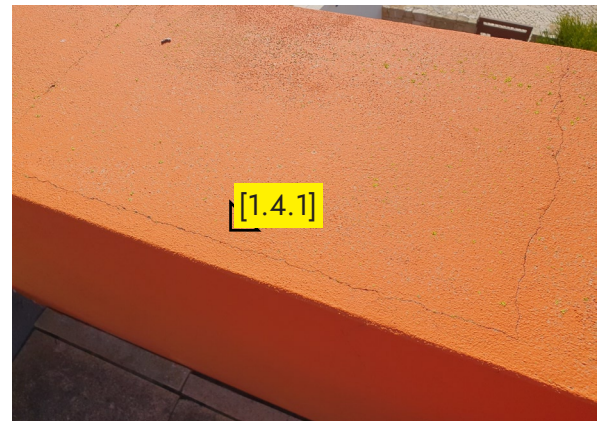
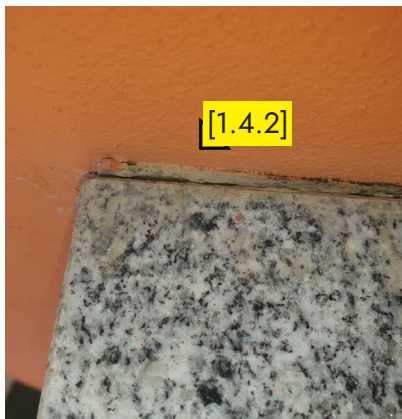
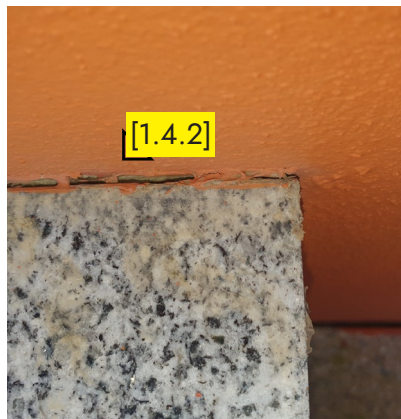
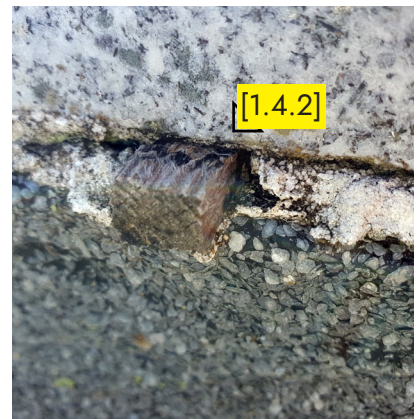
1.4. Cracks and other defects

1.4.1. The orange attic wall is all ckracked on top, with vegetation and water penetration inside. Lack of wall copings.

1.4.2. The other roof attic walls have copings made of stone, with many defects also lack of the grout on connections, improper connection with orange plastered wall and even a wooden dowel left behind.

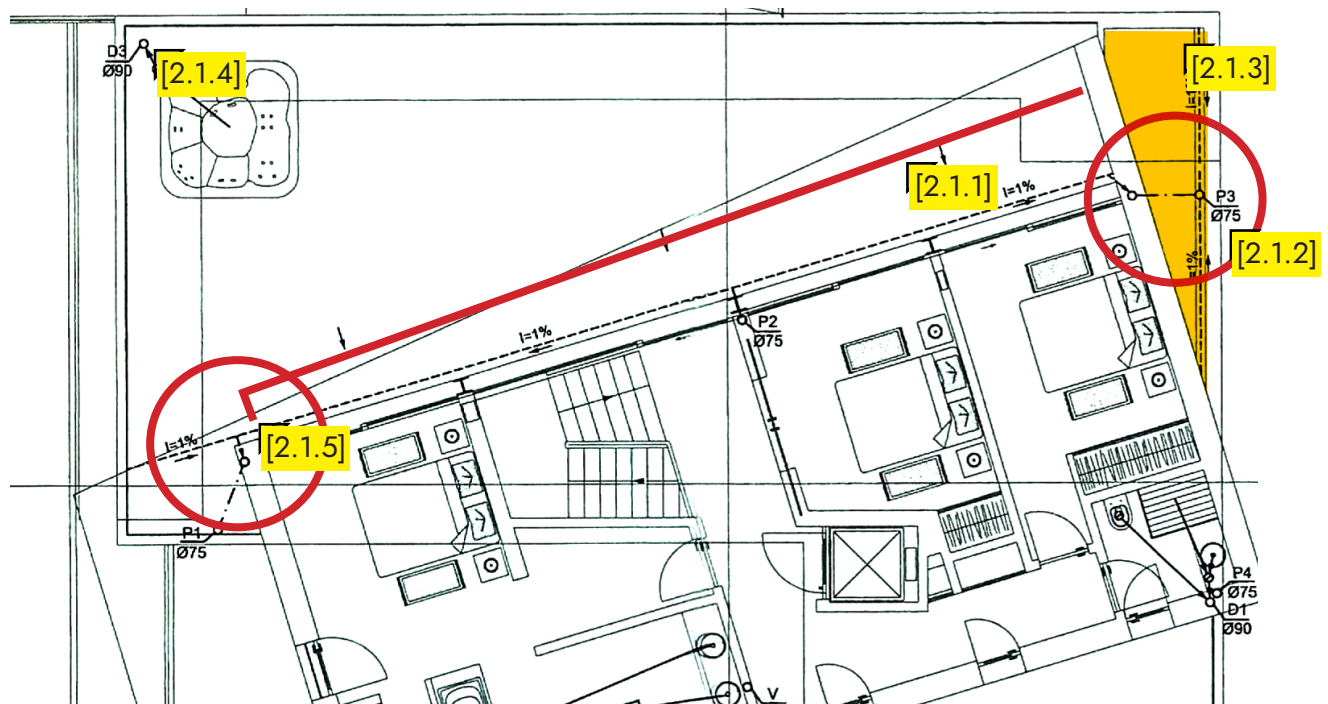
2.1.3. Furthermore, the drainage trough at P3 cannot serve as a support for the terrace drainage, as the part marked in orange is about 8 cm higher than the rest of the terrace!

2.1.4. The drainage for the jacuzzi pool (D3, 90 mm) was not made at all.

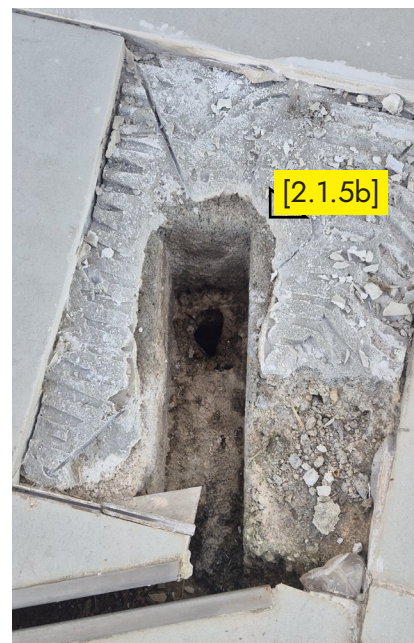
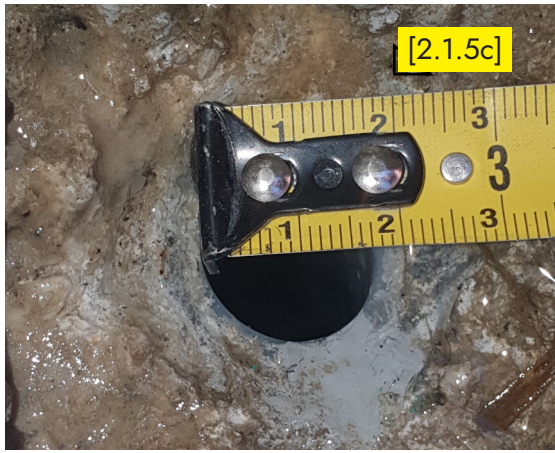
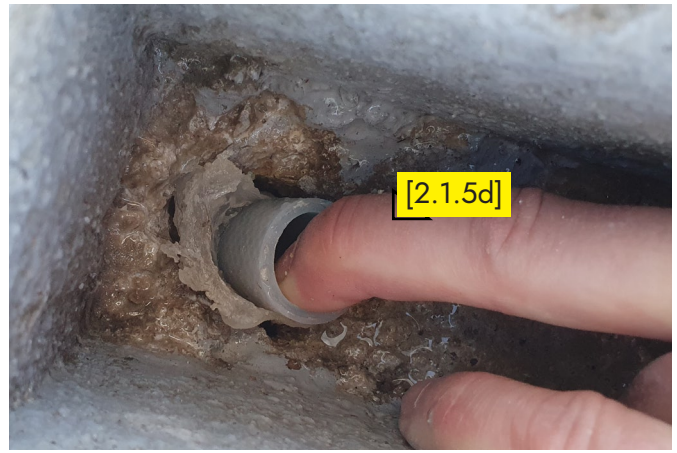
(b) The hose is embedded in an random-shaped hole in the screed, with visible ineffective attempts to seal around it [2.1.5d]. Using an endoscopic camera inserted into the hose, it was found to be completely blocked with sandy sediment.

At this point, it should be emphasised that such an arrangement is extremely prone to failure and, given the small diameter of the drain and the very difficult access to it, impossible to maintain in proper working order. The total cross-section of the terrace drainage pipes was undersized by more than 35 times!

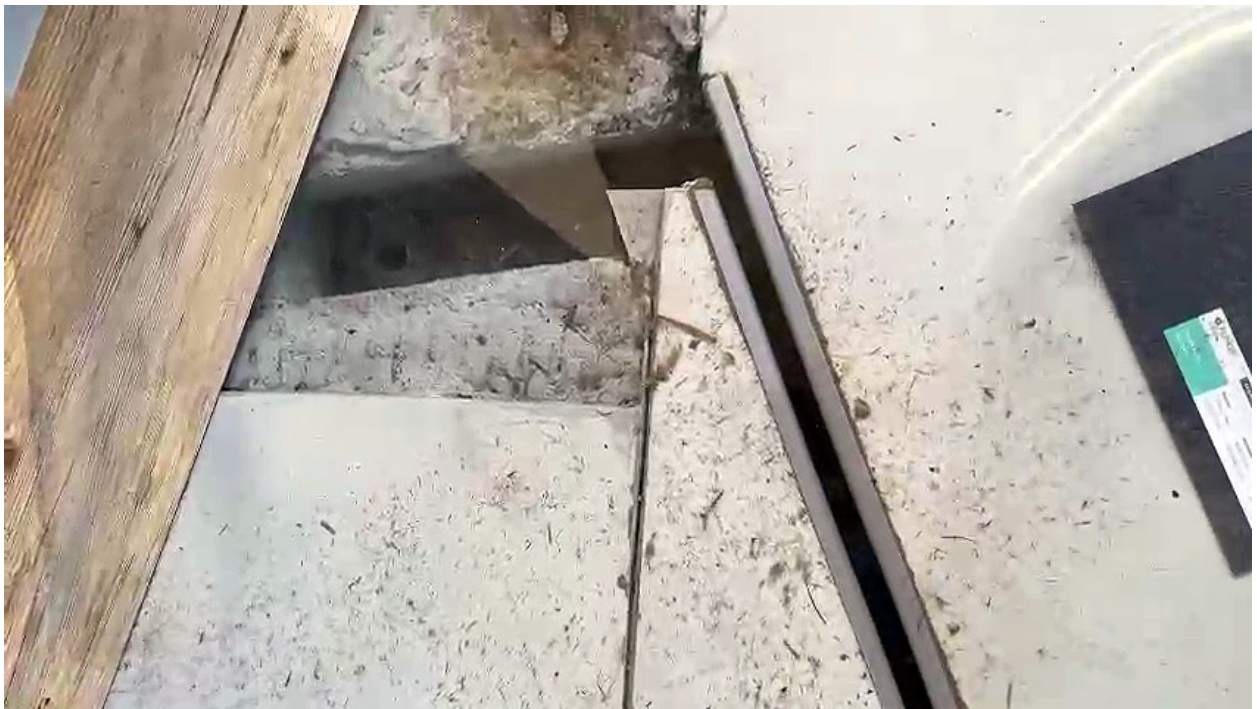
Despite exposing the drain hole and many attempt to unclog it, the water stored on the terrace could not be drained.

It was necessary to mechanically remove the water from the terrace.

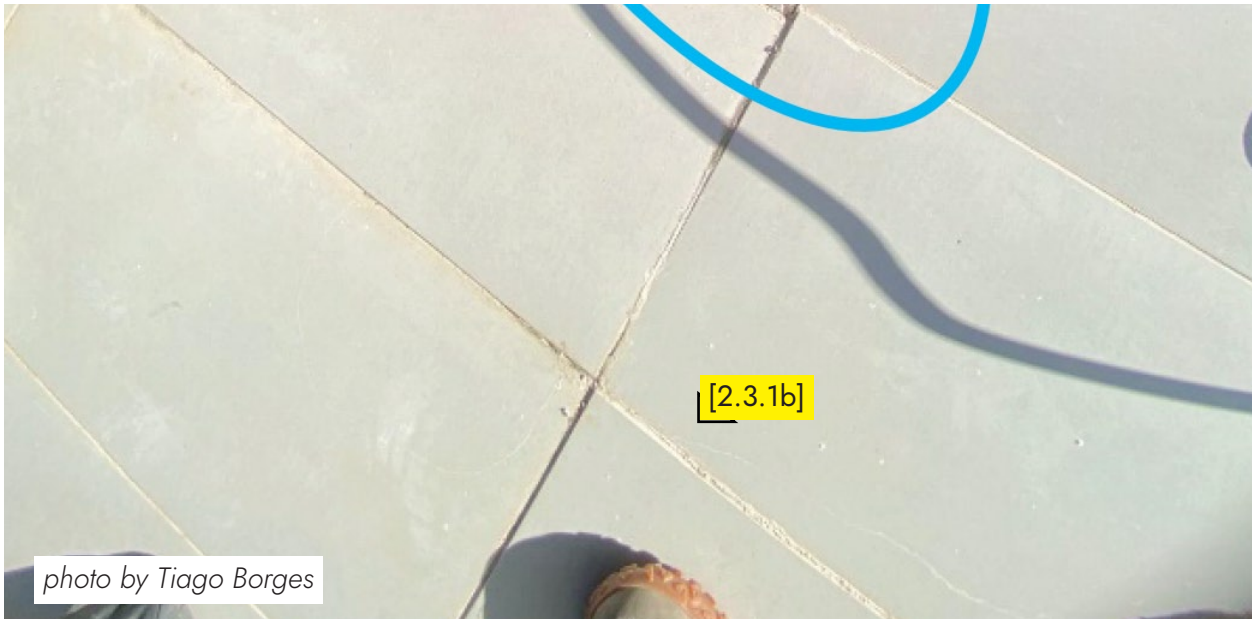
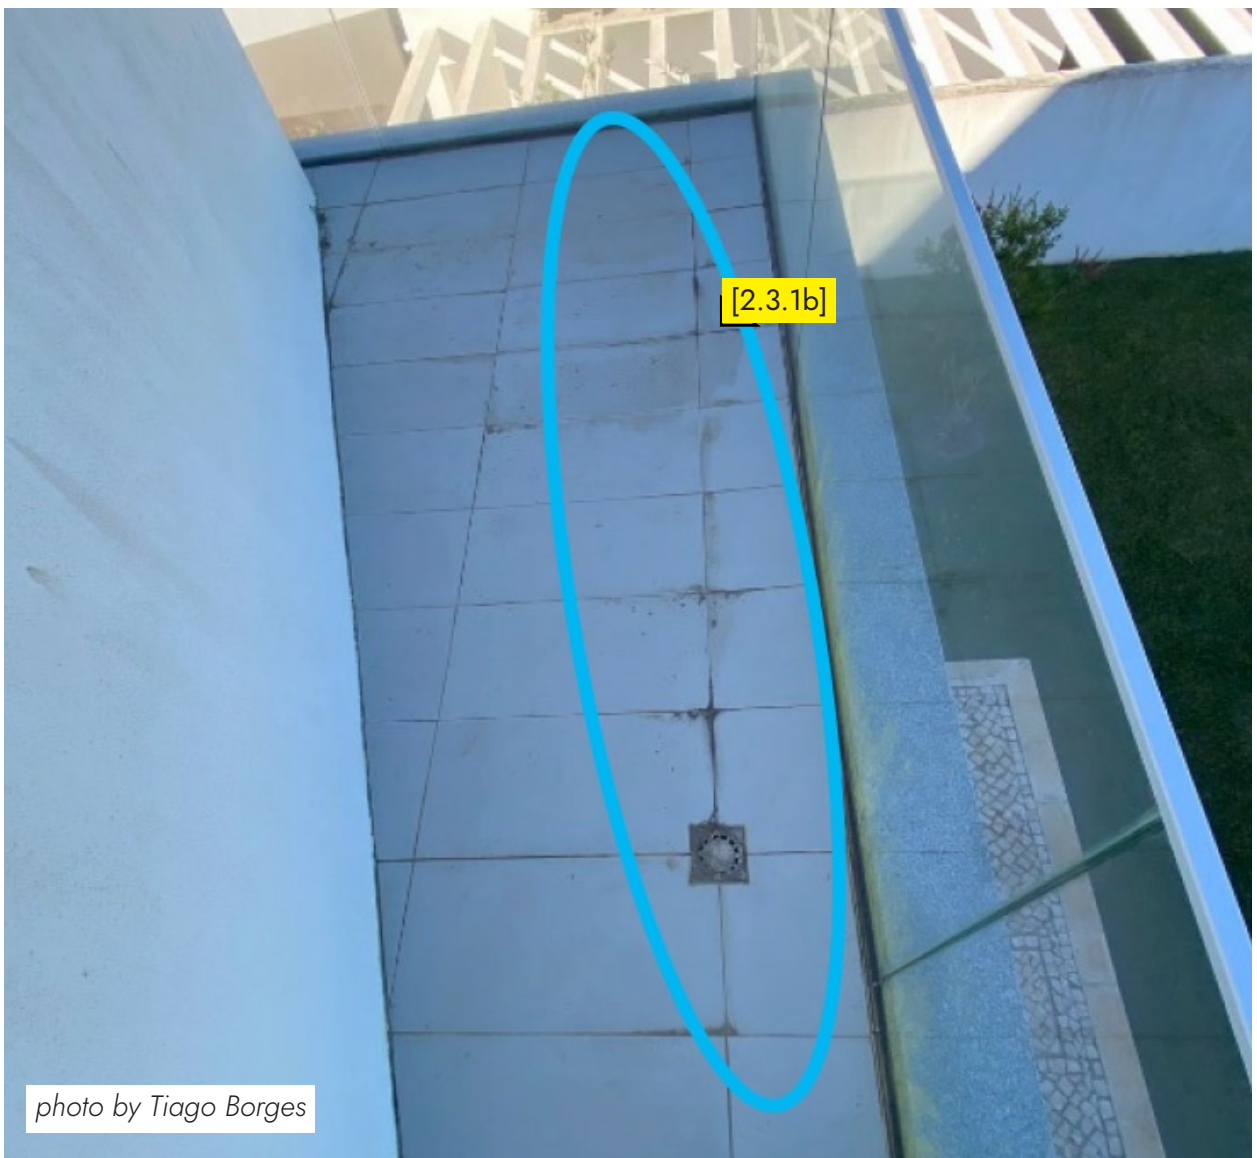
2.3.1. Numerous cavities and discolouration in the tile grouts were found on the overall terrace surface. There are many visible instances of grout erosion [2.3.1b].

The connection between the terrace surface and the balustrade is cracked or absent in many places. This creates the possibility of water penetrating into the balustrade attachment points and further erosion. Numerous vegetation can be seen nestled in the cracks [2.3.1a].

The connection between the balustrade and the terrace should be both watertight flexible.

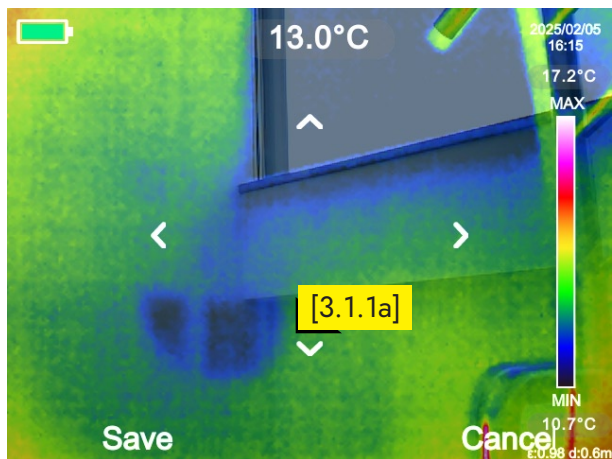
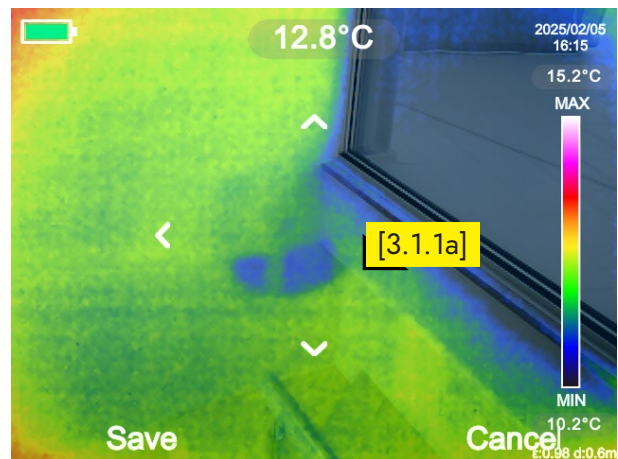
3.1.1. Water in the stairwell wall.

Using a thermal imaging camera, dampness was detected in the west wall of the stairwell [3.1.1a]. Discolouration, cracks, paint chipping and plaster degradation can be seen in the area where the terrace floor slab meets the wall [3.1.1b].

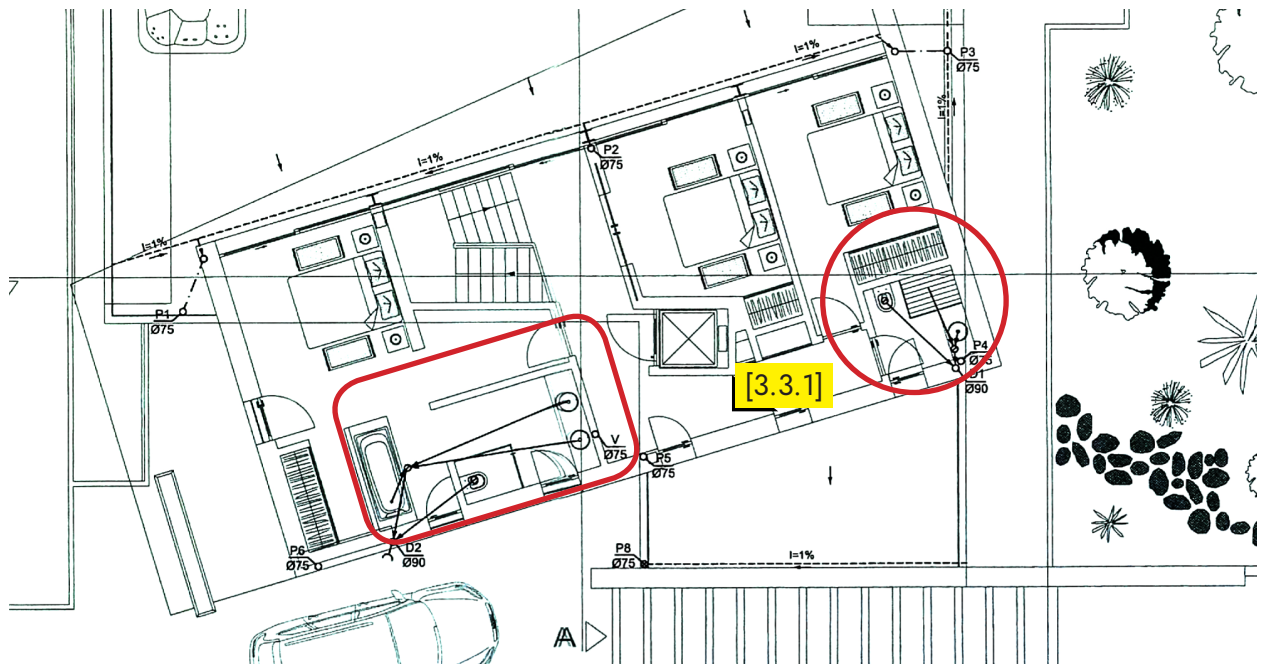
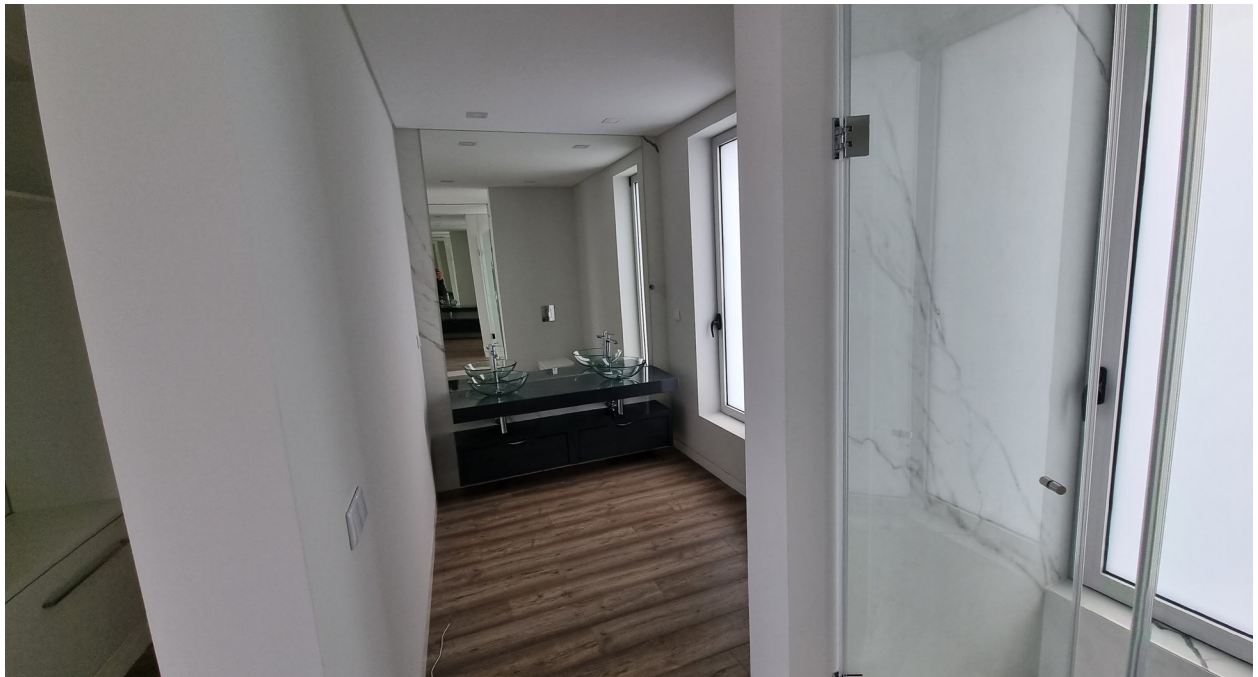
All odours and dampness will be allowed to enter the living areas and soak the the clothes in the open wardrobe located near by.

The opinion that this is not required when windows are open is not true, as this would mean that during cold or rainy weather, residents would be forced face the weather elements to provide ventilation.

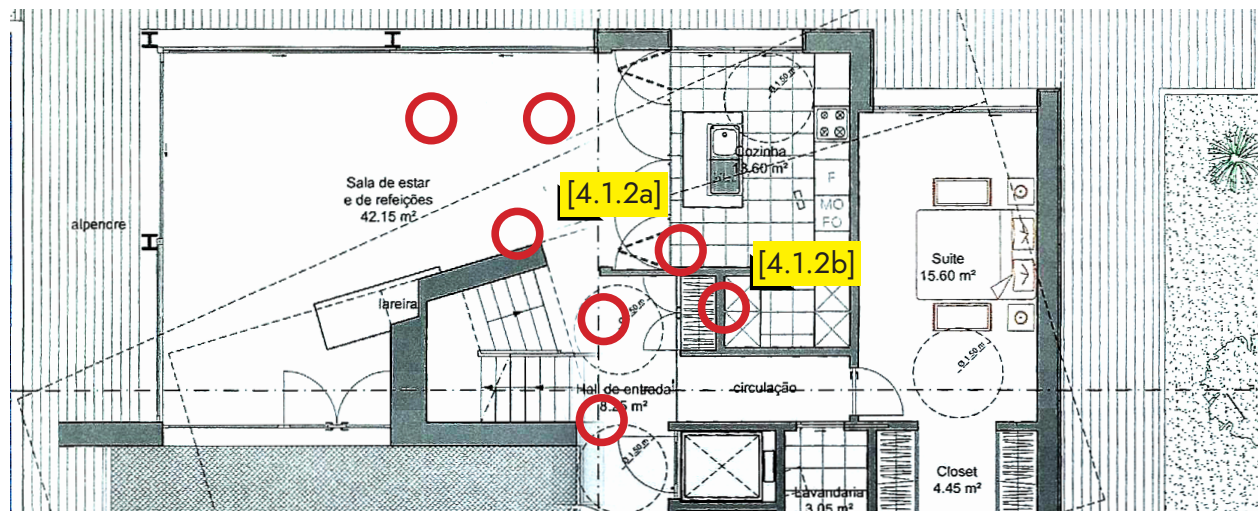
A consequence of the leaking terrace is the repeated flooding of the kitchen and living room with rainwater. On a number of occasions, water was observed dripping down the stone wall in the middle of the living room, water dripping from lamps suspended above the table, water dripping from light fittings on the ceiling [4.1.2a].

There is a distinct smell of mould in the space above the suspended ceiling!

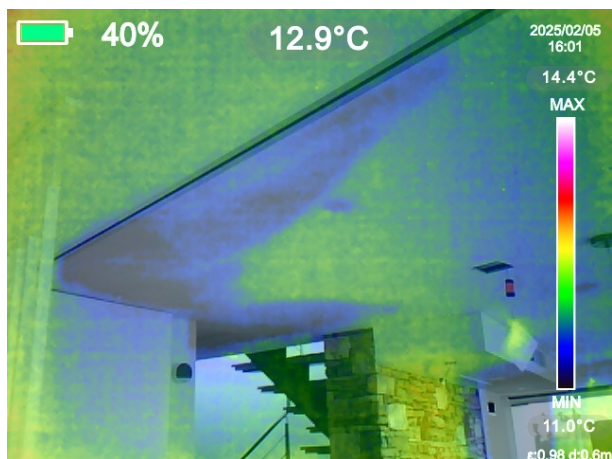
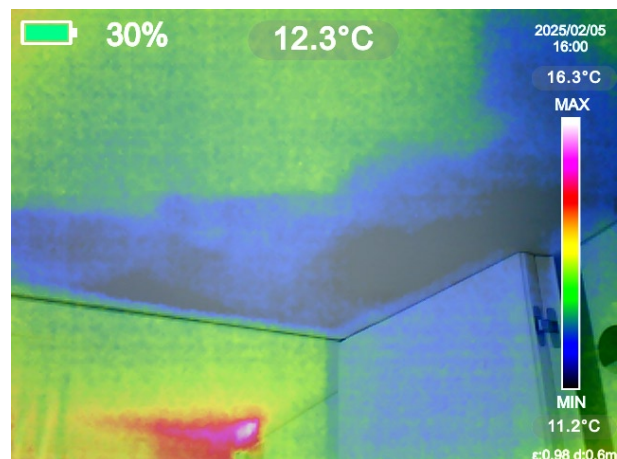
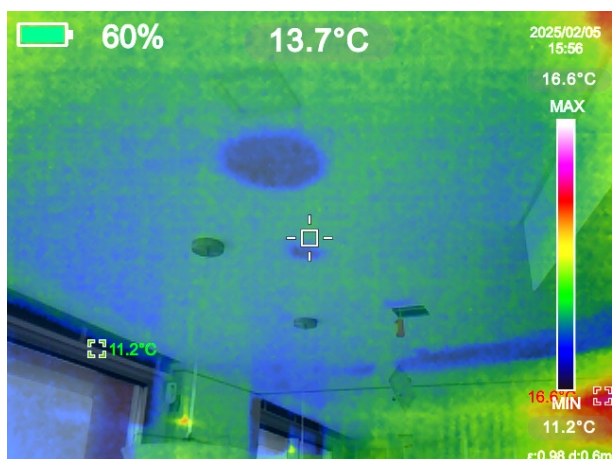
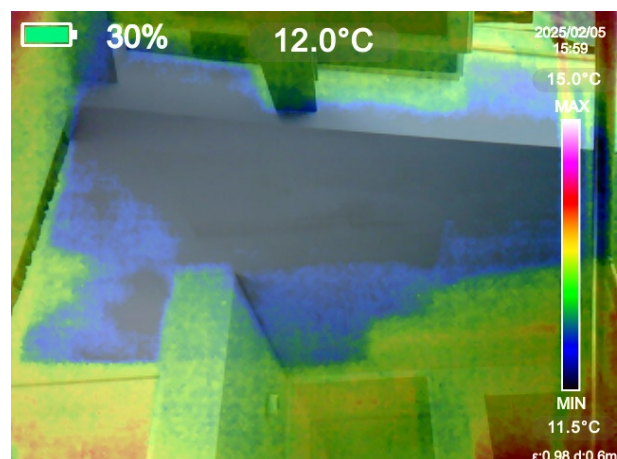
Thermal images showing water residues in the ceiling and walls.

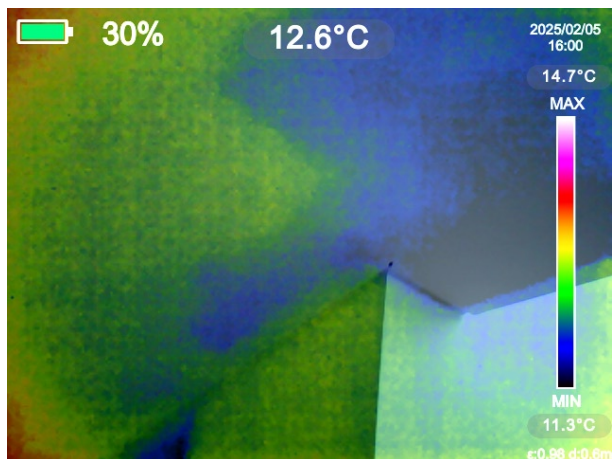
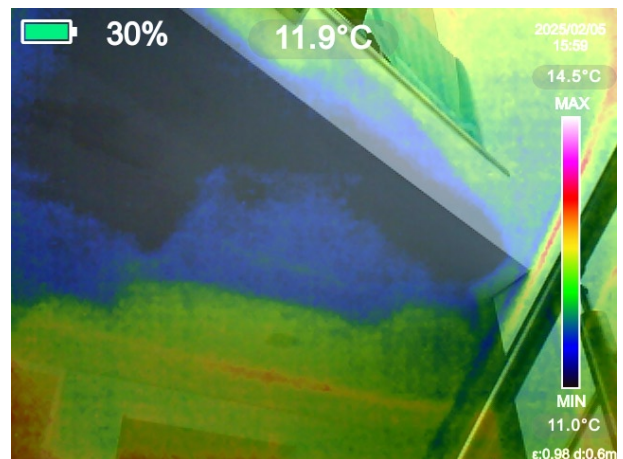
Thermal images showing water residues in the ceiling and walls.

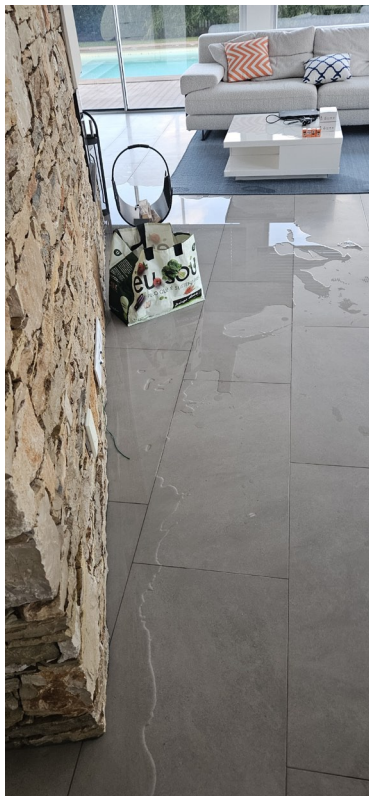
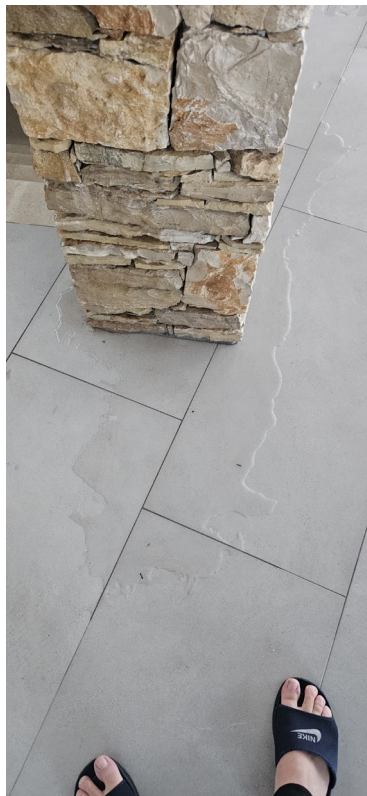
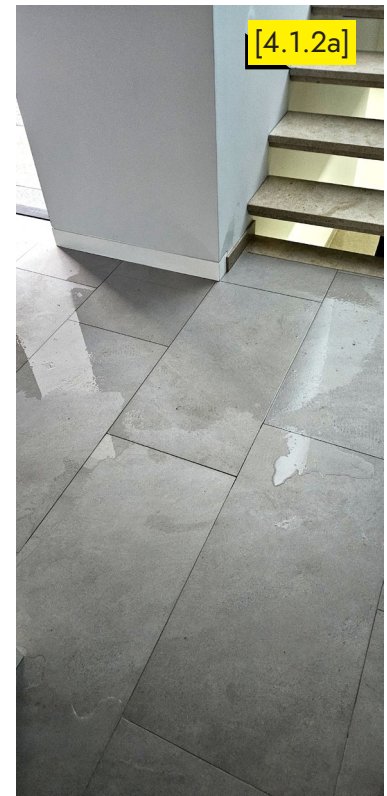
Rainwater flooding on November 2023

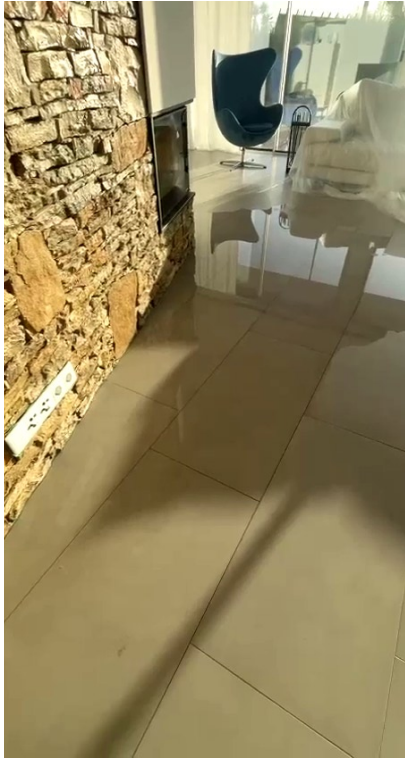
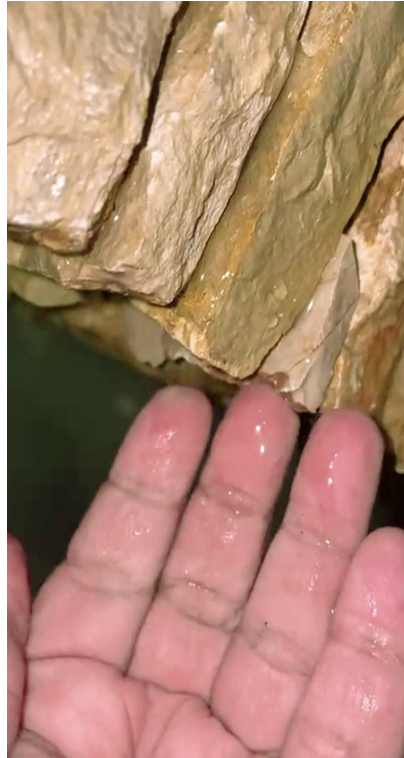
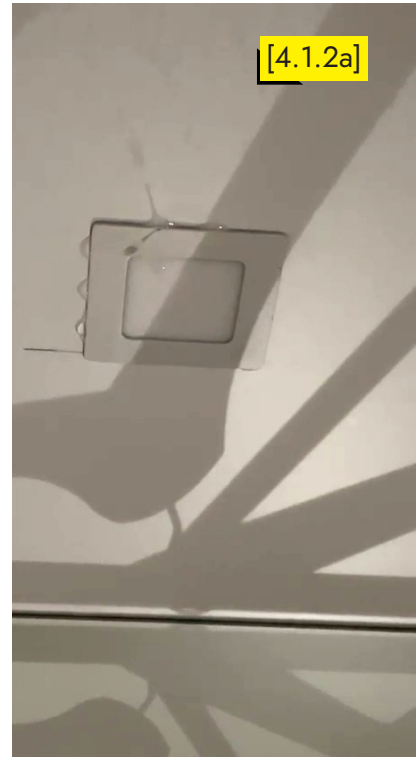
Rainwater flooding on January 2025

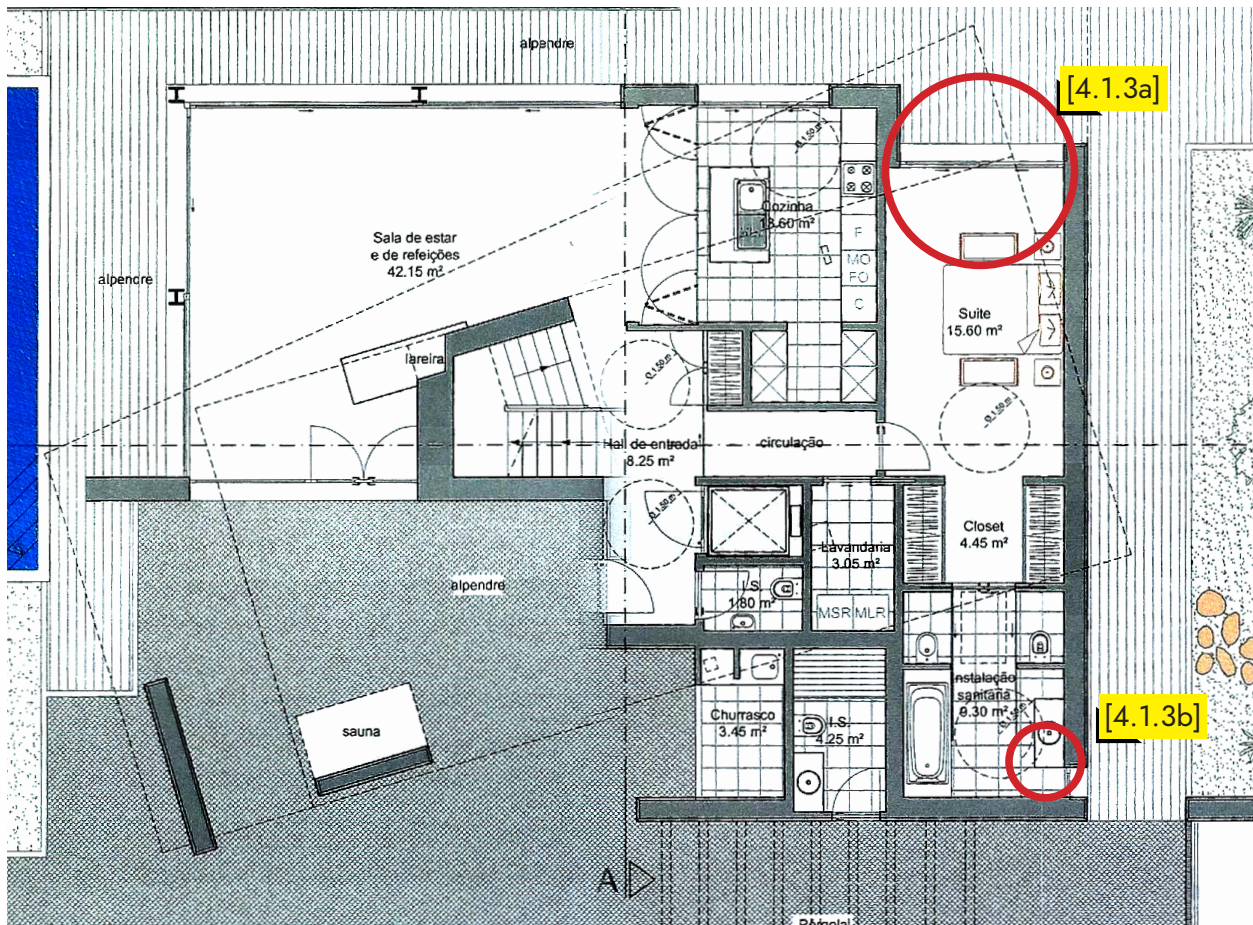
Moisture was found in the suspended ceiling of the bedroom during the inspection. Numerous mould colonies were detected on the ceiling and in the recess for the roller blinds [4.1.3a].

There is a distinct musty smell throughout the bedroom!

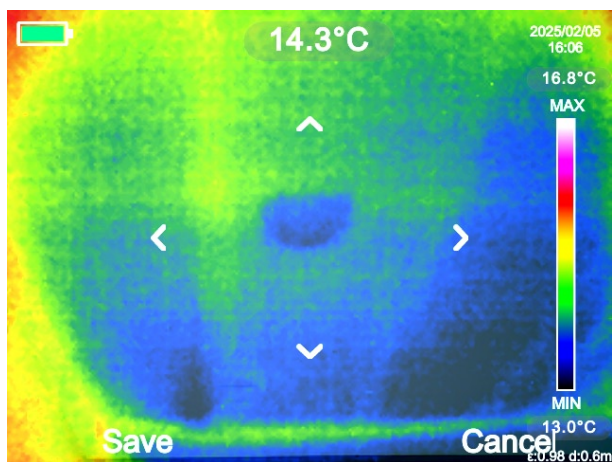
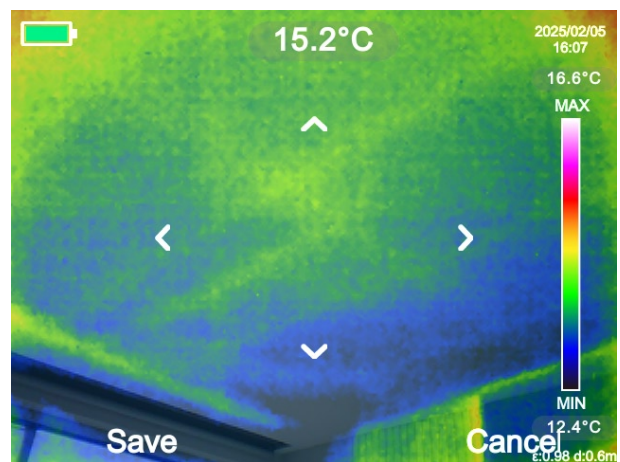
Thermal images showing water residues in the ceiling.

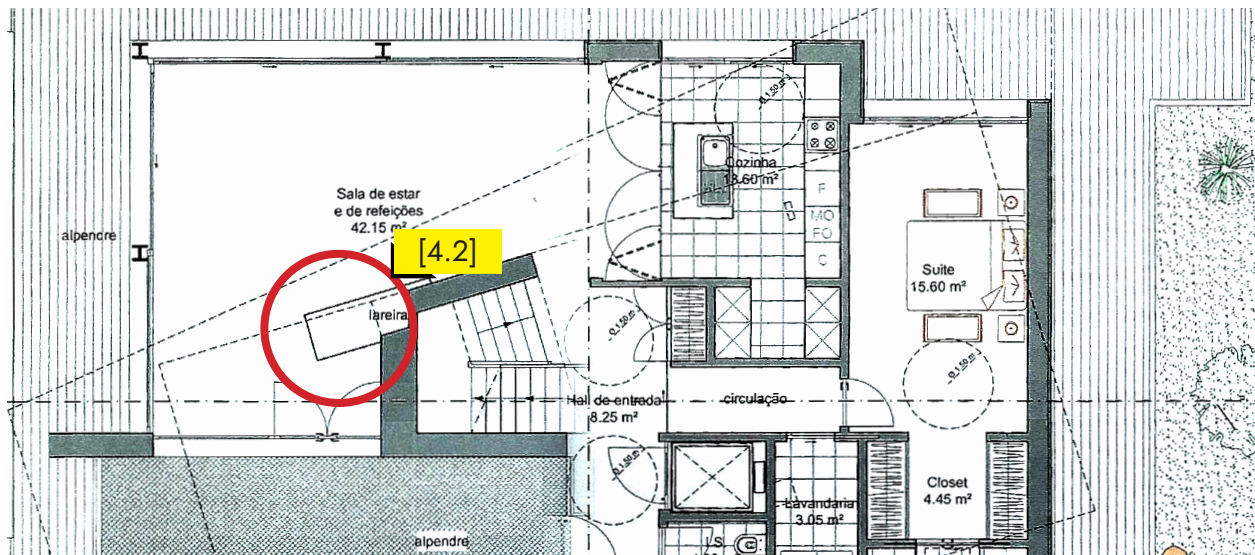
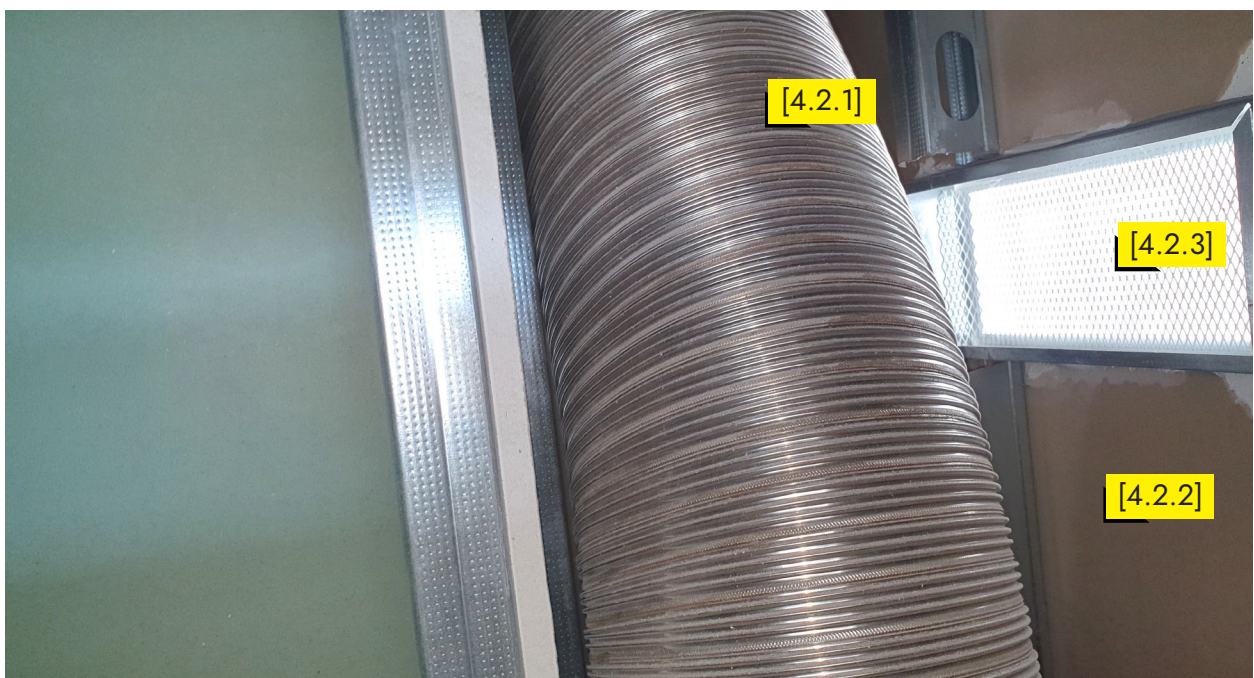
4.2.3. The fireplace cladding has two small hot air outlets in the form of grilles above the firebox, however, there is no air inlet, which should be located below the firebox. The inlet supposed to have the area comparable with the outlet. This arrangement does not ensure adequate air circulation inside the cladding and may lead to overheating.

Above, in the suspended ceiling area, the flue pipe passes in close proximity to the electrical cables. Such negligence can lead to insulation melting, fire and even electric shock!

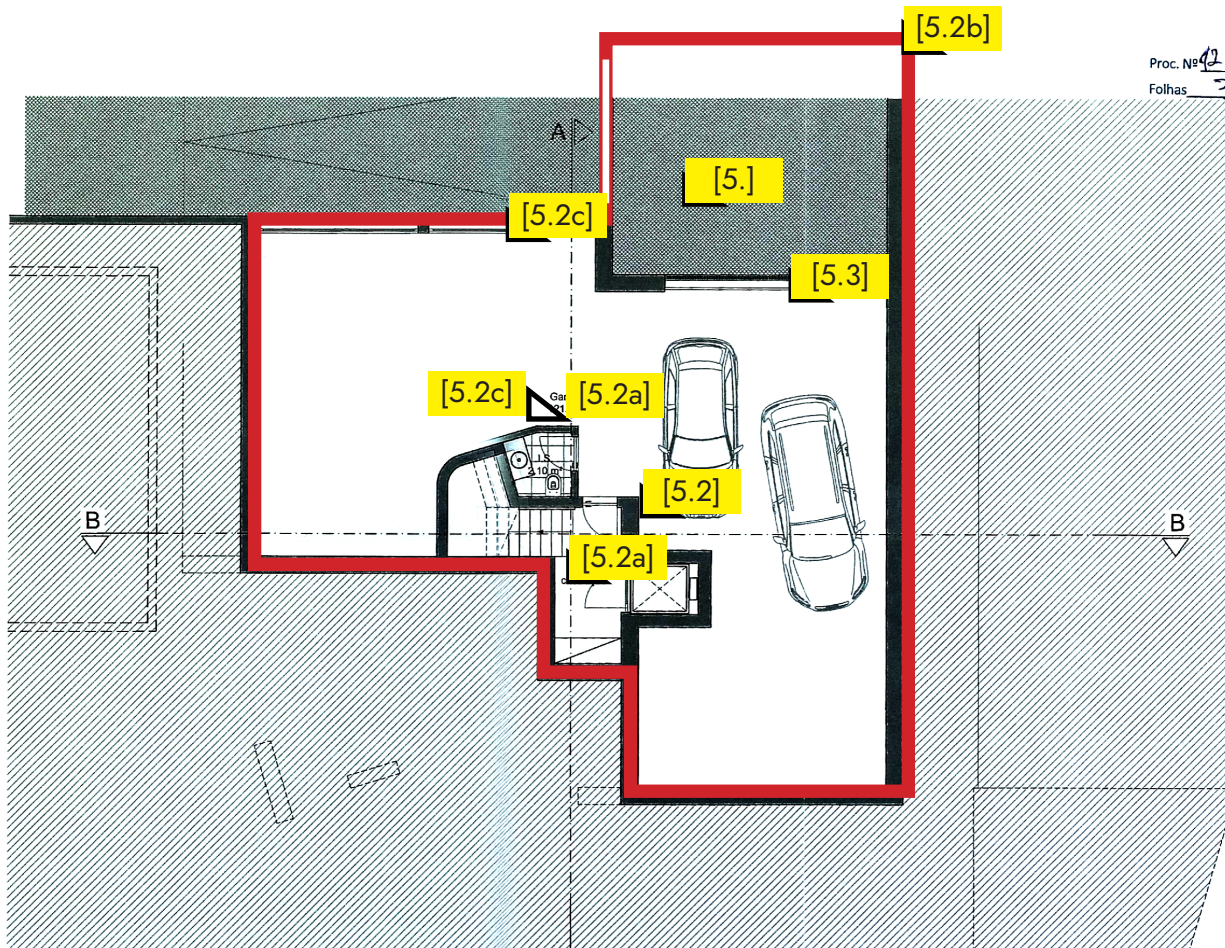
The actual shape and size of the basement differs from that shown on The Project. The basement is enlarged by the area marked on the drawing.

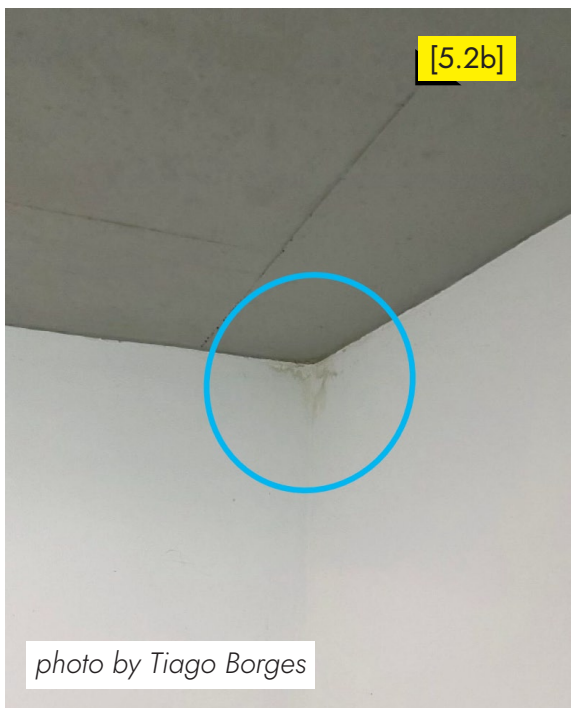
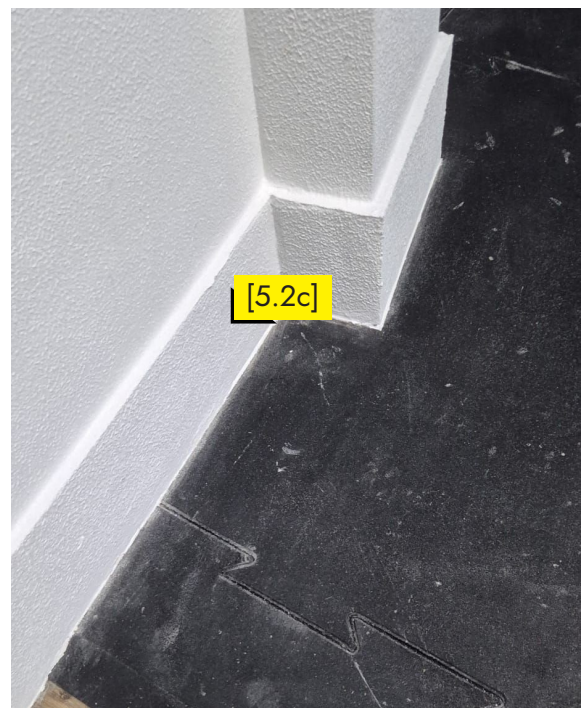
To hide the dampness on the walls, they were covered with polystyrene boards and painted [5.2c]. This solution does not solve the problem. It only traps moisture in the wall, which promotes further wall degradation and the growth of fungi and mould, the spores of which are harmful to health!

There are also damp patches on the ceiling [5.2d].

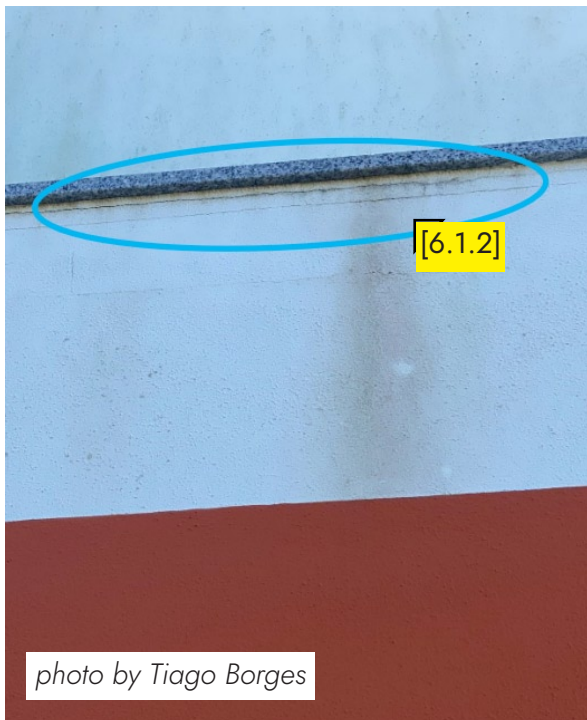
6.1.2. Cracks below top of walls and masonry.

Caused by water penetration due to missing or poorly executed copings, wall settlement and stresses arising at the boundary between different materials.

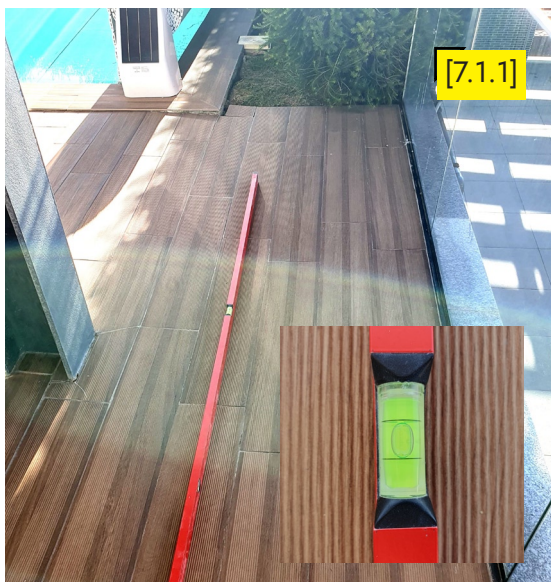
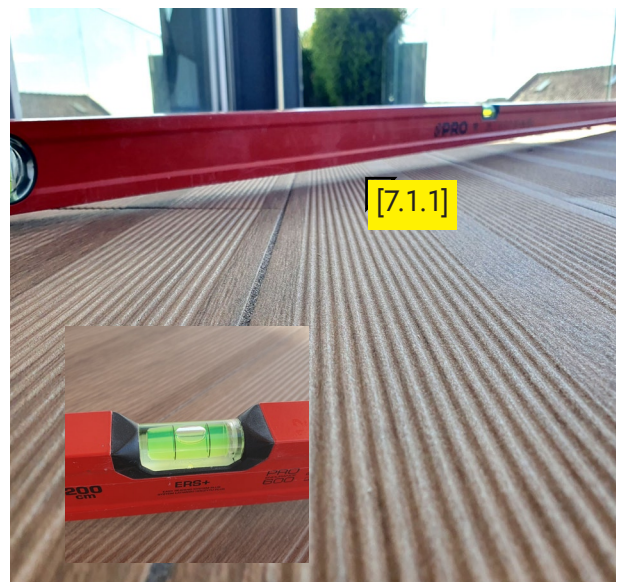
Patio surface on wrong profile – it forms a trough, there is no slope [7.1.1]. As a result, rainwater floods the patio in large puddles [7.1.2]. Excess water running off the patio is not drained anywhere. Therefore, the water has washed out a hole in the lawn [7.1.3], through which it runs off, washing up on the edges of the patio and the pool and on into the area of the underground pool pumping station room.

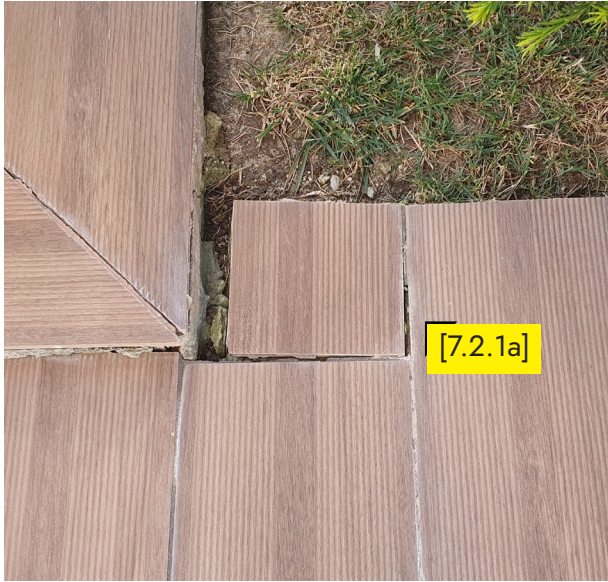
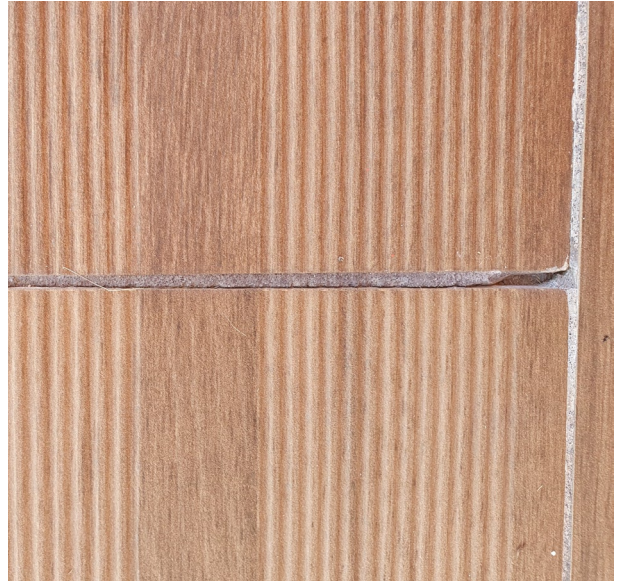
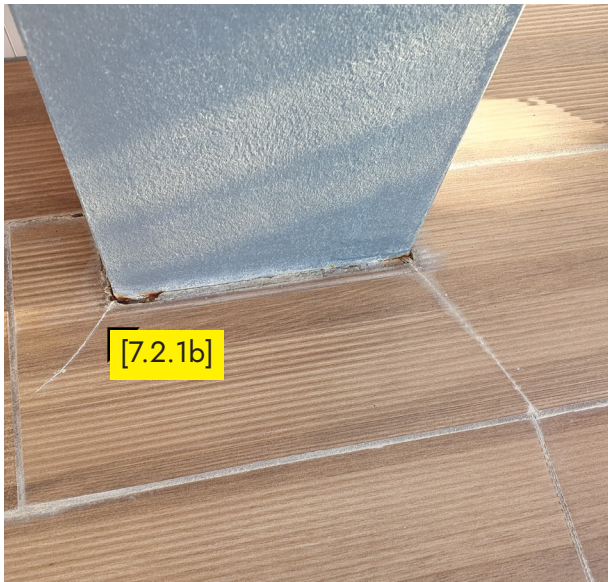
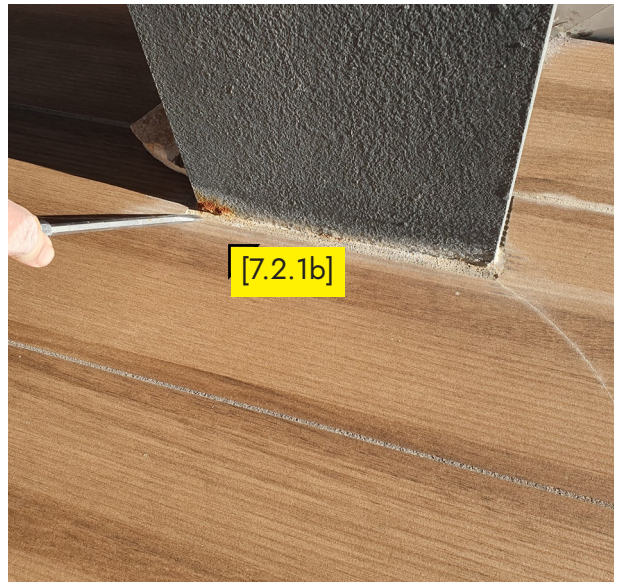
Grout is chipping all over the patio and water is seeping into the adhesive layer. Some tiles are falling off. [7.2.1a] Tile cracks are visible on the structural pillars [7.2.1b]. There are also visible signs of corrosion around the pillars [7.2.1b]. Water stains are visible on the walls of the building [7.2.2].
