The Report

February 2025

This report systematises and organises the numerous construction and workmanship errors occurring in the private residential house located in Lote 2 - Casais Porto Dinheiro.

The discrepancies were identified based on the construction project of the residential building 12146/2017, hereinafter referred to as The Project.

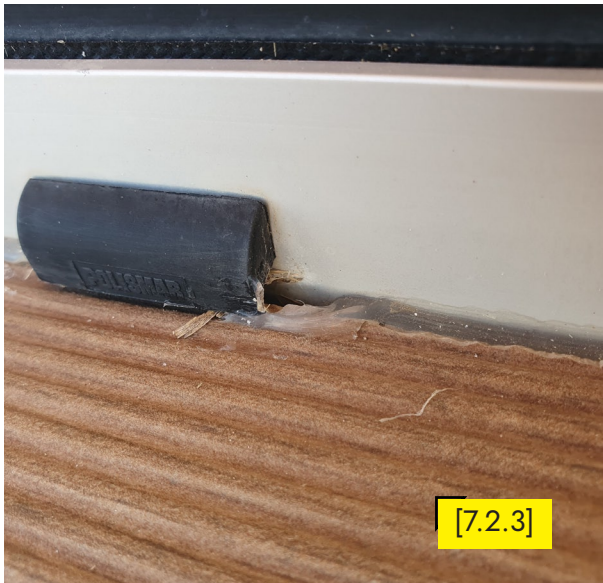
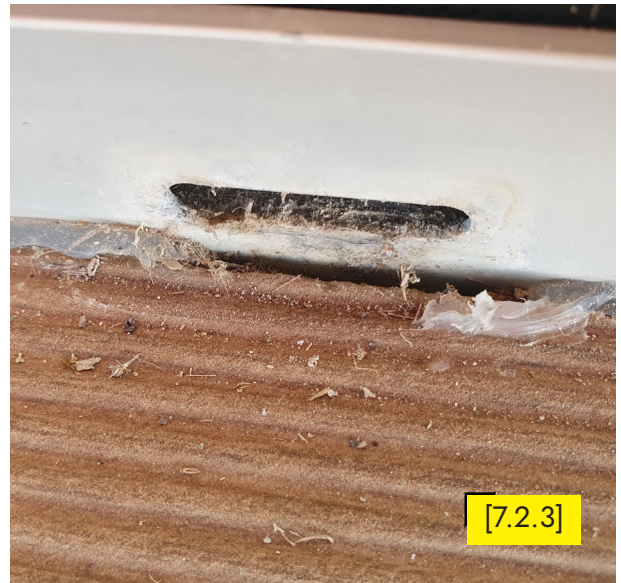
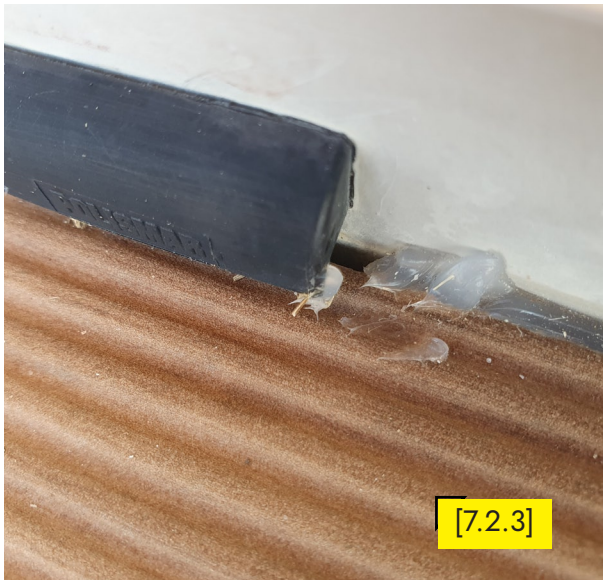
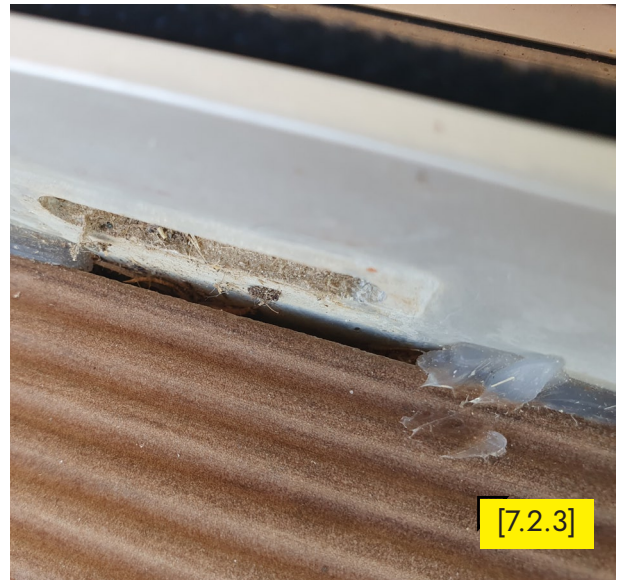
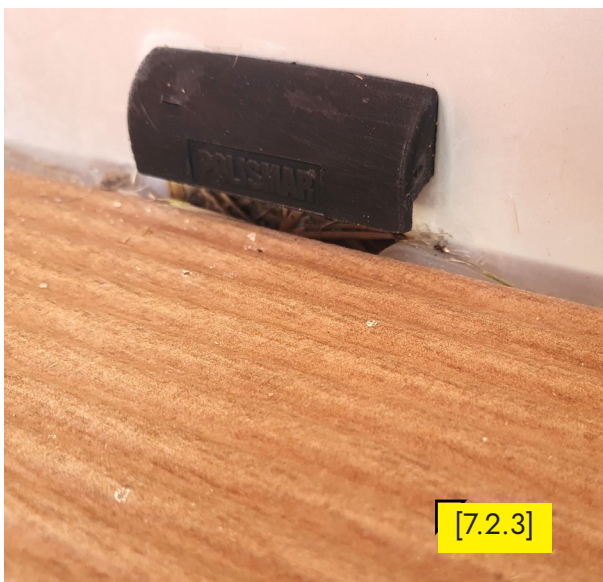
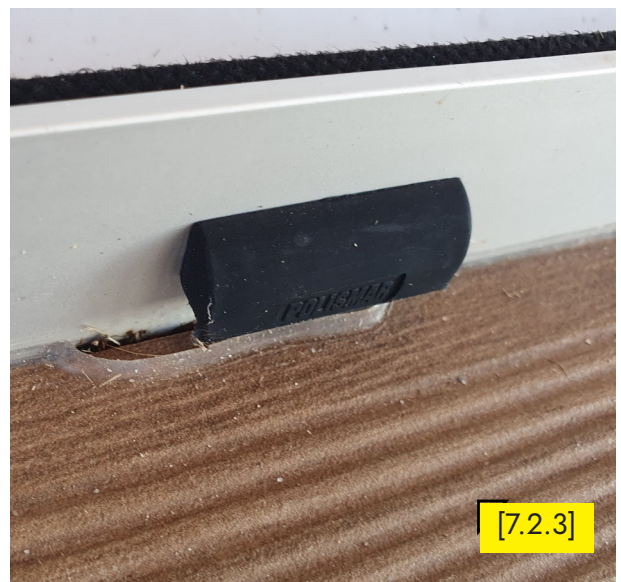
7.2.3 The sealing of the window openings is done extremely carelessly and in an extremely damaging way. Sealing is missing in all areas where the window drains are located! Thus, all the water that runs off the surface of the windows is introduced directly between the wall and the tiles!

7.2.3. Extreme negligence in sealing the patio windows.

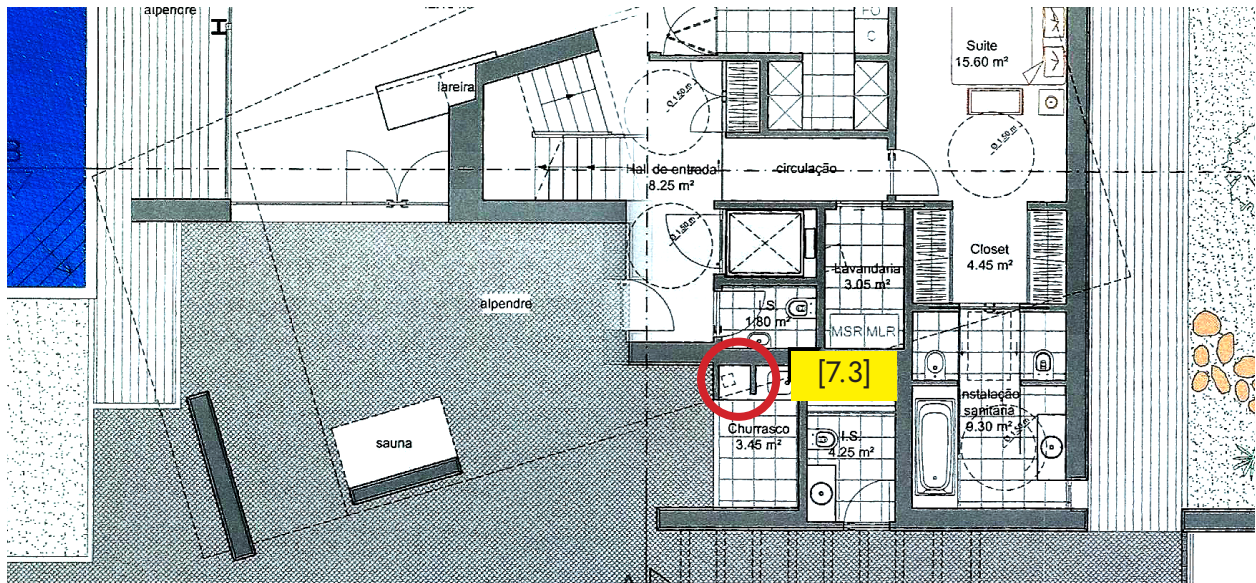
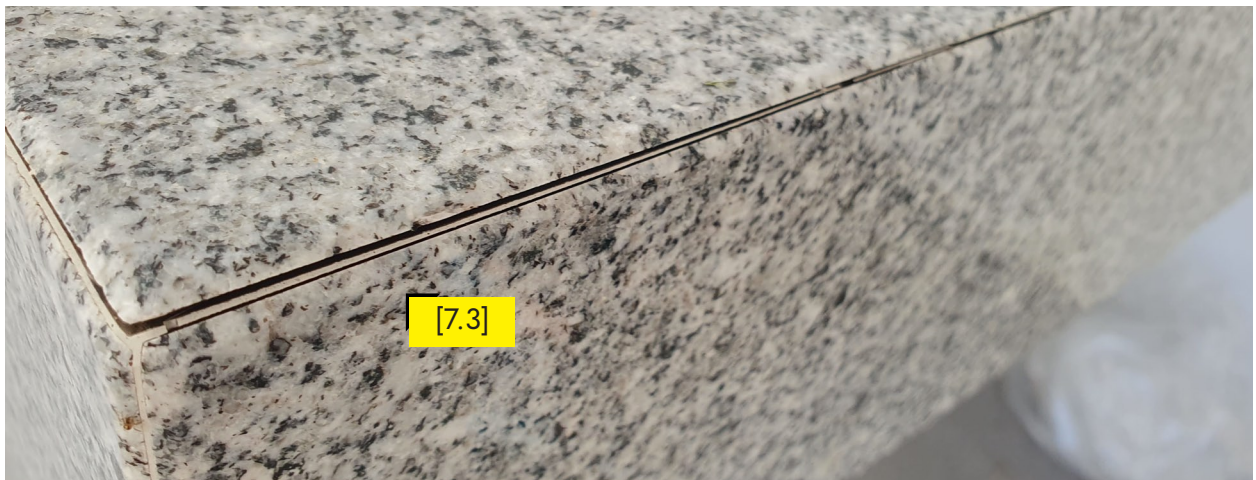
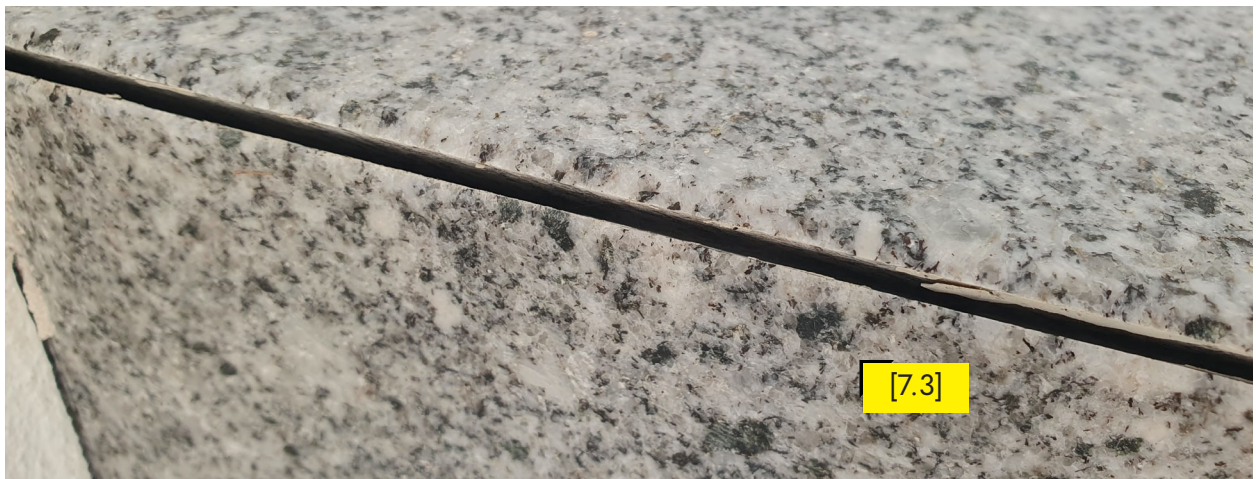
The kitchen worktop located on the patio is made of granite. Large cracks are visible at its joints. There is a concern that the front piece will fall off completely.

The granite pieces are very heavy and have sharp edges. If they fall off, they could seriously injure the person using the countertop.

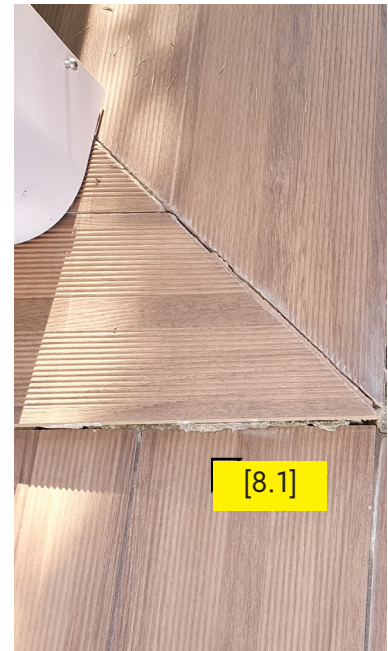
The edge of the pool is tiled in the same way as the patio. The same mistakes as on the patio are repeated - the tiles are coming off, the joints are chipped.

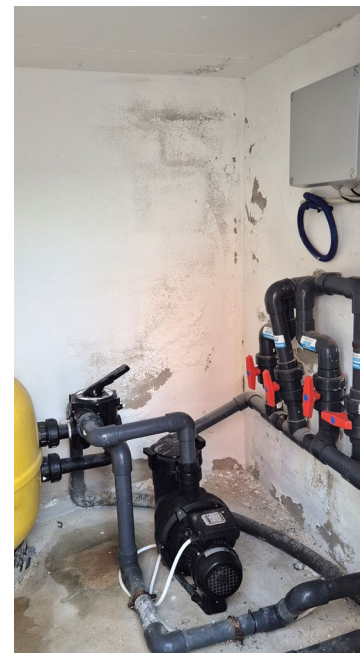
In the pool pumping compartment, the walls are damp and cracks are showing on the walls and ceiling. Plaster and paint are falling off the walls.

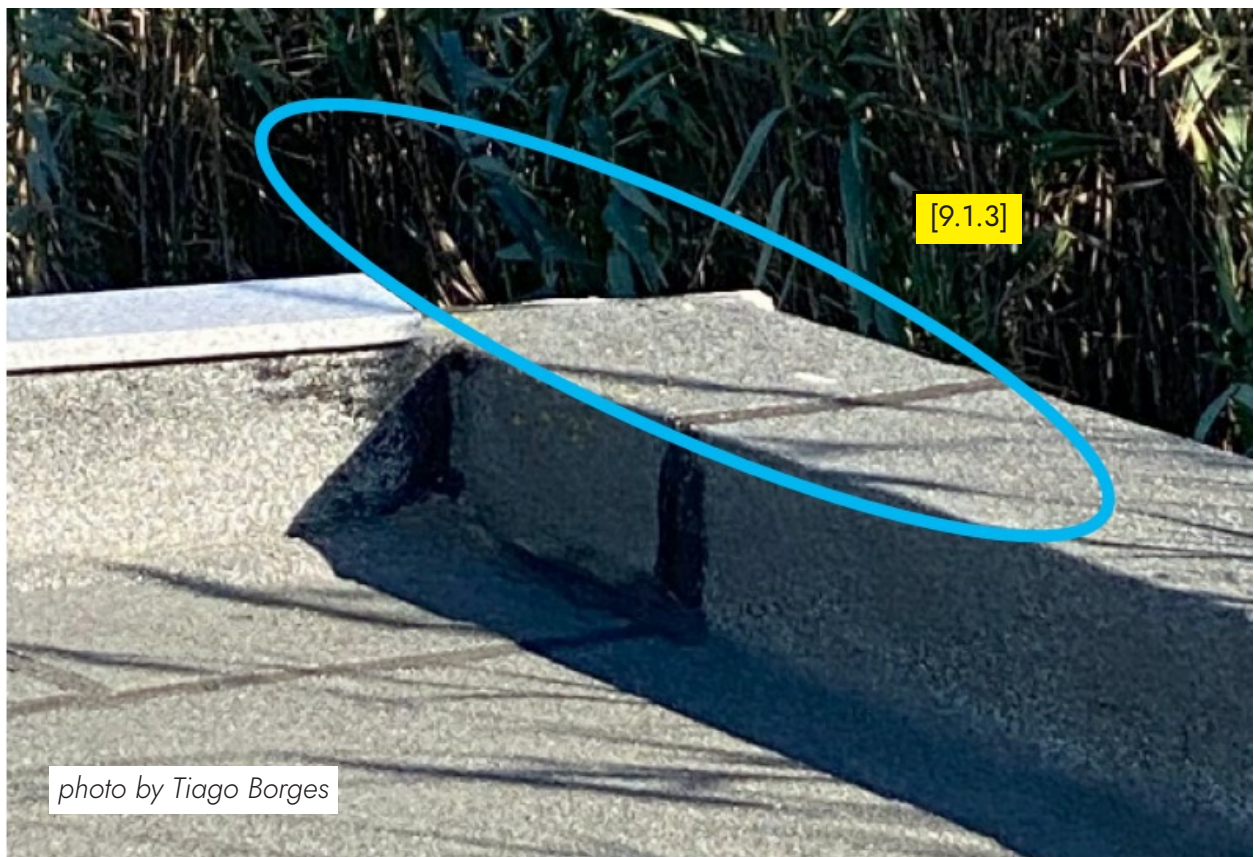
9.1.3. Lack of capping on the wall on the east side, roofing felt not properly welded.

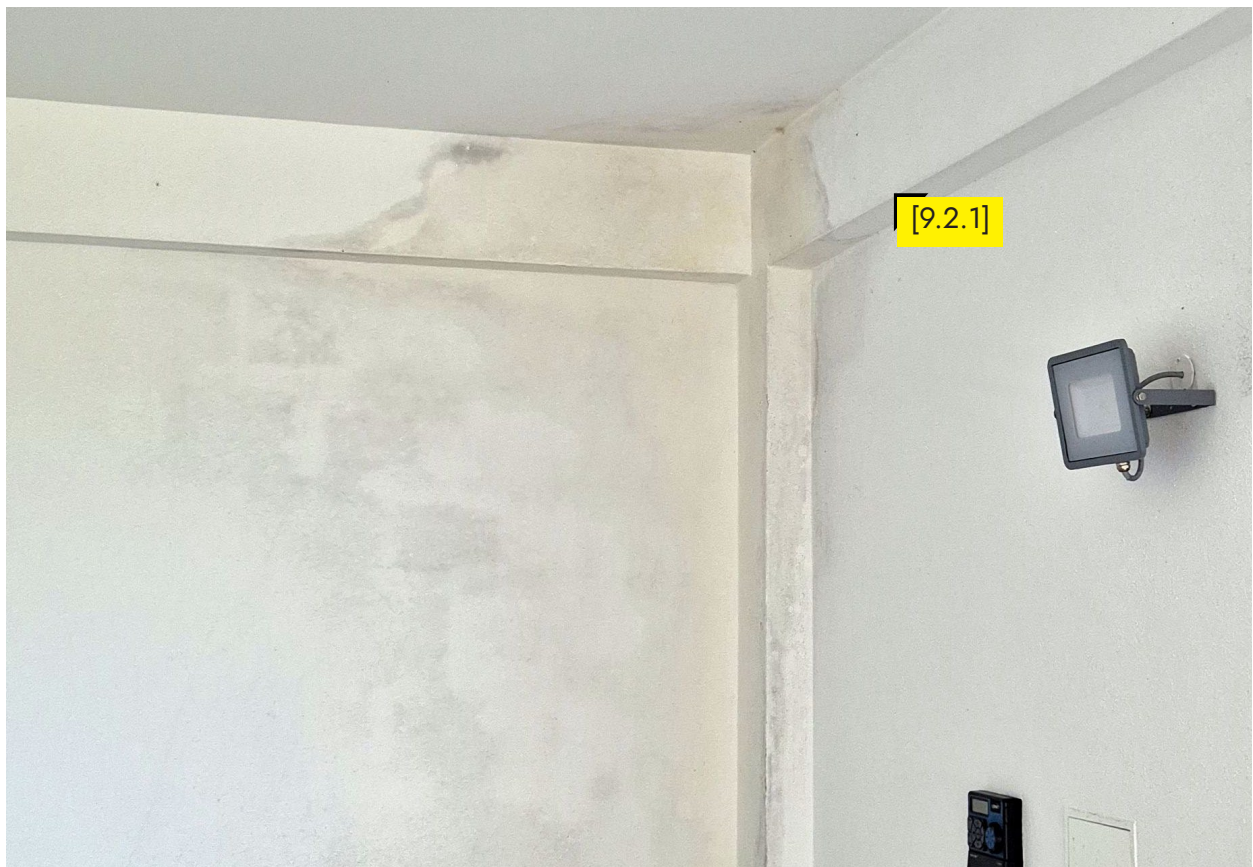
9.2.1. Visible signs of flooding - the rainwater is penetrating from the roof. Fungus and mould developing on the walls and ceiling.

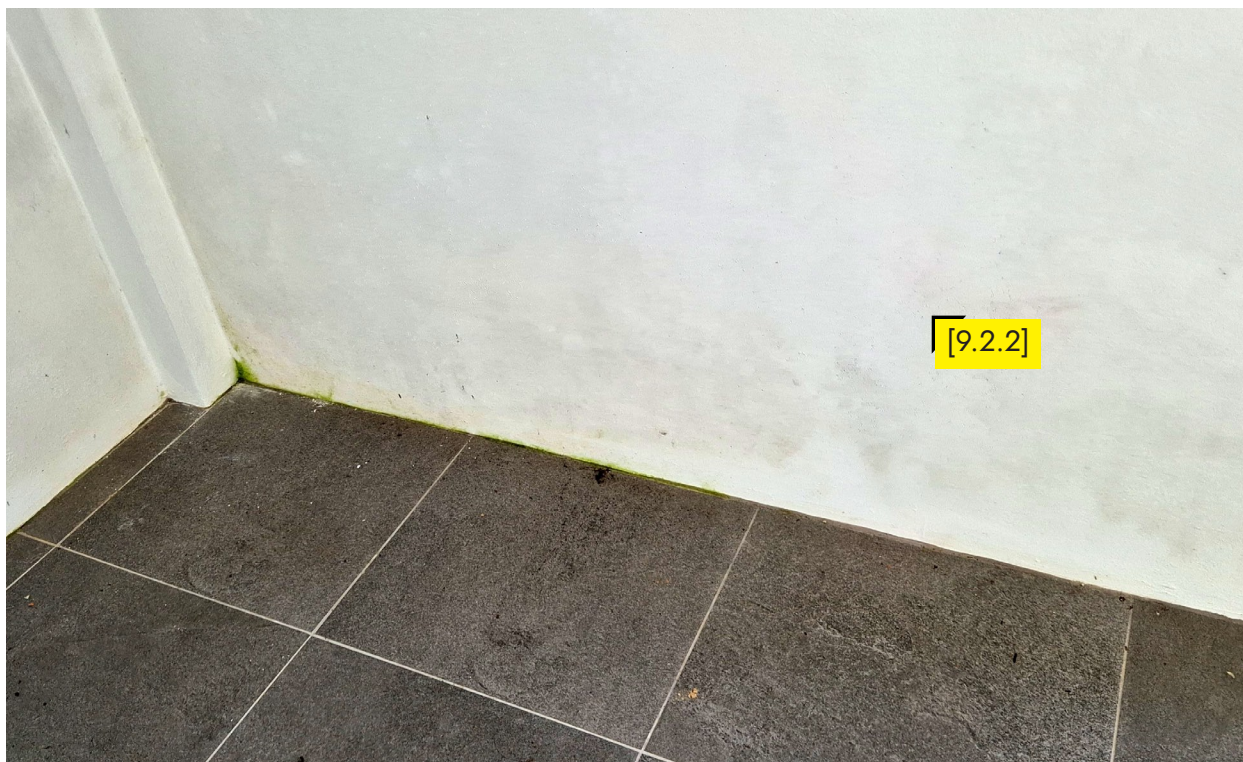
9.2.2. Damp patches on the walls. Green algae growth in plaster.

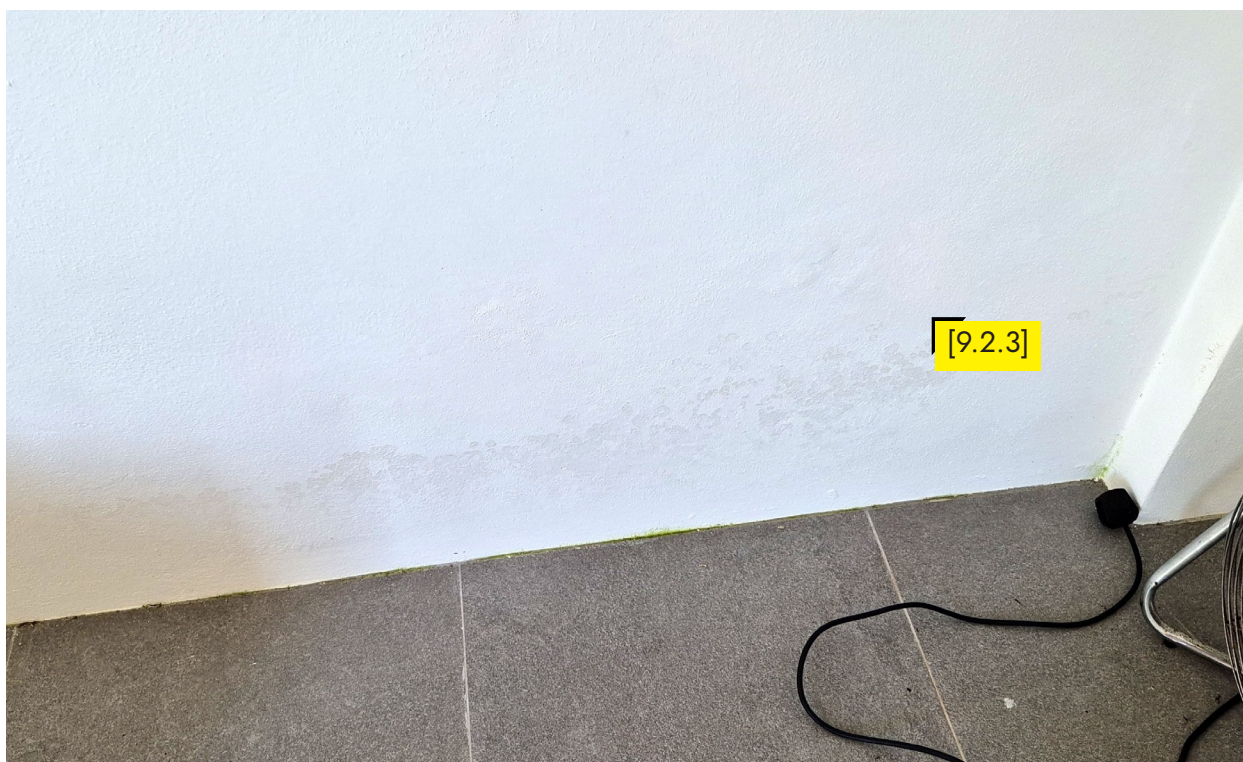
9.2.3. Crumbling plaster, soggy paint coming off.

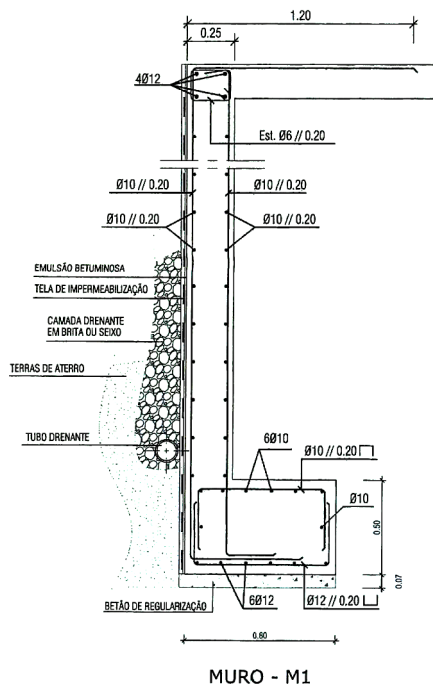
It is likely that the perimeter drainage around the house was not built as envisaged in The Project. The large amount of dampness in the basement walls and floor seems to confirm this. No drainage outlets were found during the inspection - neither in the manholes nor outside within the stone slope on the northern boundary of the plot.
