The Report

This report systematises and organises the numerous construction and workmanship errors occurring in the private residential house located in Lote 2 - Casais Porto Dinheiro.

The photographic material used in this report comes from the inspection on February 4–7, September 4-8, 2025 as well as other material produced between 2023 and 2025, and documents the various deficiencies and problems occurring during this period.

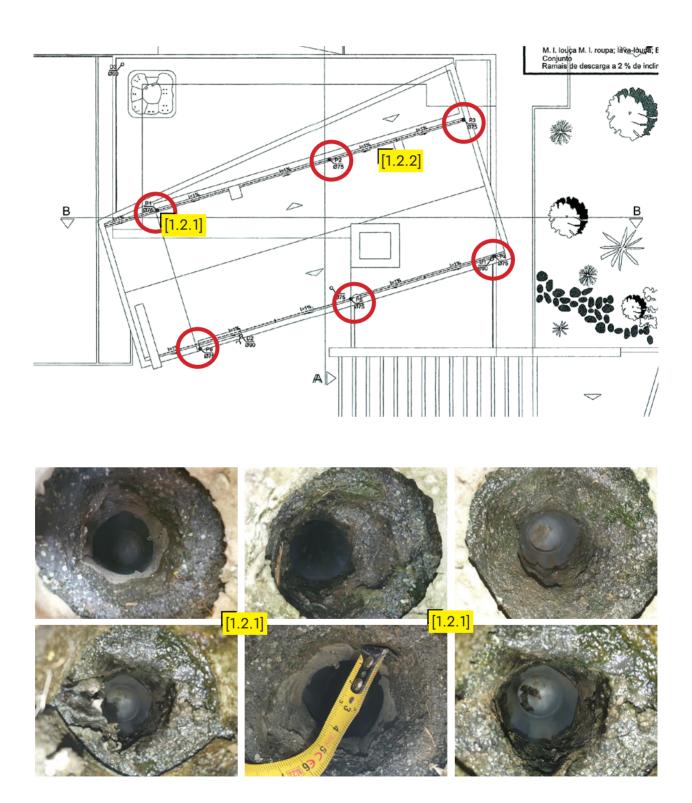
In the Project, the drain diameter was specified as 75 mm, while in reality the drains have a diameter of less than 50 mm (their diameter was reduced by the layers of roofing felt rolled inwards).

1.2.2. There were also no horizontal gutters (ditches) detected on the roof, which were shown in The Project.

- 1.2.3. The water drainage drainage hole partially choked with roofing felt.
- **1.2.4.** Drainage holes should be fitted with an appropriate outlet fitting. Its apron should be welded to the roofing felt and the drain should be sealed in the downpipe.
- **1.2.5.** The roof should also be equipped with thru-wall overflow scuppers that could drain excess water from the roof in the event of extremely heavy rain or clogged drainage holes.

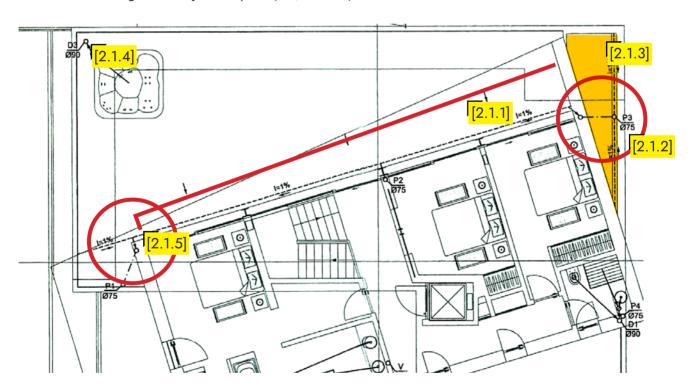
- **2.1.2.** The northern end of the drainage trough was not connected to drain P3 as shown on The Project. The drain marked on The Project as P3 should have a diameter of 75 mm, when in fact the diameter of the drain is 50 mm.
- **2.1.3.** Furthermore, the drainage trough at P3 cannot serve as a support for the terrace drainage, as the part marked in orange is about 8 cm higher than the rest of the terrace!
- 2.1.4. The drainage for the jacuzzi pool (D3, 90 mm) was not made at all.

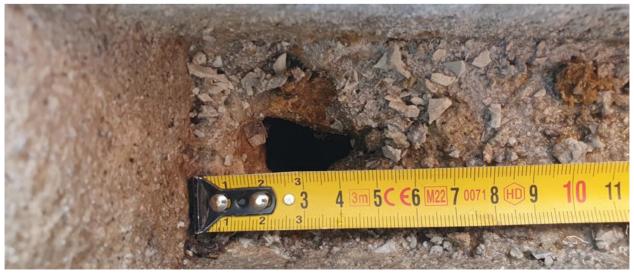
On the day of the inspection, a significant amount of water was found ponding on the terrace and numerous floods in the rooms below, as discussed later in the report.

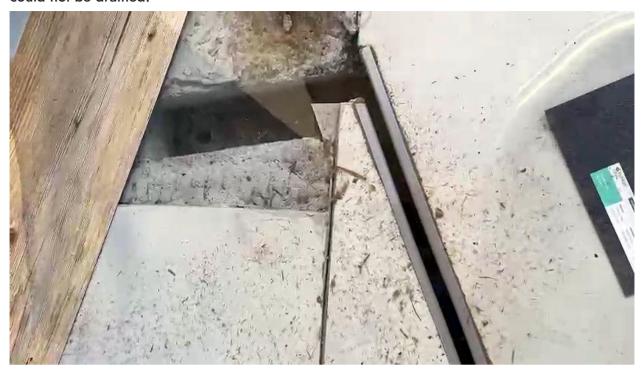
Despite exposing the drain hole and many attempt to unclog it, the water stored on the terrace could not be drained.

It was necessary to mechanically remove the water from the terrace.

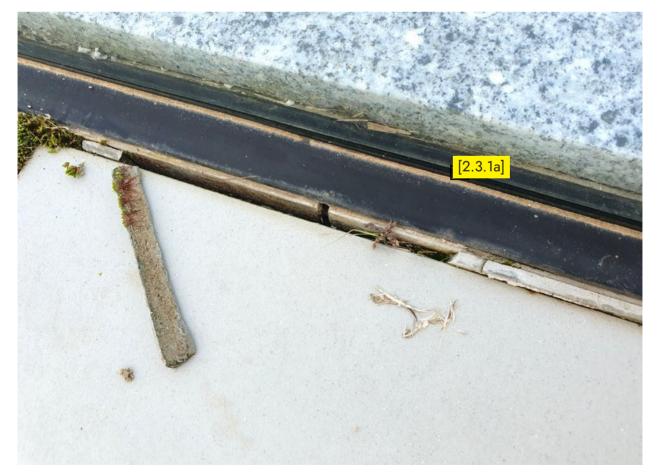
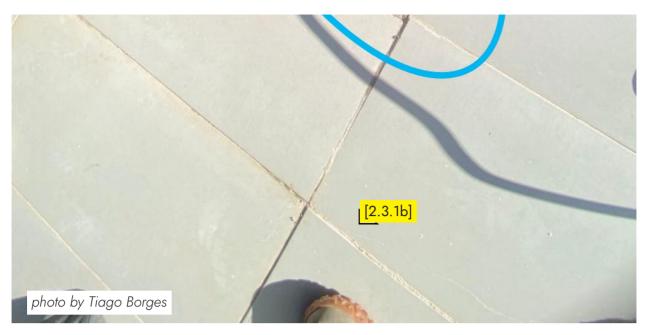
2.3.1. Numerous cavities and discolouration in the tile grouts were found on the overall terrace surface. There are many visible instances of grout erosion [2.3.1b].

The connection between the terrace surface and the balustrade is cracked or absent in many places. This creates the possibility of water penetrating into the balustrade attachment points and further erosion. Numerous vegetation can be seen nestled in the cracks [2.3.1a].

The connection between the balustrade and the terrace should be both watertight flexible.

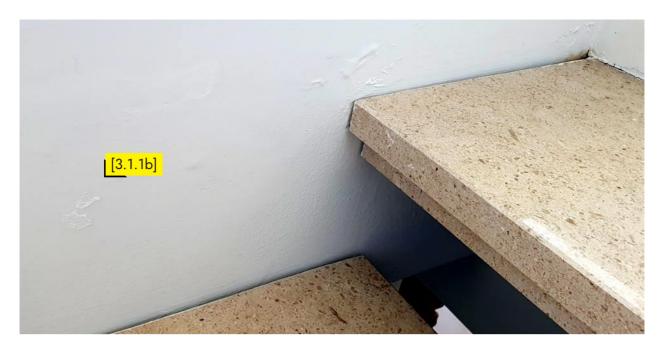
Using a thermal imaging camera, dampness was detected in the west wall of the stairwell [3.1.1a]. Discolouration, cracks, paint chipping and plaster degradation can be seen in the area where the terrace floor slab meets the wall [3.1.1b].

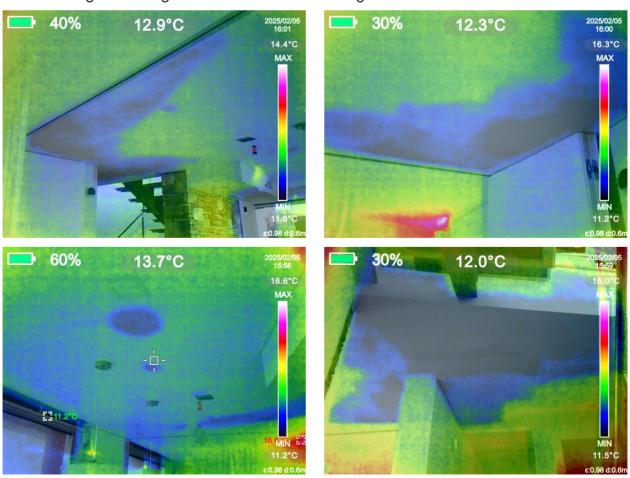
Thermal images showing water residues in the ceiling and walls.

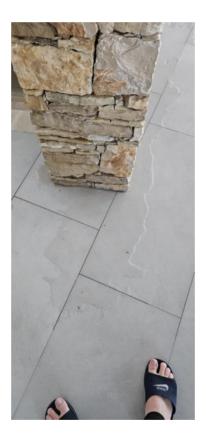
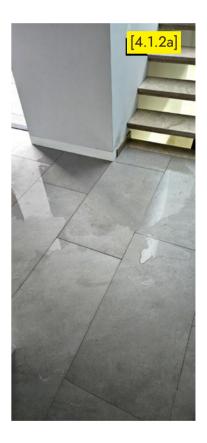
Rainwater flooding on January 2025

A consequence of the leaking terrace is the repeated flooding of the kitchen and living room with rainwater. On a number of occasions, water was observed dripping down the stone wall in the middle of the living room, water dripping from lamps suspended above the table, water dripping from light fittings on the ceiling [4.1.2a].

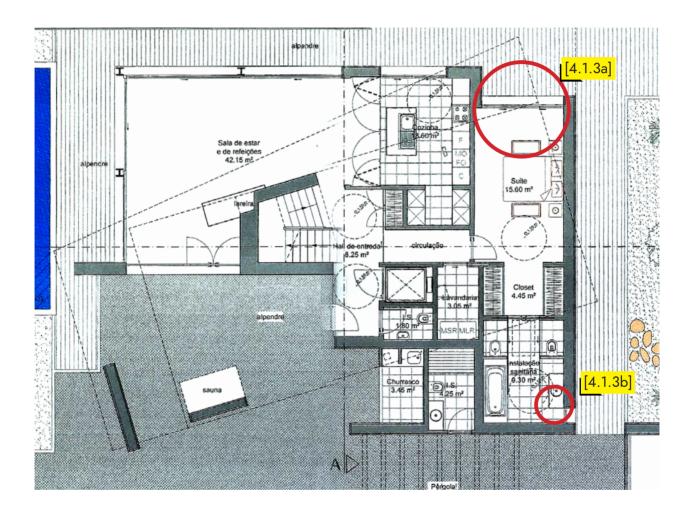
Moisture was found in the suspended ceiling of the bedroom during the inspection. Numerous mould colonies were detected on the ceiling and in the recess for the roller blinds [4.1.3a].

Thermal images showing water residues in the ceiling.

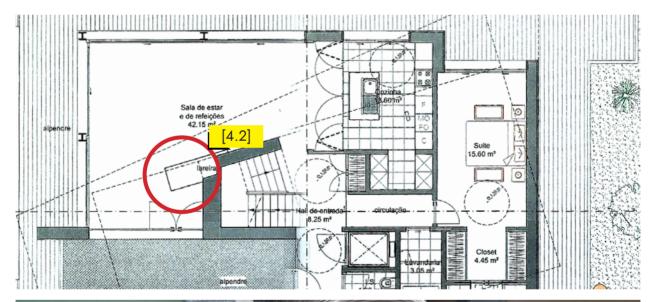
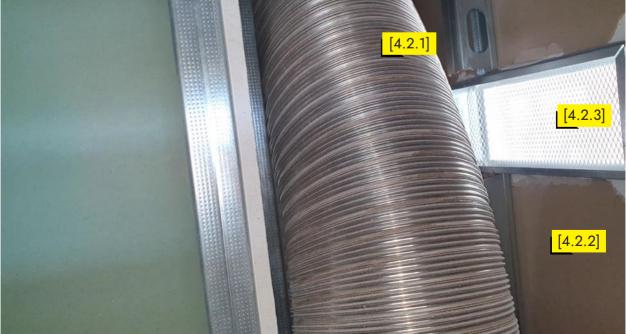
4.2.1. The fireplace was connected to the flue via a flexible flue pipe! This type of pipe is not approved for flue gas from solid fuel burners, where the flue gas temperature is not controlled and can reach up to 700 °C.

- **4.2.2.** The fireplace cladding has not been thermally insulated on the inside the plasterboard should be protected from the heat on the inside.
- **4.2.3.** The fireplace cladding has two small hot air outlets in the form of grilles above the firebox, however, there is no air inlet, which should be located below the firebox. The inlet supposed to have the area comparable with the outlet. This arrangement does not ensure adequate air circulation inside the cladding and may lead to overheating.

Above, in the suspended ceiling area, the flue pipe passes in close proximity to the electrical cables. Such negligence can lead to insulation melting, fire and even electric shock!

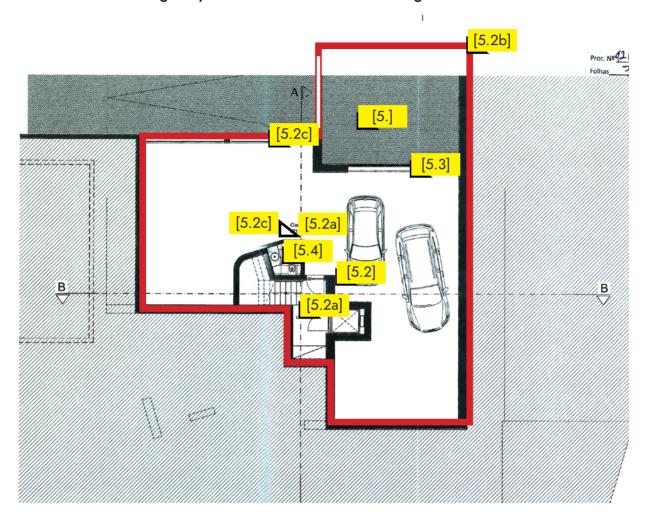
The actual shape and size of the basement differs from that shown on The Project. The basement is enlarged by the area marked on the drawing.

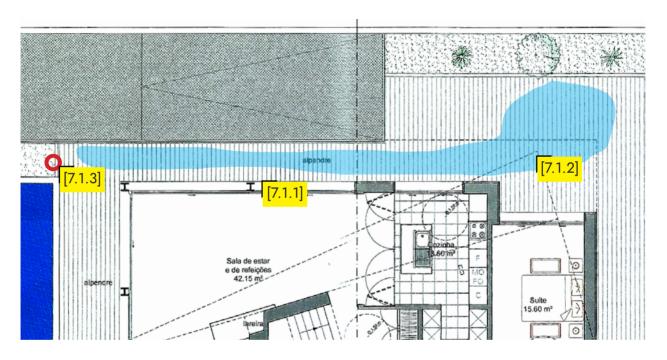
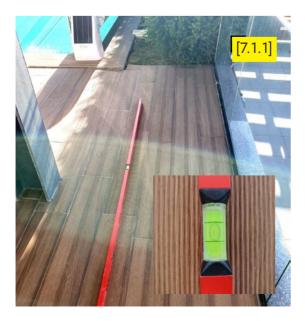
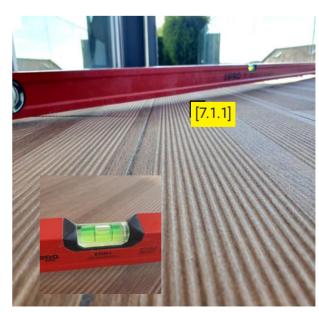
Patio surface on wrong profile – it forms a trough, there is no slope [7.1.1]. As a result, rainwater floods the patio in large puddles [7.1.2]. Excess water running off the patio is not drained anywhere. Therefore, the water has washed out a hole in the lawn [7.1.3], through which it runs off, washing up on the edges of the patio and the pool and on into the area of the undergound pool pumping station room.

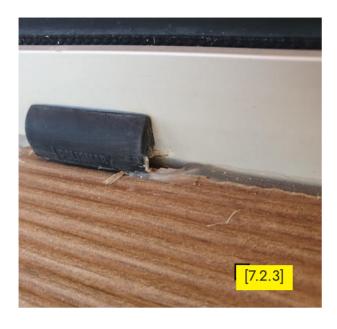
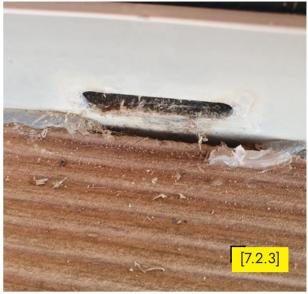
7.2.3.Extreme negligence in sealing the patio windows.

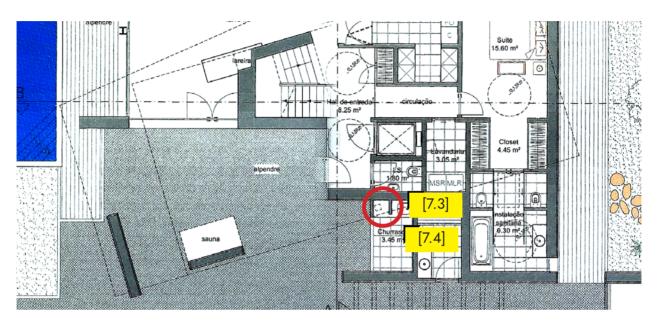
7.3. Work top next to the grill

The kitchen worktop located on the patio is made of granite. Large cracks are visible at its joints. There is a concern that the front piece will fall off completely.

The granite pieces are very heavy and have sharp edges. If they fall off, they could seriously injure the person using the countertop.

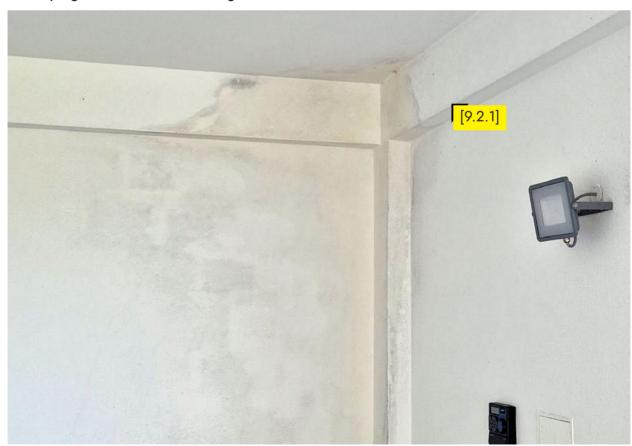
9.2.1. Visible signs of flooding - the rainwater is penetrating from the roof. Fungus and mould developing on the walls and ceiling.

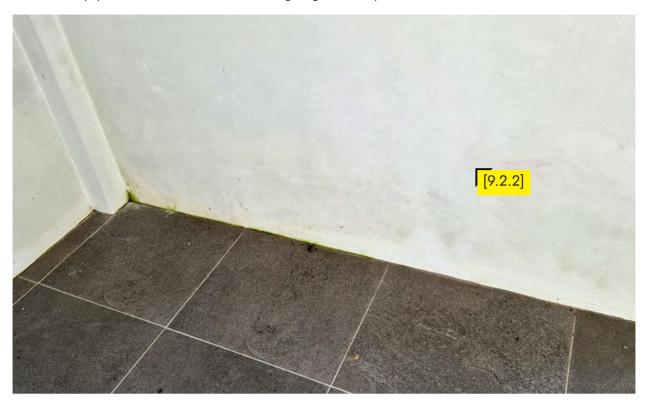
9.2.2. Damp patches on the walls. Green algae growth in plaster.
