# The Report

House No 9

This report systematises and organises the numerous construction and workmanship errors occurring in the private residential house located in Lote 3 - Casais Porto Dinheiro.

The photographic material used in this report comes from the inspection on February 4–7, March 4-14, September 4-8 2025 as well as other material produced between 2023 and 2025, and documents the various deficiencies and problems occurring during this period.

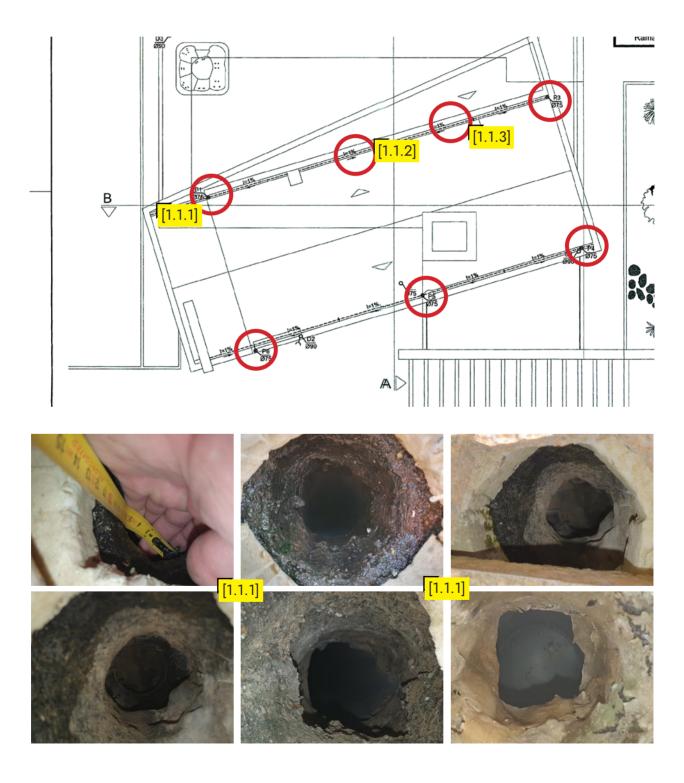
In the design, the drain diameter was specified as 75 mm, while in reality the drains have a diameter of less than 50 mm (their diameter was reduced by the layers of roofing felt rolled inwards).

1.1.2. There were also no middle drain holes (P2 and P5) which are present on the building design.

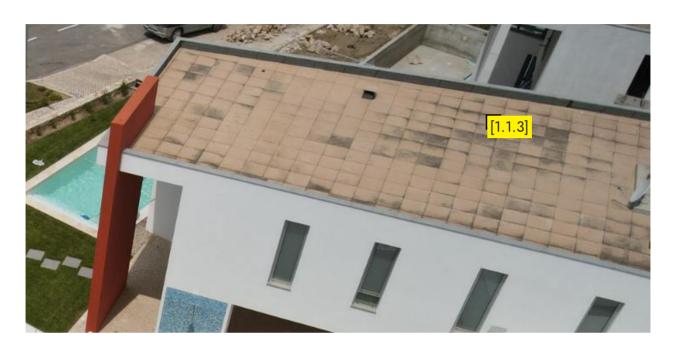
- **1.1.3.** There are no horizontal gutters (ditches) detected on the roof, which were shown in the design.
- **1.1.4.** Drainage holes should be fitted with an appropriate outlet fitting. Its apron should be welded to the roofing felt and the drain should be sealed in the downpipe.
- 1.1.4a. None of the drains have a basket to protect the drainpipes from clogging with small objects.
- **1.1.5.** The roof should also be equipped with thru-wall overflow scuppers that could drain excess water from the roof in the event of extremely heavy rain or clogged drainage holes.

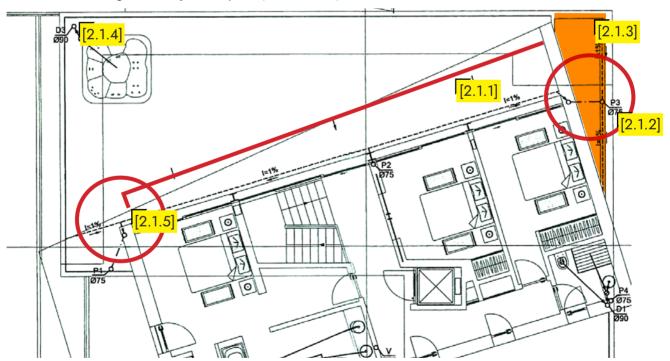
- **2.1.2.** The northern end of the drainage trough was not connected to drain P3 as shown on the building design. The drain marked on the building design as P3 is not connected with the terrace outlet at all. A drainage grate for indoor use is employed, which causes its significant degradation under the influence of environmental factors and results in frequent blockages.

- 2.1.3. Furthermore, the drainage trough at P3 cannot serve as a support for the terrace drainage, as the part marked in orange is about 8-10 cm higher than the rest of the terrace!

- 2.1.4. The drainage for the jacuzzi pool (D3, 90 mm) was not made at all.

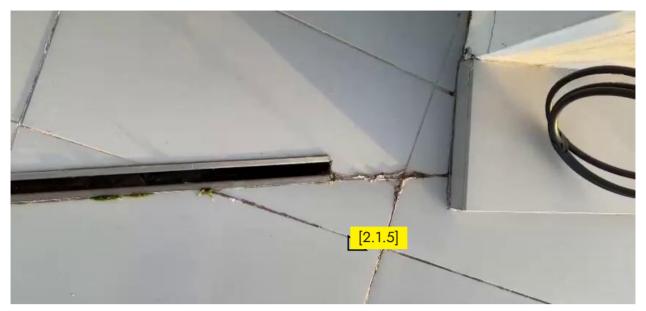
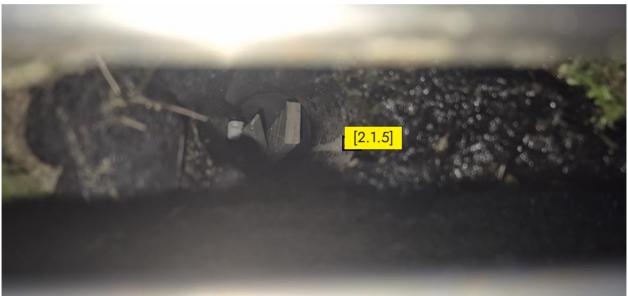
2.1.5. The drain on the south side was filled with pieces of tile and other construction waste. As these pieces were larger than the original size of the hole, it is not possible that they got in there after the construction was completed.

This kind of negligence could easily have led to the drain becoming clogged and consequently filling the terrace with water with all its consequences.

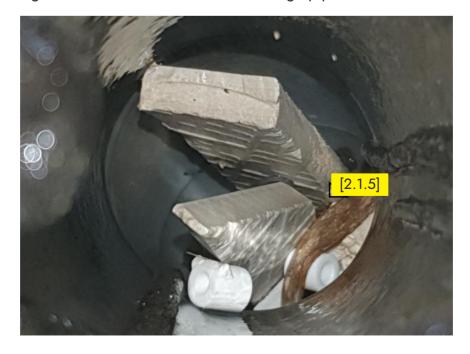
Endoscopic image of the debris in the terrace drrainage pipe

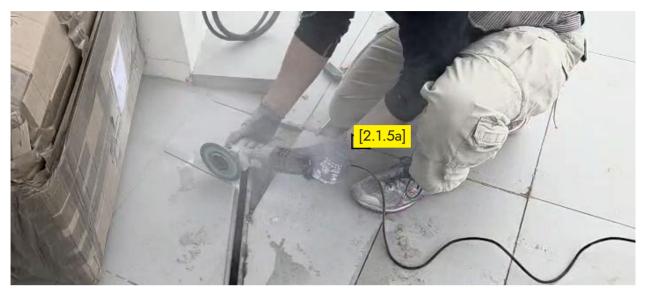
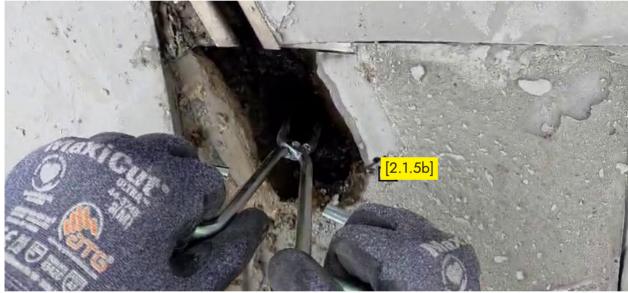
To prevent the drain from becoming completely blocked, the owner decided to take off part of the terrace covering [2.1.5a] and remove the debris that had accumulated there [2.1.5b]. Cross-section of the drain after unblocking [2.1.5c]

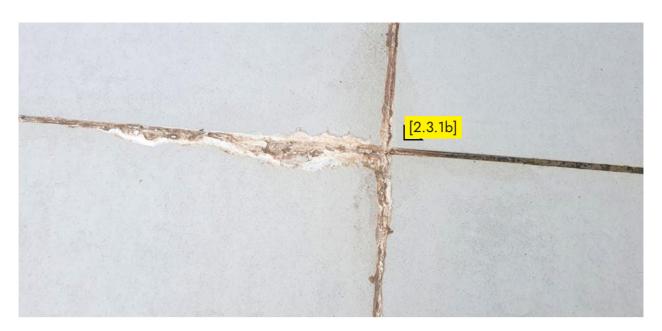
**2.3.1.** Numerous cavities and discolouration in the tile grouts were found on the overall terrace surface. There are many visible instances of grout erosion [2.3.1a].

The connection between the terrace surface and the balustrade is cracked or absent in many places. This creates the possibility of water penetrating into the balustrade attachment points and further erosion. The connection between the balustrade and the terrace should be both watertight flexible.

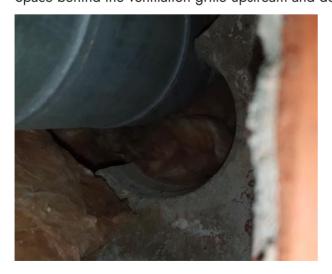
This bathroom does not even have a window, thus the ventilation is impossible!

Space behind the ventilation grille upstream and downstream of the duct.

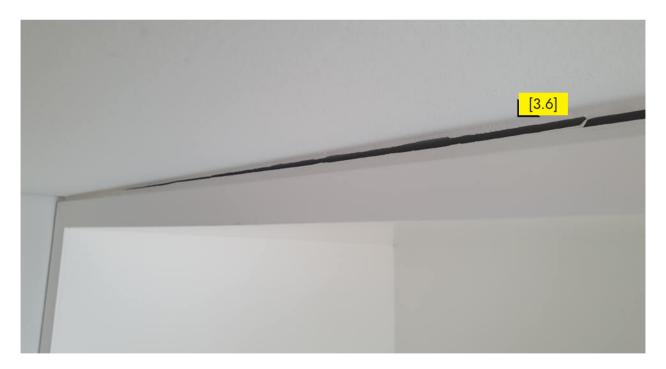
The wardrobe in the south bedroom is bulging and a large gap has been created between the wardrobe and the ceiling.

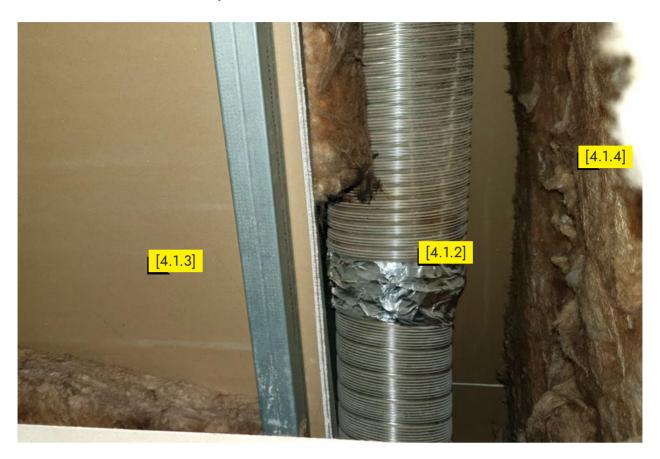
4.1.1. The fireplace was connected to the flue via a flexible flue pipe! This type of pipe is not approved for flue gas from solid fuel burners, where the flue gas temperature is not controlled and can reach up to 700 °C.

# 4.1.2. Flue pipe consists of two joined sections, connceted together with an adhesive tape!

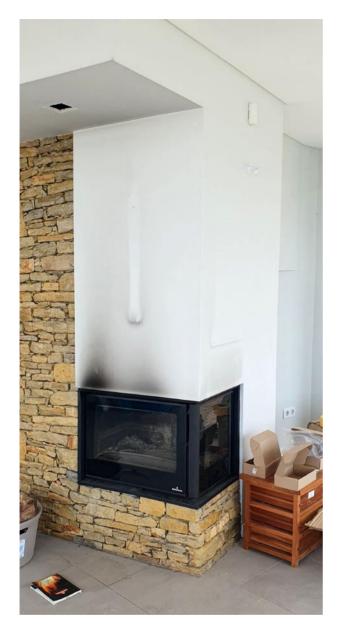
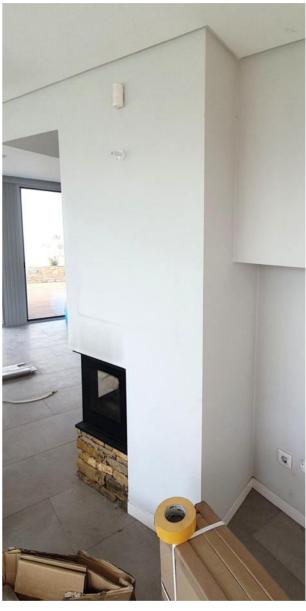
- **4.1.3.** The fireplace cladding in some parts has not been thermally insulated on the inside the plasterboard should be protected from the heat on the inside.
- **4.1.4.** The material used to insulate the fireplace is incorrect. Compressed rockwool, laminated with aluminium foil, should have been used. The aluminium layer reflects infrared radiation and prevents the fine rockwool particles from breaking off and spreading through the dwelling.

Instead, an ordinary rockwool is used (as to insulate the closed spaces in the walls), the fine needles of which can detach unhindered and be spread around the room with the hot air from the fireplace.

4.1.5. The fireplace cladding does not have a single hot air inlet or outlet! This risks overheating the firebox, the smoke pipe, the housing and other objects in the vicinity!

The fireplace is made completely contrary to the good building practice and the operating manual supplied with the fireplace!

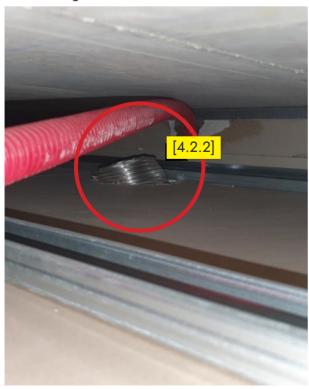
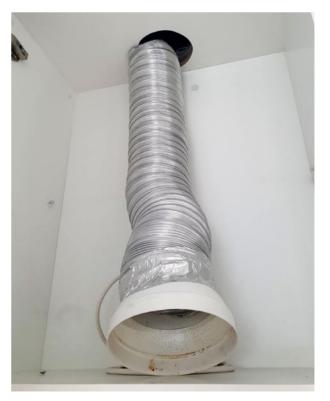
The pipe from the cooker hood was led into the space between the concrete slab and the false ceiling [4.2.2]. A few metres of ventilation pipe are missing between the cooker and the ventilation duct [4.2.3].

All cooking fumes, odours and moisture are introduced into the hollow space below the false ceiling and spread throughout the flat.

Pipe outlet from the eaves into the space over the false ceiling.

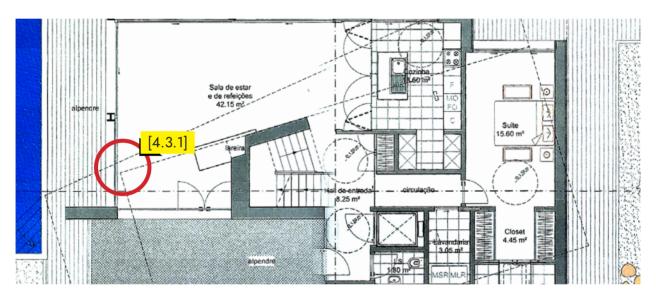
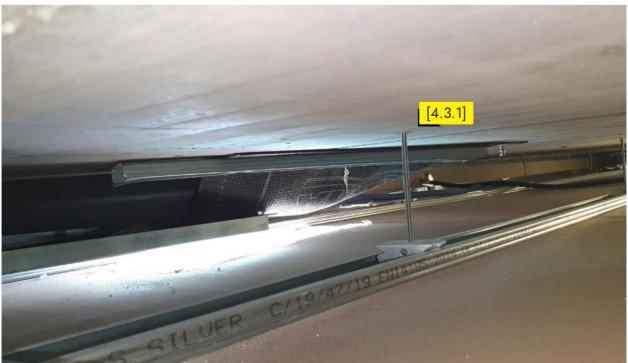
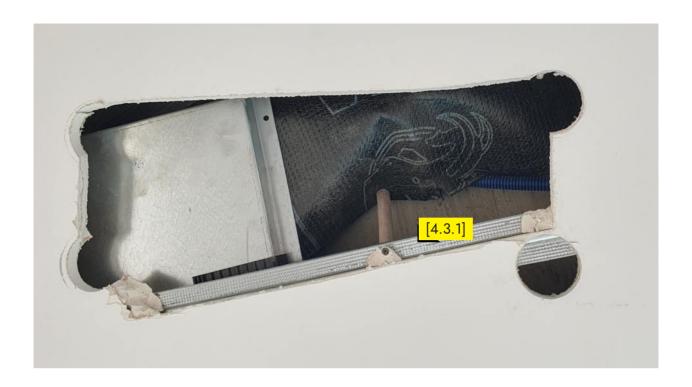
**4.3.1.** In the south-east corner of the living room, a specific structure was detected hidden above the false ceiling. It consists of a metal tray partly suspended from the ceiling and partly lying on the frame of the suspended ceiling. There is also a tar paper apron attached to the ceiling using a metal profile and supported by a wooden pole made from a cut-off brushstick.

Presumably this is a device to catch leaks from the terrace that the contractor could not deal with. Instead of sealing the penetrations through the ceiling and fixing the problem, a leak masking device was installed.

This is an unprecedented, non-technological solution and should not be used in housing.

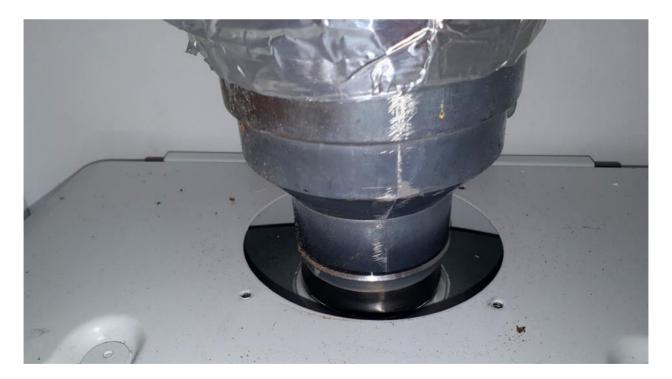
The exhaust pipe from this cooker is attached to it using aluminium self-adhesive tape. The flue gases are not discharged into the chimney, but are discharged to the outside through a simple ventilation grille.

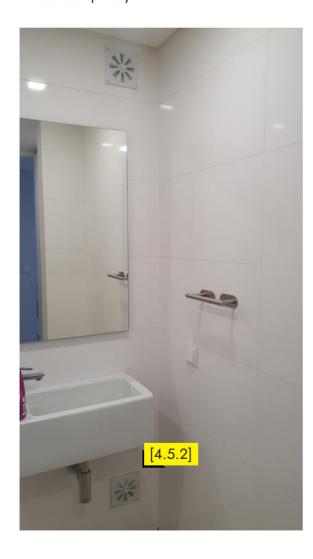
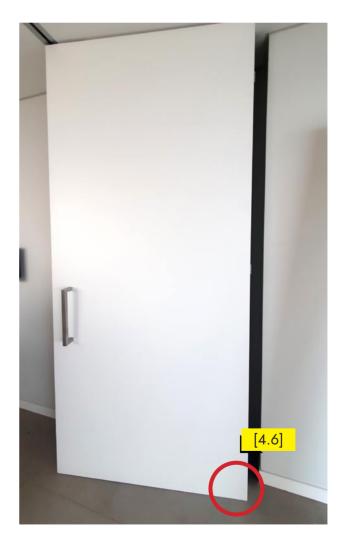
The kitchen door jams and is stuck against the floor. They can only be moved a little and cannot be closed completely. .

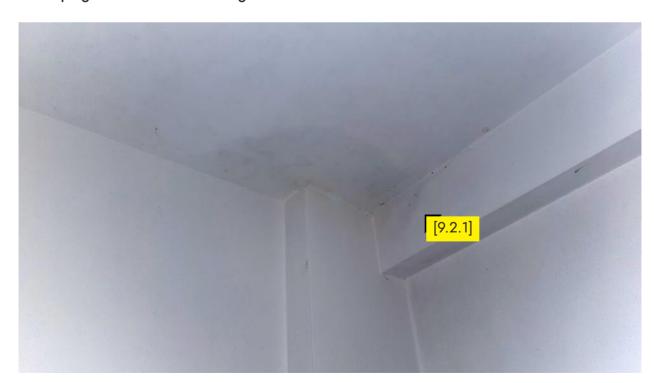
9.2.1. Visible signs of flooding - the rainwater is penetrating from the roof. Fungus and mould developing on the walls and ceiling.

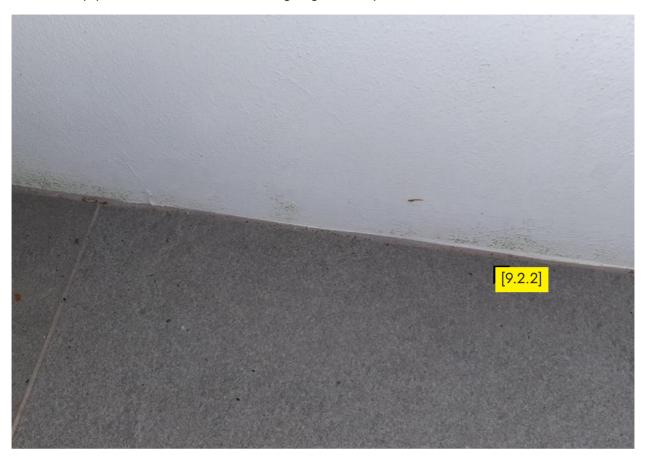
9.2.2. Damp patches on the walls. Green algae growth in plaster.

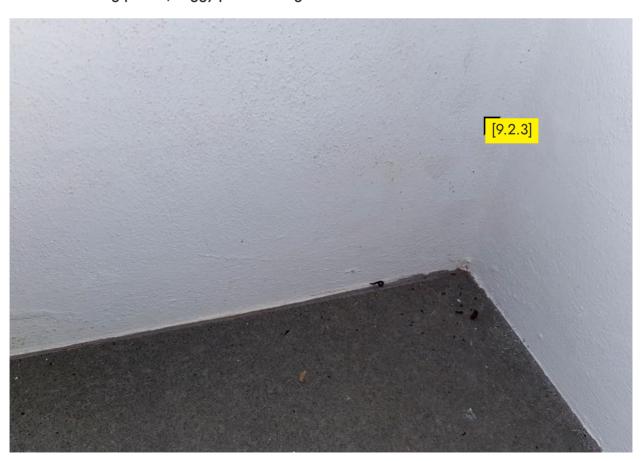
9.2.3. Crumbling plaster, soggy paint coming off.

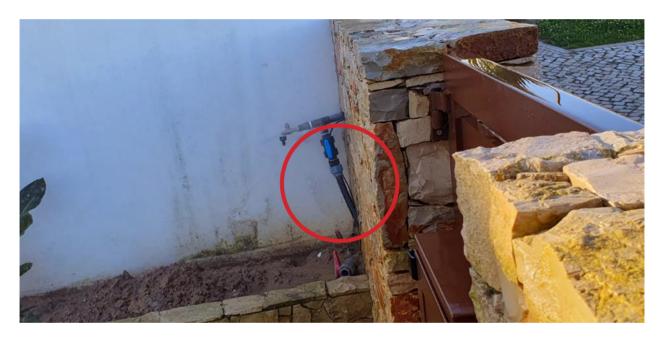
2024.06.18\_08:08:46

During a visit on 18-06-2024, it was noticed that an unknown pipe was running to the ground from a tap in the garden. Upon investigation it was found that this pipe is used to irrigate all the flower beds and lawns down the street, outside the property.

It had been connected when the house was built, and for a few years it had been used to water the lawns outside property at the homeowner's expense without informing him!
