# The Report

House No 9

*March 2025*

This report systematises and organises the numerous construction and workmanship errors occurring in the private residential house located in Lote 3 - Casais Porto Dinheiro.

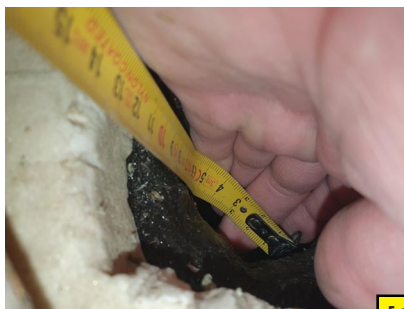
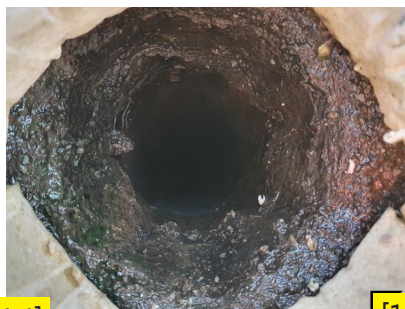
[1.1.1]

In the design, the pipe diameter was specified as 75 mm, while in reality the pipes have a diameter of less than 50 mm (their diameter was reduced by the layers of roofing felt rolled inwards).

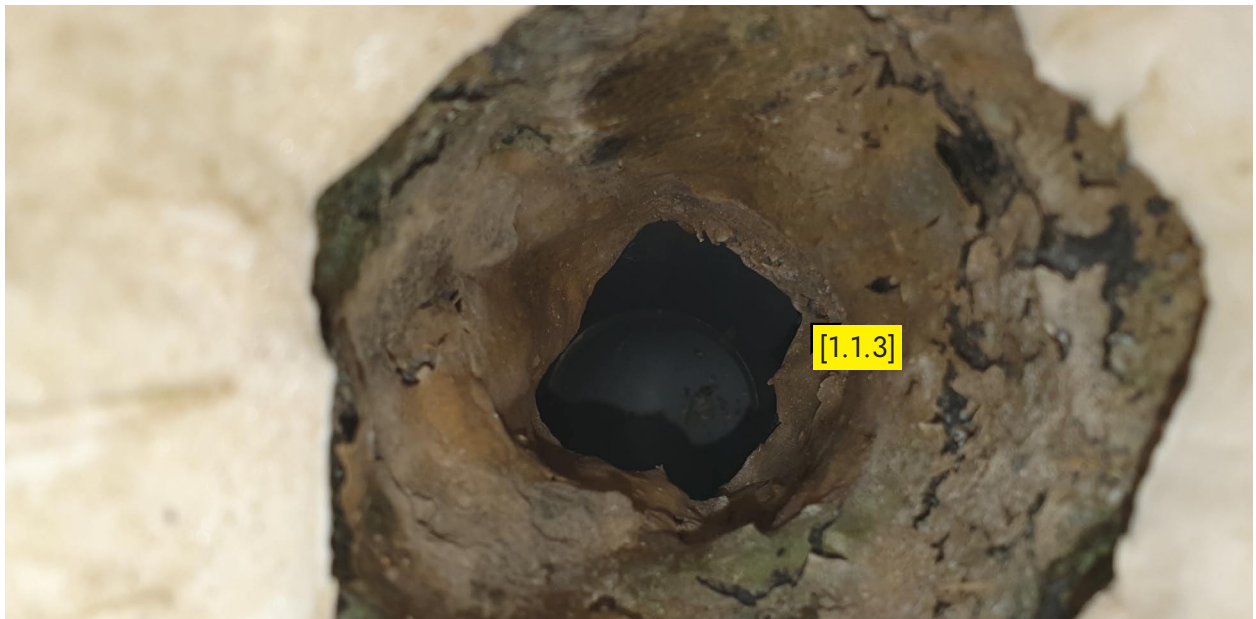
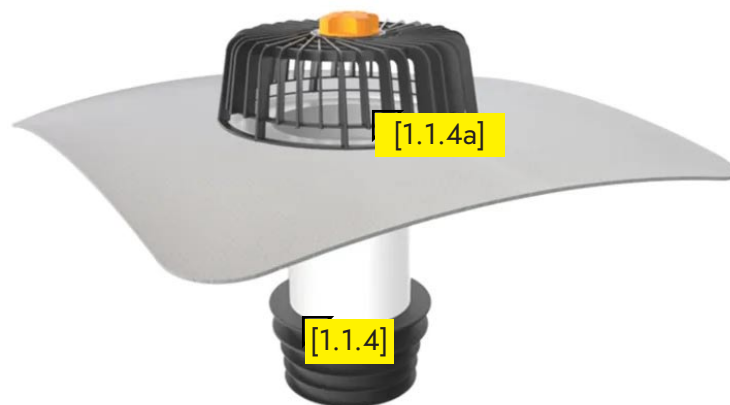
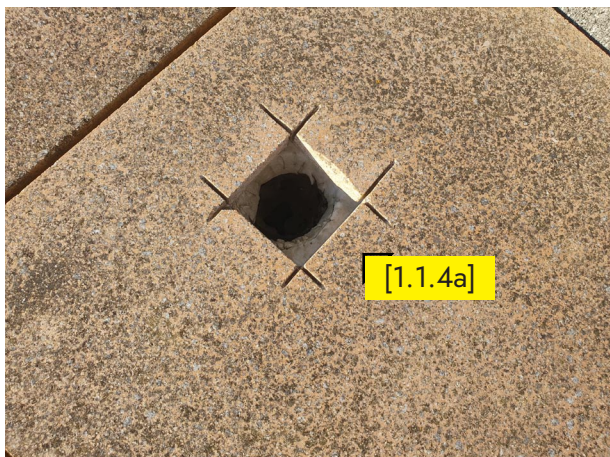
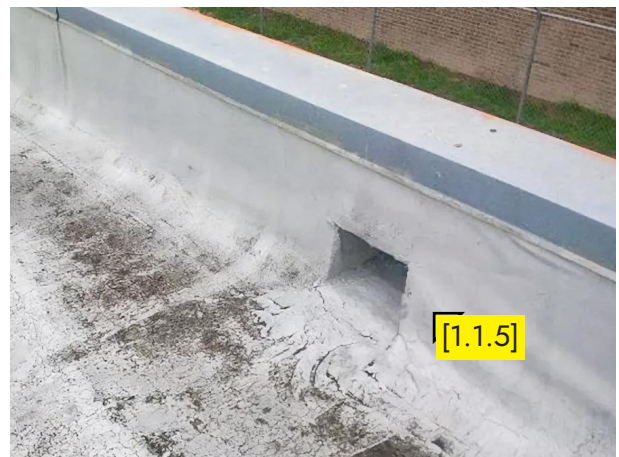
1.1.3. The water drainage through the roof ceiling was done incorrectly, as the bare ceiling slab is visible in the drainage holes. It is only partially covered by roofing felt bent inwards. This allows water to penetrate through cracks in the concrete and further flood the house.

1.1.4a. None of the drains have a basket to protect the drainpipes from clogging with small objects.

1.1.4. Drainage holes should be fitted with an appropriate outlet fitting. Its apron should be welded to the roofing felt and the drain should be sealed in the downpipe.

1.1.5. The roof should also be equipped with **thru-wall overflow scuppers** that could drain excess water from the roof in the event of extremely heavy rain or clogged drainage holes.

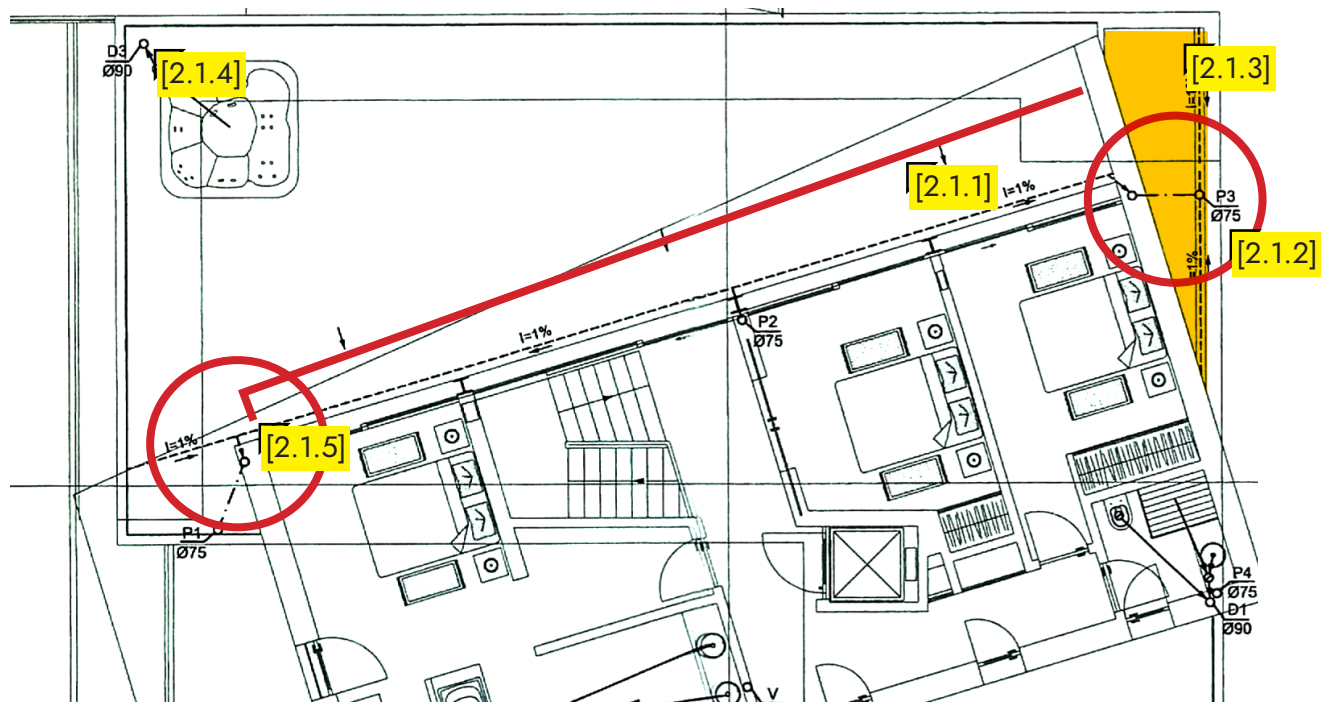
2.1.3. Furthermore, the drainage trough at P3 cannot serve as a support for the terrace drainage, as the part marked in orange is about 8-10 cm higher than the rest of the terrace!

2.1.4. The drainage for the jacuzzi pool (D3, 90 mm) was not made at all.

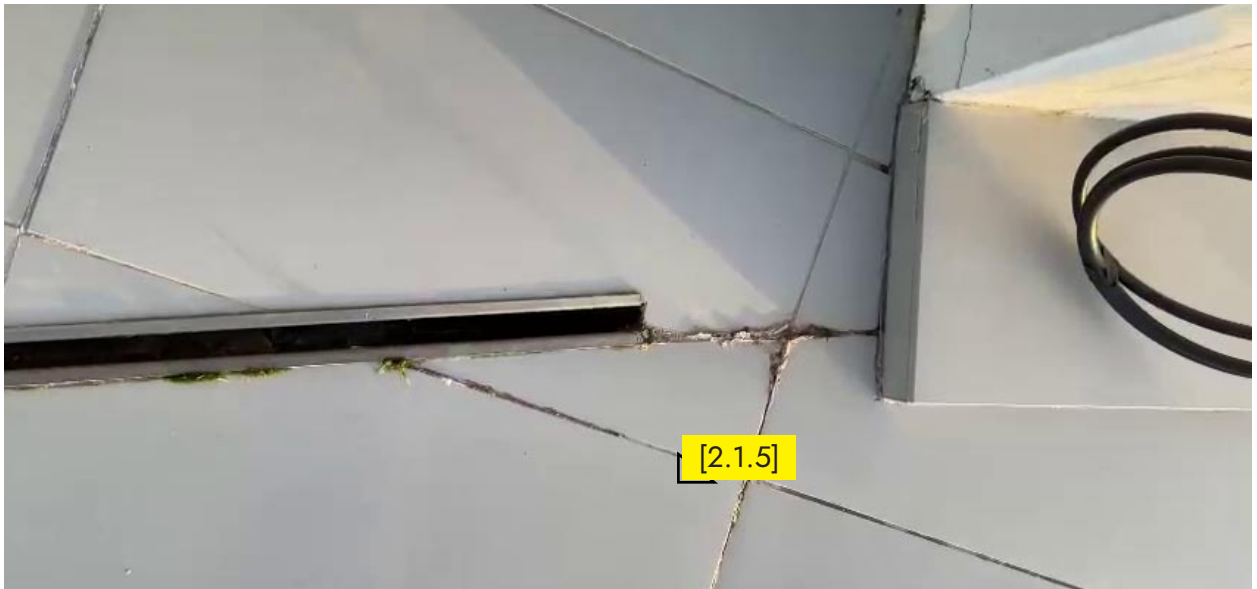
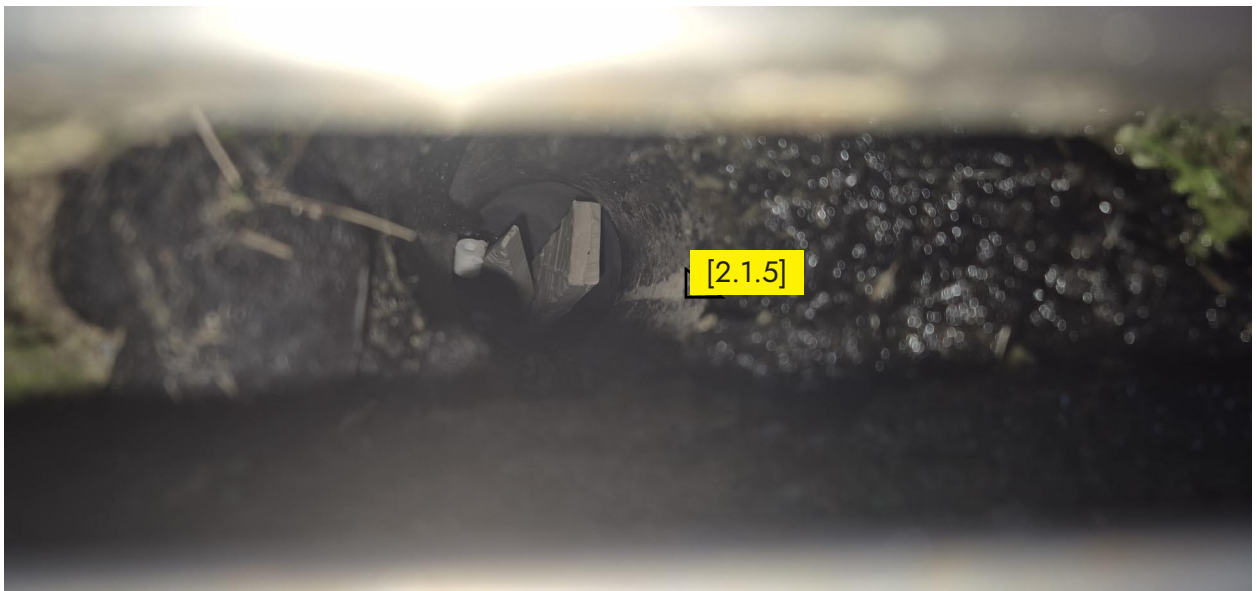
2.1.5. The drain on the south side was filled with pieces of tile and other construction waste. As these pieces were larger than the original size of the hole, it is not possible that they got in there after the construction was completed.

This kind of negligence could easily have led to the drain becoming clogged and consequently filling the terrace with water with all its consequences.

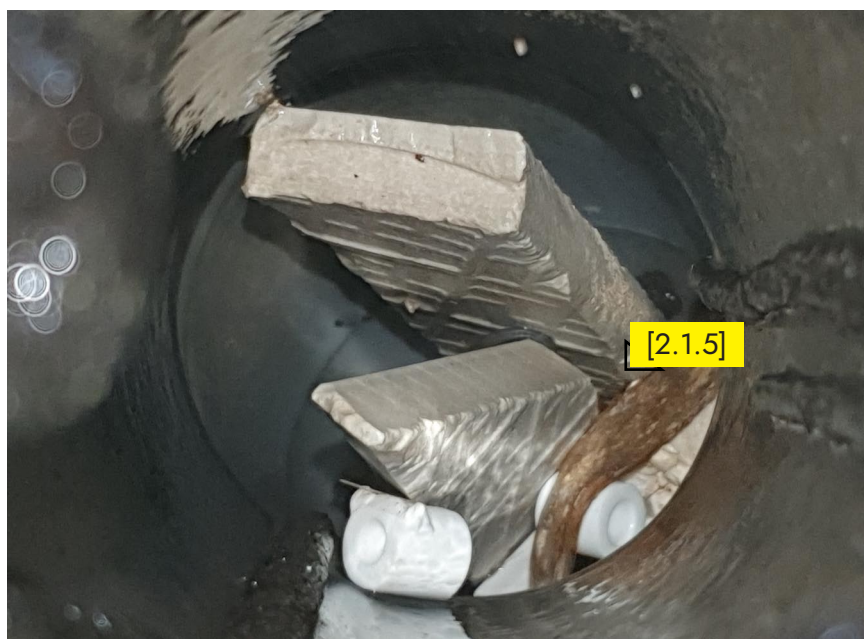
Endoscopic image of the debris in the terrace drainage pipe

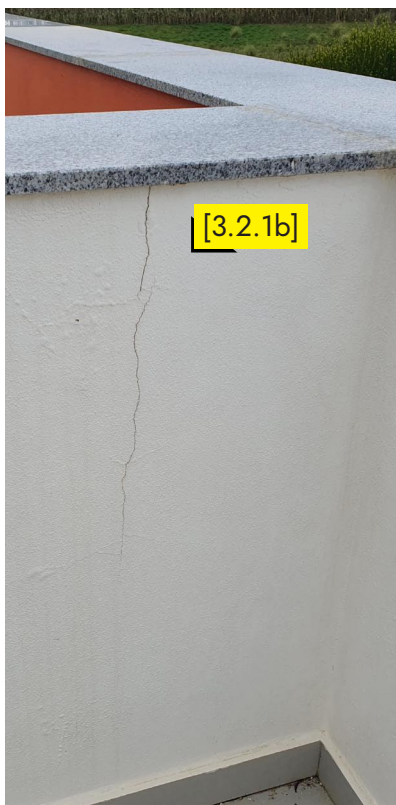
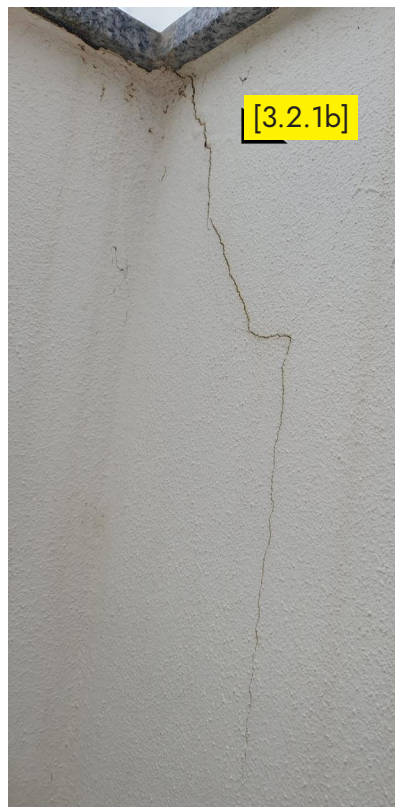
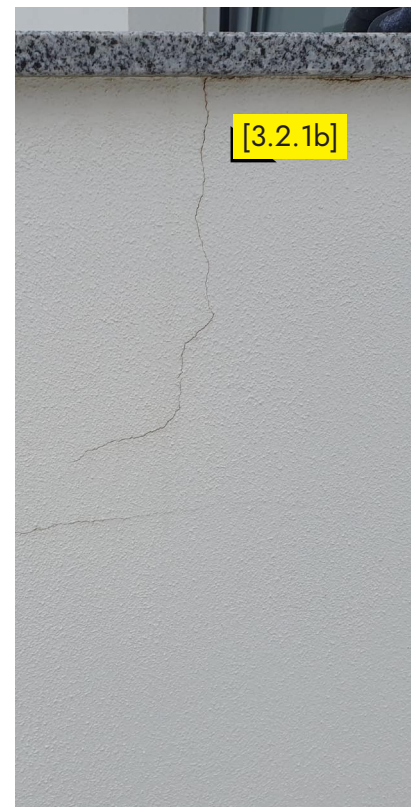
Cracks in the masonry fence of the balcony [3.1.1b].

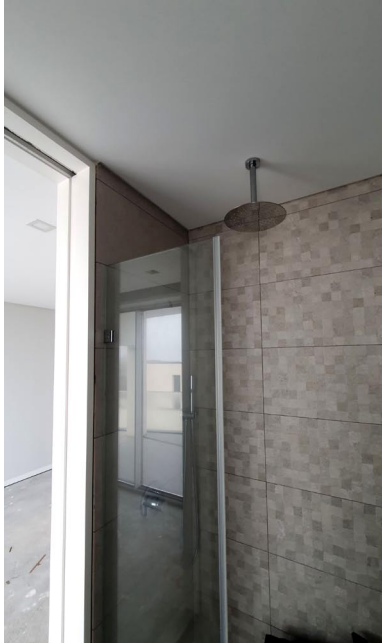
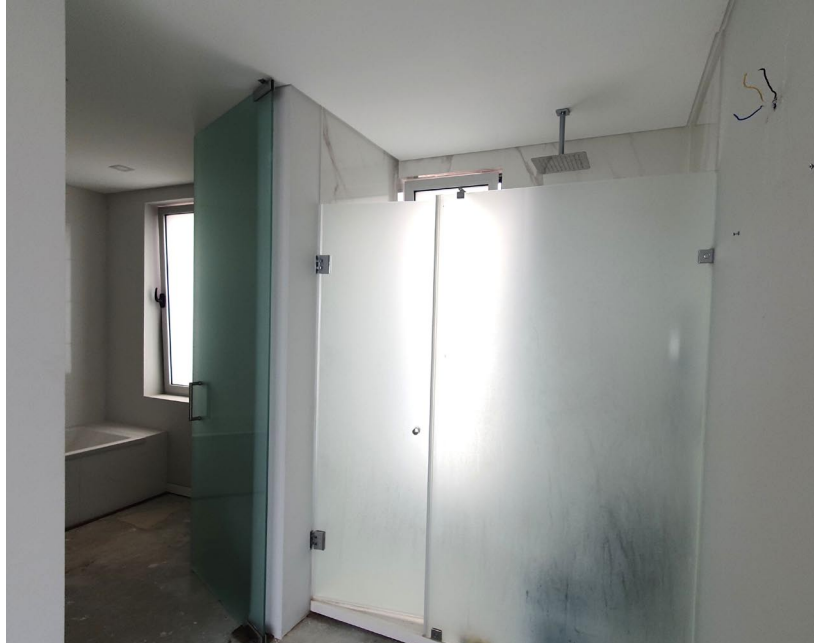
All odours and dampness will be allowed to enter the living areas and soak the clothes in the open wardrobe located near by.

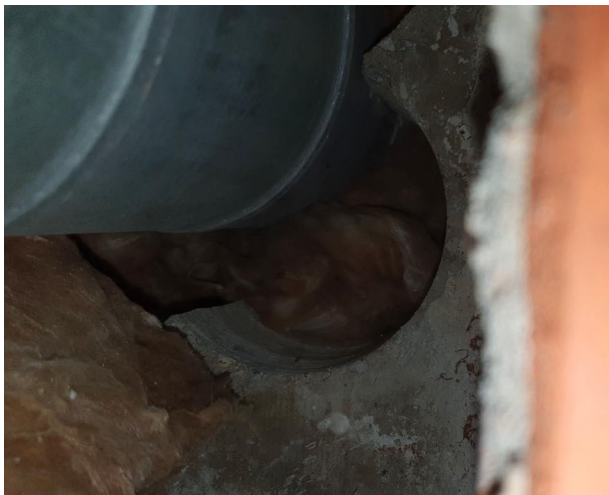
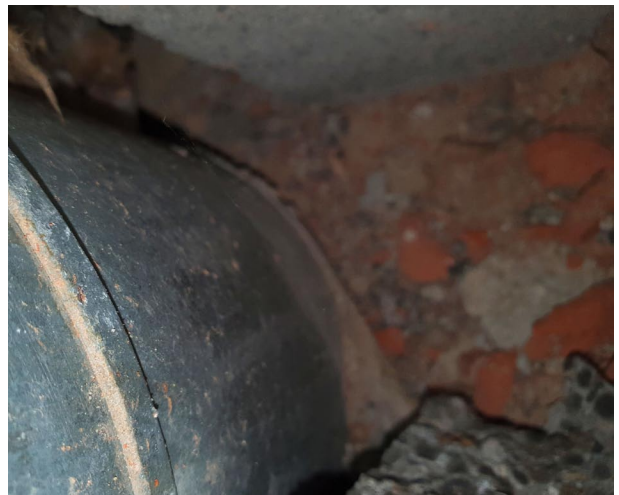
**3.4.2.** The bathroom adjacent to the small bedroom has two air vents, but these lead to a blind section of technical duct in the wall. This duct is closed off towards the roof and on the bottom, so there is no air exchange.

The only effect of these vents is to saturate the bricks in the wall with moisture.

**This bathroom does not even have a window, thus the ventilation is impossible!**

Space behind the ventilation grille upstream and downstream of the duct.

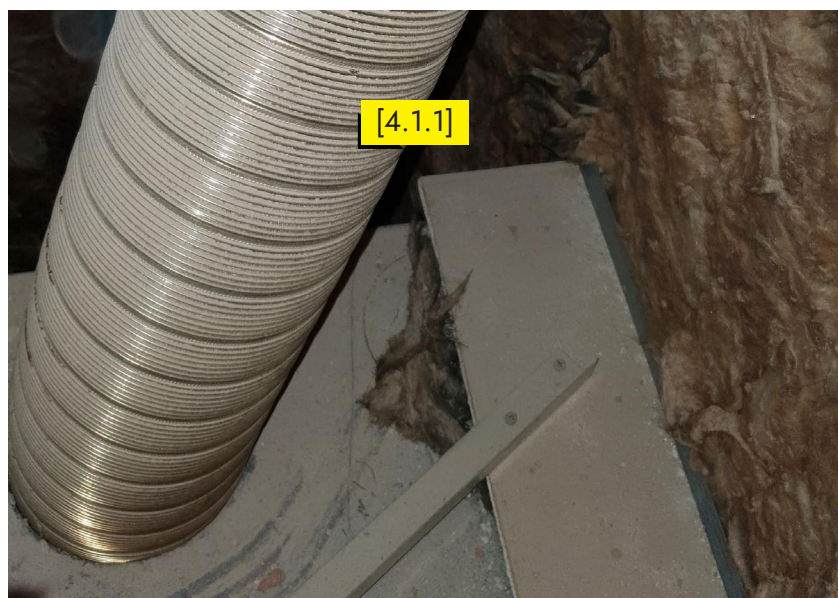
4.1.1. The fireplace was connected to the flue via a flexible flue pipe!

This type of pipe is not approved for flue gas from solid fuel burners, where the flue gas temperature is not controlled and can reach up to 700 °C.

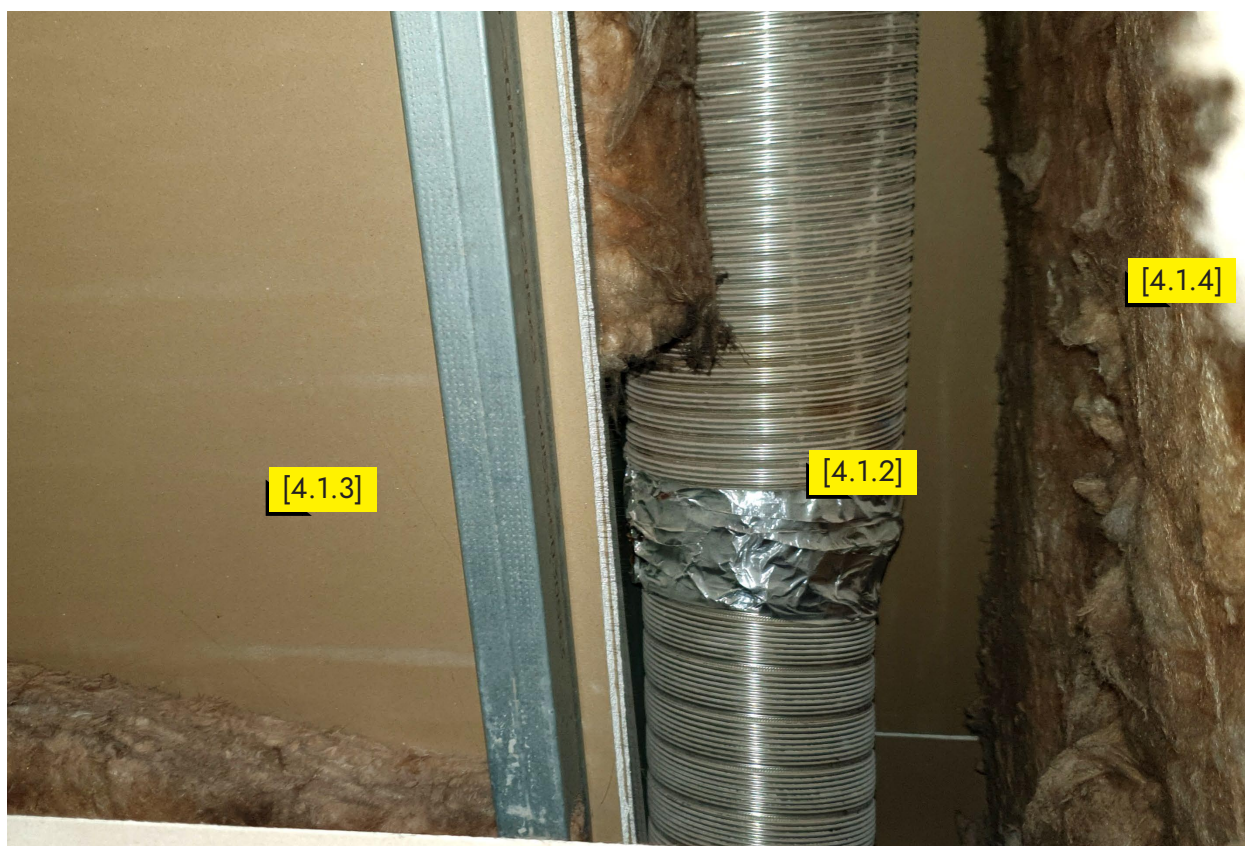
**4.1.2. Flue pipe consists of two joined sections, connected together with an adhesive tape!**

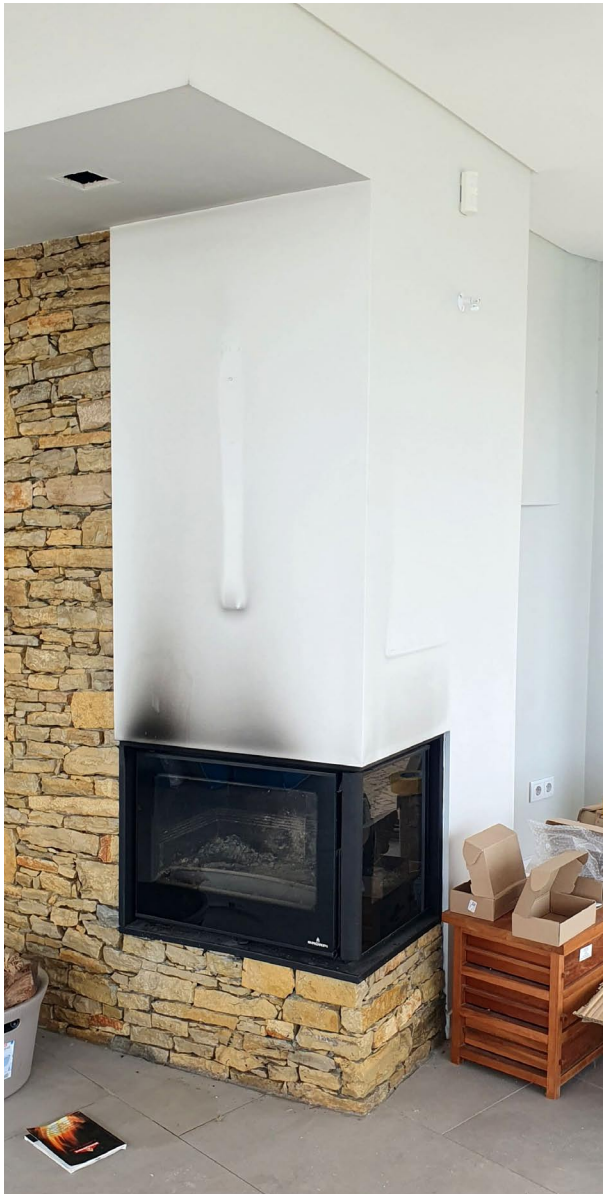
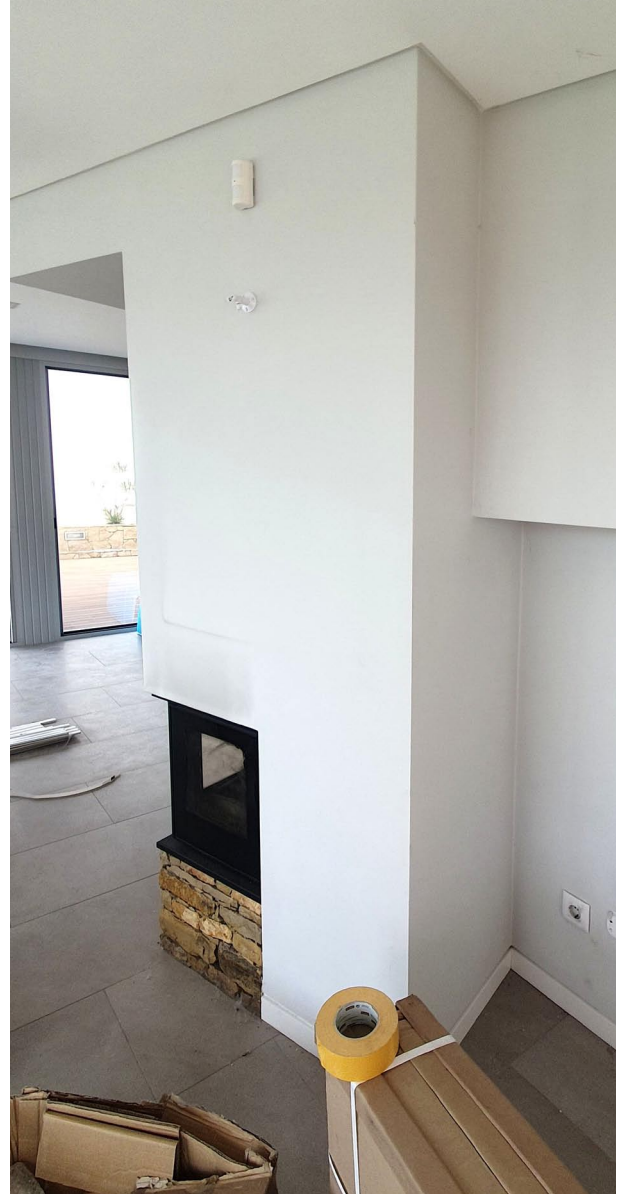
**4.1.3.** The fireplace cladding in some parts has not been thermally insulated on the inside - the plasterboard should be protected from the heat on the inside.

**4.1.4.** The material used to insulate the fireplace is incorrect. Compressed rockwool, laminated with aluminium foil, should have been used. The aluminium layer reflects infrared radiation and prevents the fine rockwool particles from breaking off and spreading through the dwelling.

**4.1.5. The fireplace cladding does not have a single hot air inlet or outlet!  
This risks overheating the firebox, the smoke pipe, the housing and other  
objects in the vicinity!**

**The fireplace is made completely contrary to the good building  
practice and the operating manual supplied with the fireplace!**

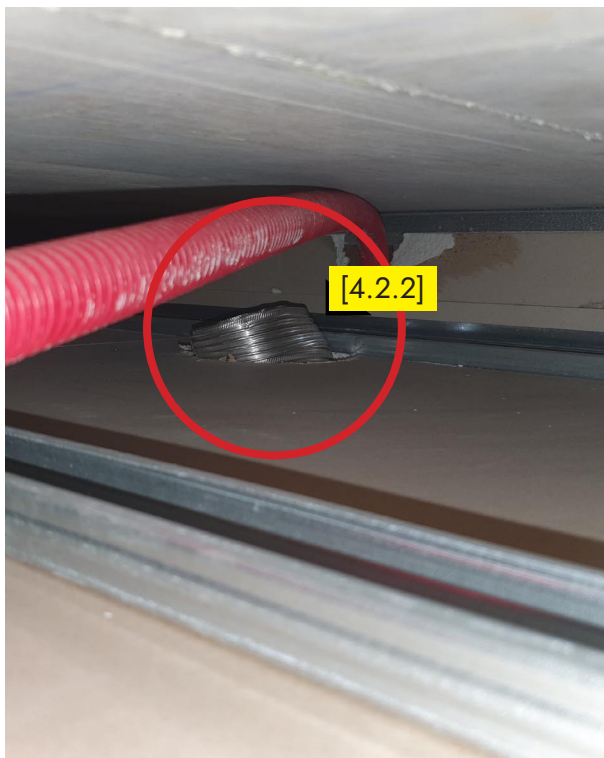
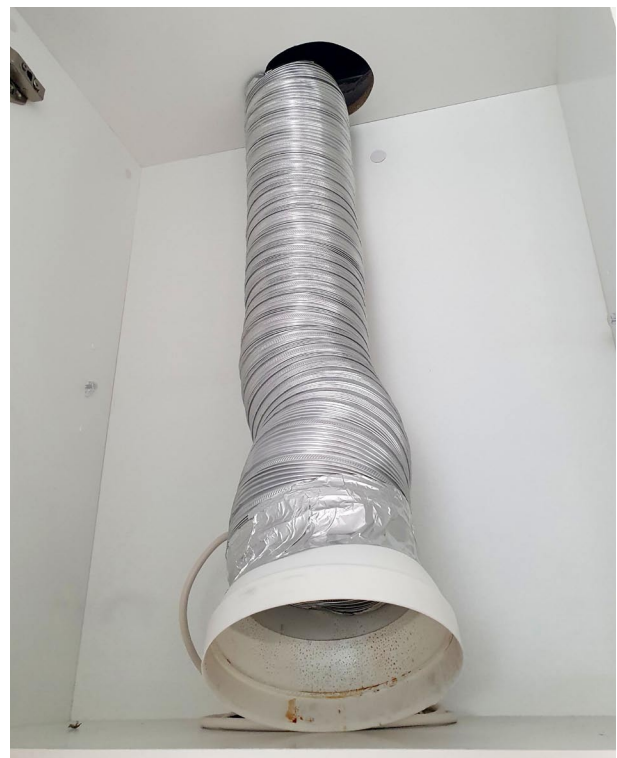
The pipe from the cooker hood was led into the space between the concrete slab and the false ceiling [4.2.2]. A few metres of ventilation pipe are missing between the cooker and the ventilation duct [4.2.3].

All cooking fumes, odours and moisture are introduced into the hollow space below the false ceiling and spread throughout the flat.

Pipe outlet from the eaves into the space over the false ceiling.

Dismounted hood pipe in the kitchen cupboard.

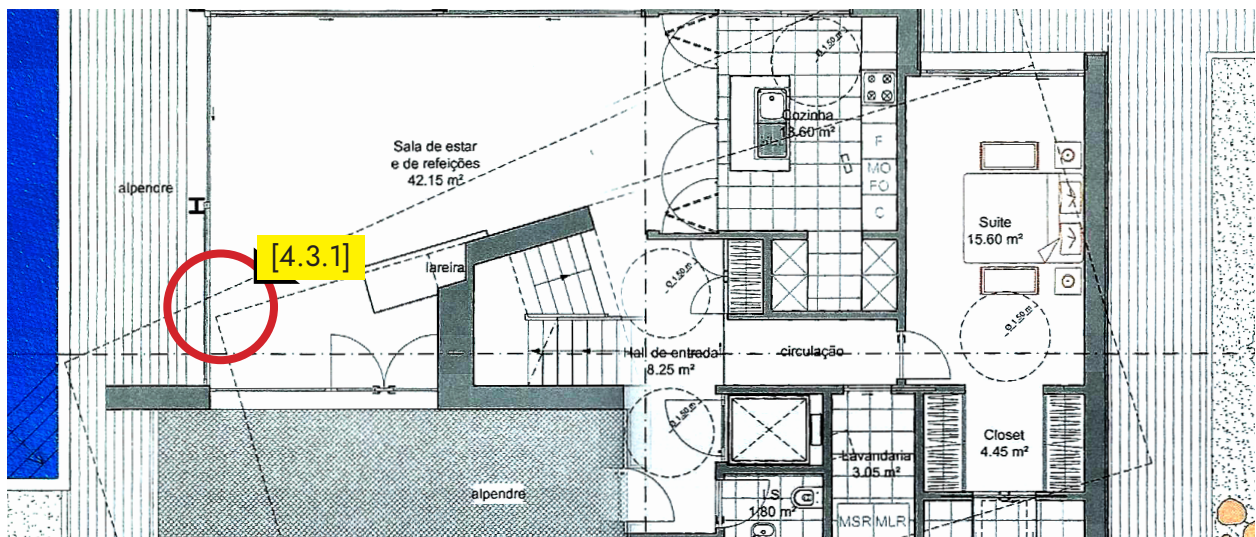
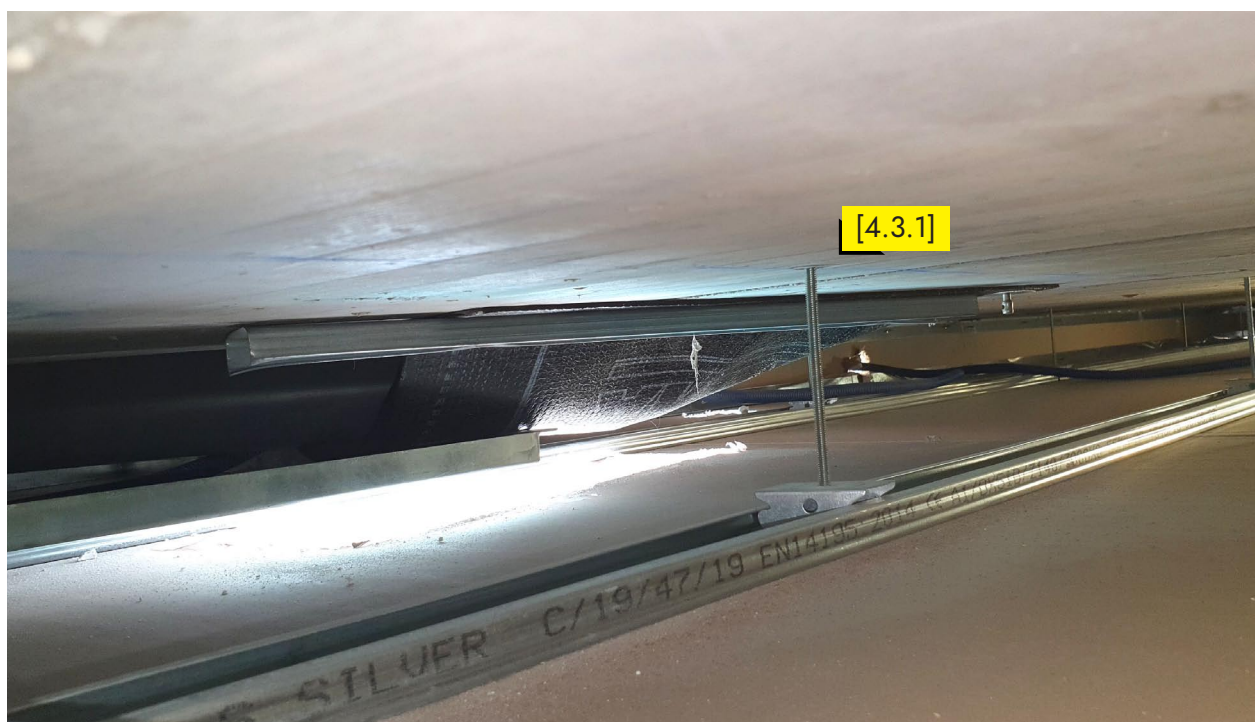
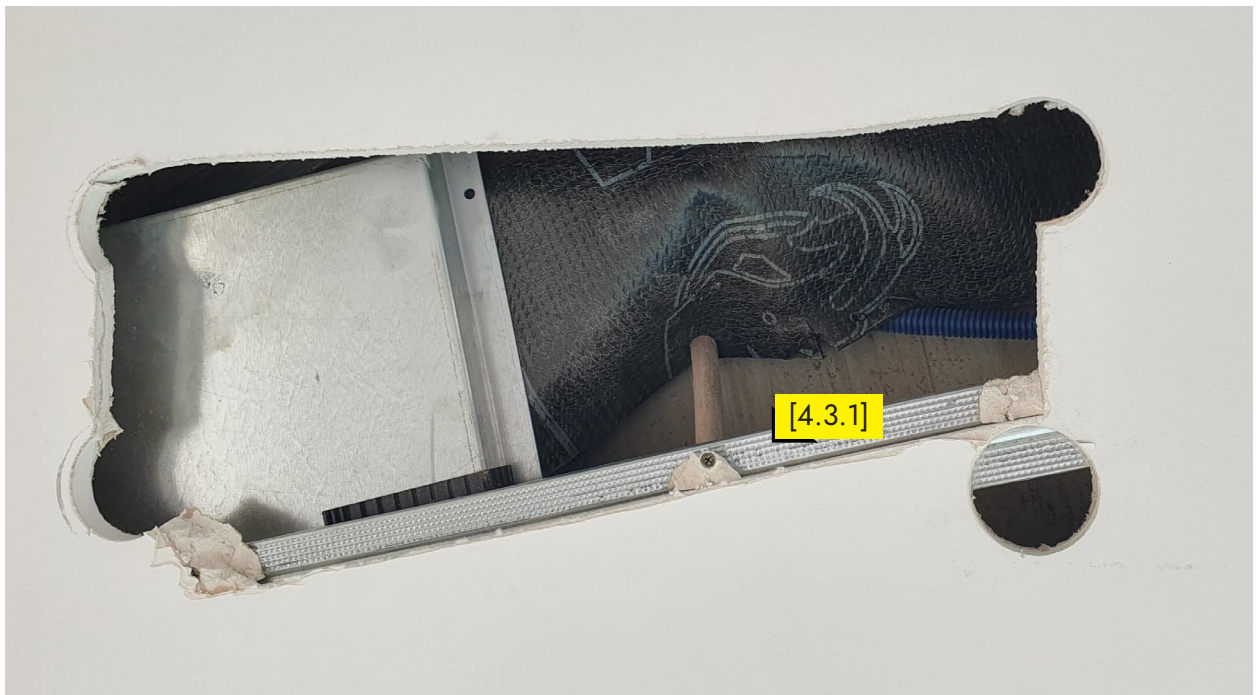
4.3.1. In the south-east corner of the living room, a specific structure was detected hidden above the false ceiling. It consists of a metal tray partly suspended from the ceiling and partly lying on the frame of the suspended ceiling. There is also a tar paper apron attached to the ceiling using a metal profile and supported by a wooden pole made from a cut-off brushstick.

Presumably this is a device to catch leaks from the terrace that the contractor could not deal with. Instead of sealing the penetrations through the ceiling and fixing the problem, a leak masking device was installed.

This is an unprecedented, non-technological solution and should not be used in housing.

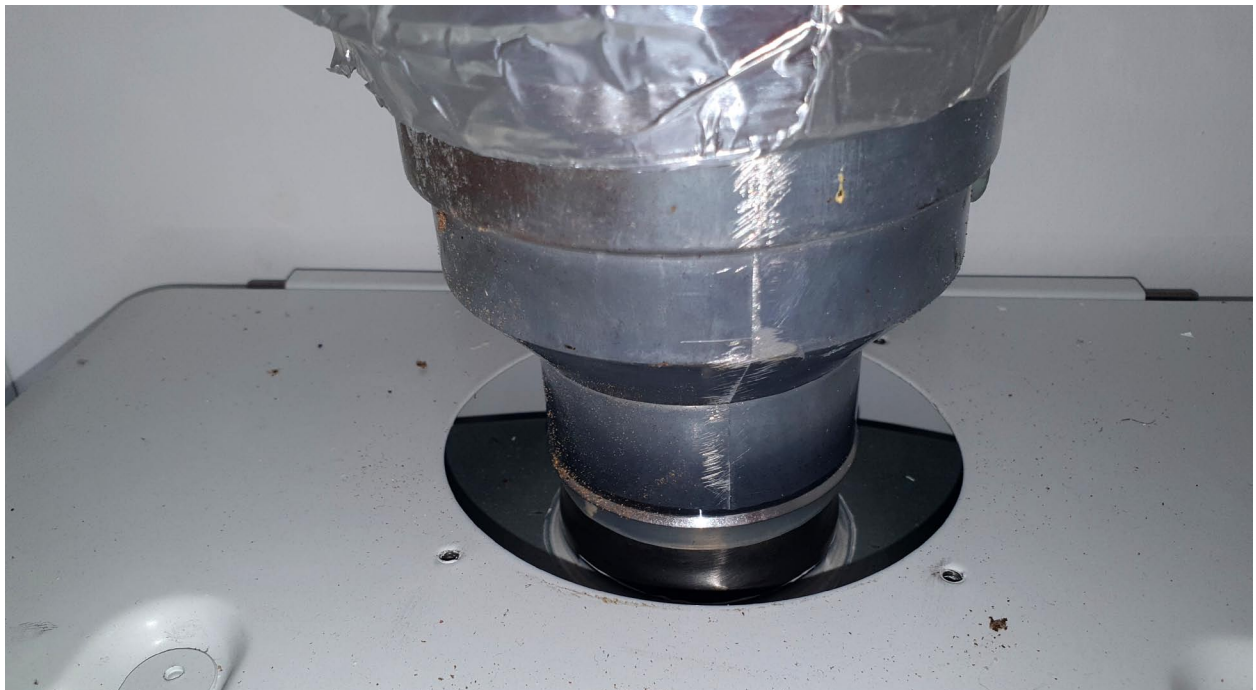
The gas water heater is located in the kitchen cupboard.

The exhaust pipe from this cooker is attached to it using aluminium self-adhesive tape. The flue gases are not discharged into the chimney, but are discharged to the outside through a simple ventilation grille.

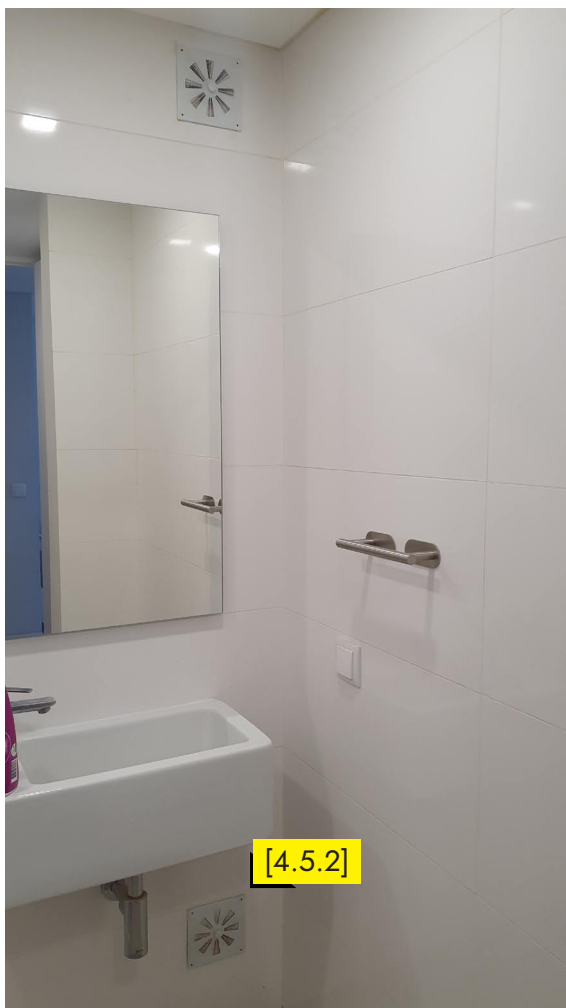
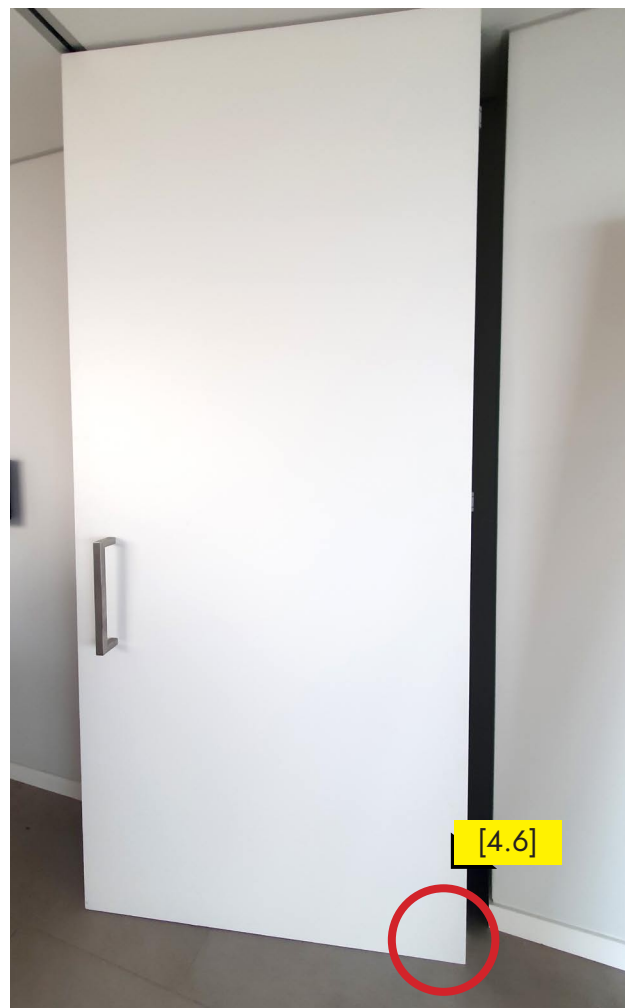
The kitchen door jams and is stuck against the floor. They can only be moved a little and cannot be closed completely. .

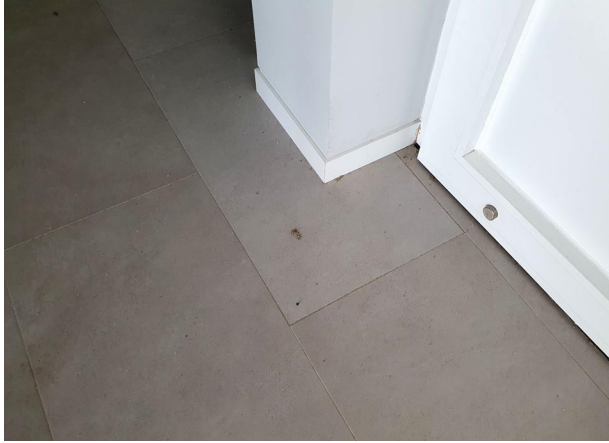
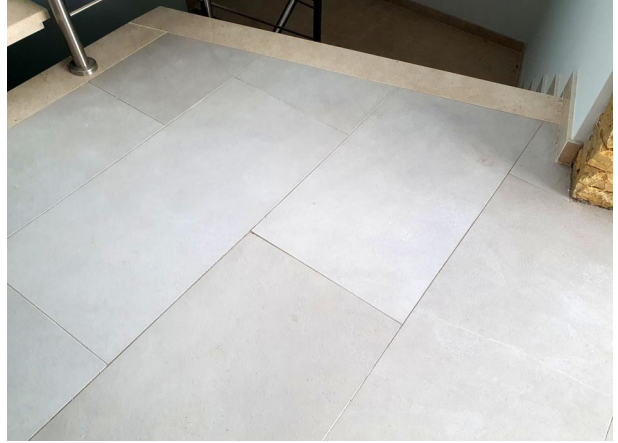
#### 4.7. The corridor floor tiles

The tiles in the corridor at the entrance have different shades. This is a clear omission, as it is part of good building practice to ensure that the tiles come from the same production batch and are the same shade.

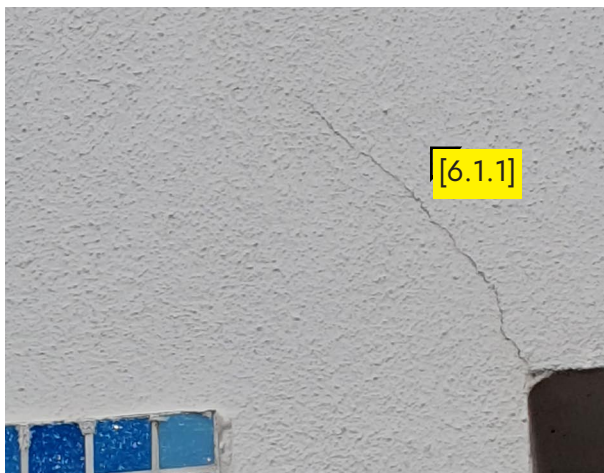
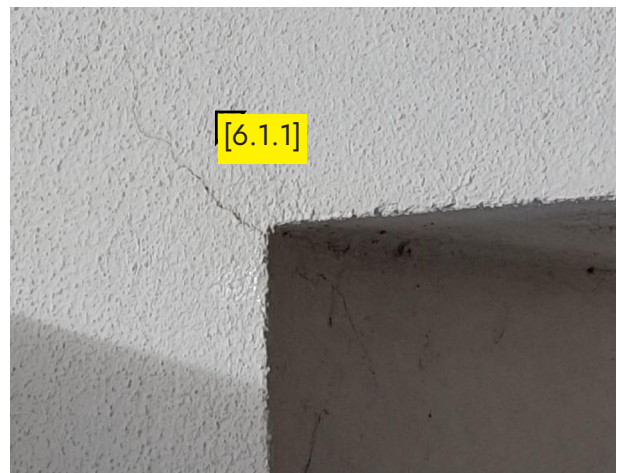
6.1.1. Cracks in the façade around the window openings and corners.

The main cause of their formation is the lack of diagonal reinforcement in the plaster layer.

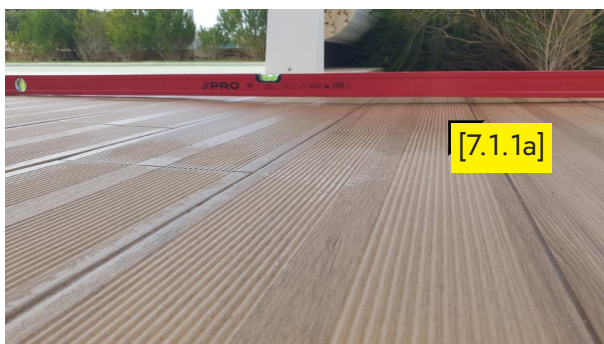
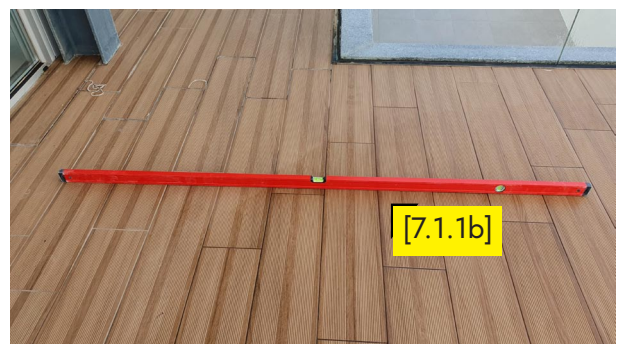
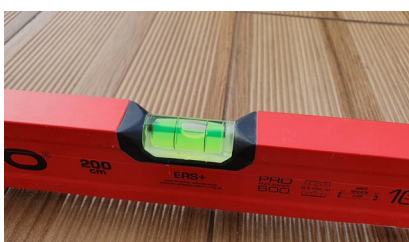
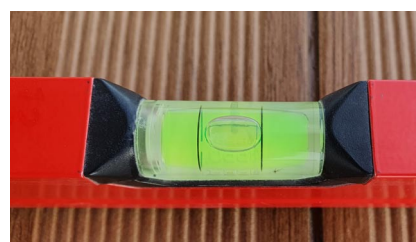
### 7.1. Patio profile and drainage

Patio surface on wrong profile – it forms a trough, there is no slope [7.1.1a] or even worse - the slope is slightly to the building direction [7.1.1a]. As a result, rainwater floods the patio in puddles [7.1.2]. Excess water running off the patio is not drained anywhere. It is likely that some of the water flows freely from the terrace near the wall and infiltrates into the garage - hence the stains in the corner under the ceiling [7.1.3], and some run off at the edge of the patio and pool, as well as in the area of the underground pool pump room.

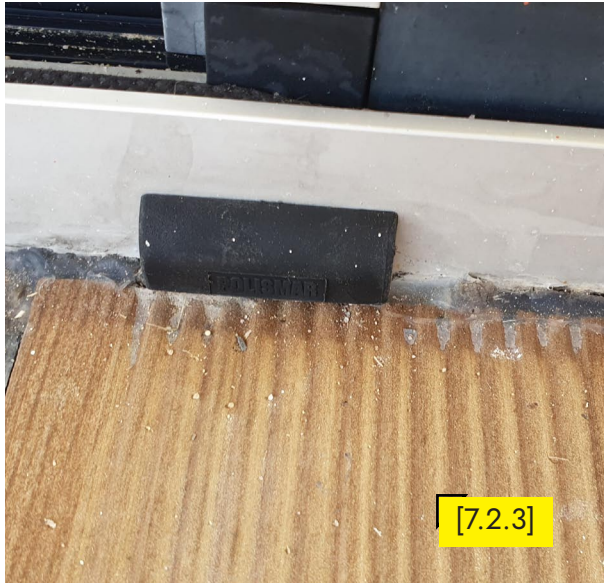
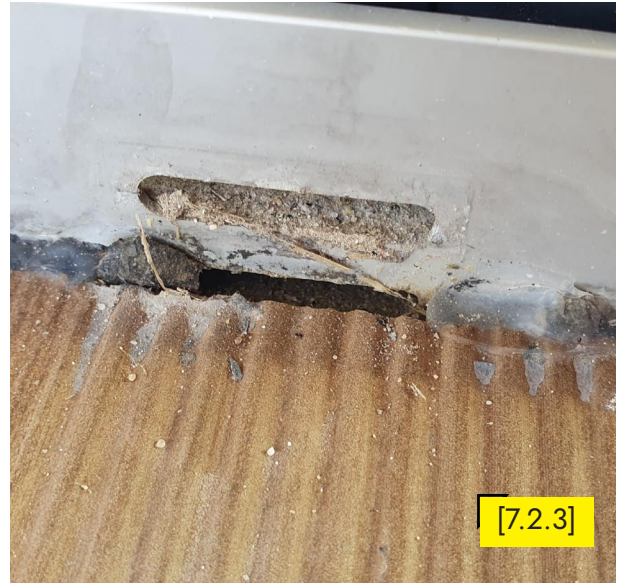
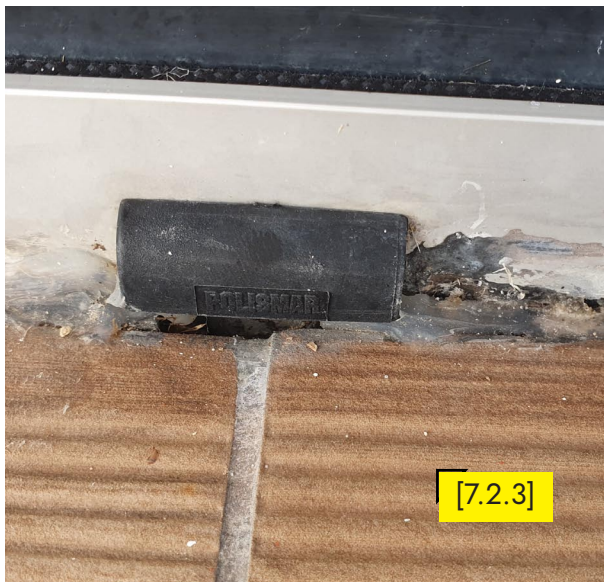
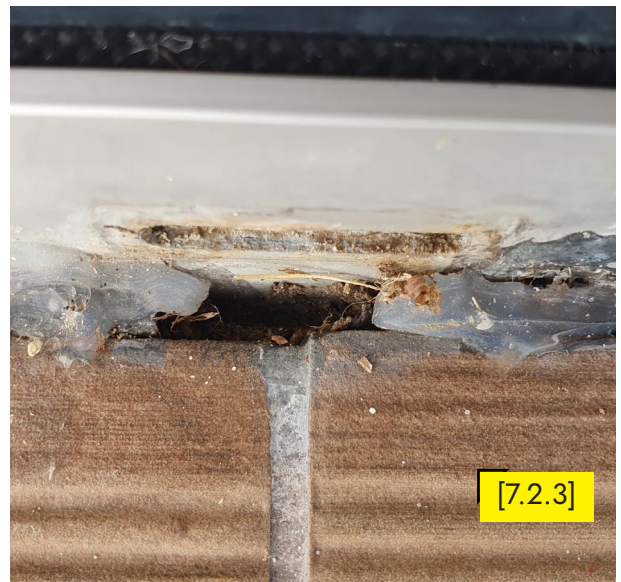
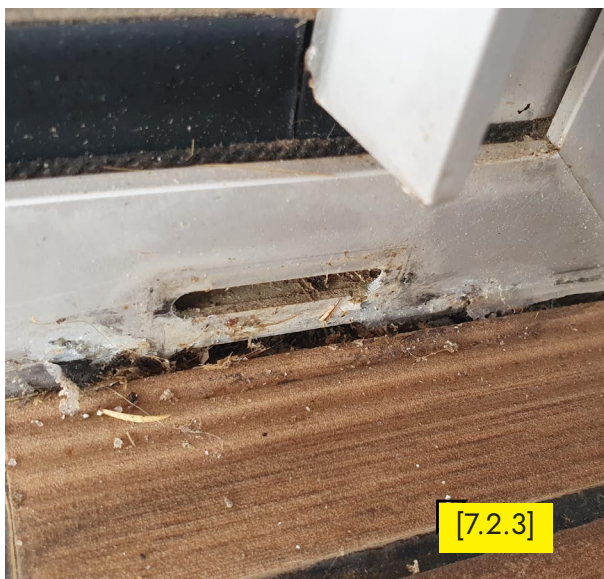
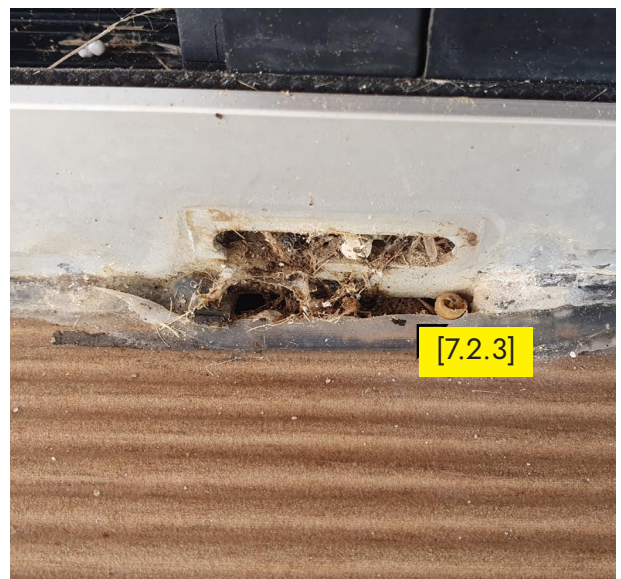
### 7.2.3. Extreme negligence in sealing the patio windows.

There is a lack of tile sealing directly under the water outlets of the window frames, where most water flows out.

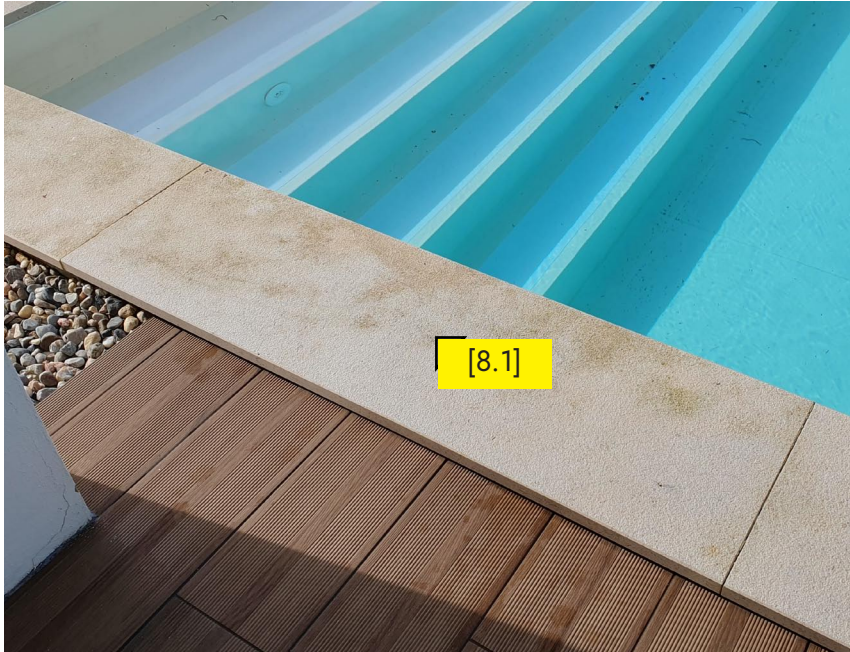
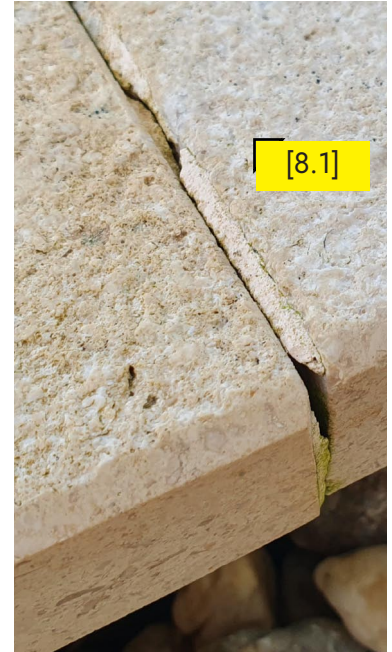
### 8.1. The edge of the pool

The stone slab in the pool frame are loose and wobbly. Cracked out grout can be observed.

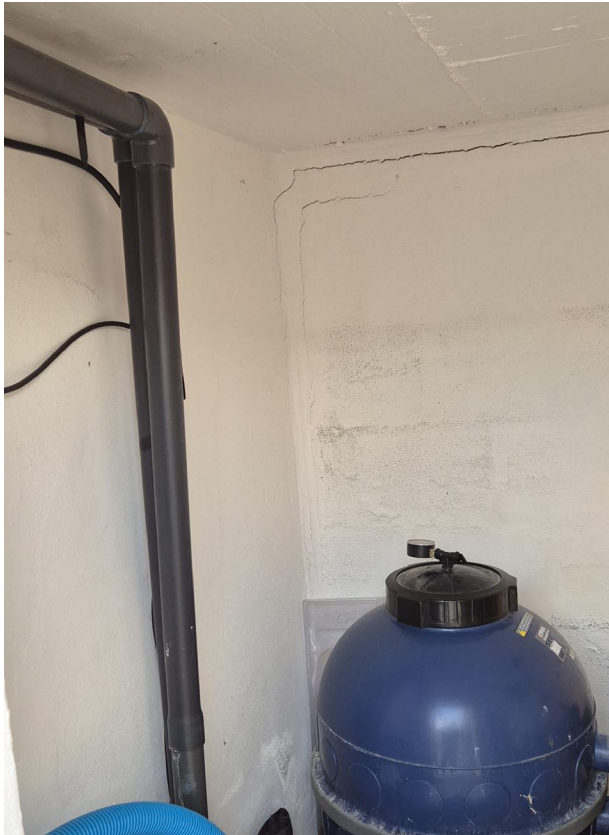
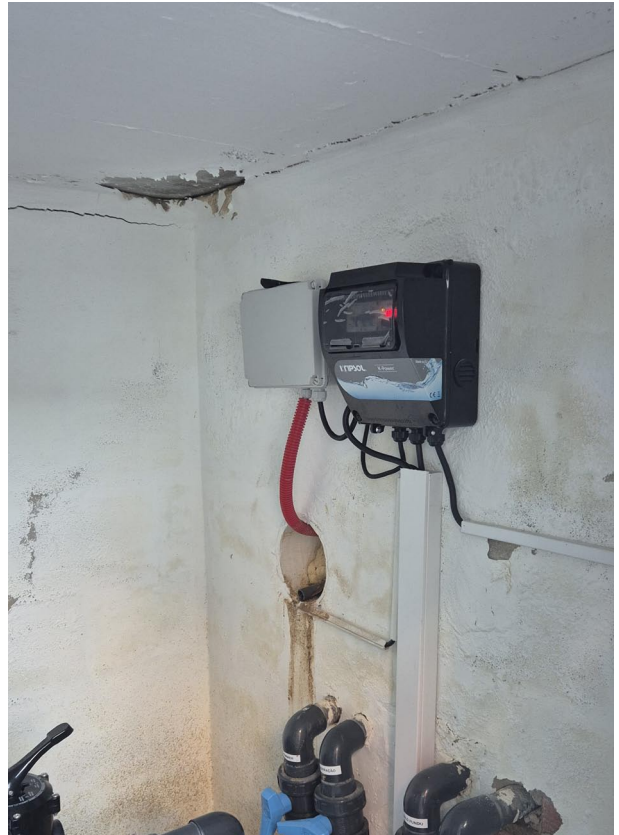
### 8.3. The pumping compartment

In the pool pumping compartment, the walls are damp and cracks are showing on the walls and ceiling. Plaster and paint are falling off the walls.
