# The Report

House No 9

*March 2025*

This report systematises and organises the numerous construction and workmanship errors occurring in the private residential house located in Lote 3 - Casais Porto Dinheiro.

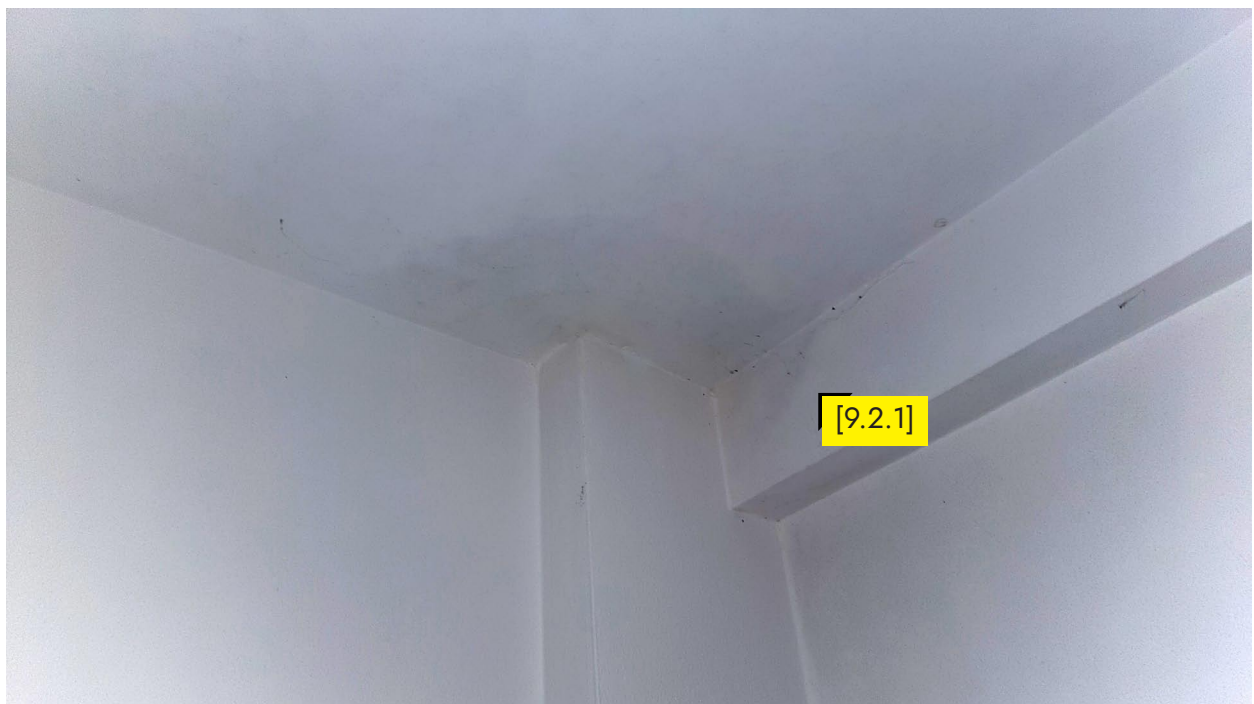
9.2.1. Visible signs of flooding - the rainwater is penetrating from the roof. Fungus and mould developing on the walls and ceiling.

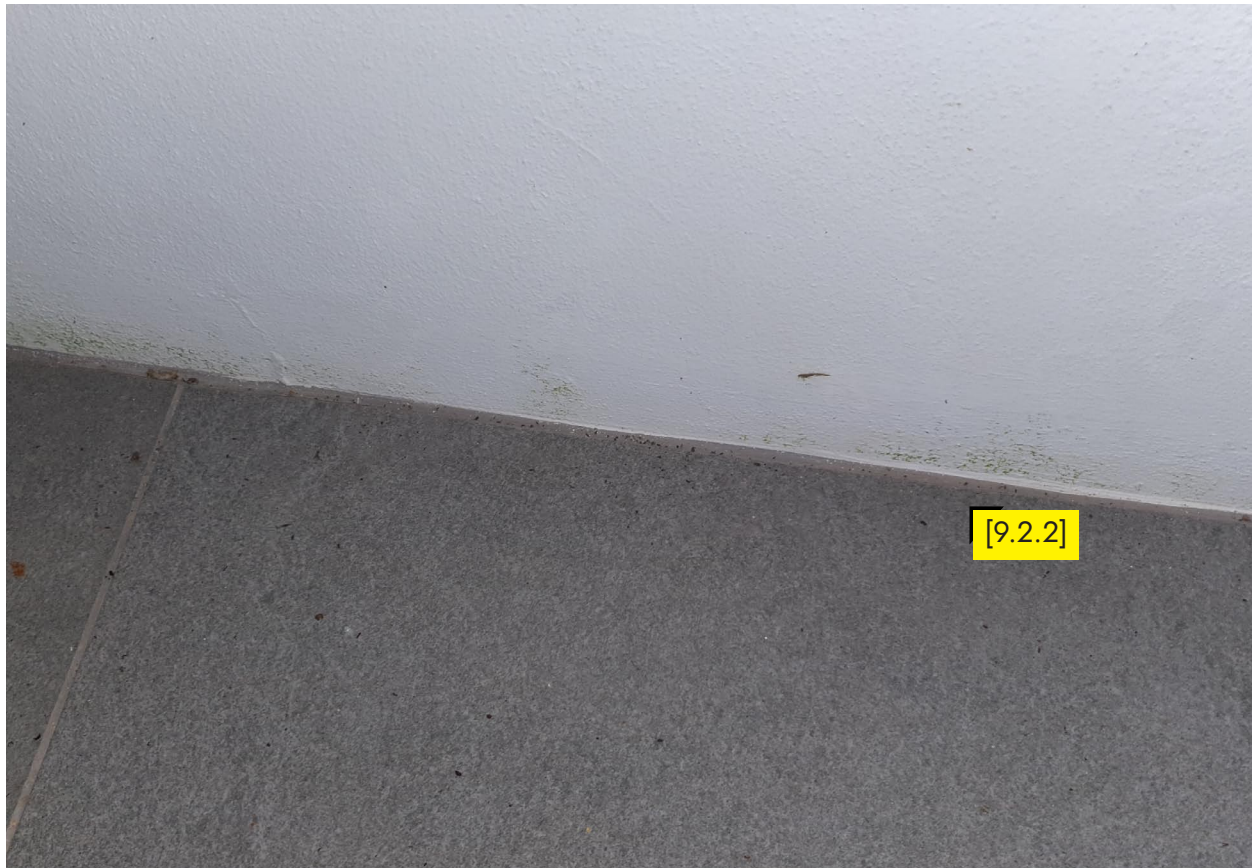
9.2.2. Damp patches on the walls. Green algae growth in plaster.

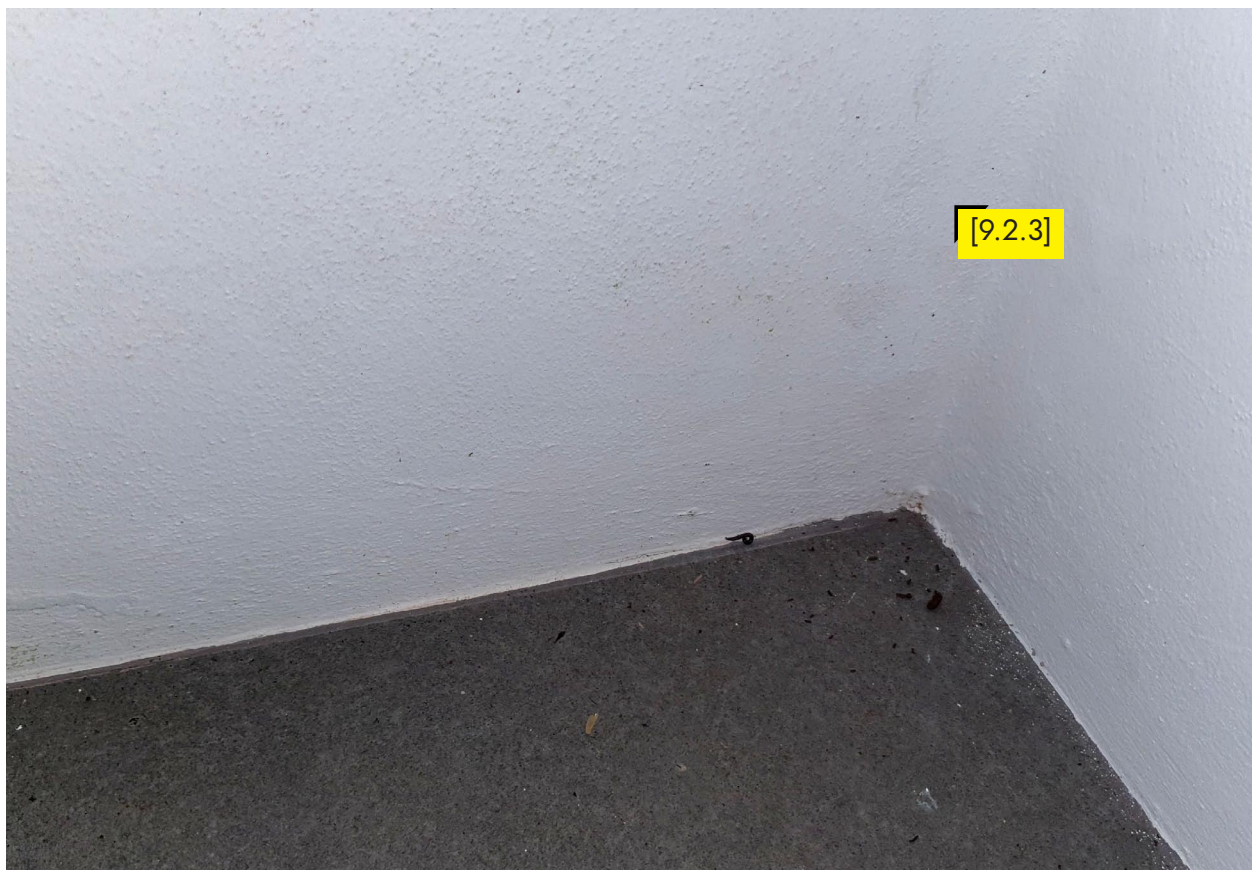
9.2.3. Crumbling plaster, soggy paint coming off.

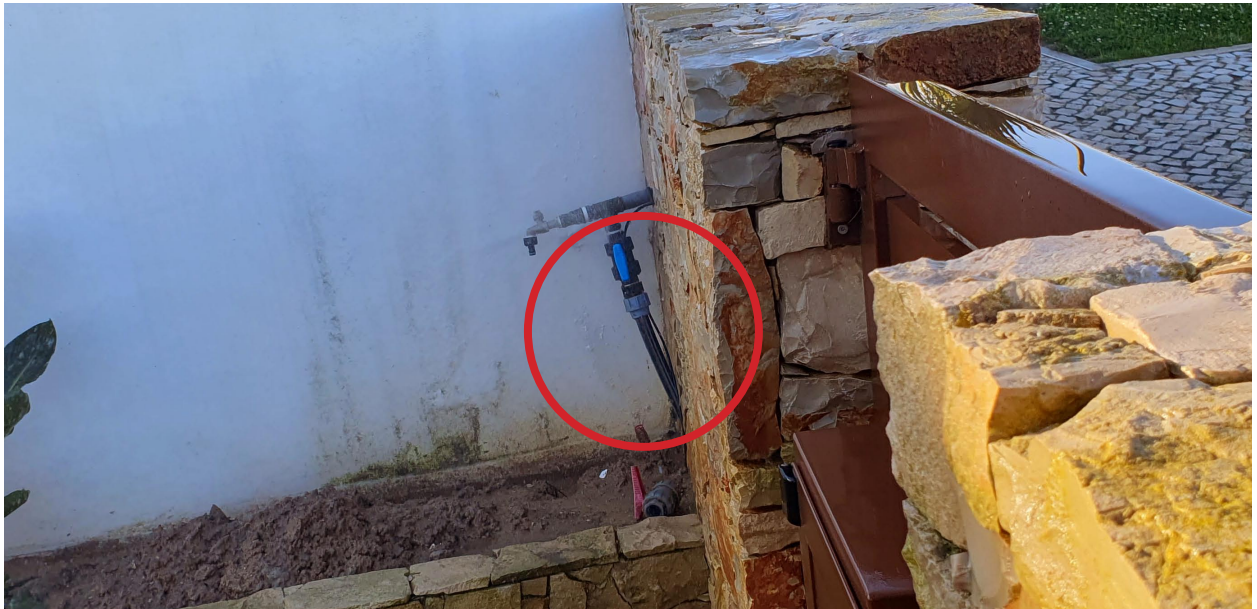
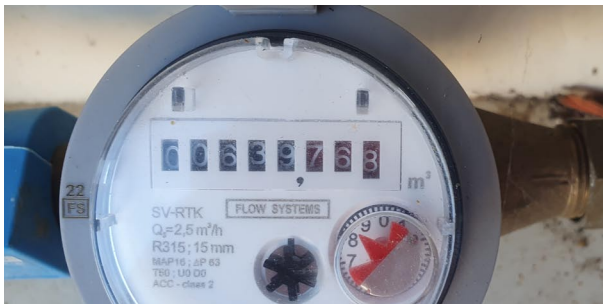
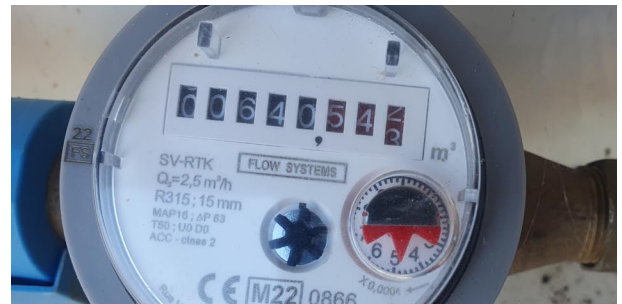
During a visit on 18-06-2024, it was noticed that an unknown pipe was running to the ground from a tap in the garden. Upon investigation it was found that this pipe is used to irrigate all the flower beds and lawns down the street, outside the property.

It had been connected when the house was built, and for a few years it had been used to water the lawns outside property at the homeowner's expense without informing him!

Estimated loss was ca 750 liter per day!

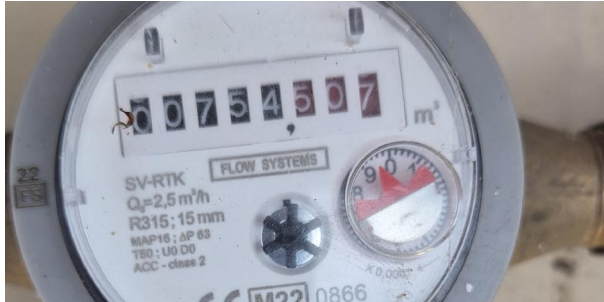
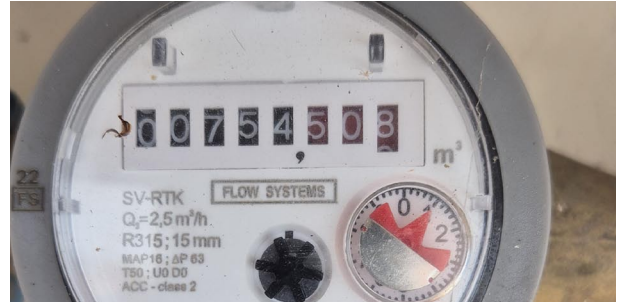
All the valves in the house were turned off, but the water meter continued to turn. Once the main water valve at the water meter was turned off, the problem stopped. The average loss was 0.25 liter per minute. There are many videos and pictures documenting this phenomenon after this date.
