# The Report

*February 2025*

This report systematises and organises the numerous construction and workmanship errors occurring in the private residential house located in Lote 2 - Casais Porto Dinheiro.

The discrepancies were identified based on the construction project of the residential building 12146/2017, hereinafter referred to as The Project.

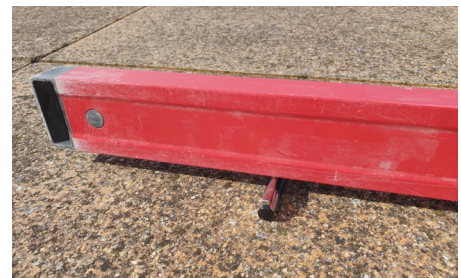
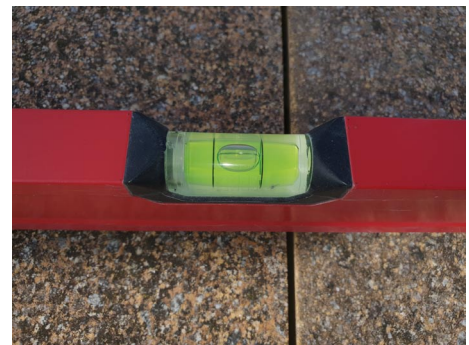
1.1.1. Roof profiling discrepancies were detected in relation to The Project. In some cases, the roof slope is the opposite of the design. Instead of a slope of about 1% towards the drain holes, a counterslope of about 0.5% was detected, which causes water to flow away from the drain hole.

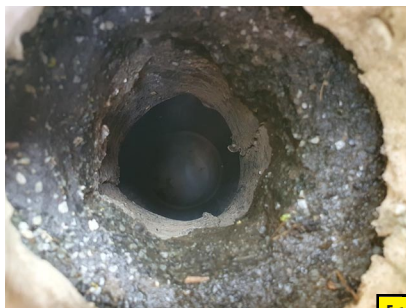
[1.2.1]

1.2.1. All the downpipes (P1-P4) from the roof are of insufficient diameter.

In the Project, the pipe diameter was specified as 75 mm, while in reality the pipes have a diameter of less than 50 mm (their diameter was reduced by the layers of roofing felt rolled inwards).

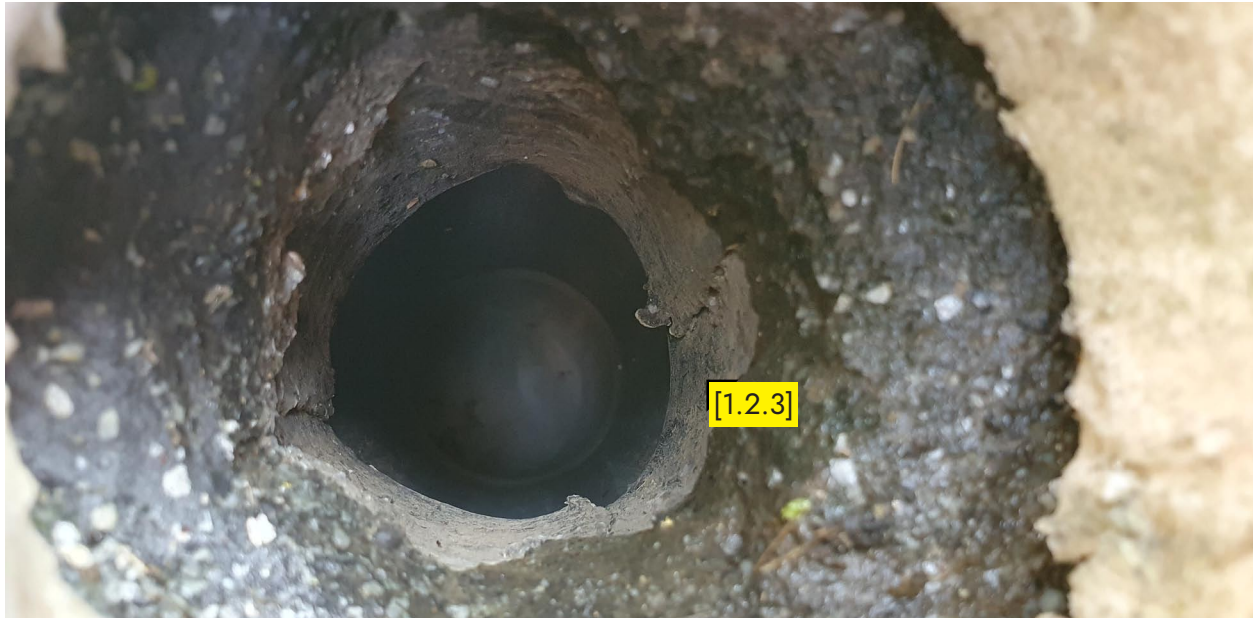
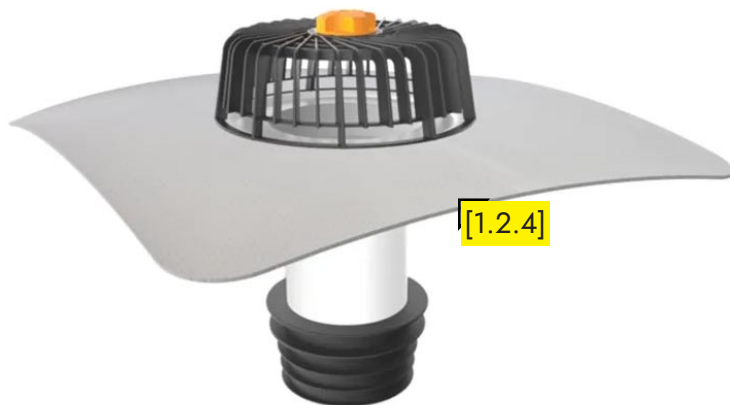
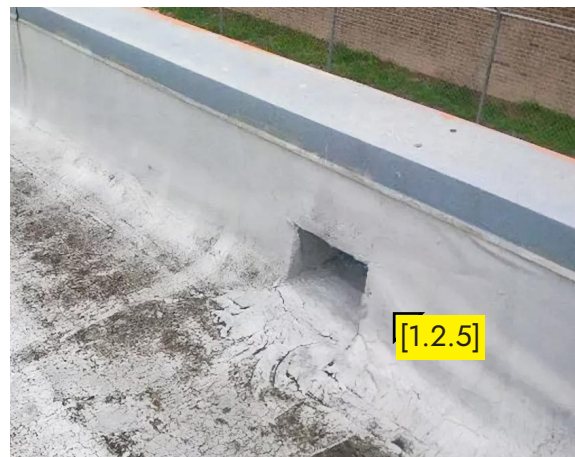
1.2.3. The water drainage through the roof ceiling was done incorrectly, as the bare ceiling slab is visible in the drainage holes. It is only partially covered by roofing felt bent inwards.

This allows water to penetrate through cracks in the concrete and further flood the house.

1.2.4. Drainage holes should be fitted with an appropriate outlet fitting. Its apron should be welded to the roofing felt and the drain should be sealed in the downpipe.

1.2.5. The roof should also be equipped with **thru-wall overflow scuppers** that could drain excess water from the roof in the event of extremely heavy rain or clogged drainage holes.

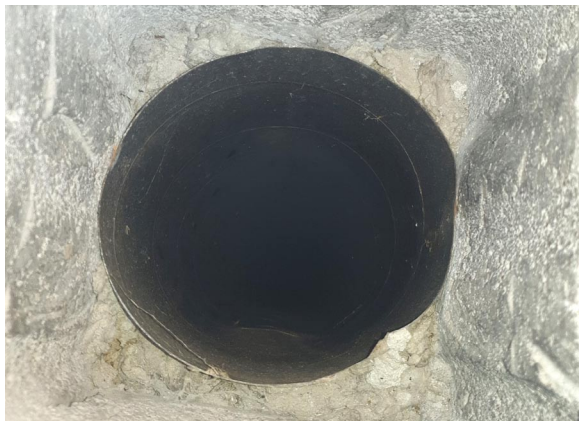
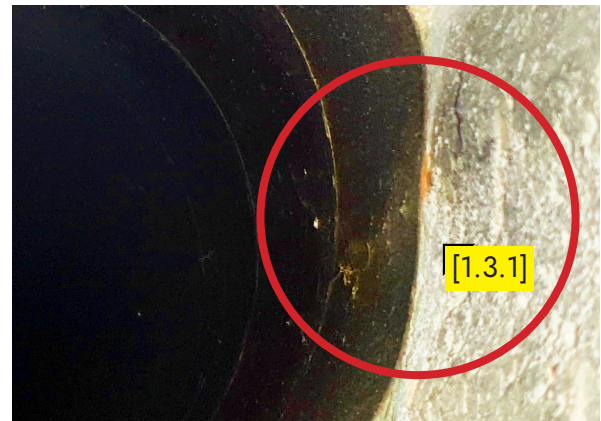
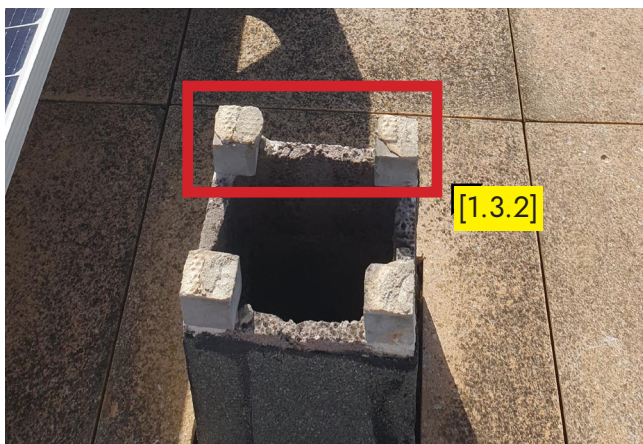
1.3.2. The chimney cap was made incorrectly. It has the form of a concrete slab mounted on 4 posts. The clearance between the cap and the chimney is created by very small gaps, thus limiting the chimney draft!

Despite little use, traces of corrosion are already visible on the pipe.

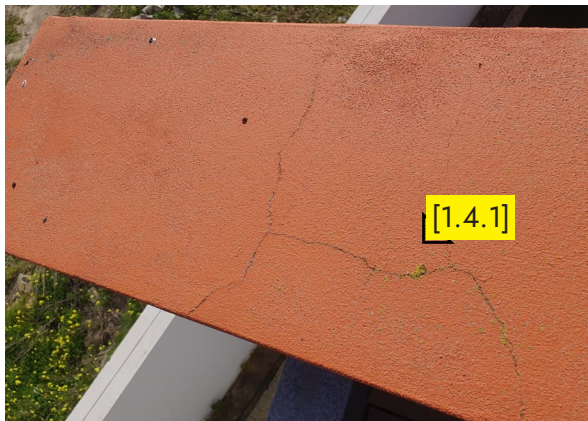
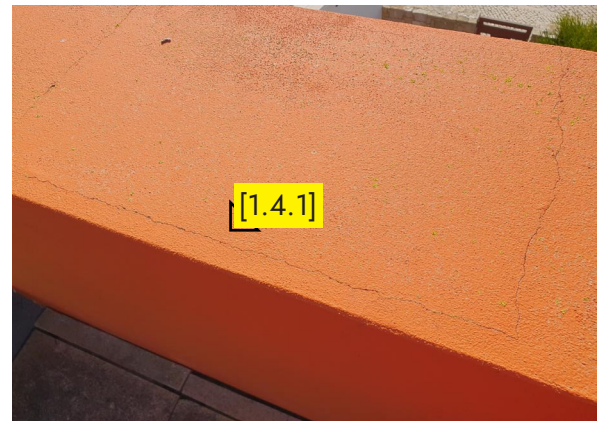
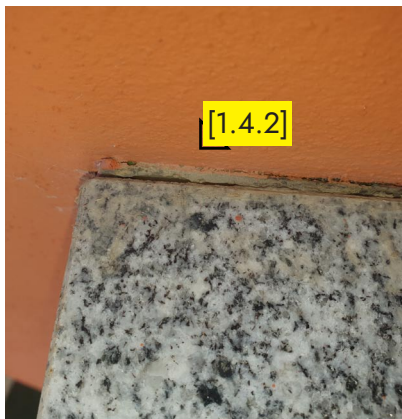
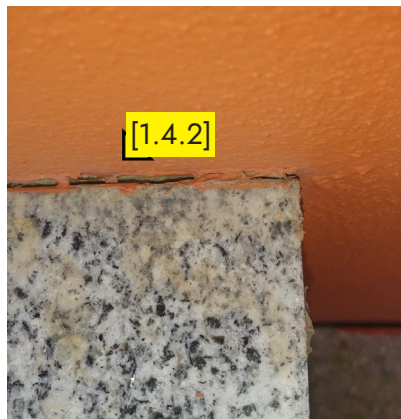
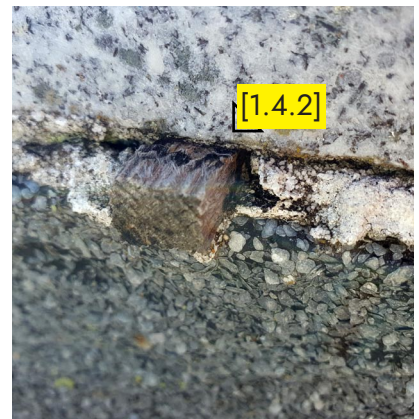
1.4.1. The orange attic wall is all ckracked on top, with vegetation and water penetration inside. Lack of wall copings.

1.4.2. The other roof attic walls have copings made of stone, with many defects also lack of the grout on connections, improper connection with orange plastered wall and even a wooden dowel left behind.

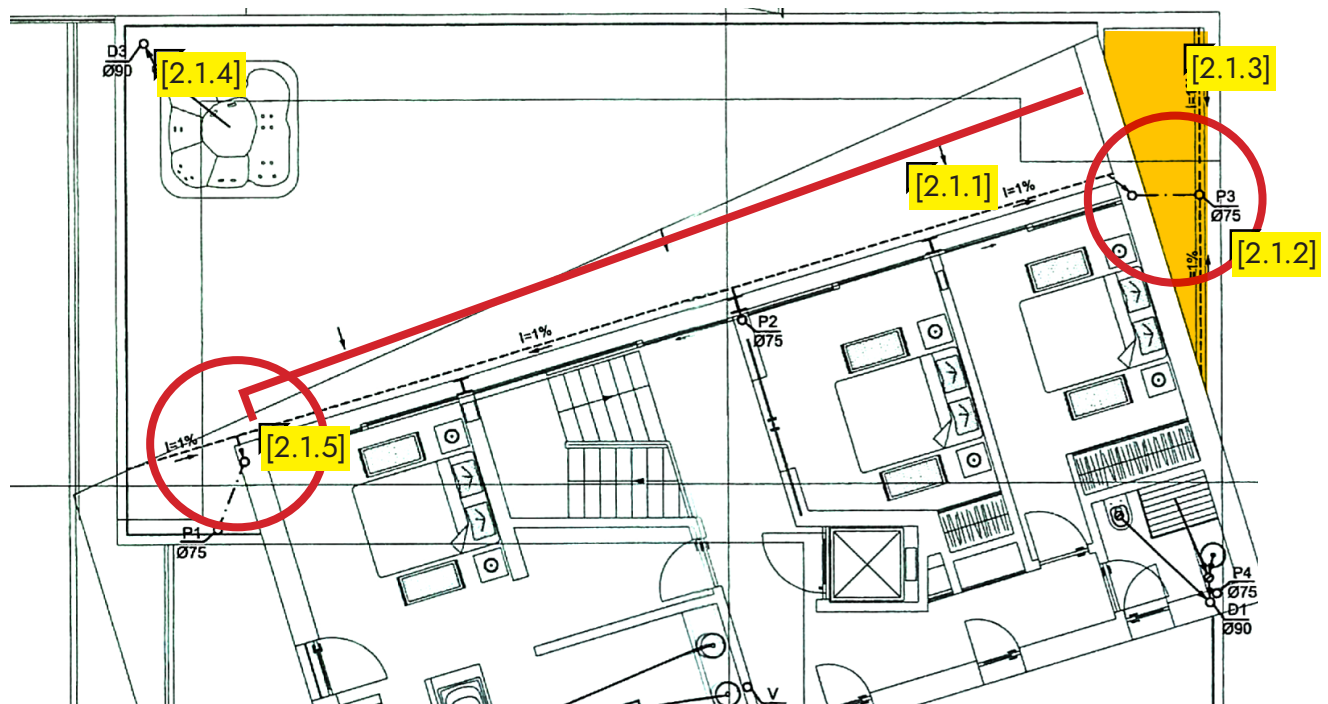
2.1.3. Furthermore, the drainage trough at P3 cannot serve as a support for the terrace drainage, as the part marked in orange is about 8 cm higher than the rest of the terrace!

2.1.4. The drainage for the jacuzzi pool (D3, 90 mm) was not made at all.

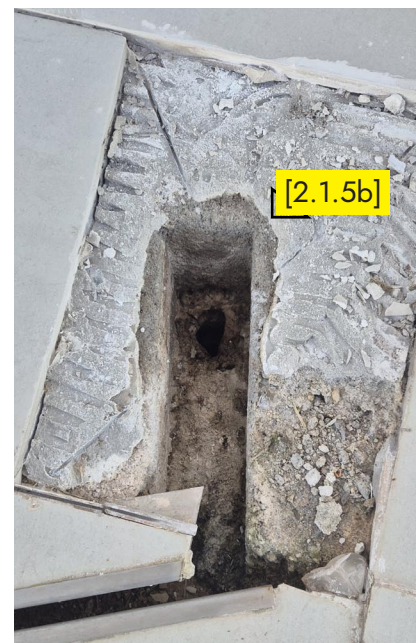
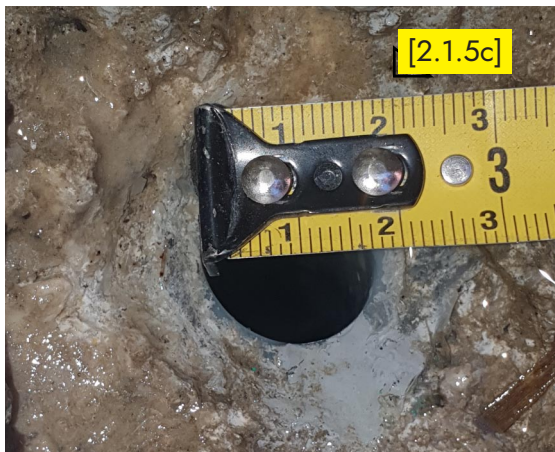
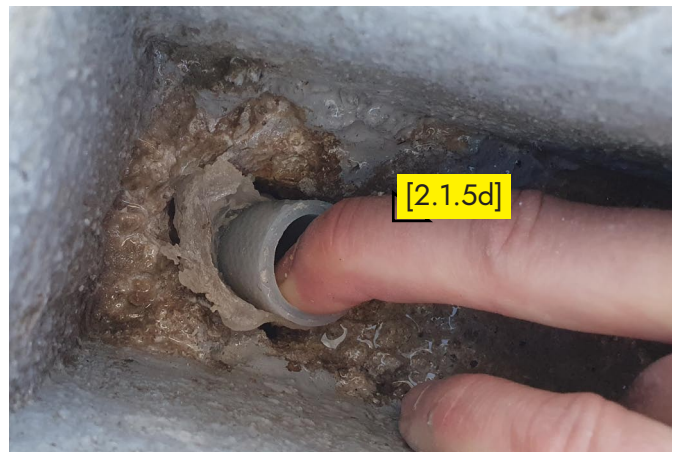
- (a) the only drain from the entire terrace of approx. 70 m<sup>2</sup> was an 18 mm diameter garden hose [2.1.5c].
- (b) The hose is embedded in an random-shaped hole in the screed, with visible ineffective attempts to seal around it [2.1.5d]. Using an endoscopic camera inserted into the hose, it was found to be completely blocked with sandy sediment.

At this point, it should be emphasised that such an arrangement is extremely prone to failure and, given the small diameter of the drain and the very difficult access to it, impossible to maintain in proper working order. The total cross-section of the terrace drainage pipes was undersized by more than 35 times!

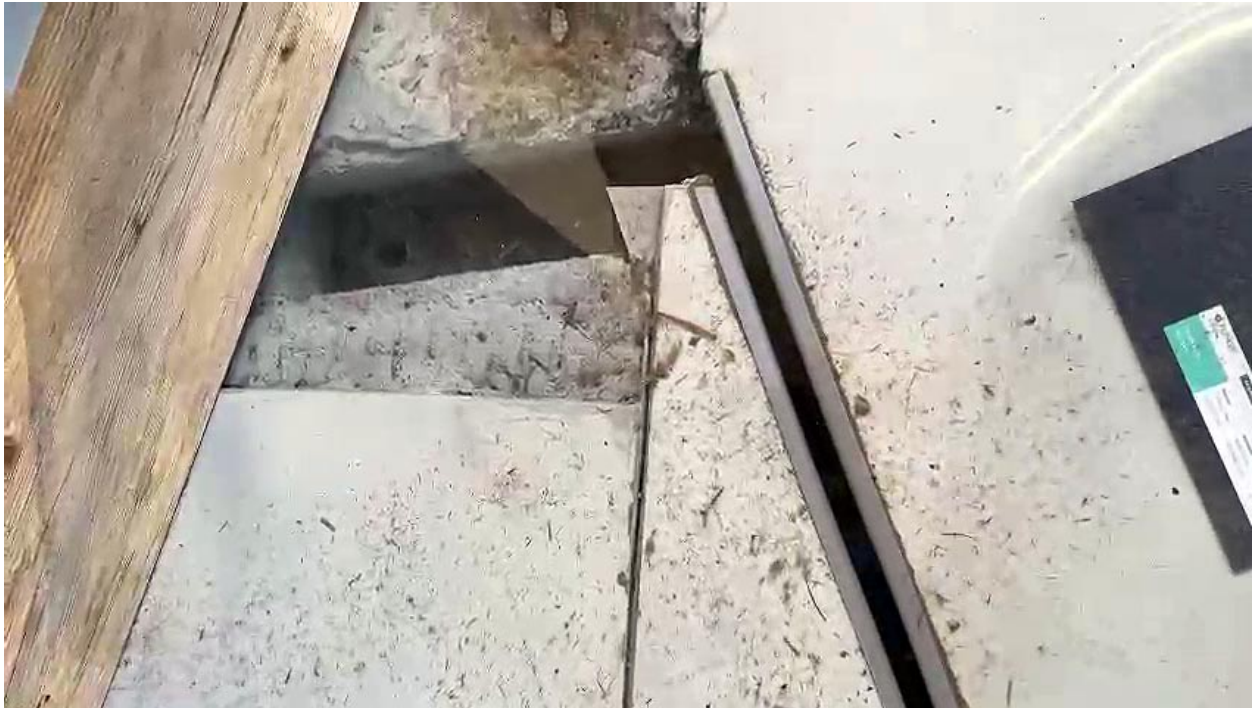
Despite exposing the drain hole and many attempt to unclog it, the water stored on the terrace could not be drained.

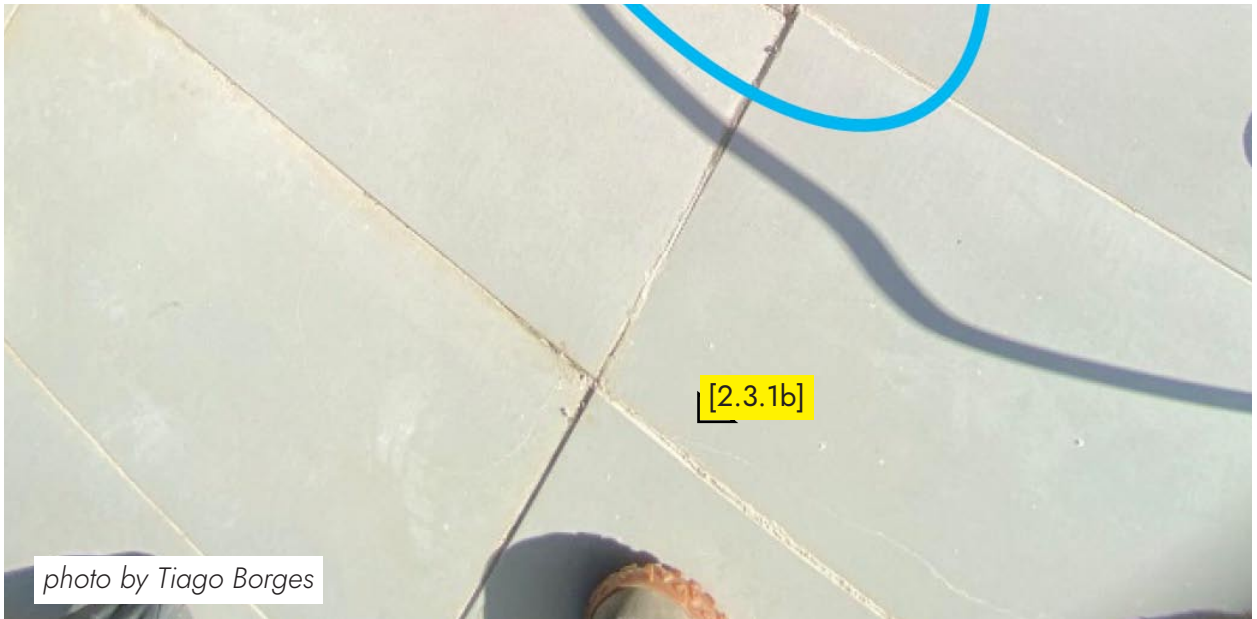
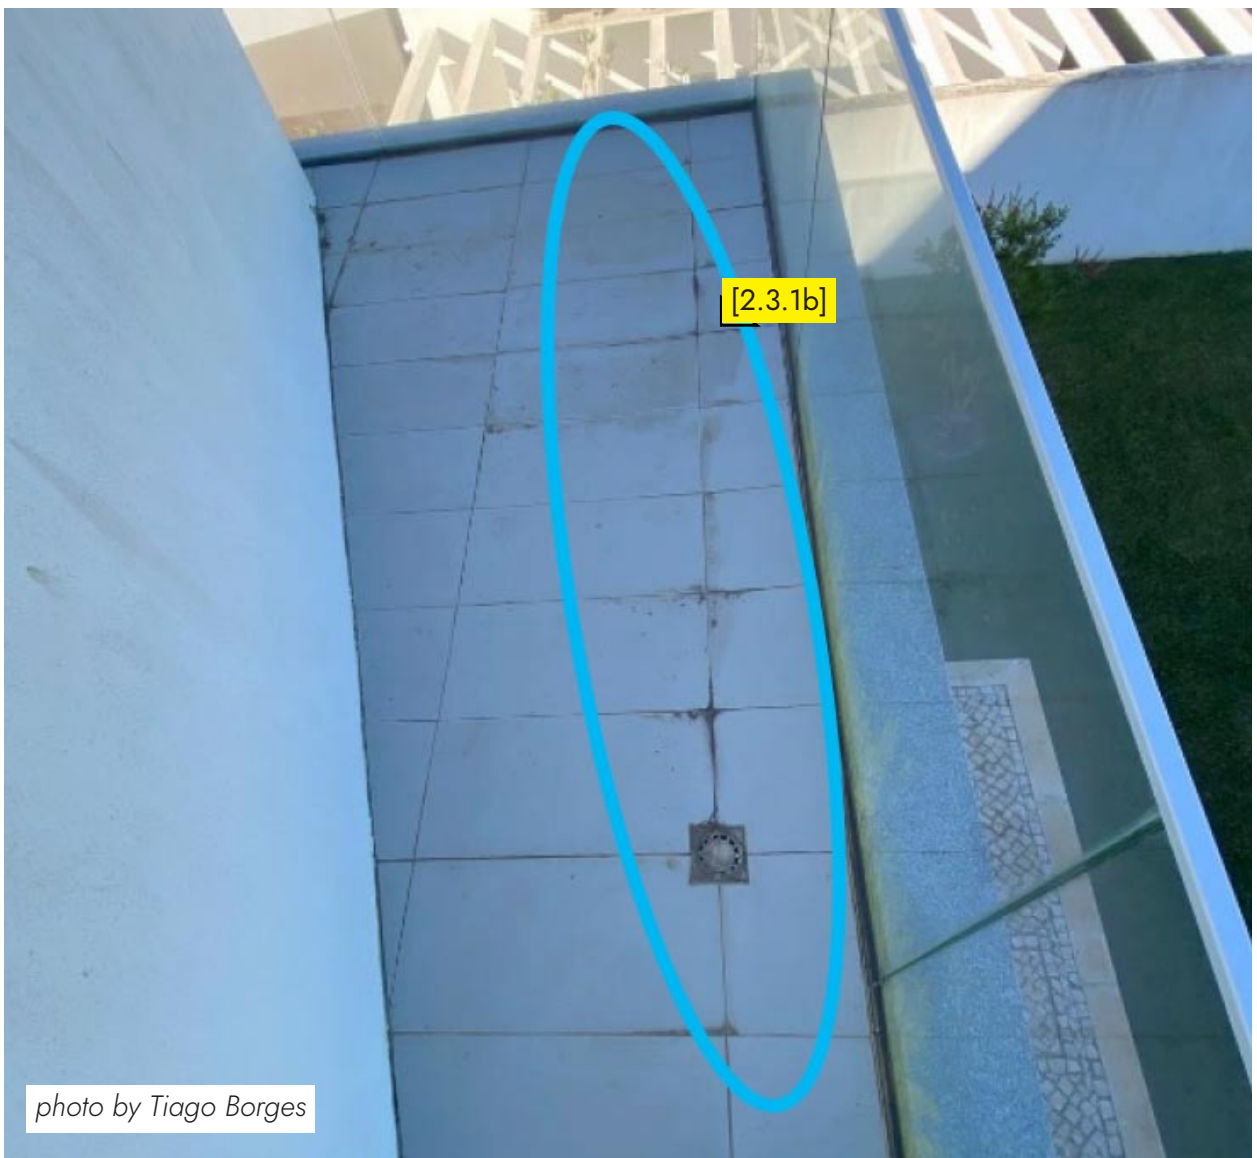
2.3.1. Numerous cavities and discolouration in the tile grouts were found on the overall terrace surface. There are many visible instances of grout erosion [2.3.1b].

The connection between the terrace surface and the balustrade is cracked or absent in many places. This creates the possibility of water penetrating into the balustrade attachment points and further erosion. Numerous vegetation can be seen nestled in the cracks [2.3.1a].

The connection between the balustrade and the terrace should be both watertight flexible.

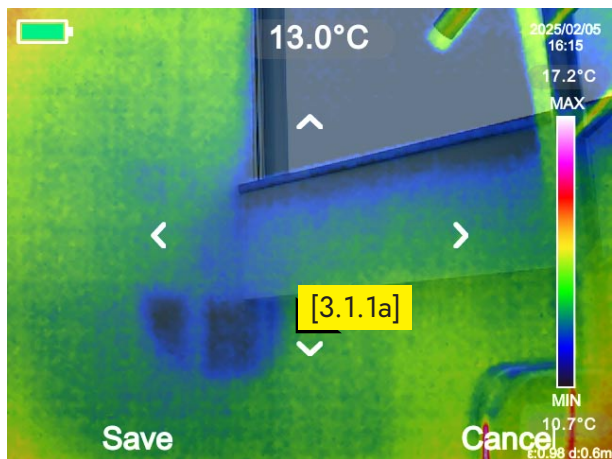
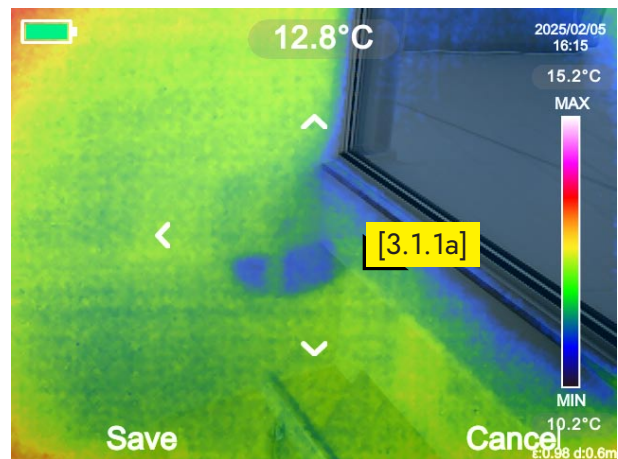
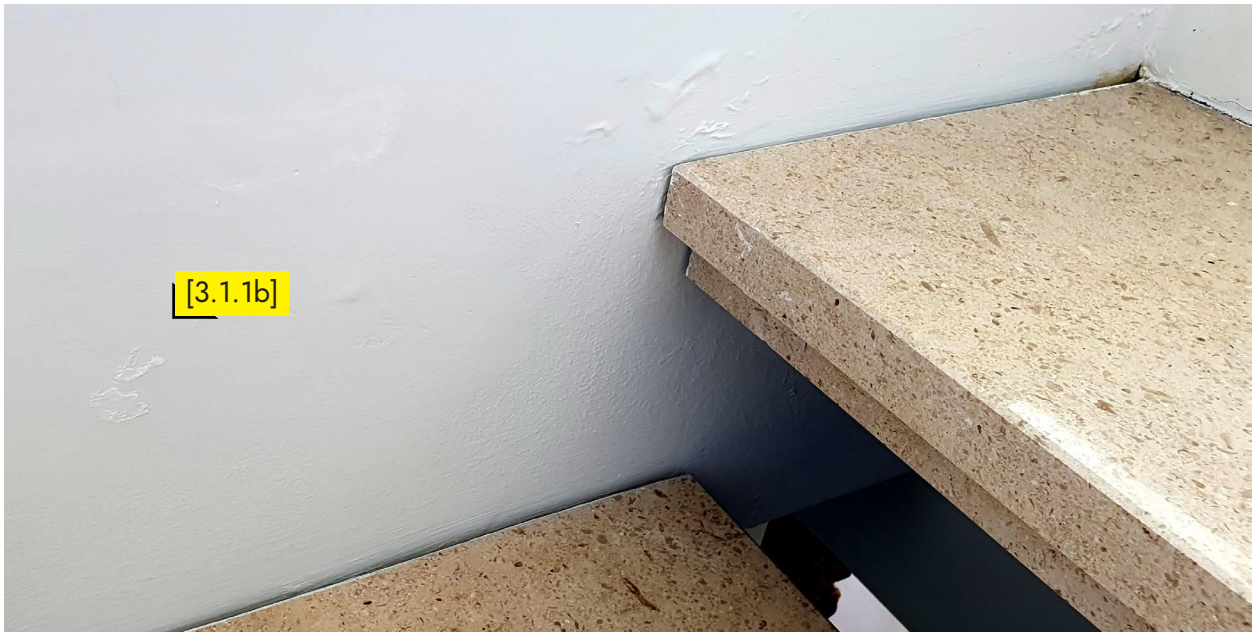
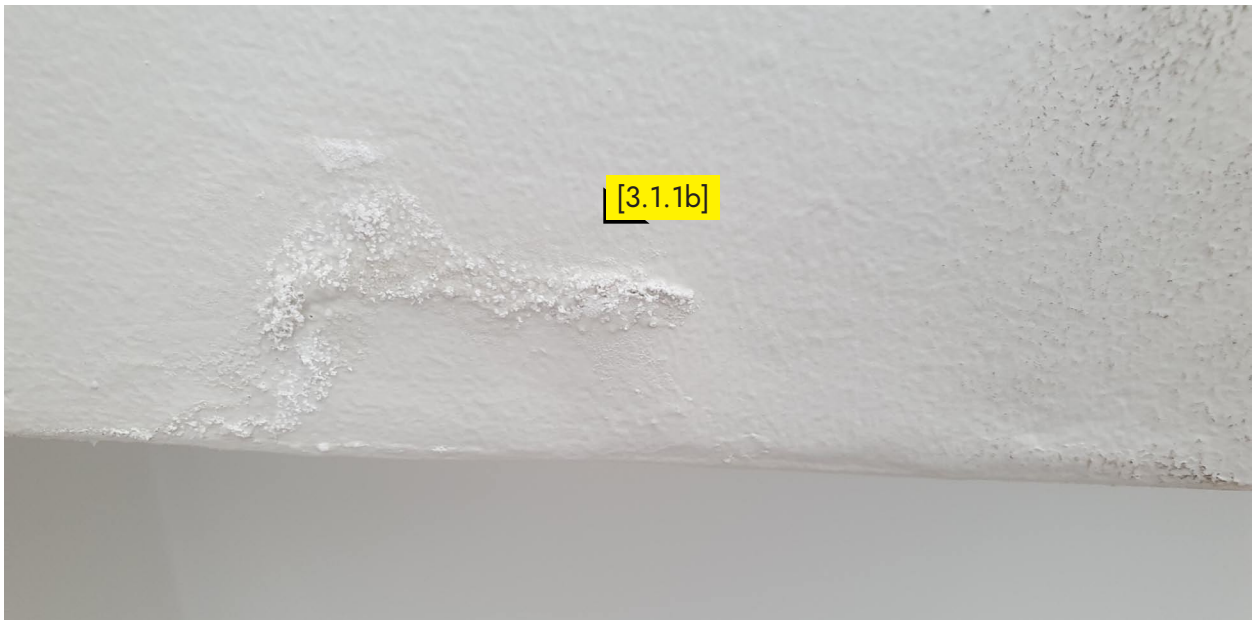
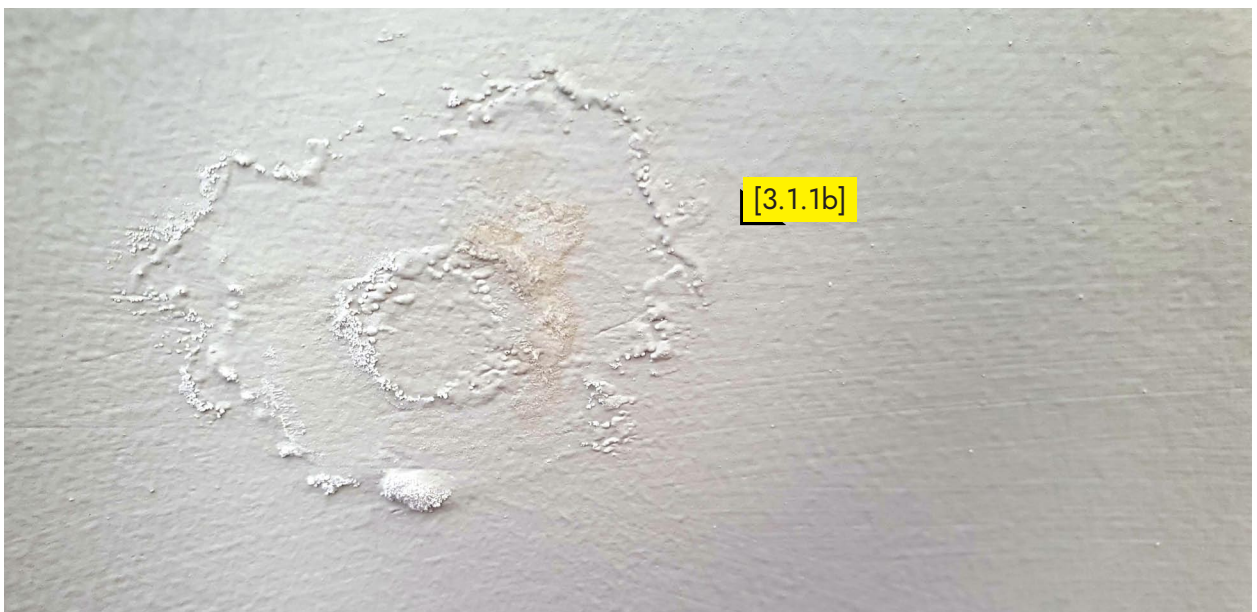
Using a thermal imaging camera, dampness was detected in the west wall of the stairwell [3.1.1a]. Discolouration, cracks, paint chipping and plaster degradation can be seen in the area where the terrace floor slab meets the wall [3.1.1b].

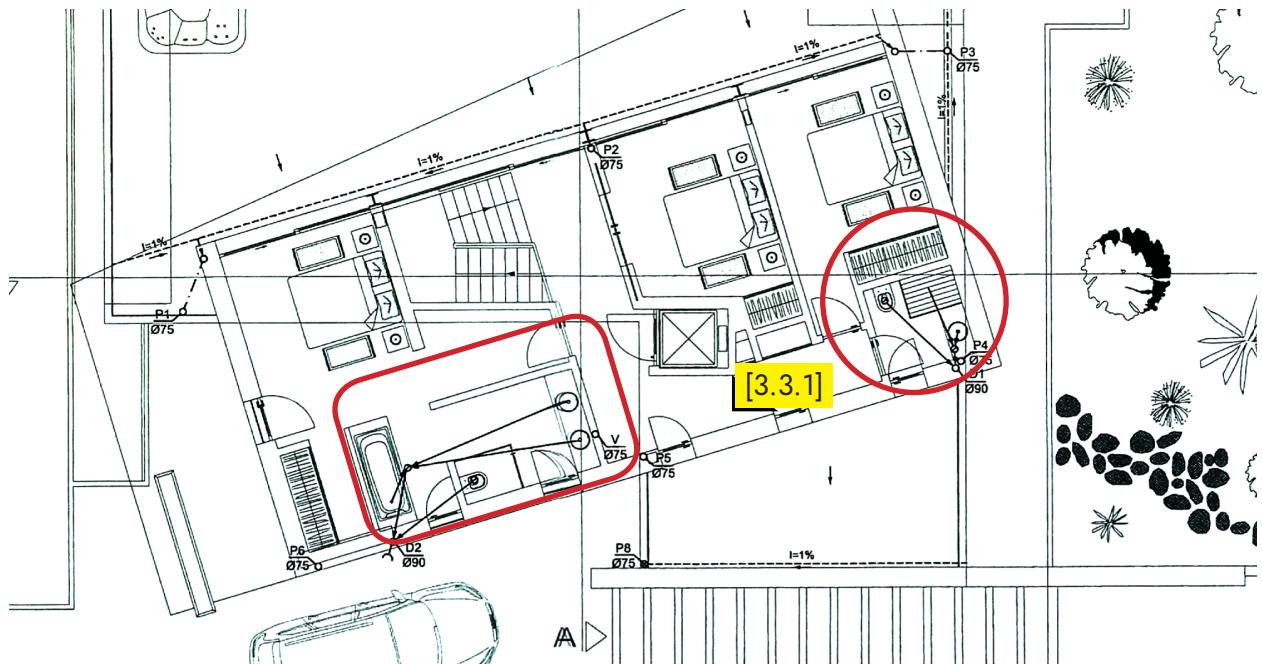
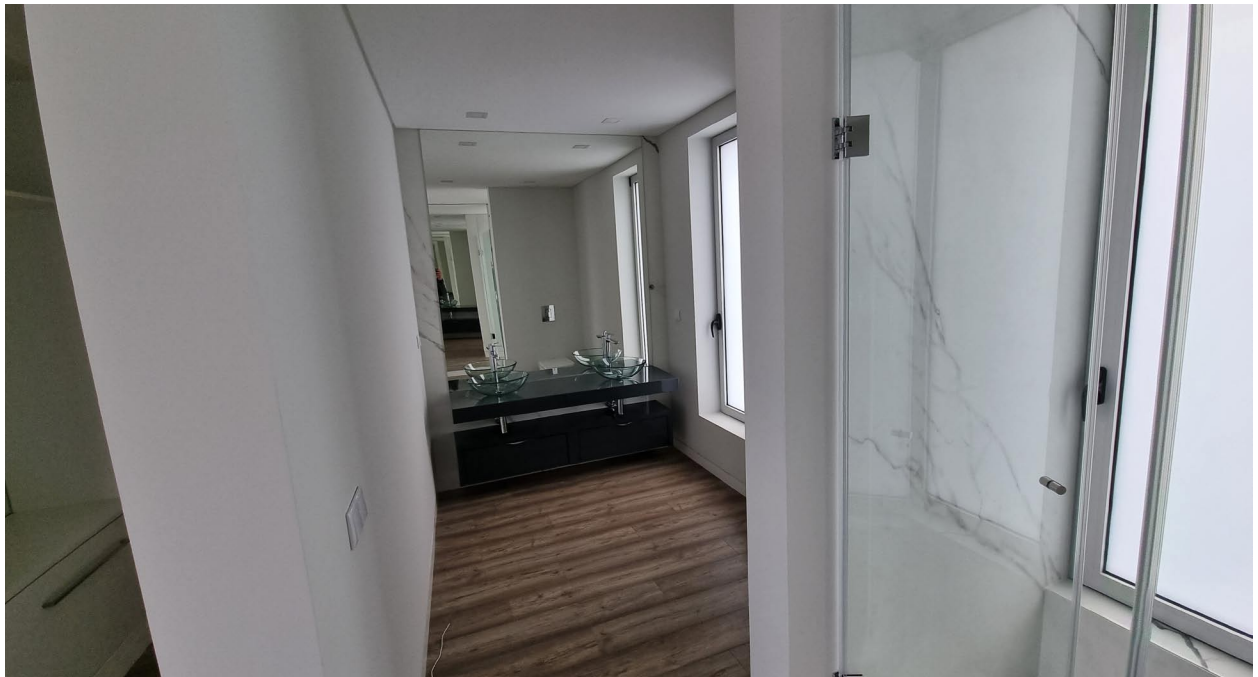
All odours and dampness will be allowed to enter the living areas and soak the the clothes in the open wardrobe located near by.

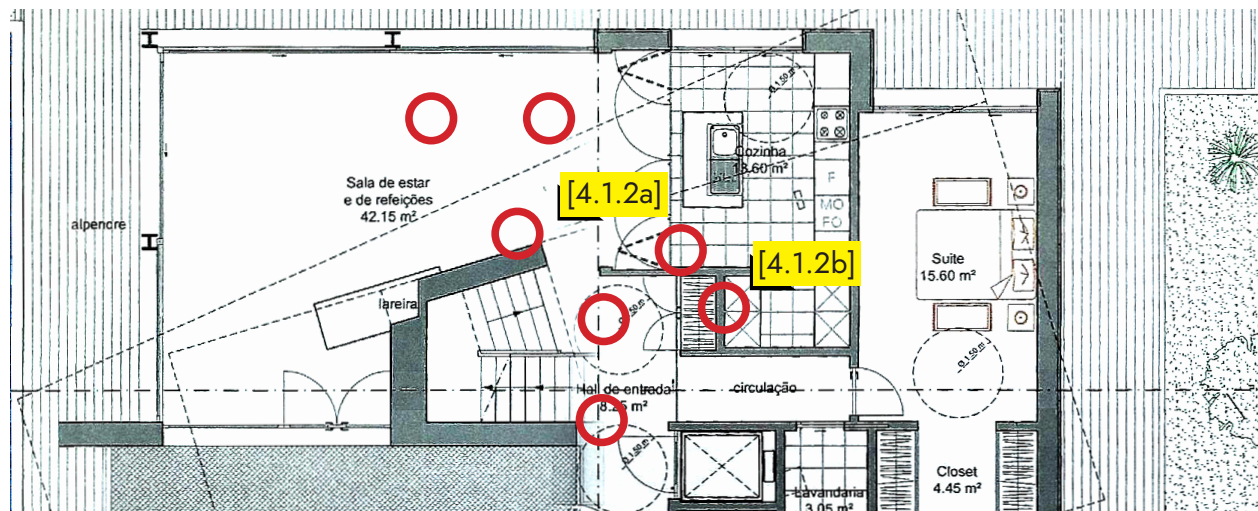
**There is a distinct smell of mould in the space above the suspended ceiling!**

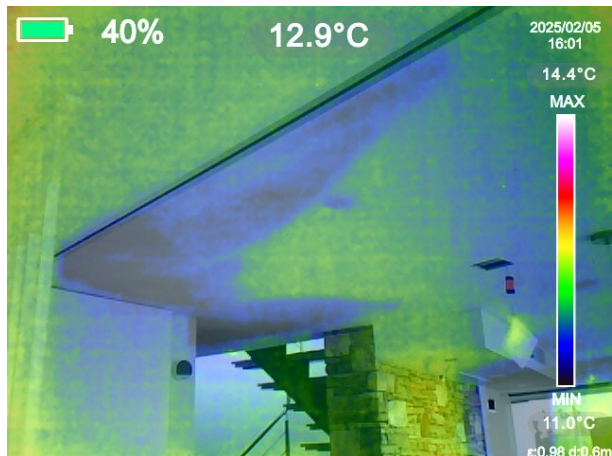
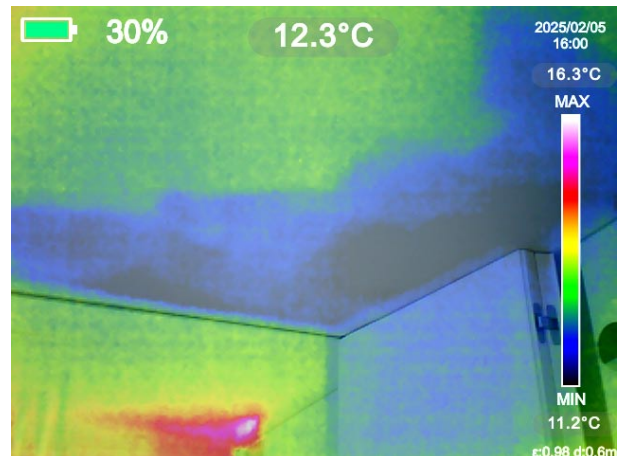
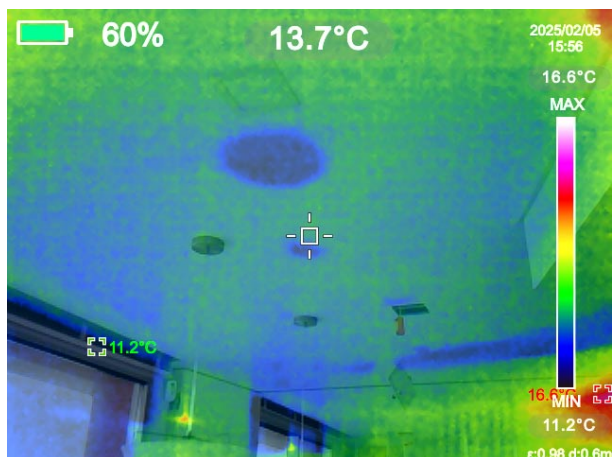
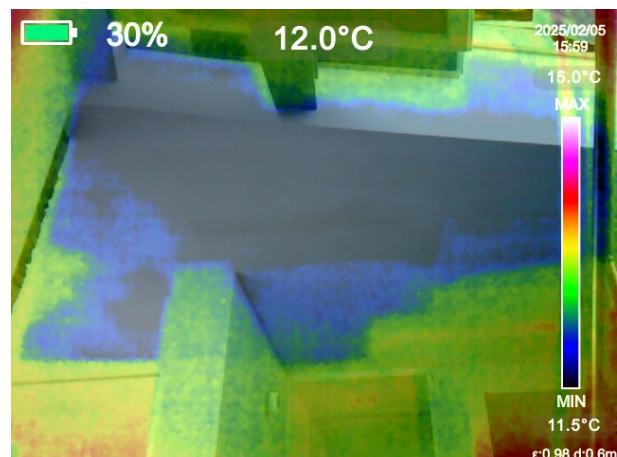
A consequence of the leaking terrace is the repeated flooding of the kitchen and living room with rainwater. On a number of occasions, water was observed dripping down the stone wall in the middle of the living room, water dripping from lamps suspended above the table, water dripping from light fittings on the ceiling [4.1.2a].

Thermal images showing water residues in the ceiling and walls.

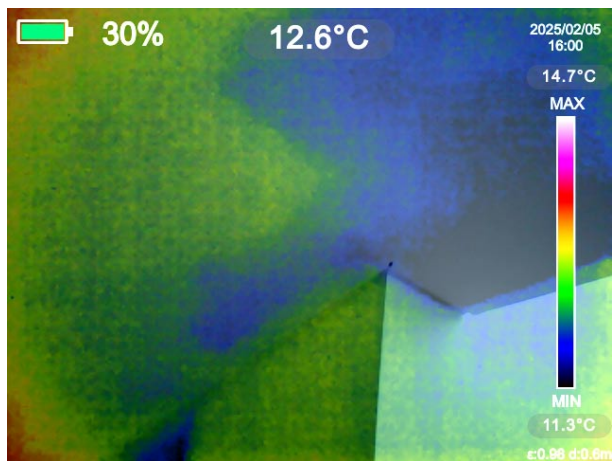
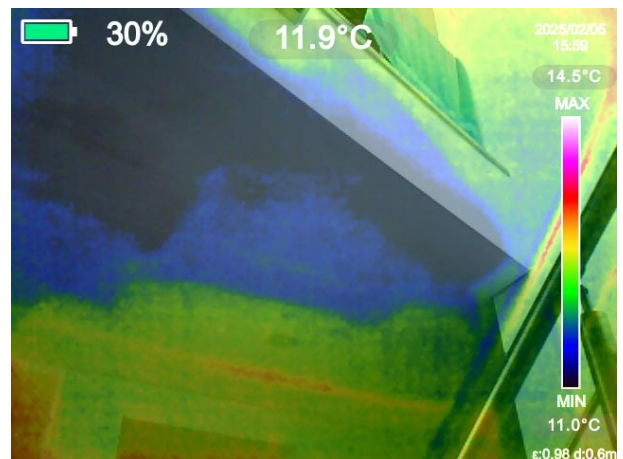
Thermal images showing water residues in the ceiling and walls.

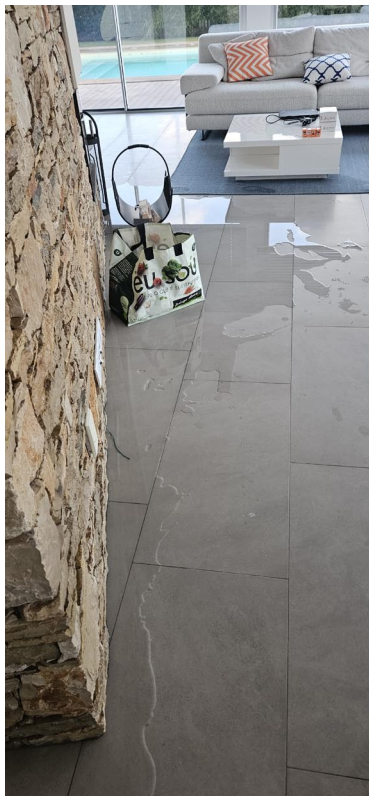
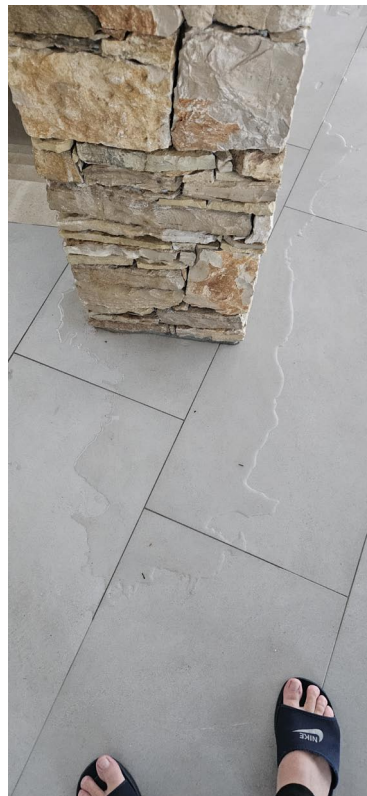
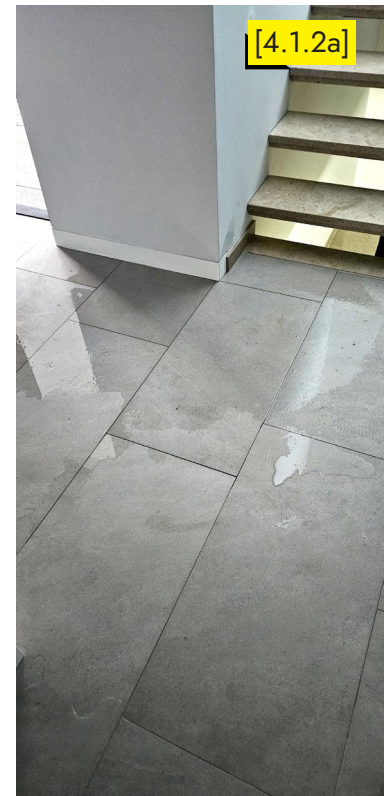
Rainwater flooding on November 2023

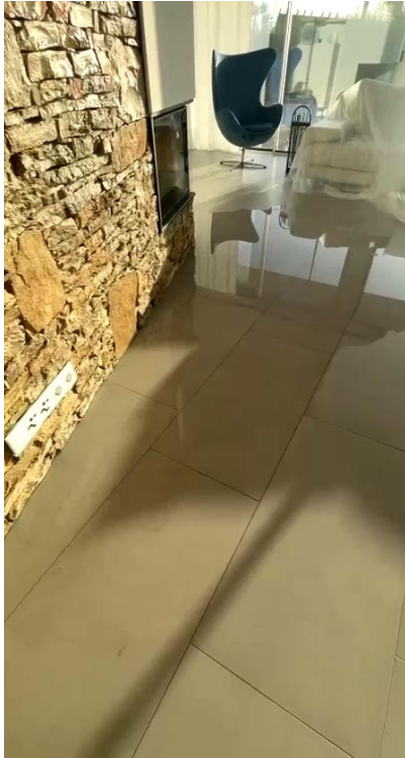
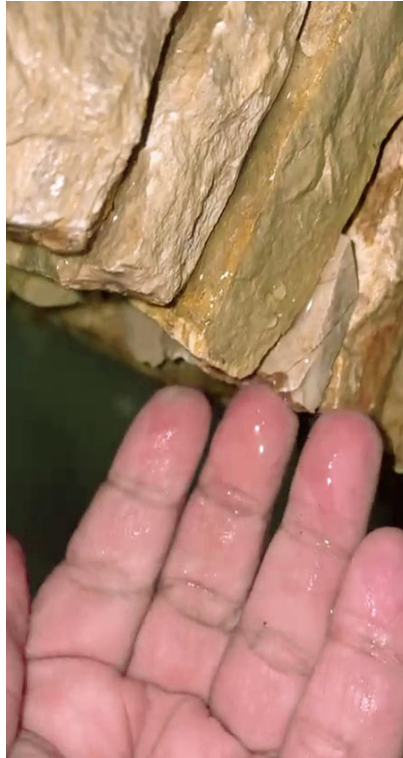
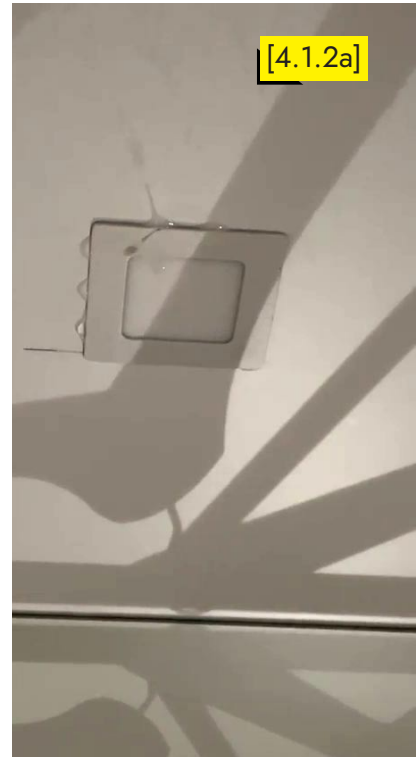
Rainwater flooding on January 2025

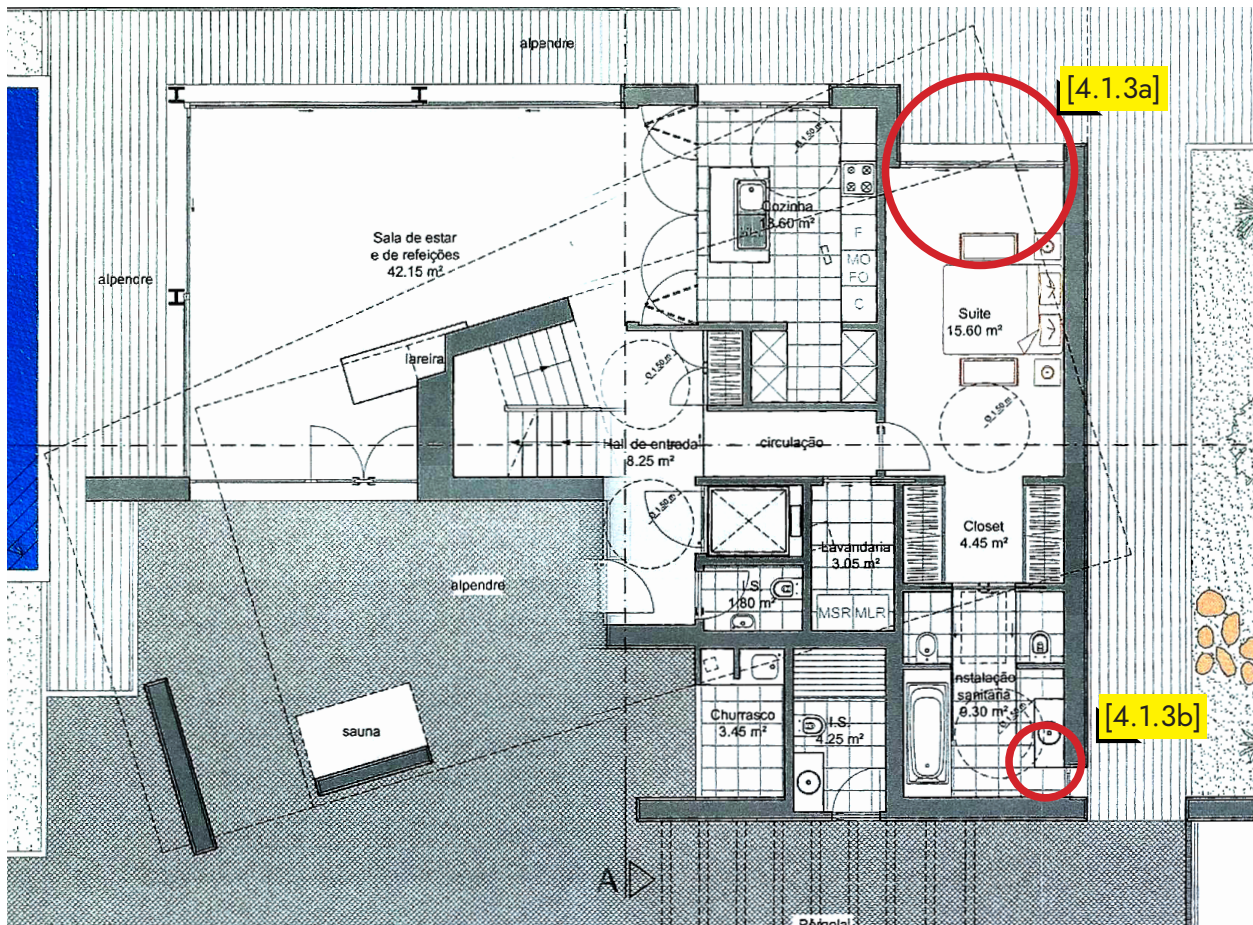
Moisture was found in the suspended ceiling of the bedroom during the inspection. Numerous mould colonies were detected on the ceiling and in the recess for the roller blinds [4.1.3a].

**There is a distinct musty smell throughout the bedroom!**

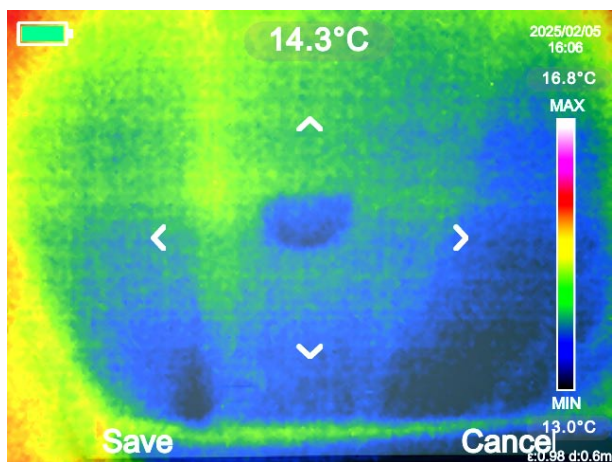
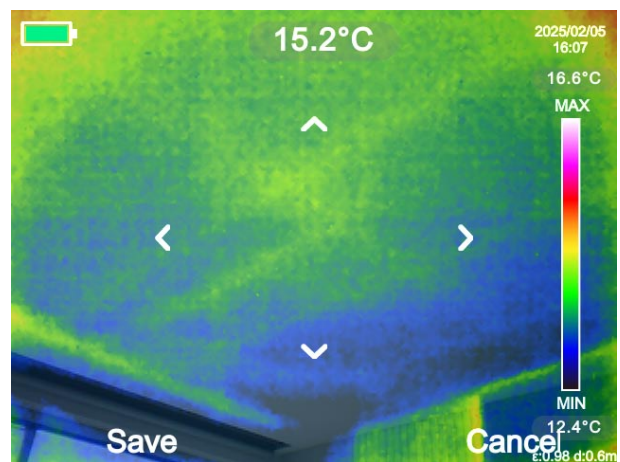
Thermal images showing water residues in the ceiling.

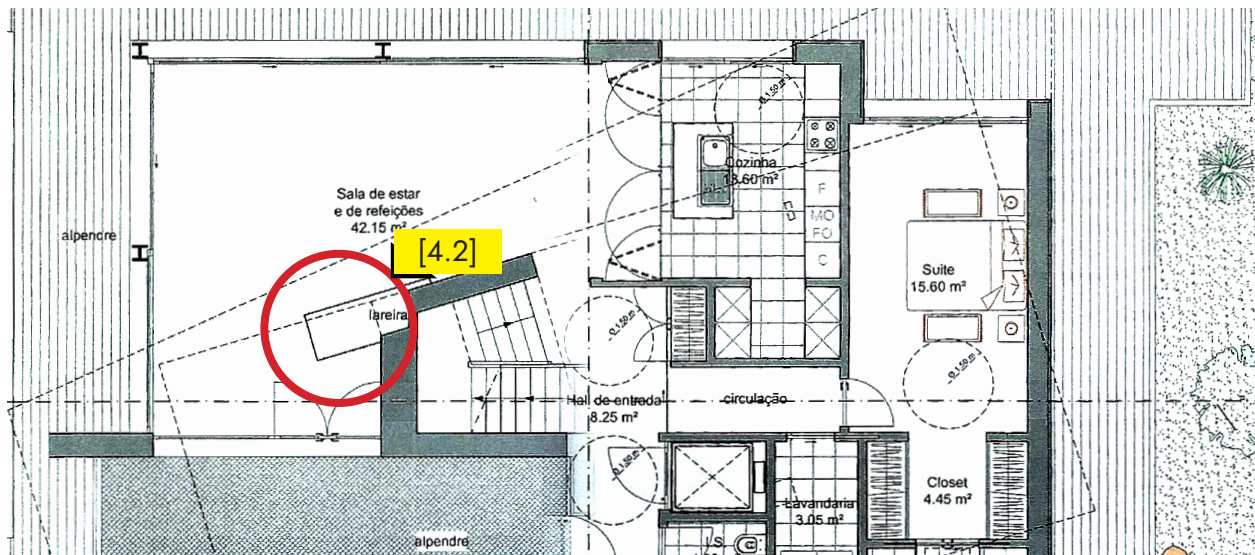
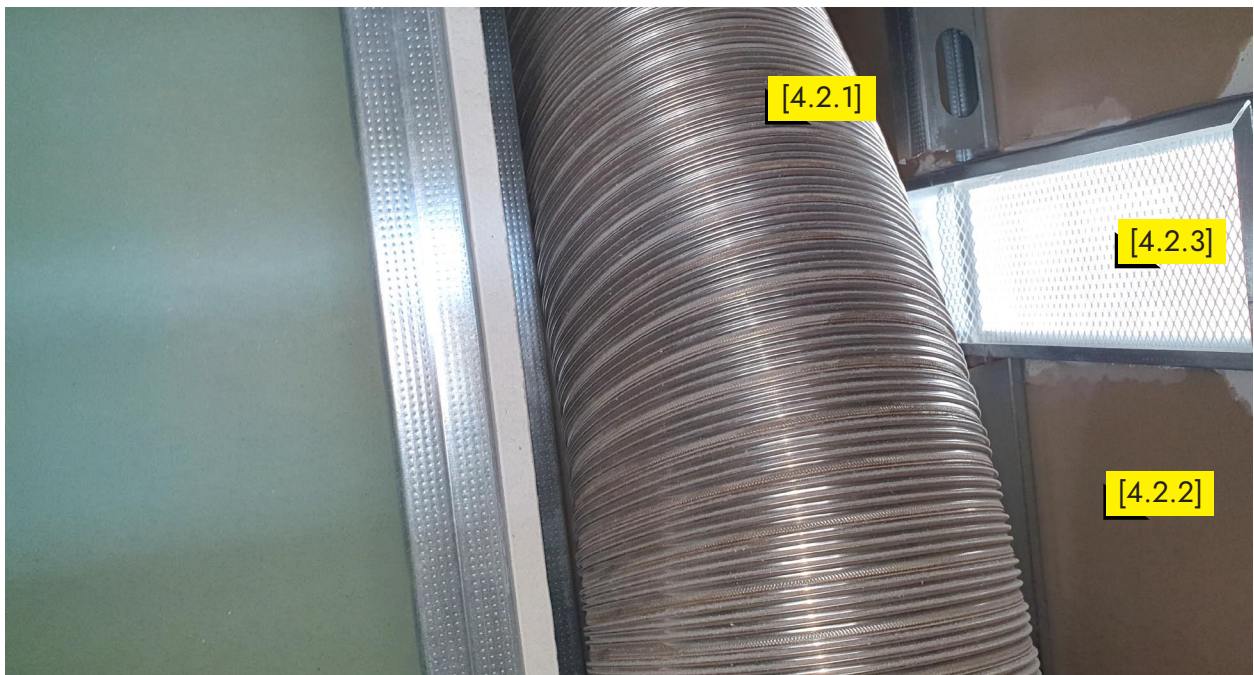
4.2.3. The fireplace cladding has two small hot air outlets in the form of grilles above the firebox, however, there is no air inlet, which should be located below the firebox. The inlet supposed to have the area comparable with the outlet. This arrangement does not ensure adequate air circulation inside the cladding and may lead to overheating.

Above, in the suspended ceiling area, the flue pipe passes in close proximity to the electrical cables. Such negligence can lead to insulation melting, fire and even electric shock!

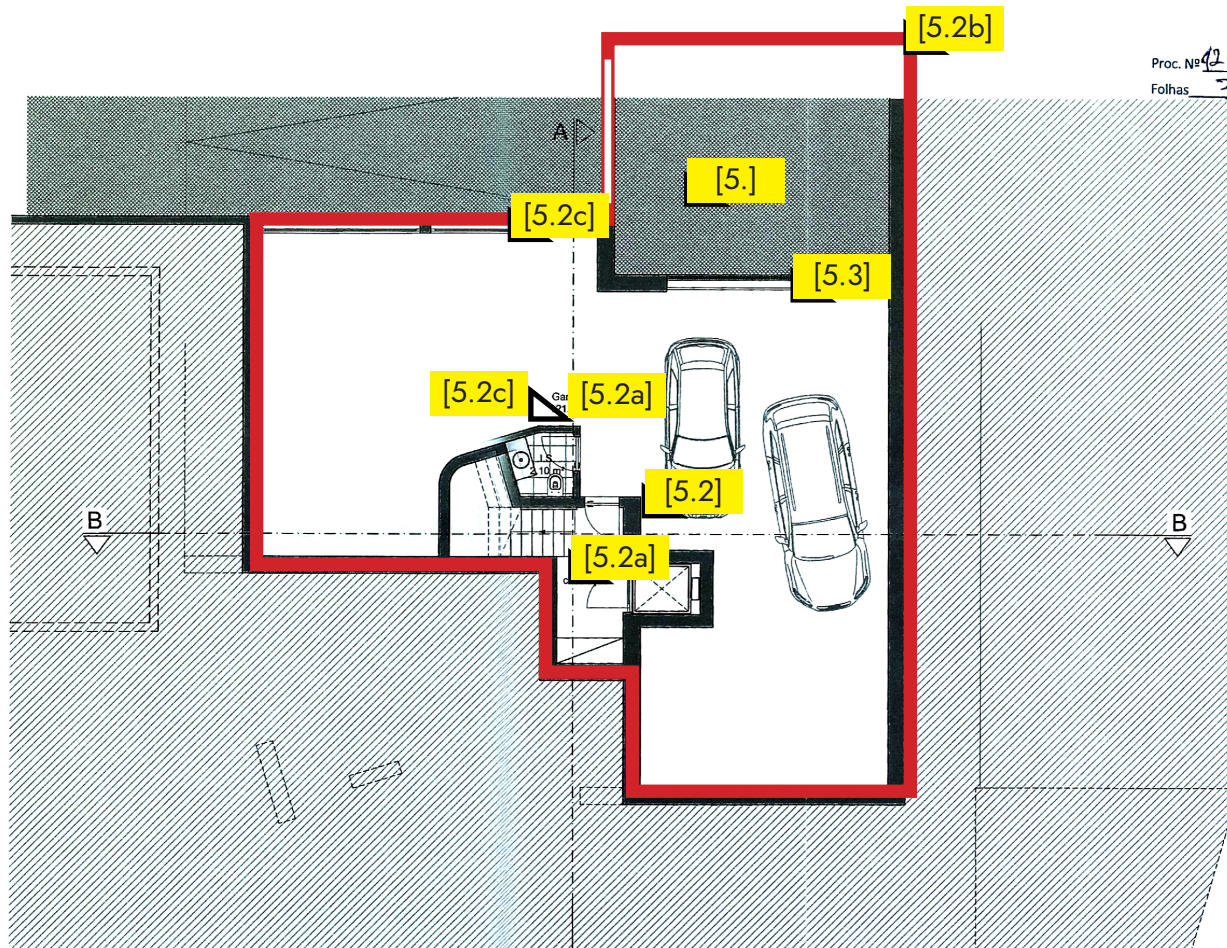
The actual shape and size of the basement differs from that shown on The Project. The basement is enlarged by the area marked on the drawing.
