# The Report

*February 2025*

This report systematises and organises the numerous construction and workmanship errors occurring in the private residential house located in Lote 2 - Casais Porto Dinheiro.

The discrepancies were identified based on the construction project of the residential building 12146/2017, hereinafter referred to as The Project.

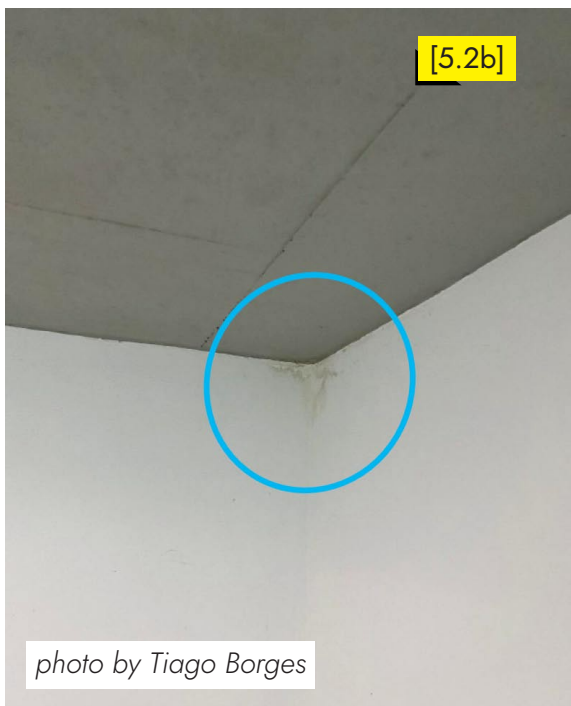
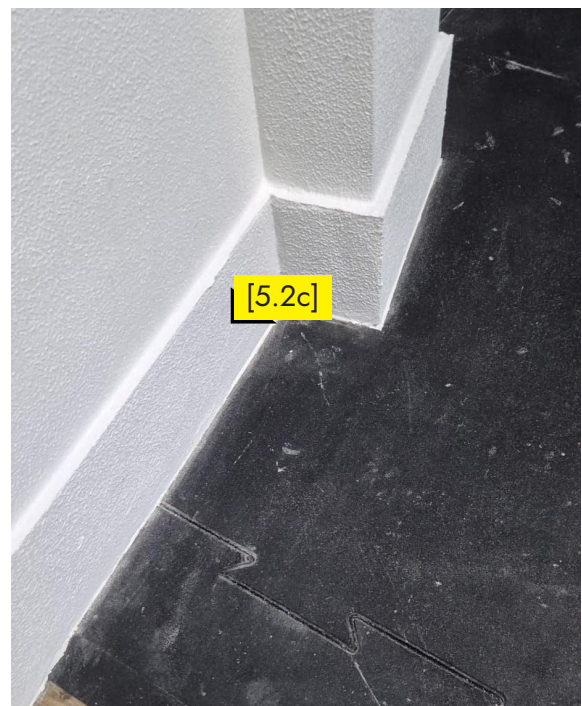
To hide the dampness on the walls, they were covered with polystyrene boards and painted [5.2c]. This solution does not solve the problem. It only traps moisture in the wall, which promotes further wall degradation and the growth of fungi and mould, the spores of which are harmful to health!

There are also damp patches on the ceiling [5.2d].

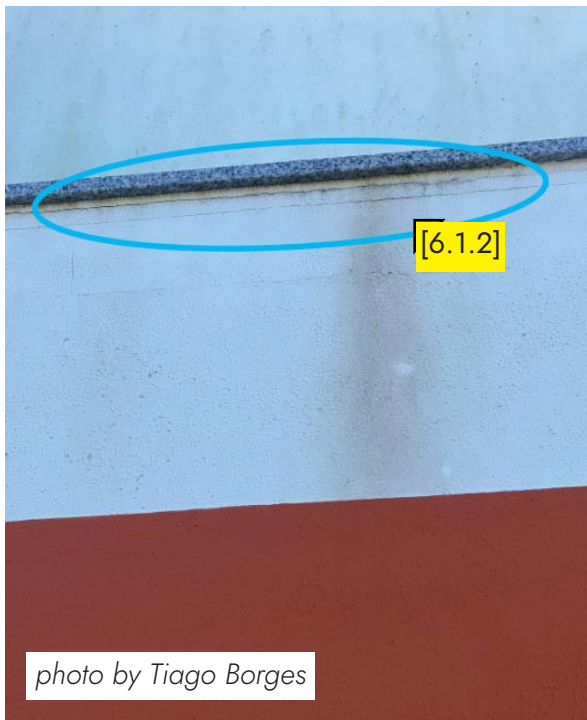
### 6.1.2. Cracks below top of walls and masonry.

Caused by water penetration due to missing or poorly executed copings, wall settlement and stresses arising at the boundary between different materials.

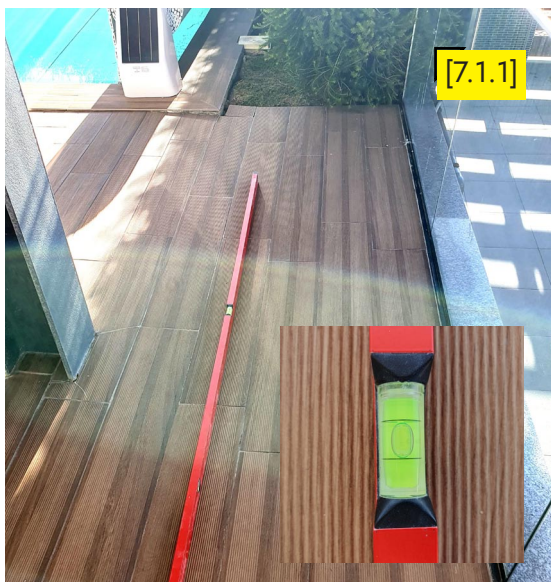
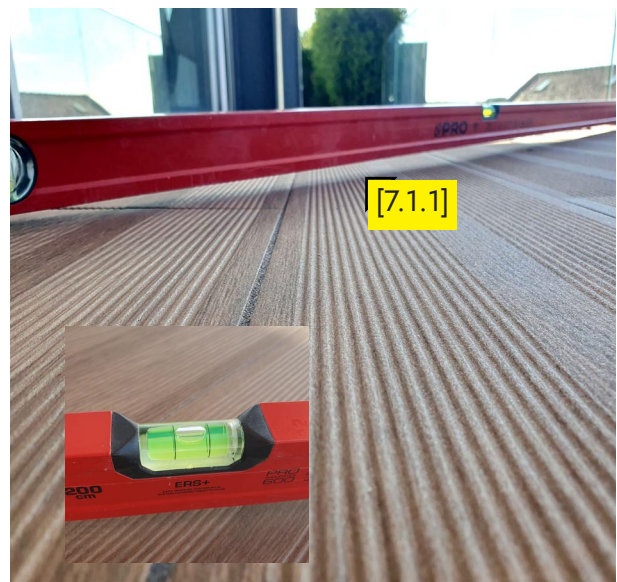
Patio surface on wrong profile – it forms a trough, there is no slope [7.1.1]. As a result, rainwater floods the patio in large puddles [7.1.2]. Excess water running off the patio is not drained anywhere. Therefore, the water has washed out a hole in the lawn [7.1.3], through which it runs off, washing up on the edges of the patio and the pool and on into the area of the underground pool pumping station room.

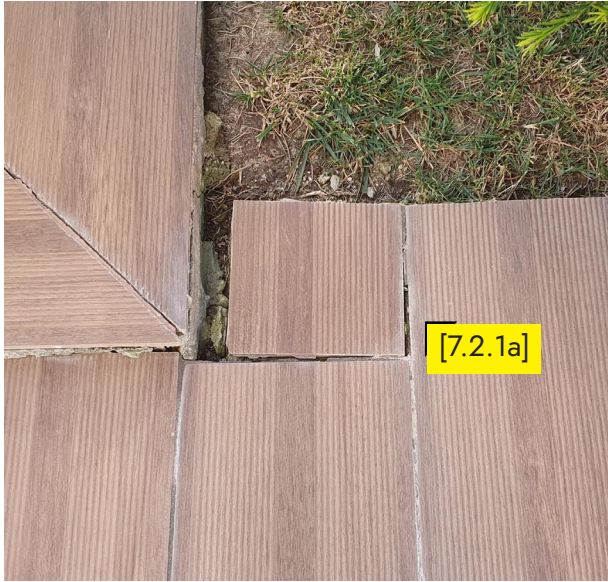
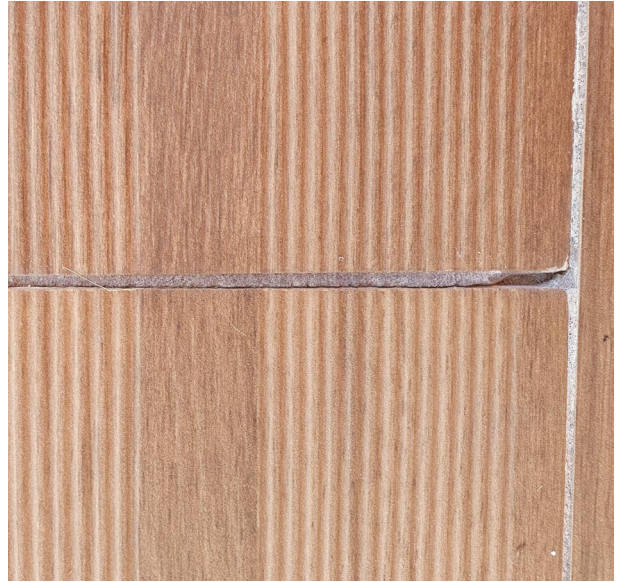
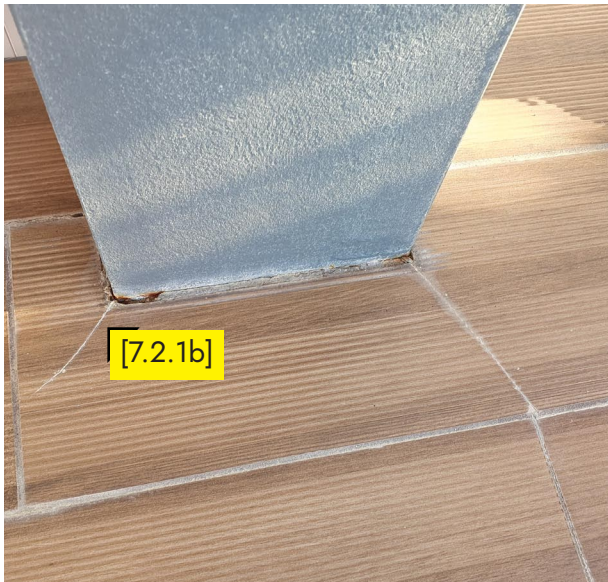
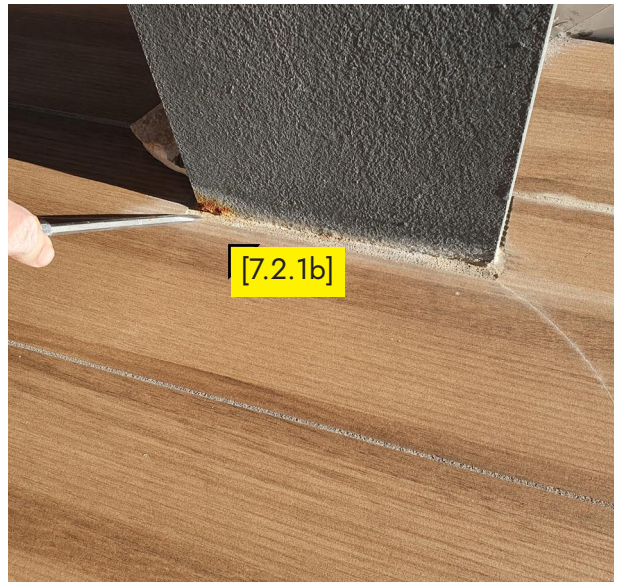
Grout is chipping all over the patio and water is seeping into the adhesive layer. Some tiles are falling off. [7.2.1a] Tile cracks are visible on the structural pillars [7.2.1b]. There are also visible signs of corrosion around the pillars [7.2.1b]. Water stains are visible on the walls of the building [7.2.2].

7.2.3 The sealing of the window openings is done extremely carelessly and in an extremely damaging way. Sealing is missing in all areas where the window drains are located! Thus, all the water that runs off the surface of the windows is introduced directly between the wall and the tiles!

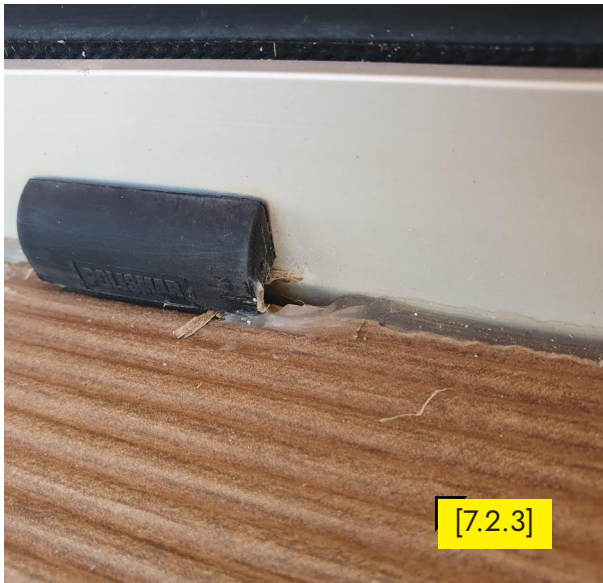
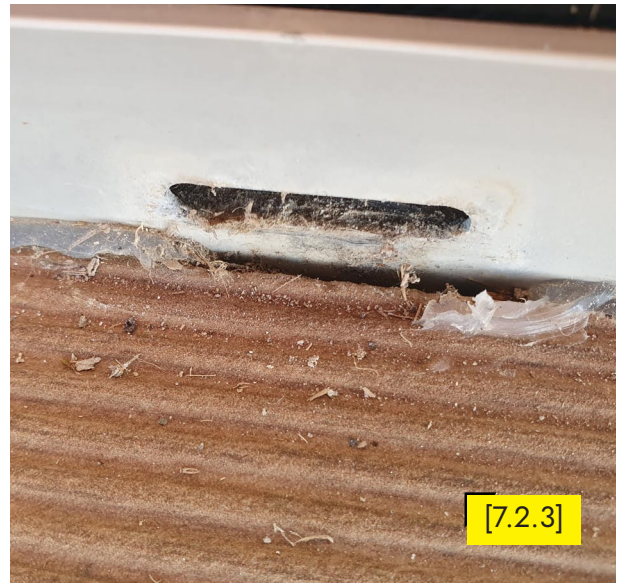
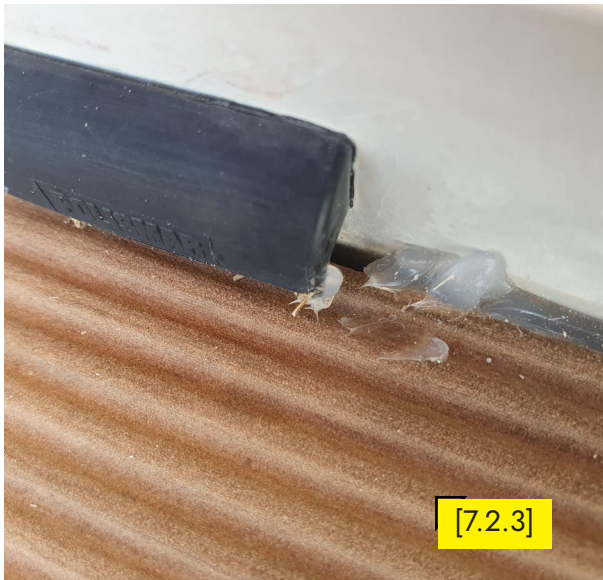
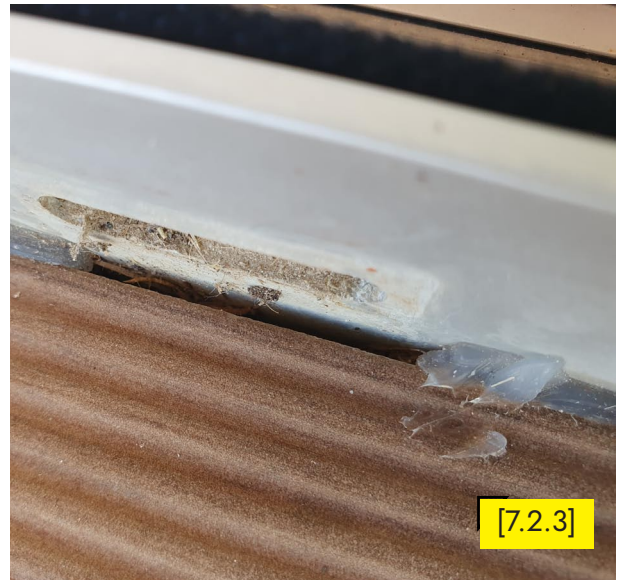
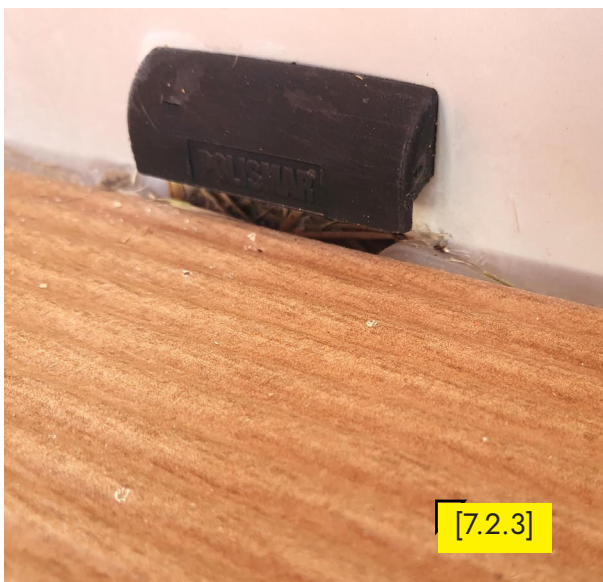
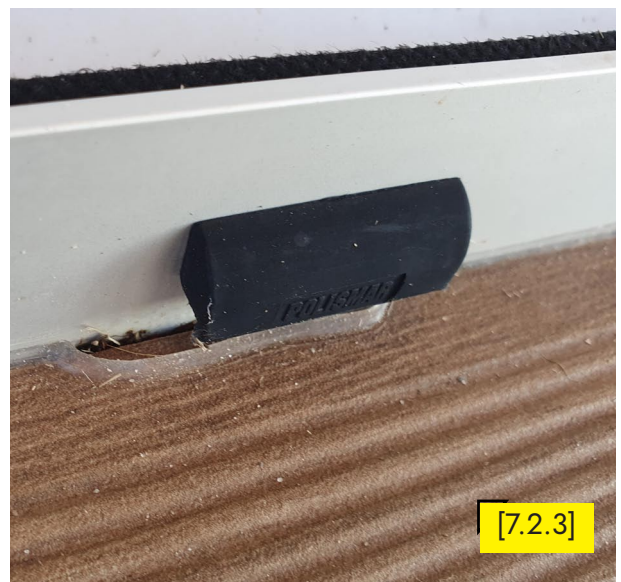
7.2.3. Extreme negligence in sealing the patio windows.

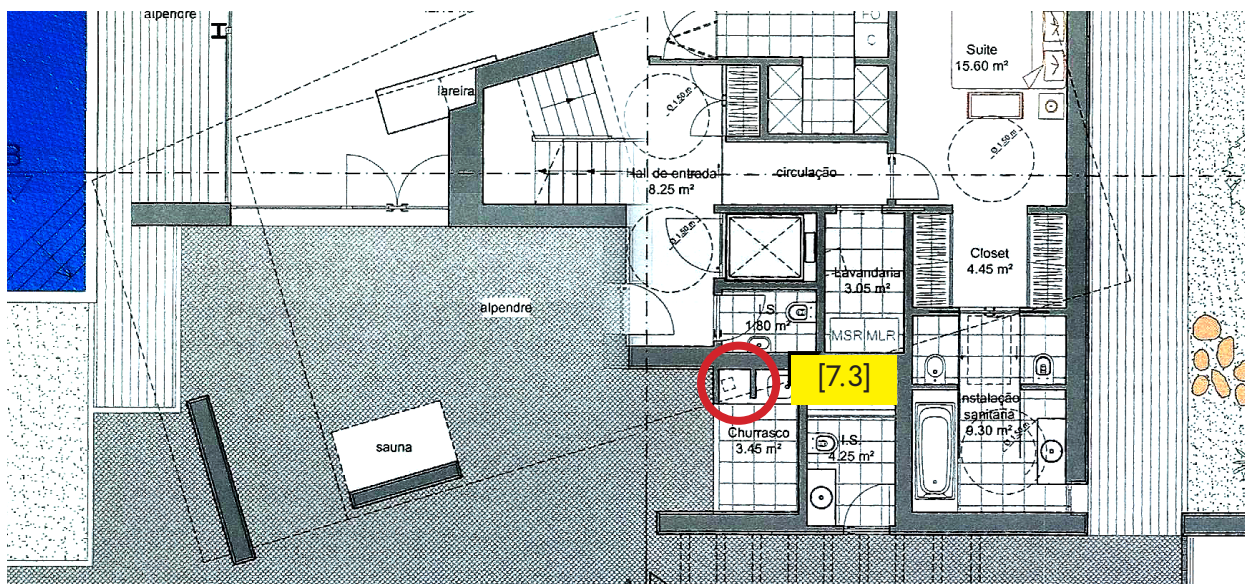
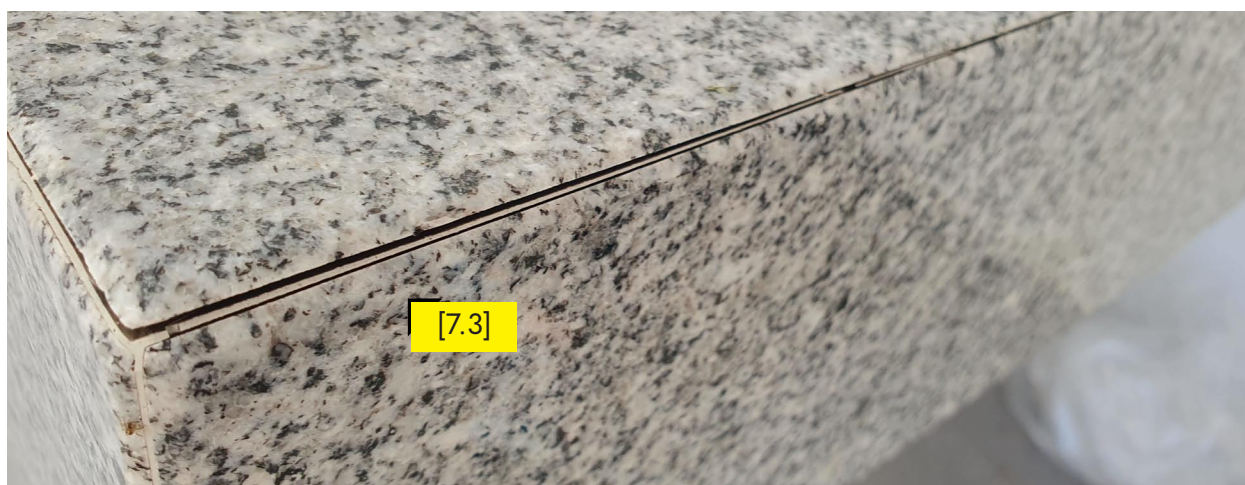
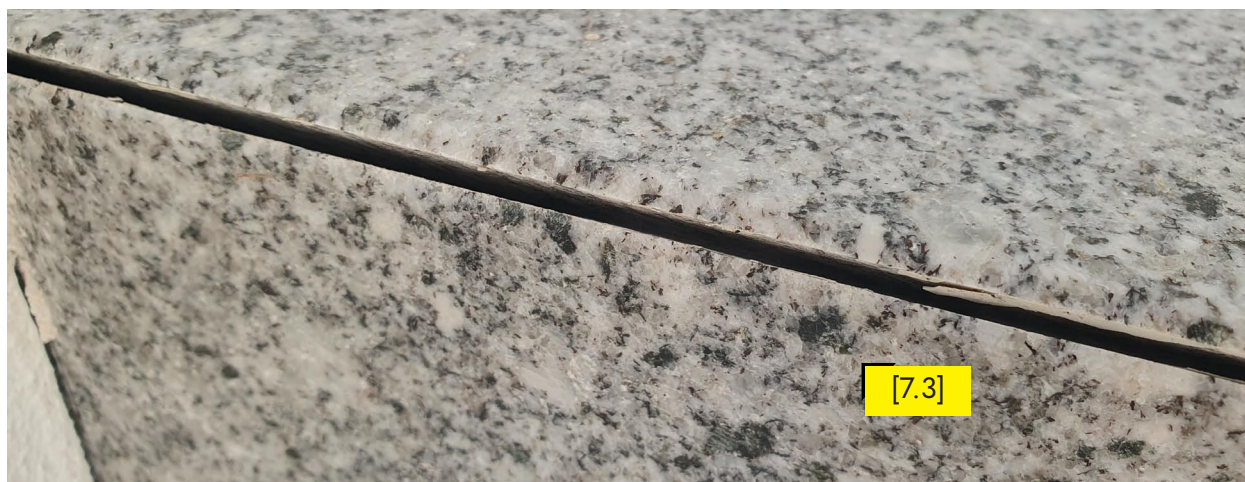
### 7.3. Work top next to the grill

The kitchen worktop located on the patio is made of granite. Large cracks are visible at its joints. There is a concern that the front piece will fall off completely.

The granite pieces are very heavy and have sharp edges. If they fall off, they could seriously injure the person using the countertop.

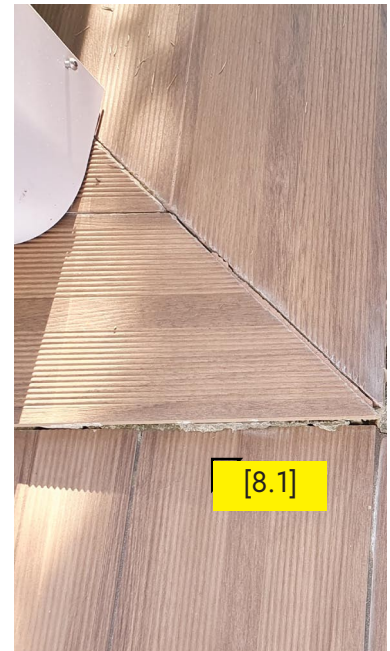
### 8.1. The edge of the pool.

The edge of the pool is tiled in the same way as the patio. The same mistakes as on the patio are repeated - the tiles are coming off, the joints are chipped.

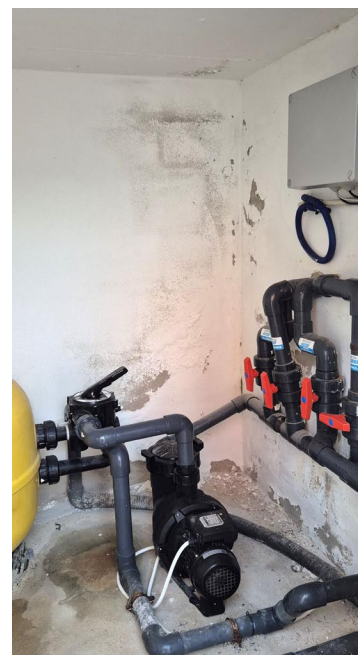
### 8.2. The pumping compartment

In the pool pumping compartment, the walls are damp and cracks are showing on the walls and ceiling. Plaster and paint are falling off the walls.

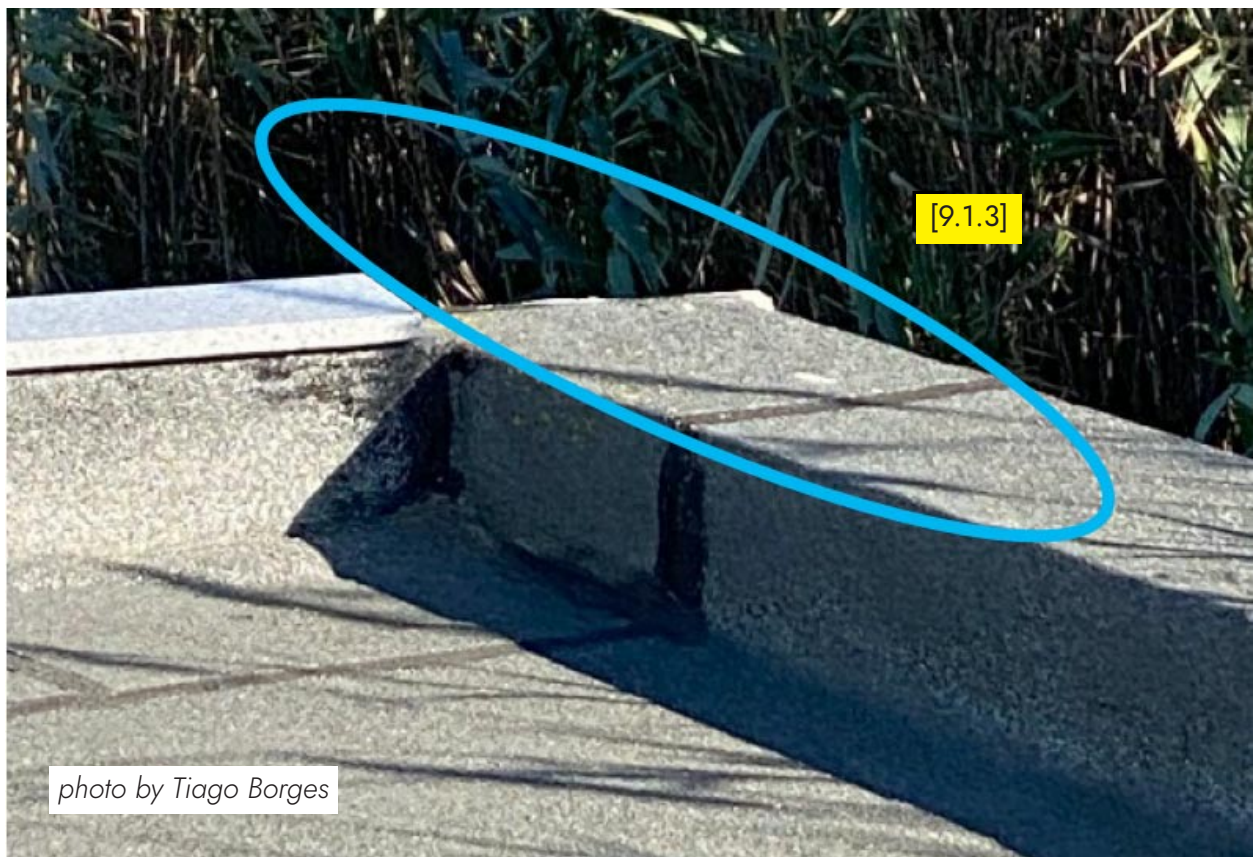
9.1.3. Lack of capping on the wall on the east side, roofing felt not properly welded.

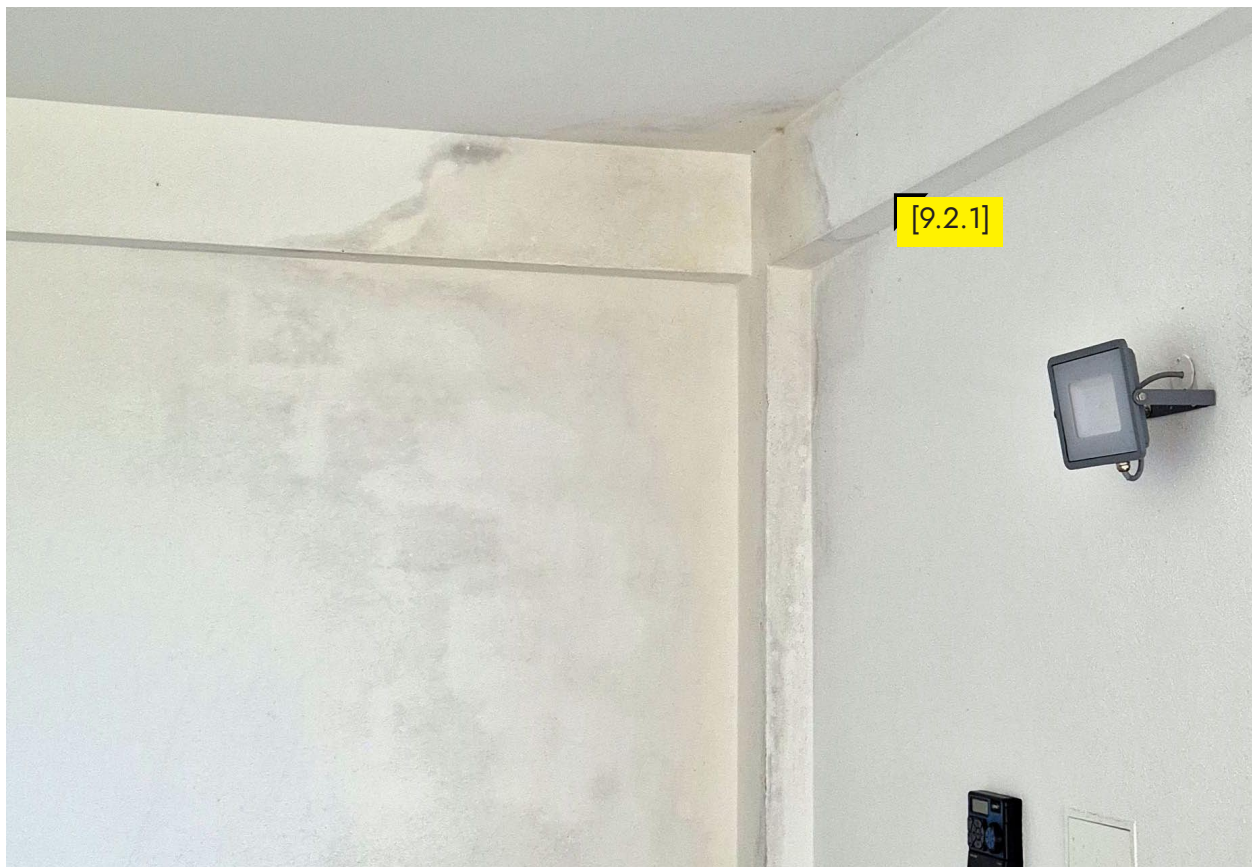
9.2.1. Visible signs of flooding - the rainwater is penetrating from the roof. Fungus and mould developing on the walls and ceiling.

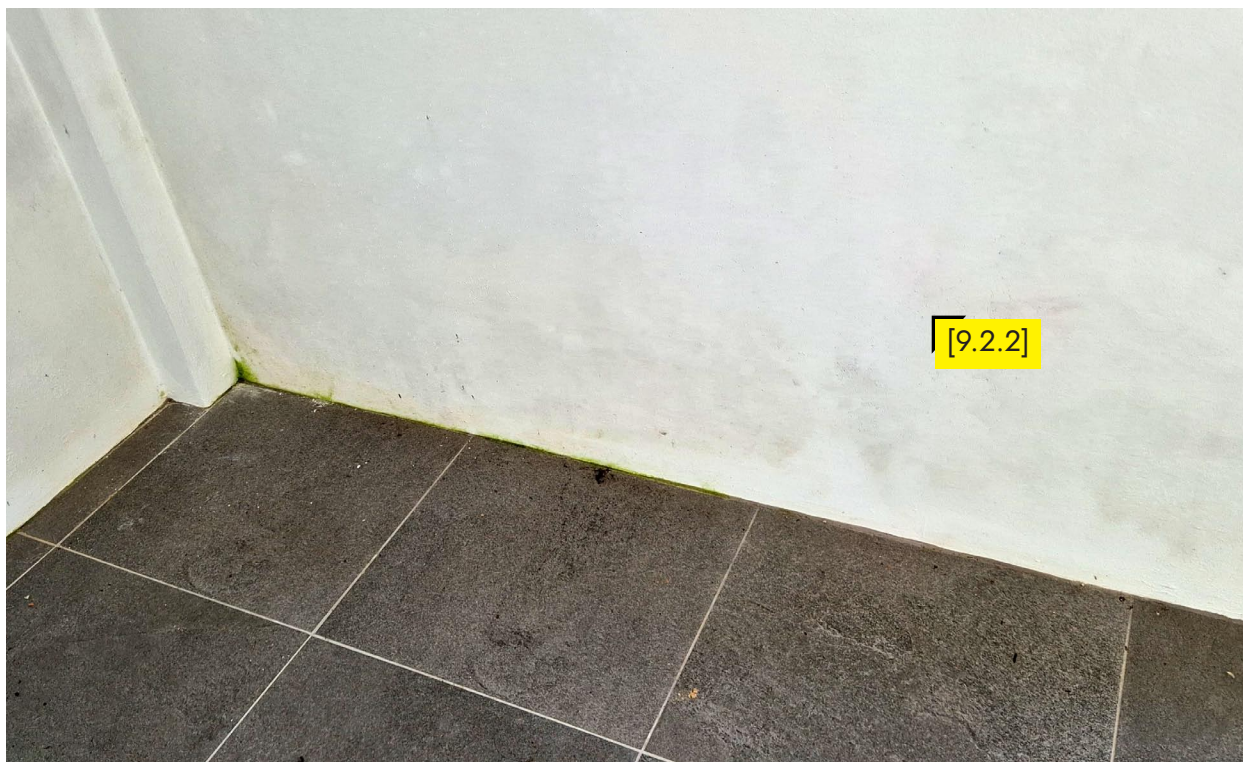
9.2.2. Damp patches on the walls. Green algae growth in plaster.

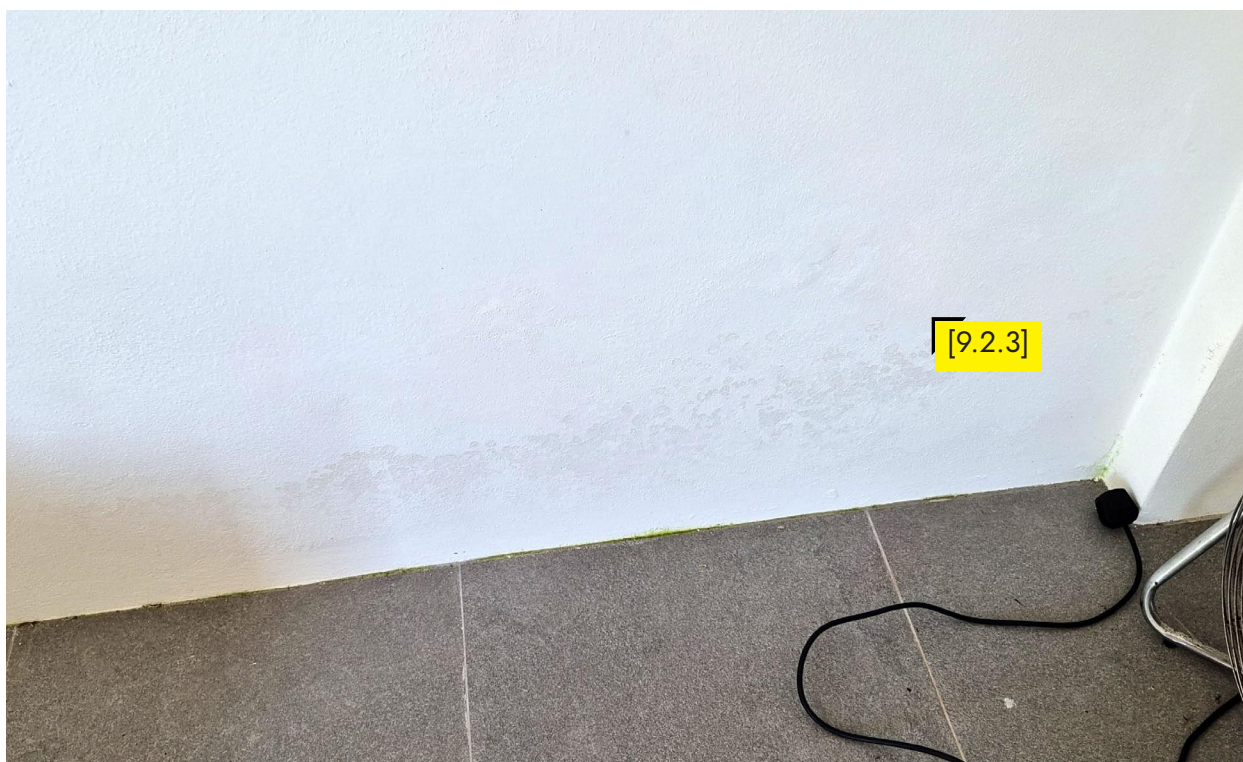
9.2.3. Crumbling plaster, soggy paint coming off.
